**Re: Reconnaissance Inspection (Carroll Co)**  
**AFIN: 08-00029 NPDES Permit No. AR0044300**

On October 4 2013, I performed a reconnaissance inspection of the Statue Road Inn wastewater treatment plant in accordance with the provisions of the federal Clean Water Act, the Arkansas Water and Air Pollution Control Act and the regulations promulgated there under. This inspection revealed the following violation:

UNITED STATES ENVIRONMENTAL PROTECTION AGENCY  
Washington, D.C. 20460Form Approved  
OMB No. 2040-0003**NPDES Compliance Inspection Report****Section A: National Data System Coding**

Statue Road Inn located on the east side of Eureka Springs North of Hwy 62 at 909  
Passion Play Road in Carroll County

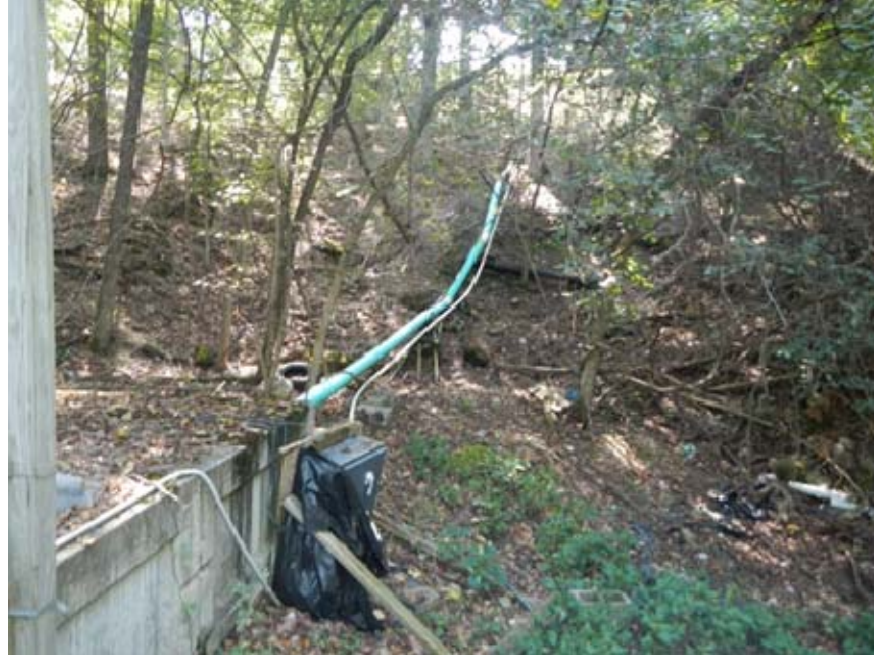
| <b>Photo #</b> | 1 | <b>Of</b> | 4 | <b>Date:</b> | 10/04/13 | <b>Time:</b> | 12:58 |

| <b>Description:</b> | Inflow piping dropping downhill from the motel to the treatment plant head works. | | | | | | |

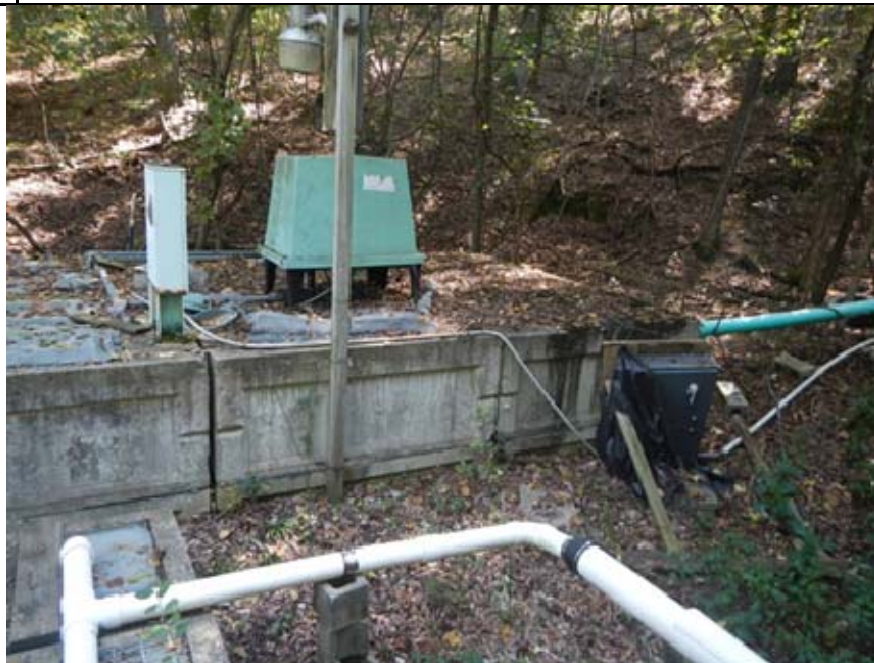
| <b>Photo #</b> | 2 | <b>Of</b> | 4 | <b>Date:</b> | 10/04/13 | <b>Time:</b> | 13:00 |

| <b>Description:</b> | Aeration tank with blower motor and electrical control panel propped up with boards. | | | | | | |

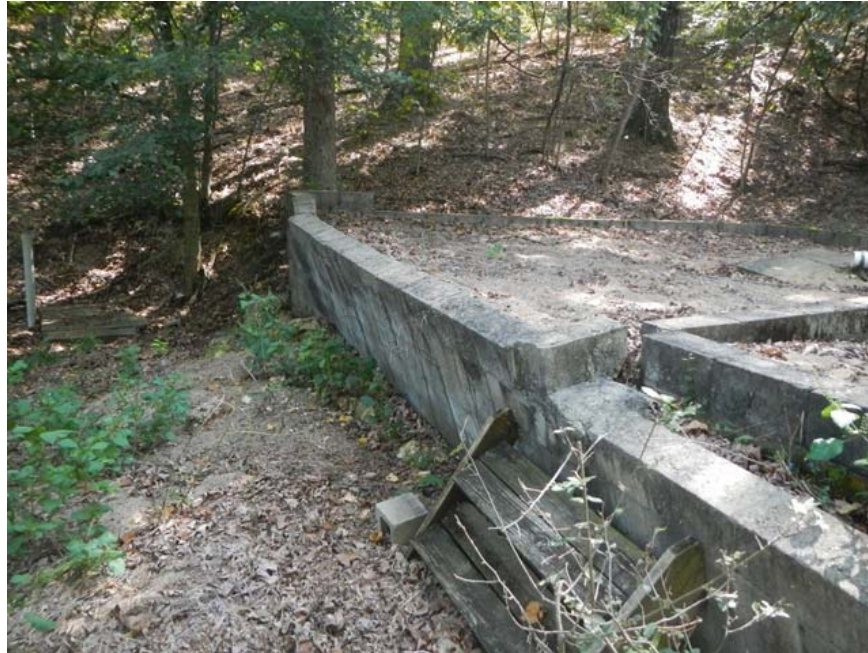
| <b>Photo #</b> | 3 | <b>Of</b> | 4 | <b>Date:</b> | 10/04/13 | <b>Time:</b> | 12:56 |

**You have failed to properly operate and maintain the treatment system, which is a violation of Part II Section B.1 of the permit.** At the time of this inspection, the plant was not operating and appeared to have been shut down for an extended period of time. The treatment units were in a state of disrepair. Of particular concern was the intermittent sand filter which will likely no longer contain liquid due to cracks in the collapsing north wall.

| <b>Description:</b> | Collapsing north wall of the intermittent sand filter with chlorination/dechlorination on left. | | | | | | |

**As long as the permit remains active, you must continue to submit Discharge Monitoring Reports (DMRs) and report "No Discharge." Prior to restarting the plant, an evaluation of the integrity of all piping and treatment units must be done, and the plant will have to be reseeded with activated sludge.**

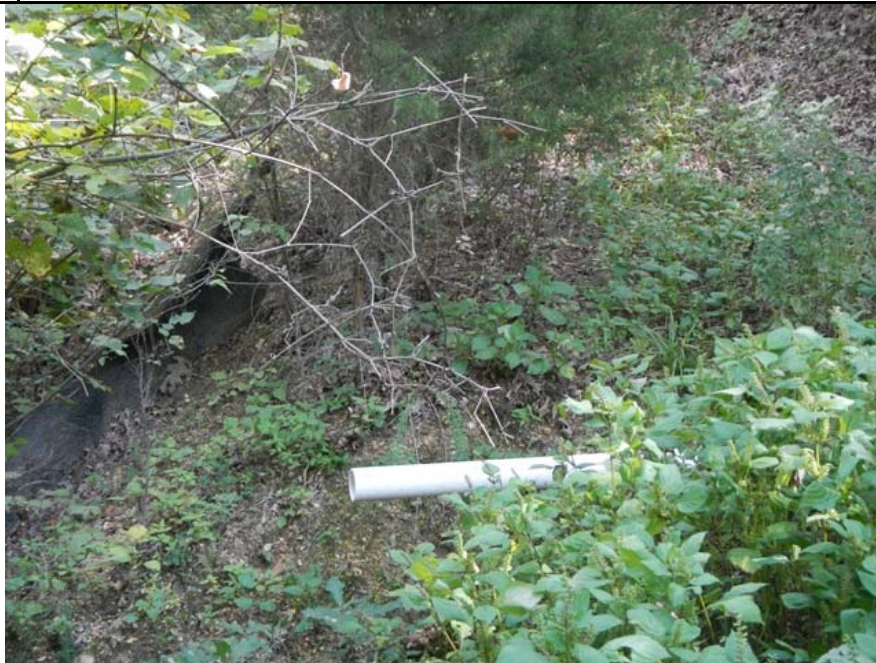
| <b>Photo #</b> | 4 | <b>Of</b> | 4 | <b>Date:</b> | 10/04/13 | <b>Time:</b> | 12:55 |

| <b>Description:</b> | Outfall 001 with no discharge from the plant. | | | | | | |
