Appendix C

Lake Conway Depositional Layer
Assessment Photographs

EXXONMOBIL ENVIRONMENTAL SERVICES COMPANY
MAYFLOWER PIPELINE INCIDENT RESPONSE, MAYFLOWER, ARKANSAS
DOWNSTREAM AREAS DATA ASSESSMENT REPORT

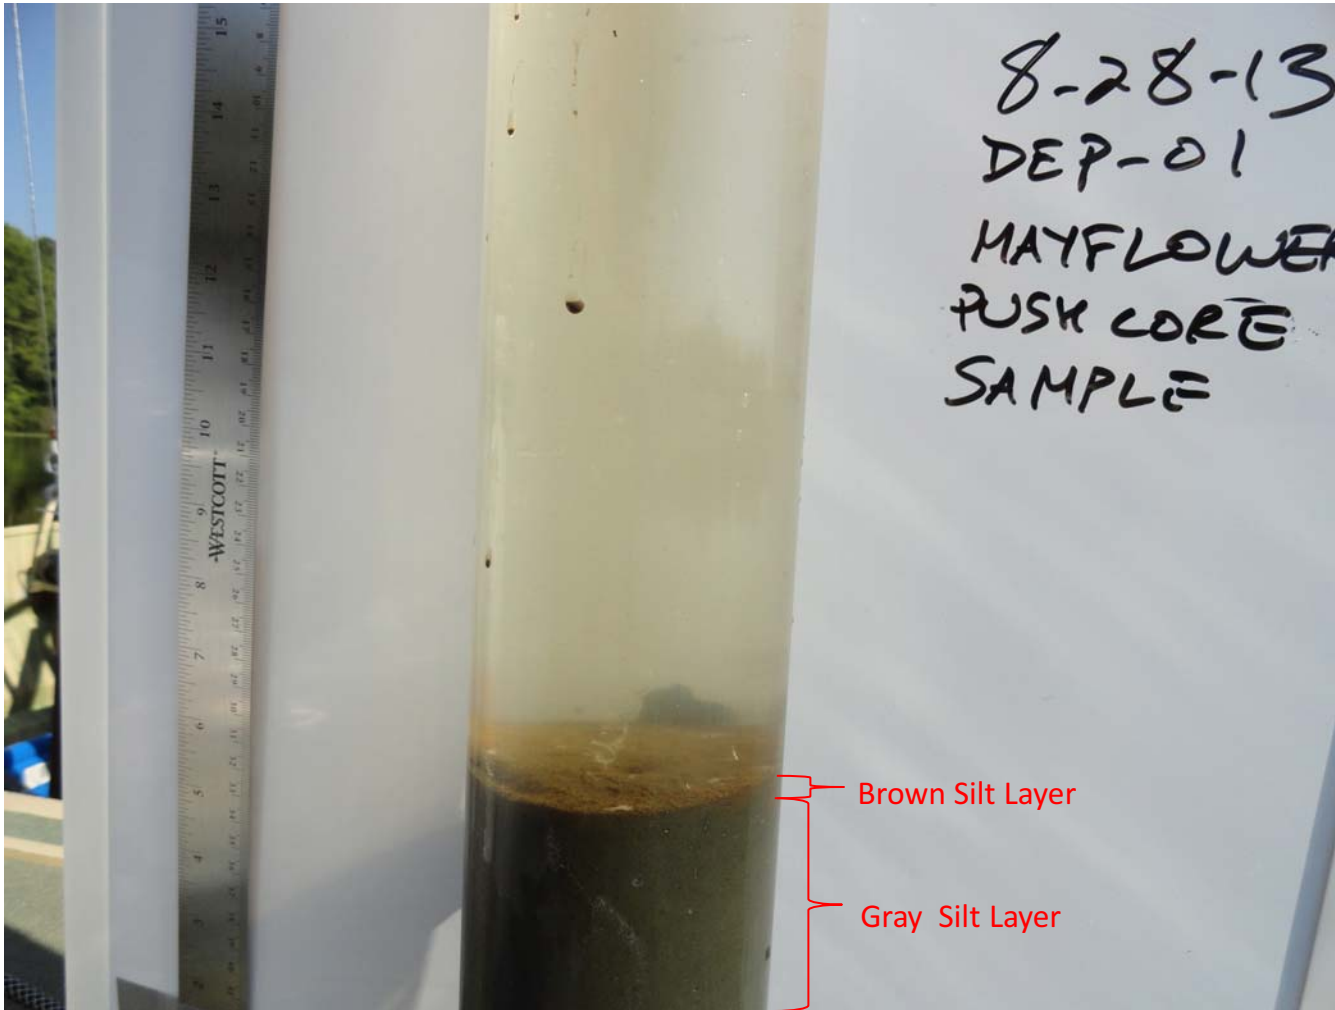
FIGURE
C-1

DEPOSITIONAL LAYER ASSESSMENT
CORE: DEP-01

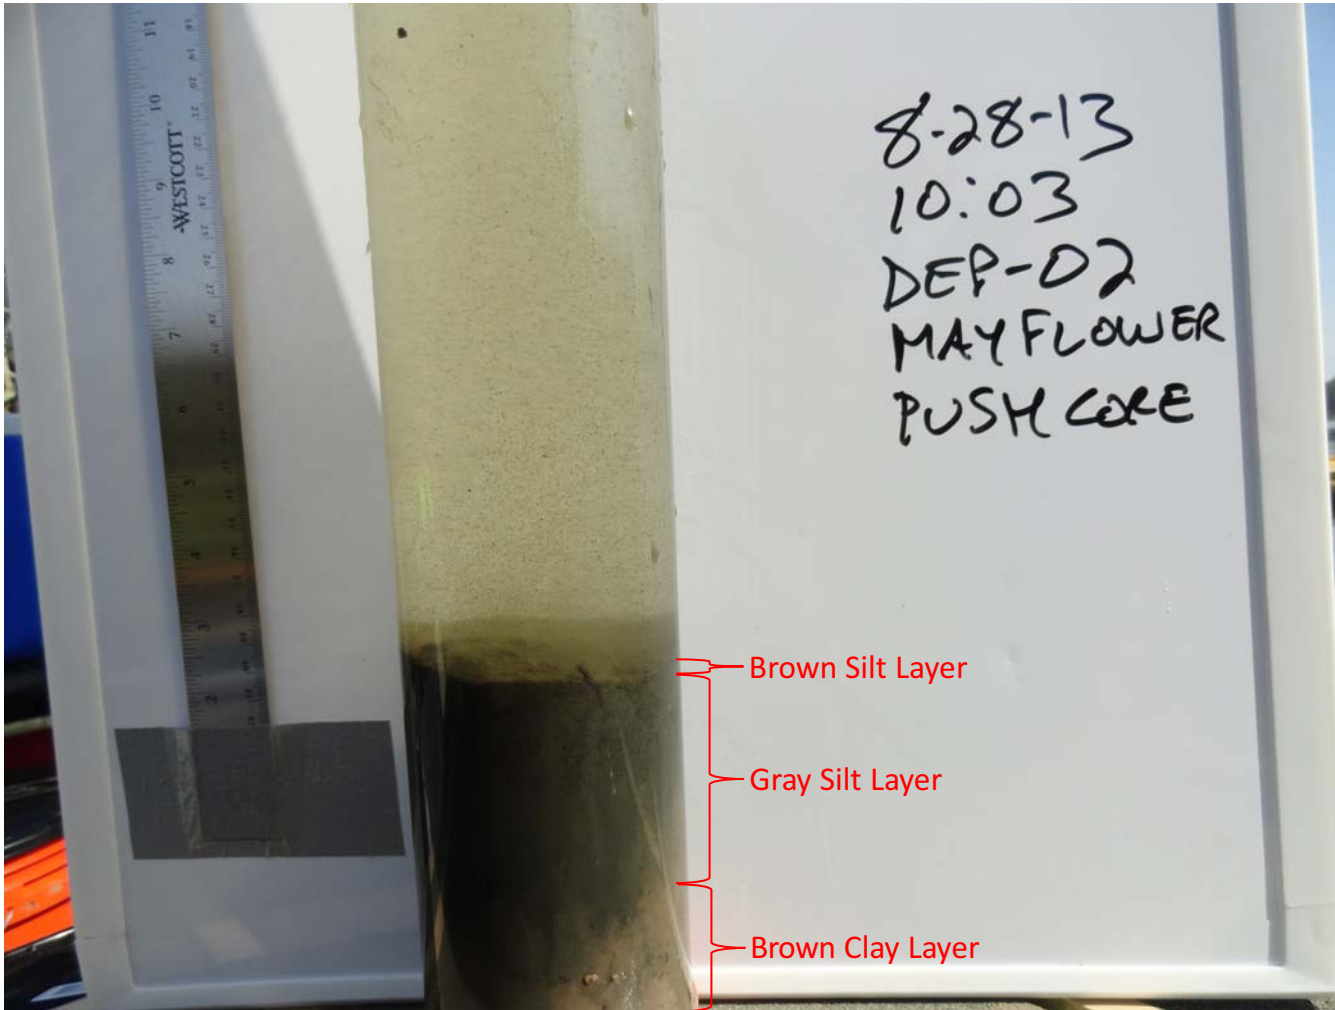
FIGURE
C-2

DEPOSITIONAL LAYER ASSESSMENT
CORE: DEP-02

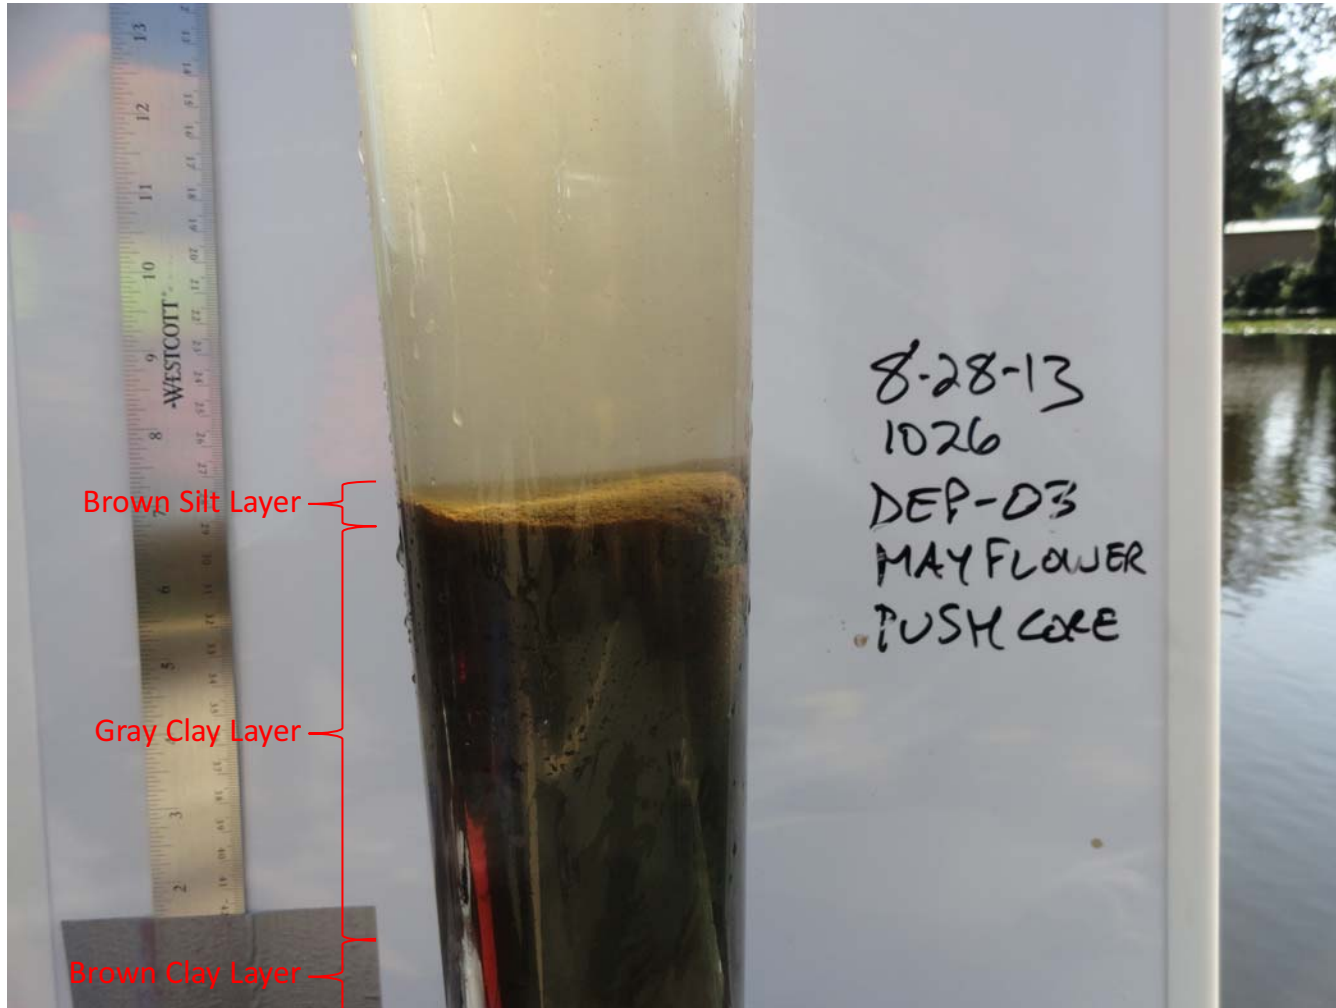
FIGURE
C-3

DEPOSITIONAL LAYER ASSESSMENT
CORE: DEP-03

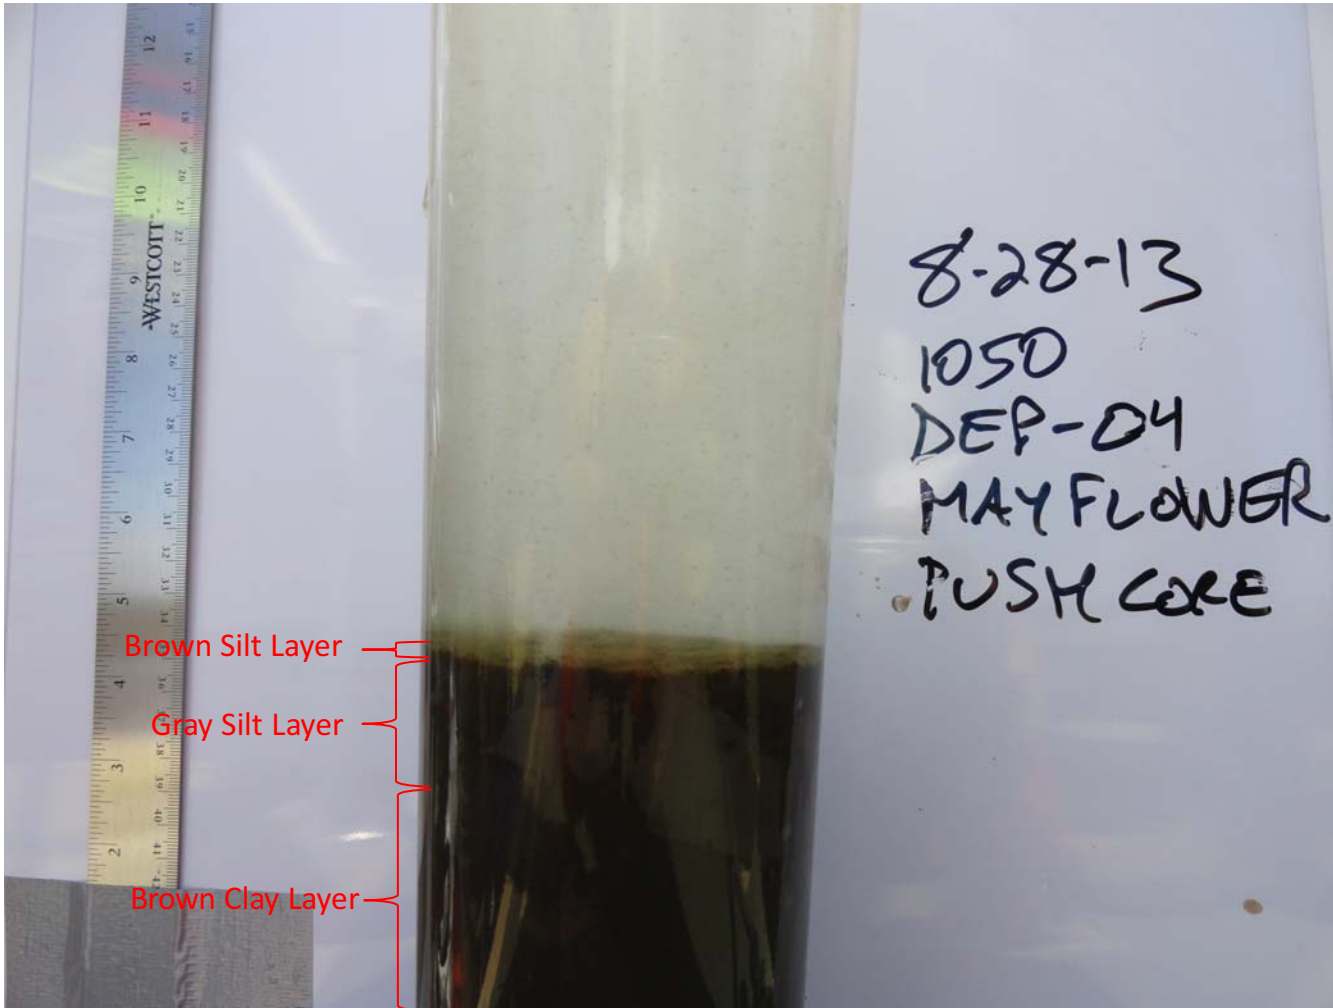
FIGURE
C-4

DEPOSITIONAL LAYER ASSESSMENT
CORE: DEP-04

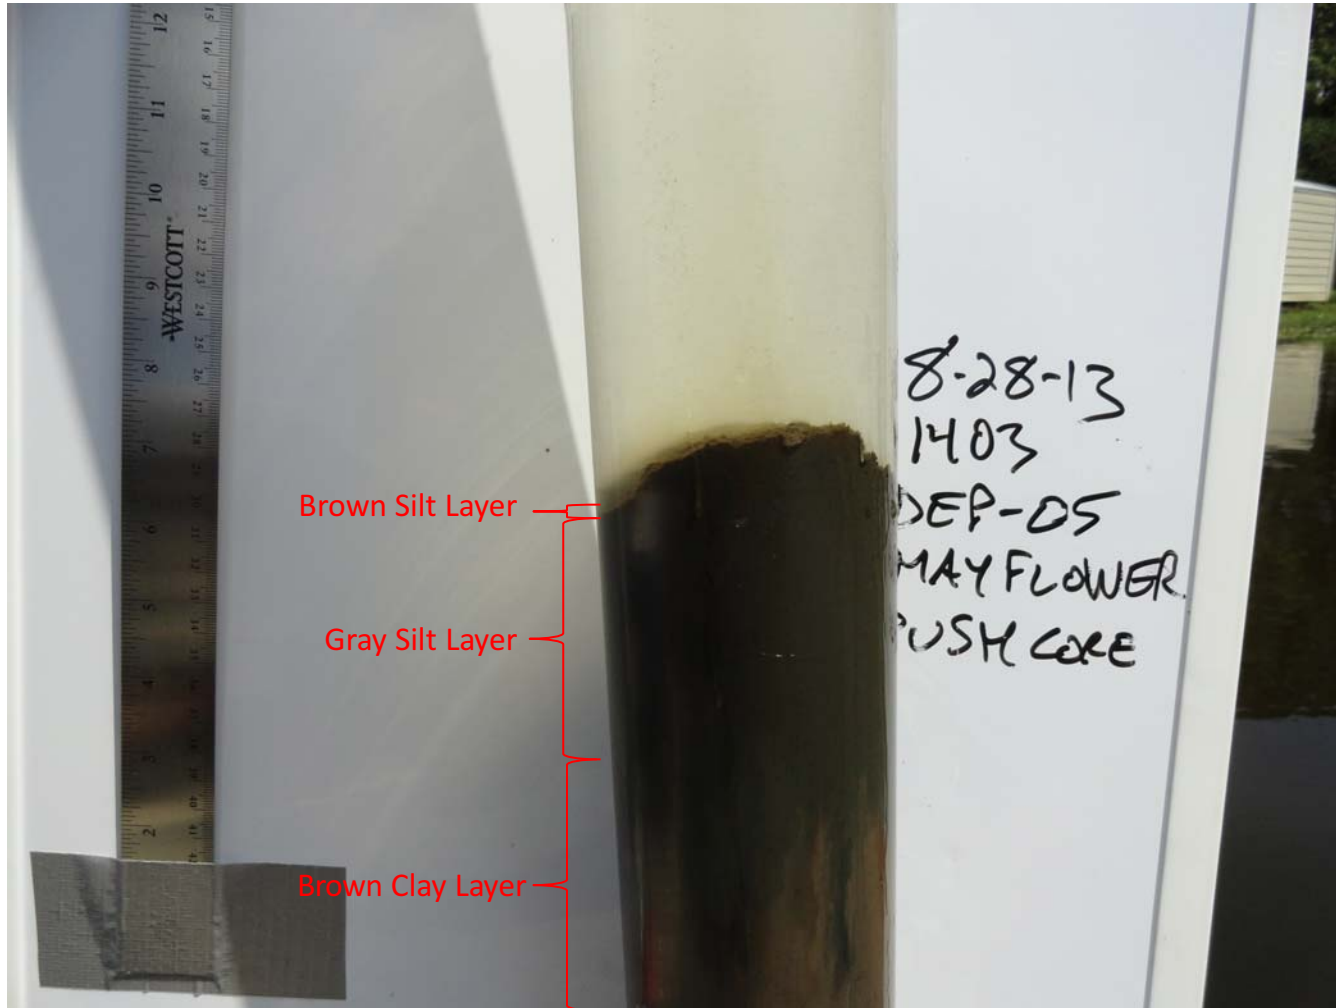
FIGURE
C-5

DEPOSITIONAL LAYER ASSESSMENT
CORE: DEP-05

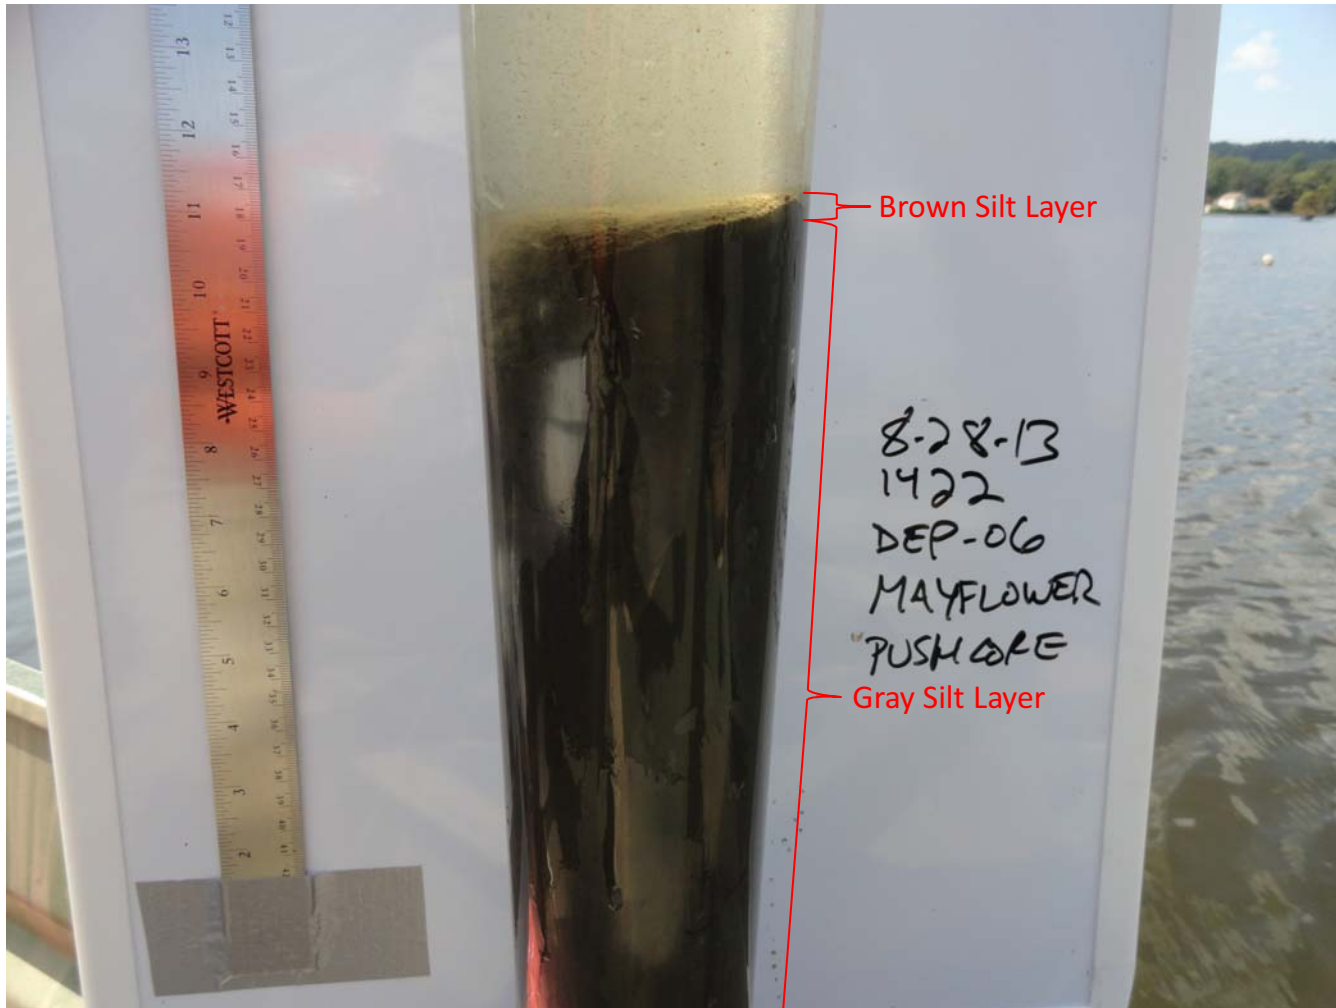
FIGURE
C-6

**DEPOSITIONAL LAYER ASSESSMENT
CORE: DEP-06**

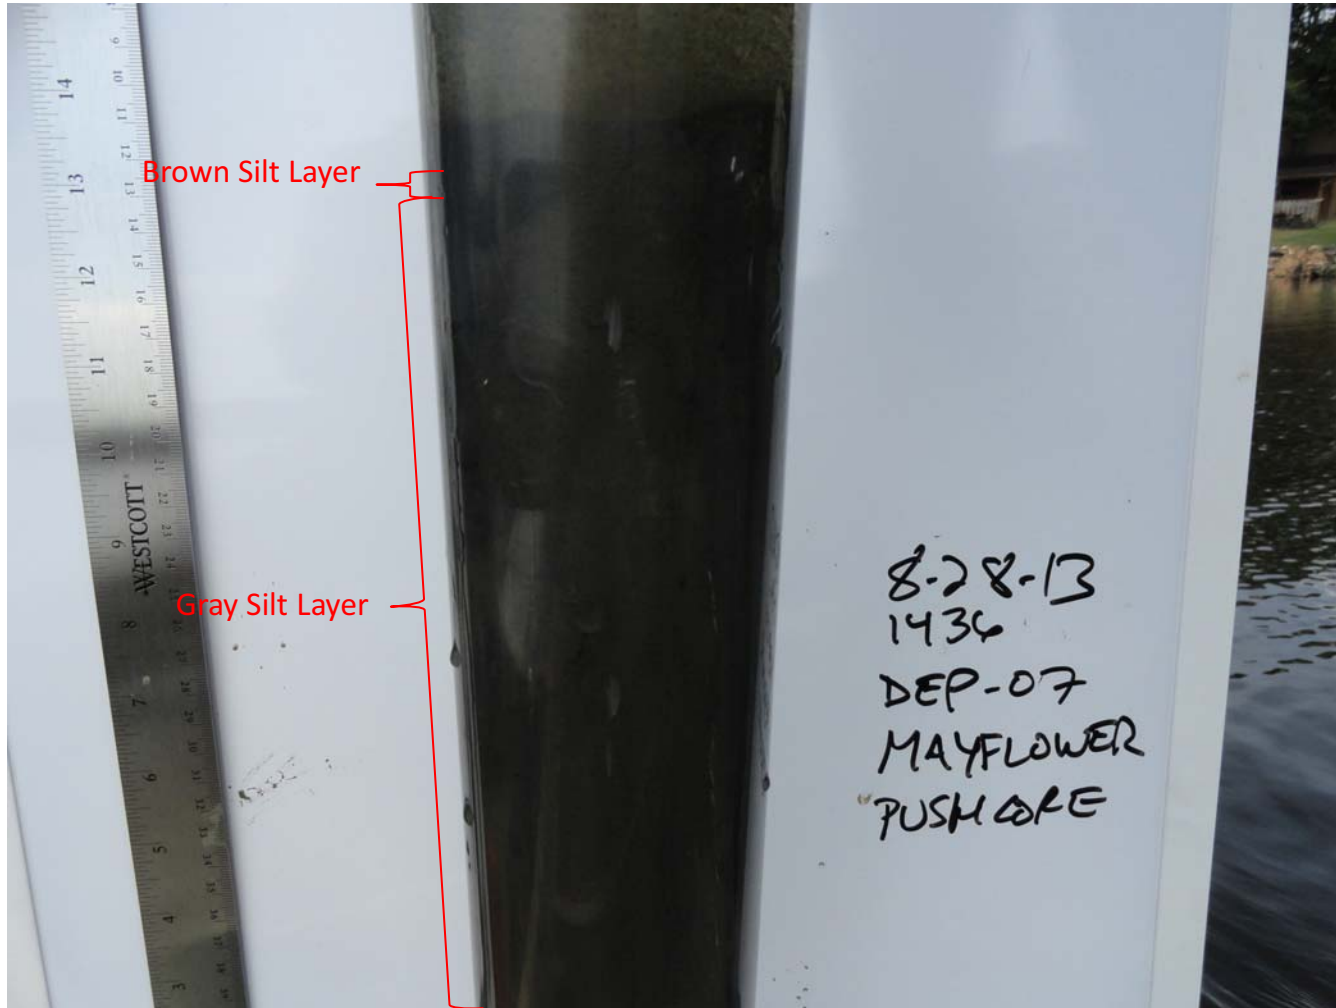
FIGURE
C-7

DEPOSITIONAL LAYER ASSESSMENT
CORE: DEP-07

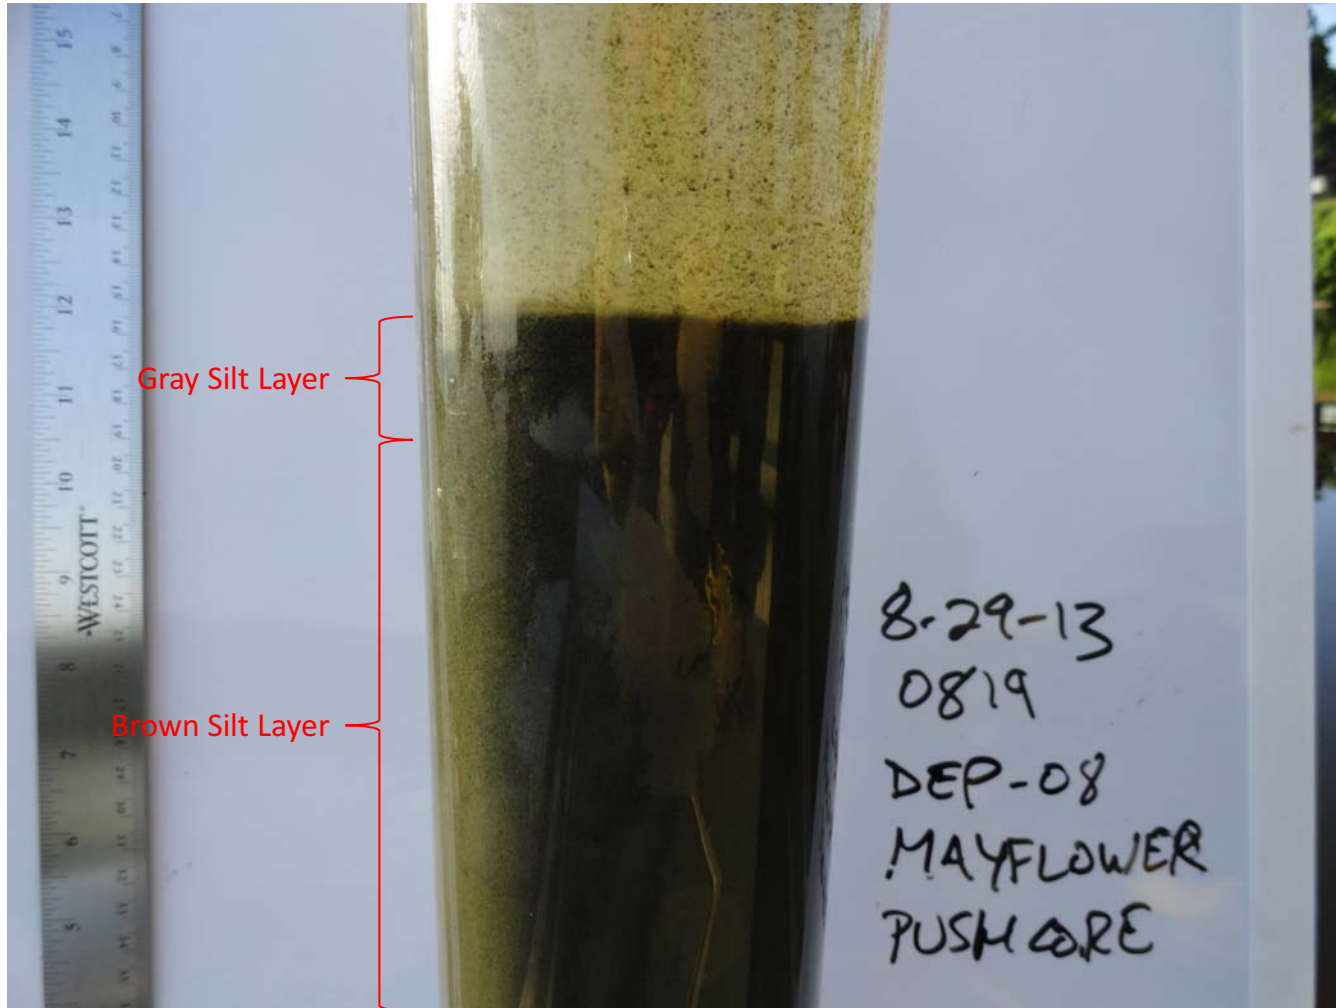
FIGURE
C-8

DEPOSITIONAL LAYER ASSESSMENT
CORE: DEP-08

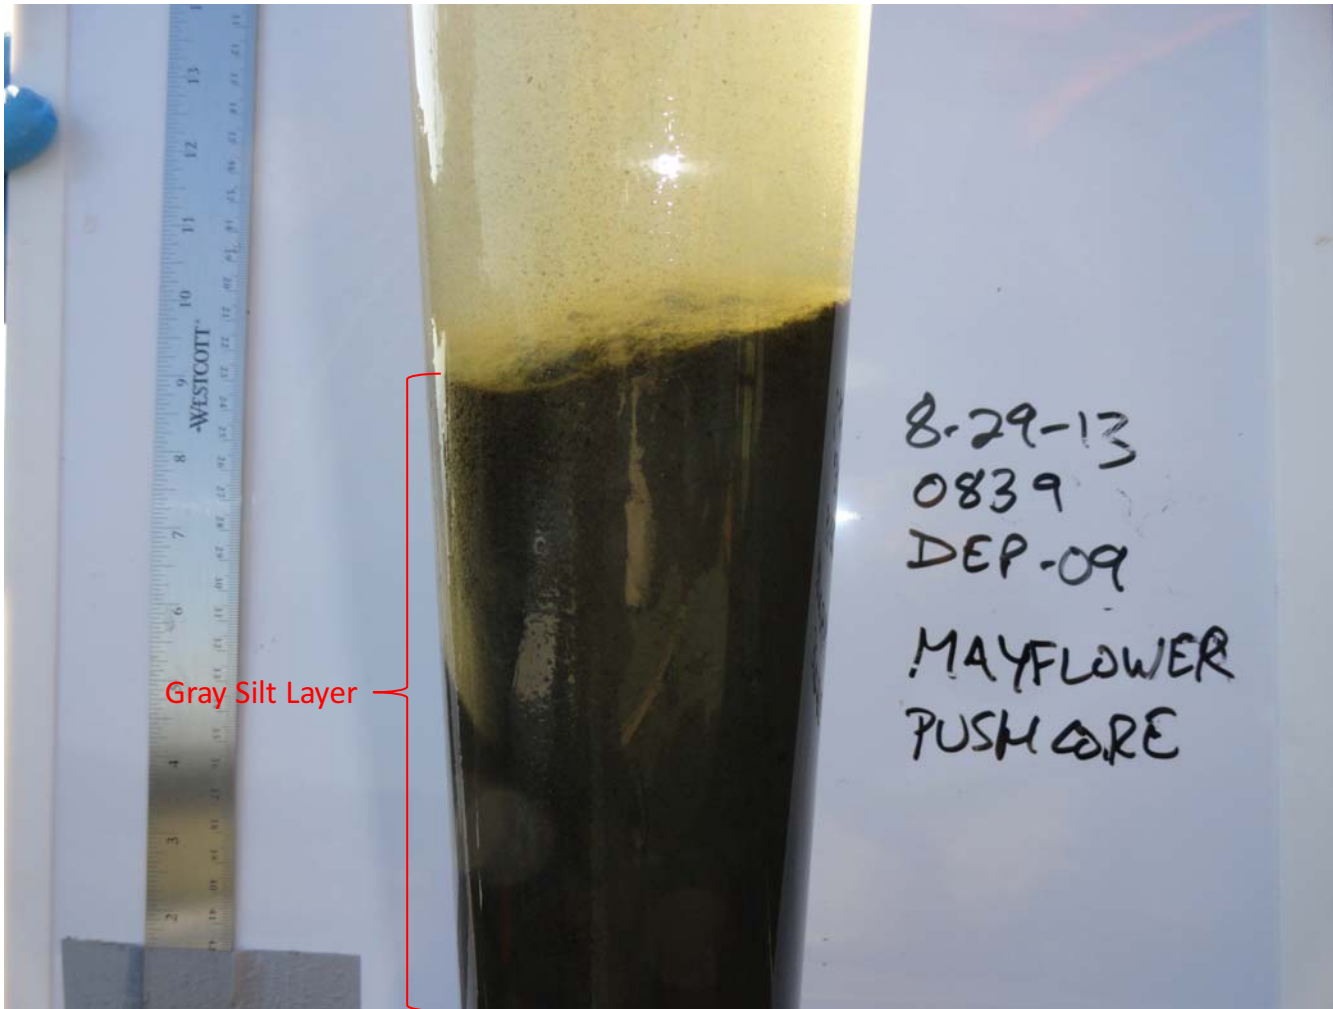
FIGURE
C-9

DEPOSITIONAL LAYER ASSESSMENT
CORE: DEP-09

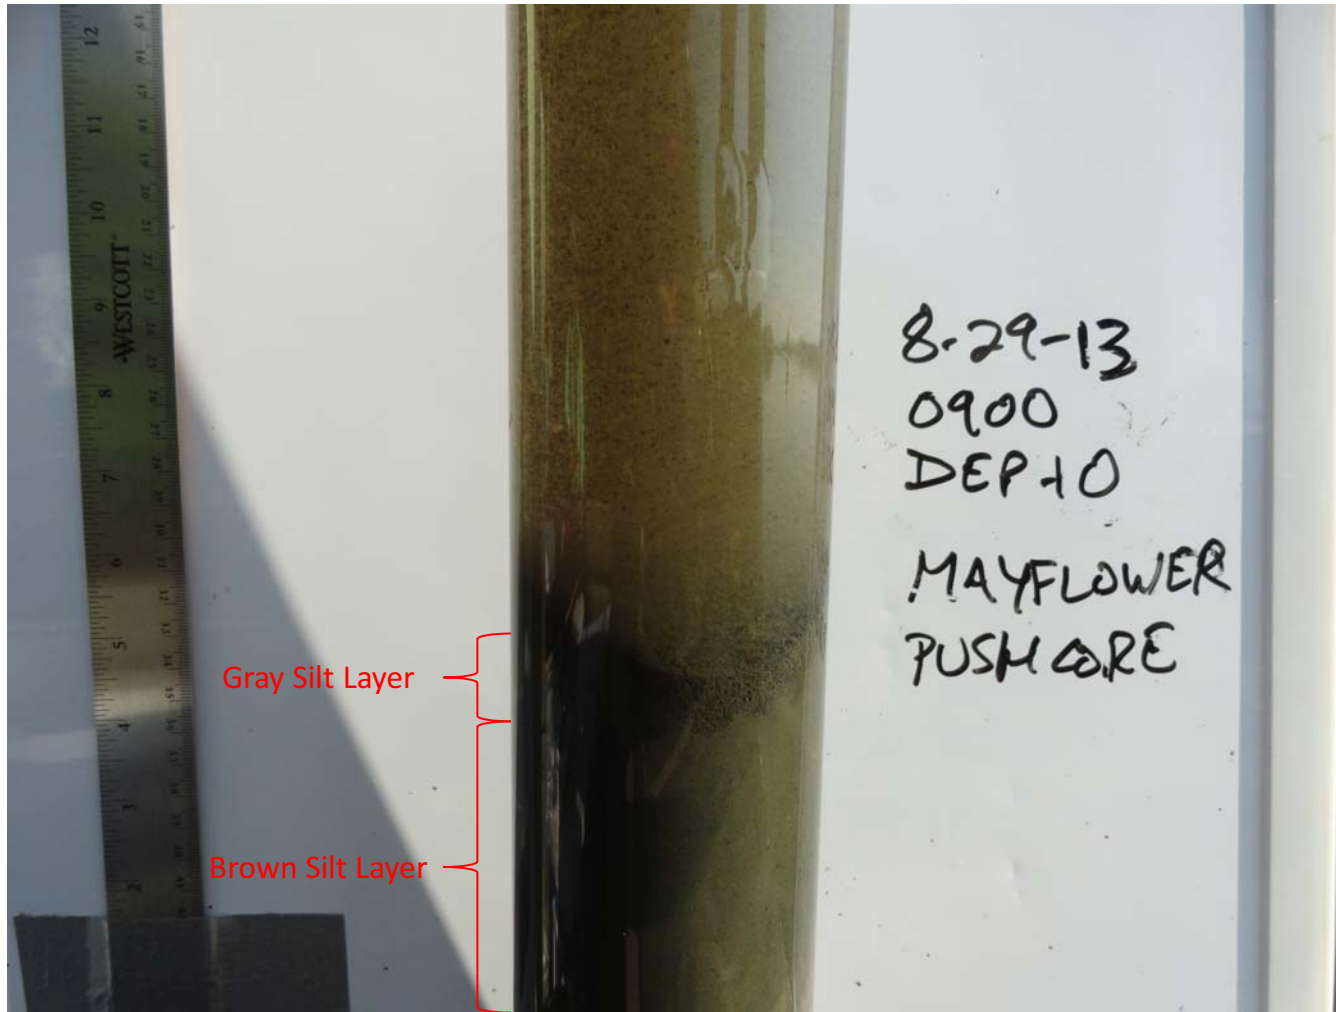
FIGURE
C-10

DEPOSITIONAL LAYER ASSESSMENT
CORE: DEP-10

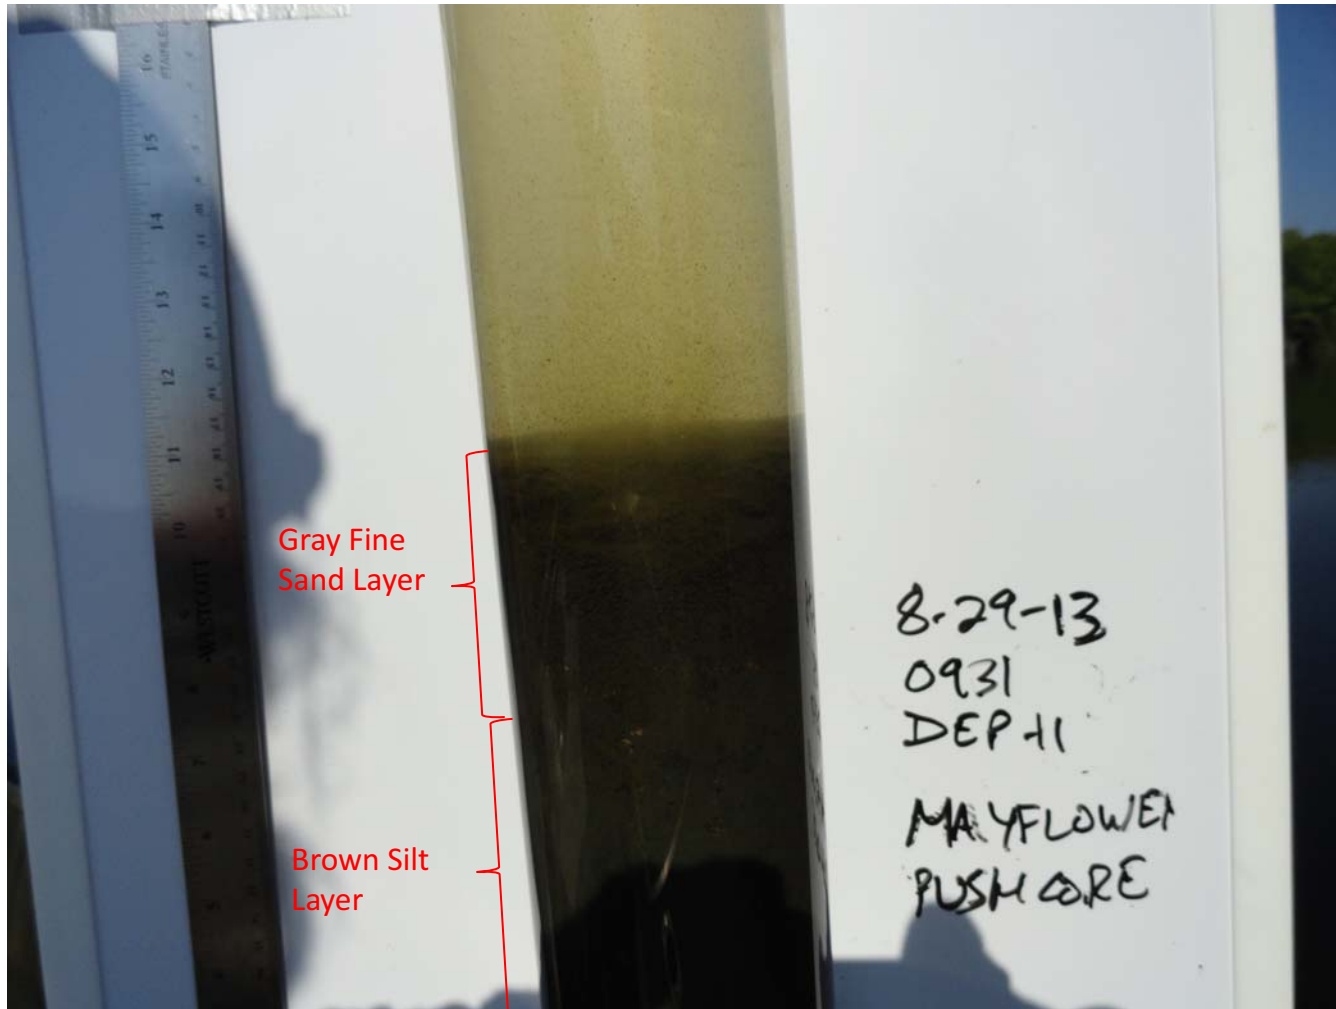
FIGURE
C-11

DEPOSITIONAL LAYER ASSESSMENT
CORE: DEP-11

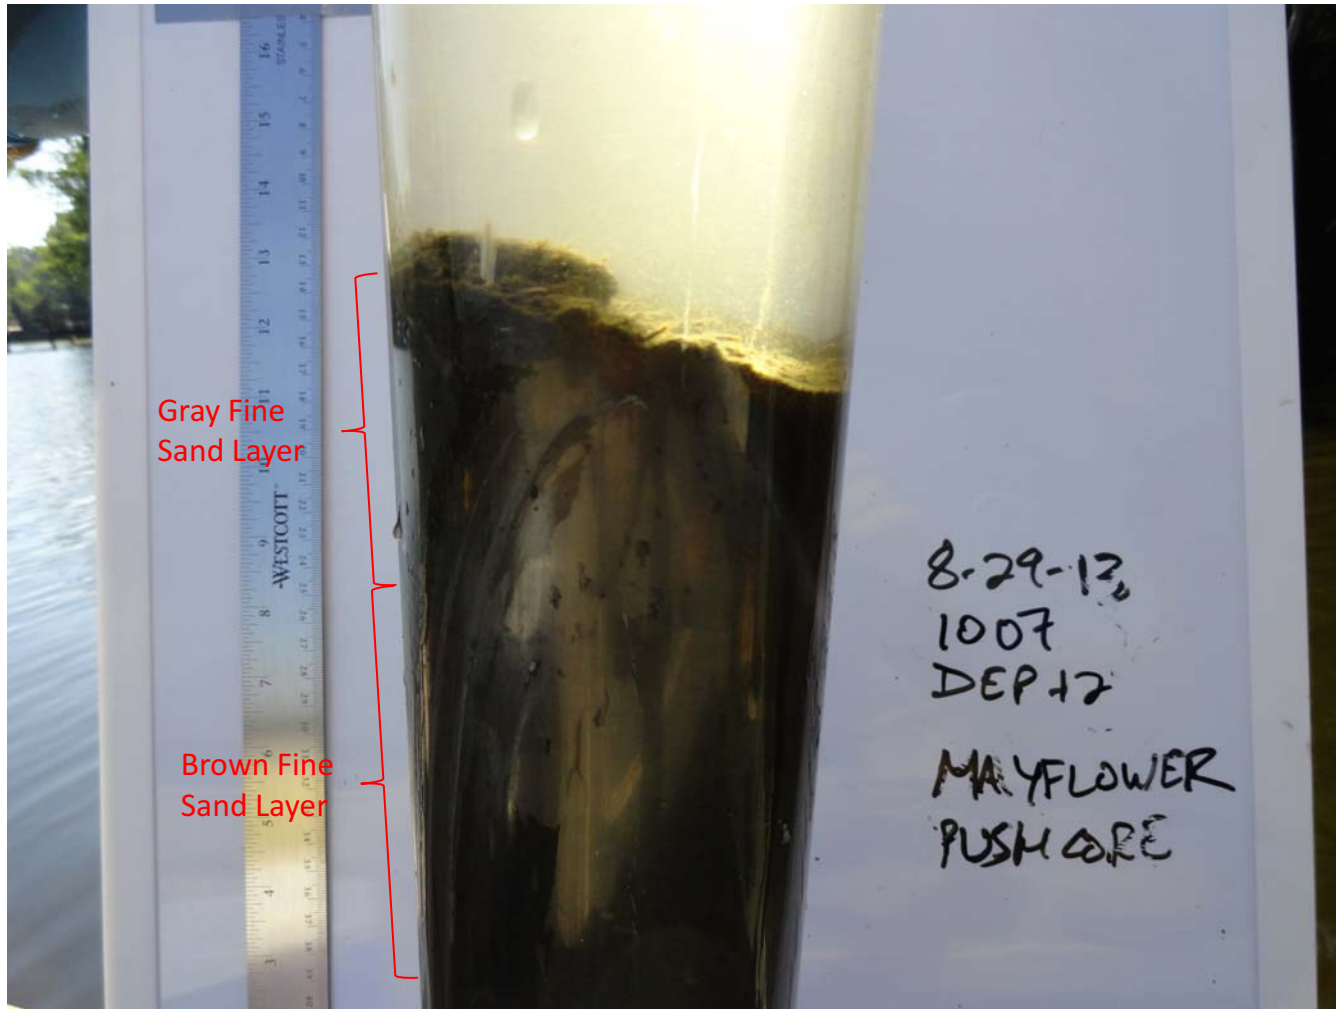
FIGURE
C-12

DEPOSITIONAL LAYER ASSESSMENT
CORE: DEP-12

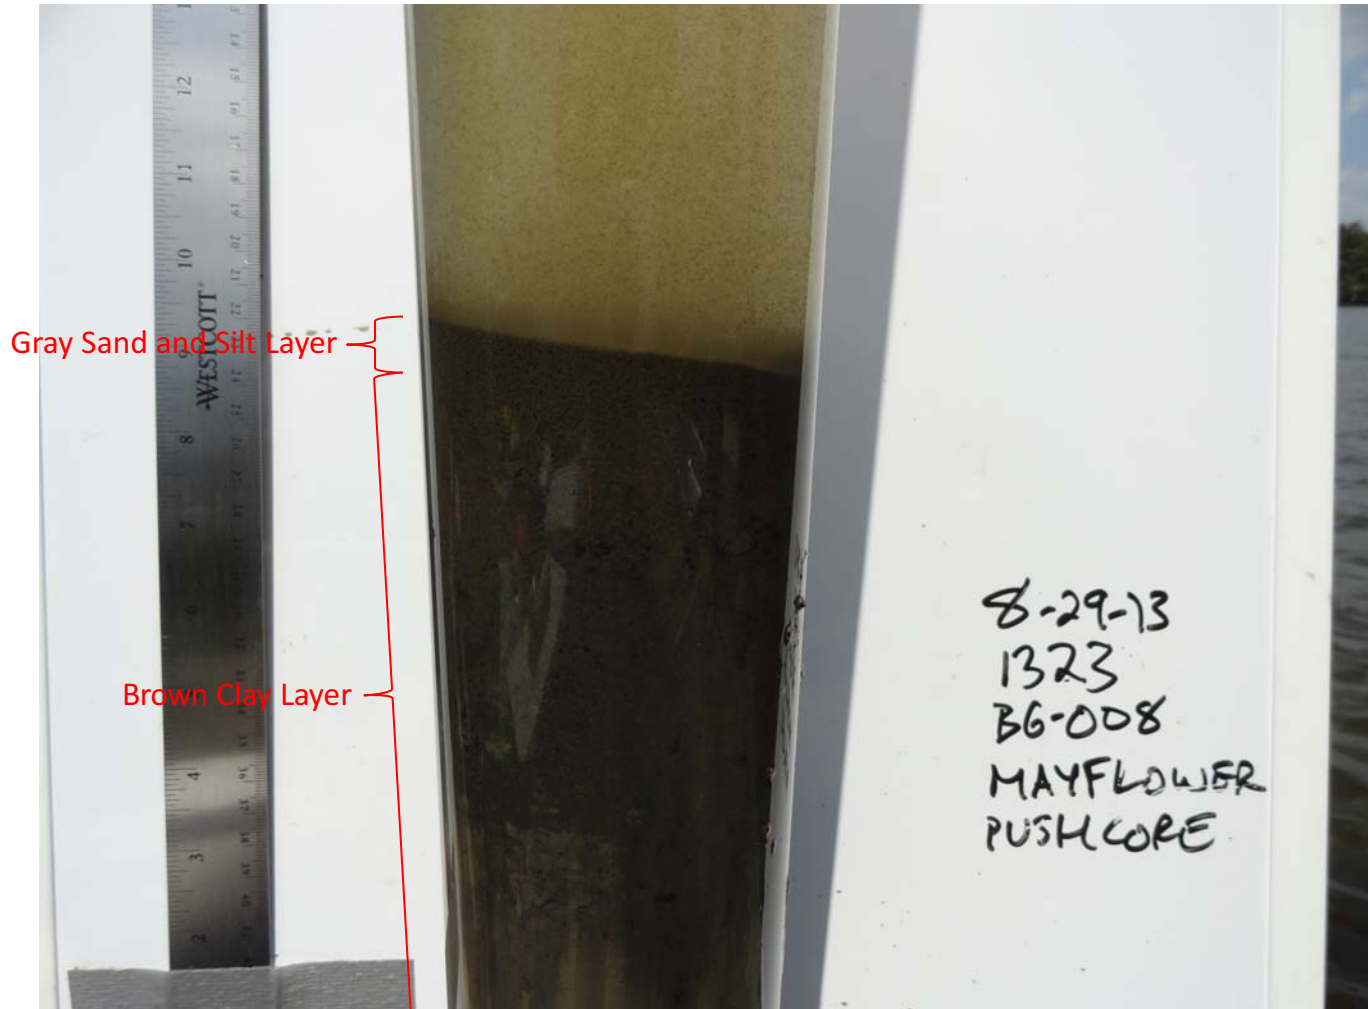
FIGURE
C-13

DEPOSITIONAL LAYER ASSESSMENT
CORE: DEP-BG-008

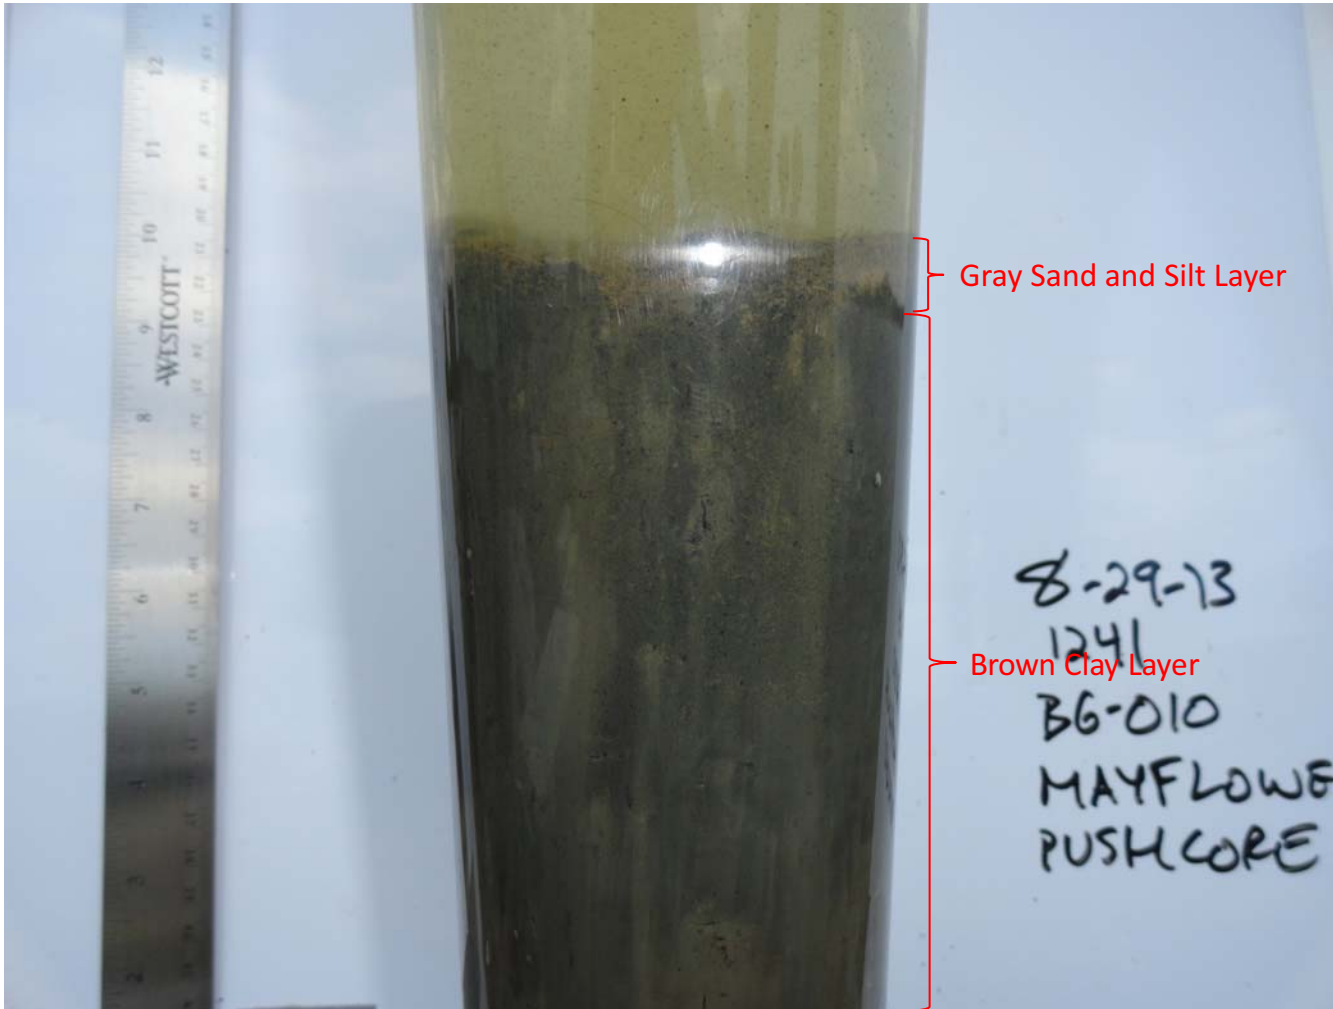
FIGURE
C-14

DEPOSITIONAL LAYER ASSESSMENT
CORE: DEP-BG-010

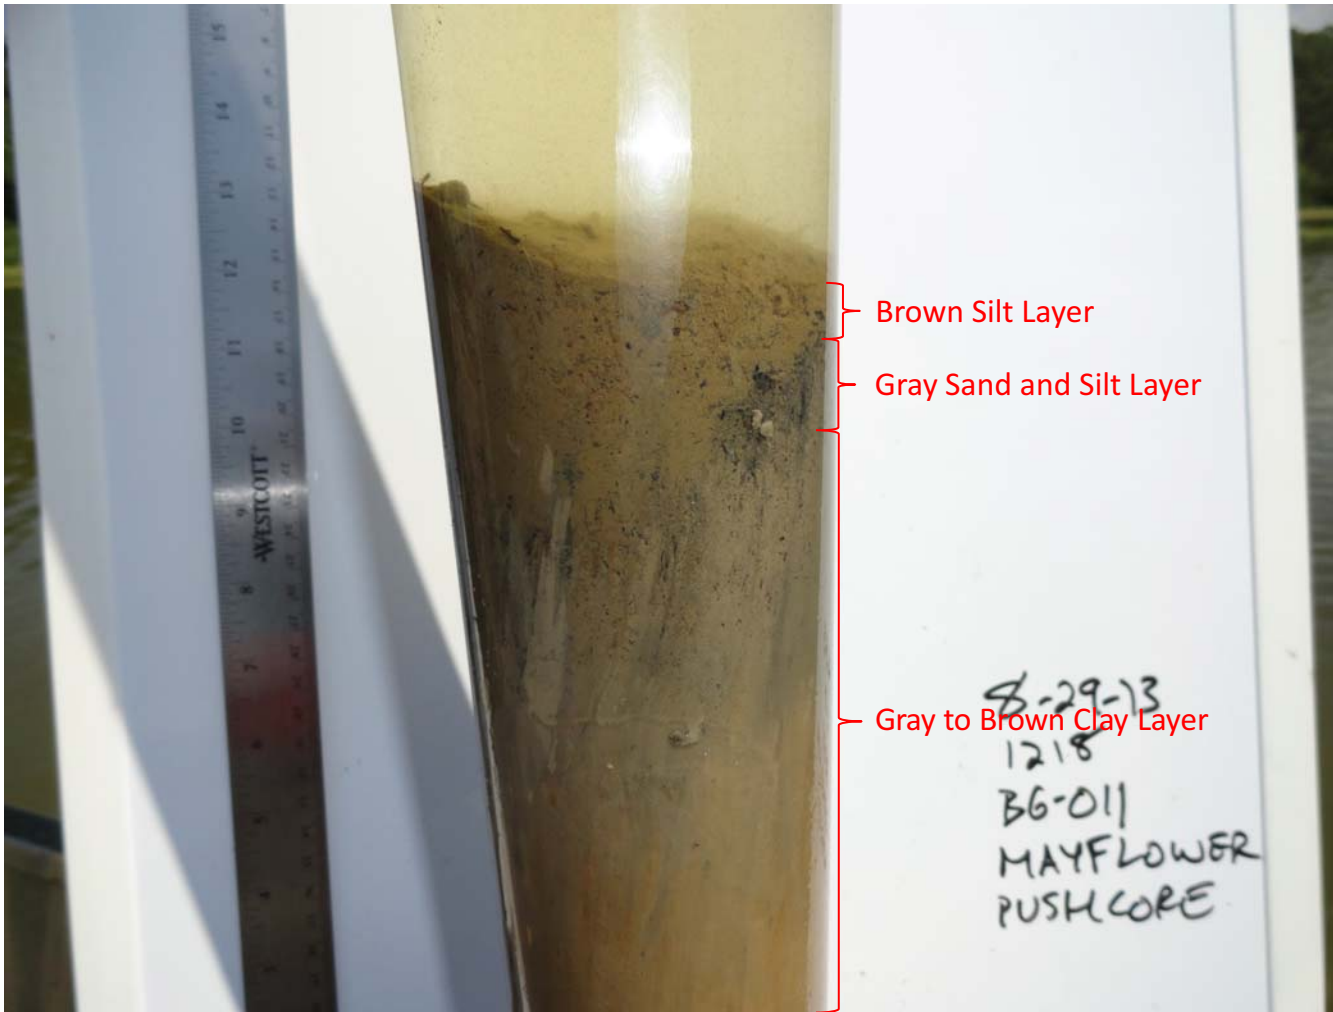
FIGURE
C-15

DEPOSITIONAL LAYER ASSESSMENT
CORE: DEP-BG-011

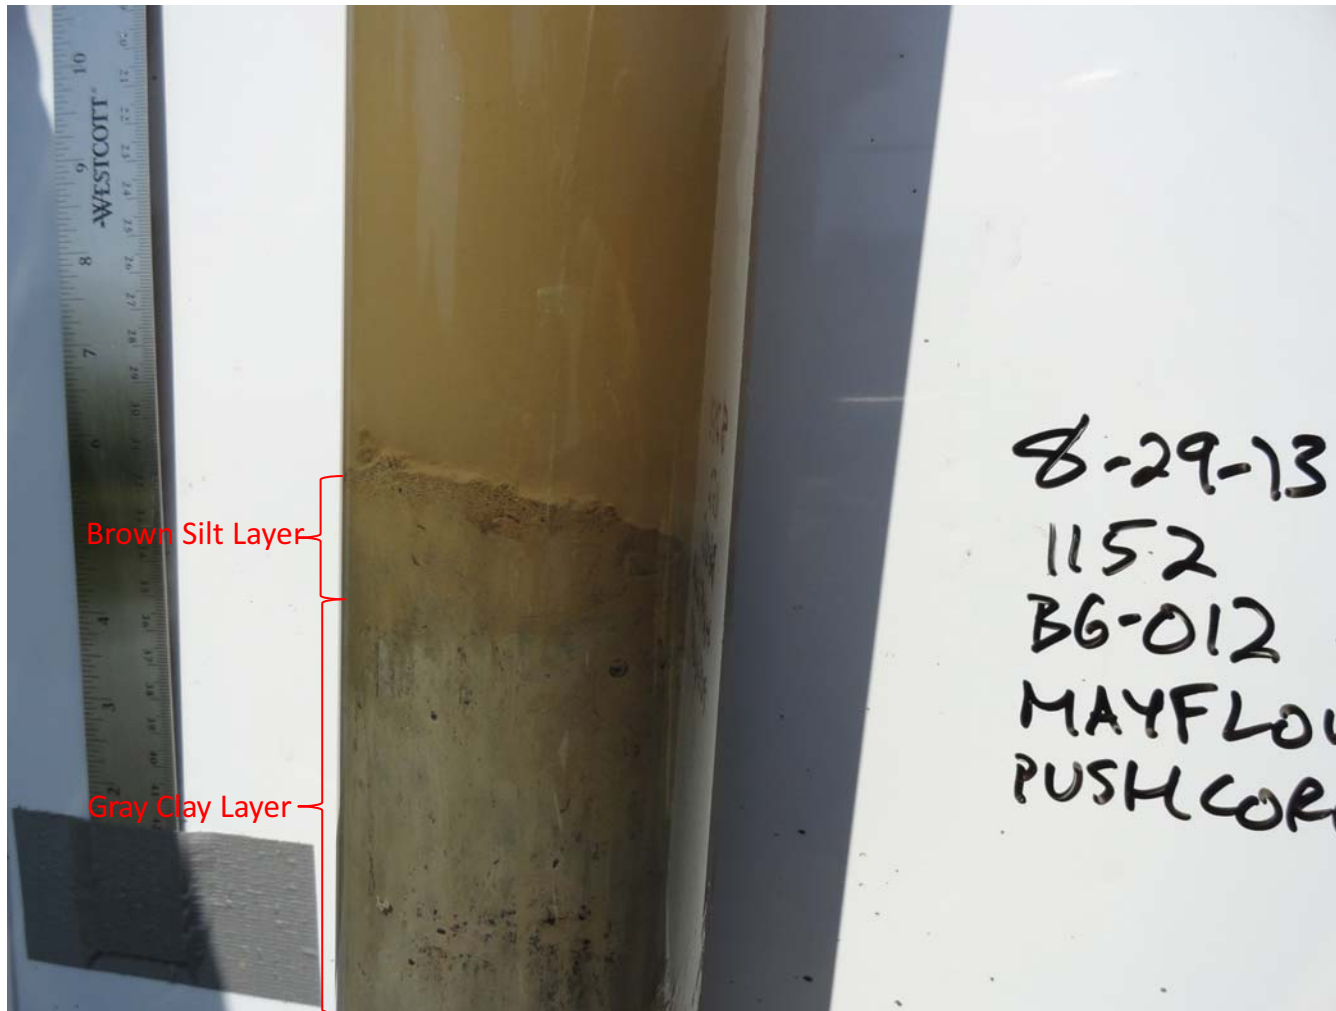
FIGURE
C-16

DEPOSITIONAL LAYER ASSESSMENT
CORE: DEP-BG-012
