Sheen Monitoring Report #10

Mayflower Pipeline Incident Response

Mayflower, Arkansas

Monitoring Period: Daily from 12/23/2013 through 12/29/2013

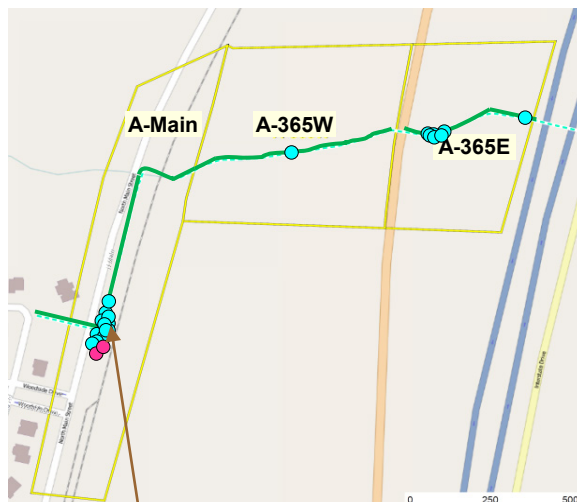
Drainage Ways (Summary of Observations from 12/23/2013 through 12/29/2013)

- A-Main
 - One streamer, six covers (no particular structure), and three patches of metallic sheens; and two covers (no particular structure) of rainbow sheens observed. Sheens broke apart when disturbed (“brittle”)¹.
 - One cover (no particular structure) and one patch of metallic sheens observed. Sheens did not break when disturbed (“non-brittle”)².
- A365W
 - One cover (no particular structure) of brittle¹ metallic sheens observed.
- A365E
 - Four covers (no particular structure) and two patches of brittle¹ metallic sheens, and one patch of brittle¹ rainbow sheens observed.

Mitigation: Suspected petrogenic sheens were removed using absorbent materials.

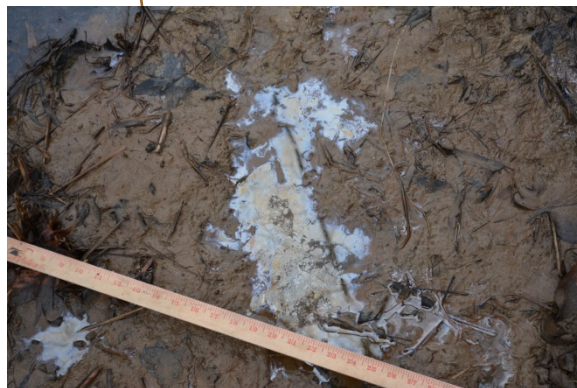
Rainbow Sheen Cover Observation on 12/28/2013

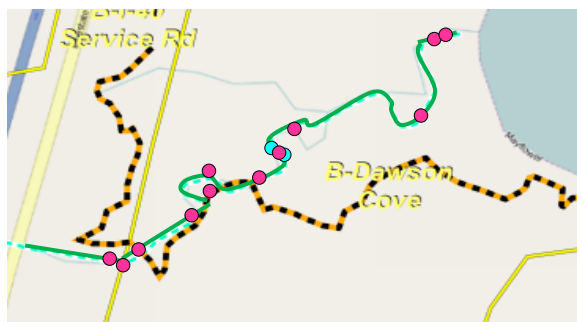
Dawson Cove Inlet Channel (Summary of Observations from 12/23/2013 through 12/29/2013)

- One cover (no particular structure) and one patch of brittle¹ metallic sheens observed.
- Five patches (four with 0.1-inch wide oil spots), five covers (no particular structure), and two streamers (one with 0.1-inch wide oil spots) of non-brittle² rainbow sheens observed.

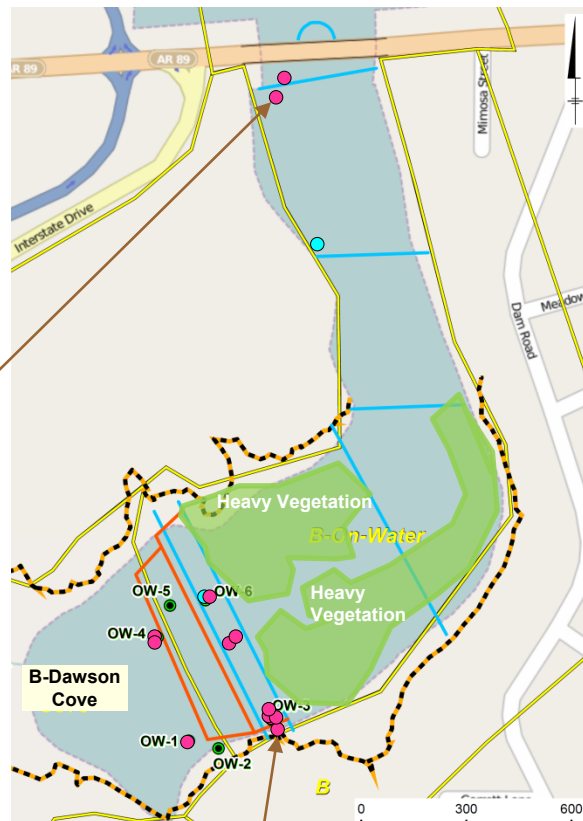
Dawson Cove (Summary of Observations from 12/23/2013 through 12/29/2013)

- Four patches (with 0.1-, 0.25-, 0.5-, and 0.75-inch wide oil spots) and eight streamers (with 0.1-, 0.25-, and 0.5-inch wide oil spots) of non-brittle² rainbow sheens; and one streamer of non-brittle² metallic sheens observed.
- One patch of brittle¹ metallic sheens and one patch of brittle¹ rainbow sheens observed.

- Continue sheen monitoring in all areas.

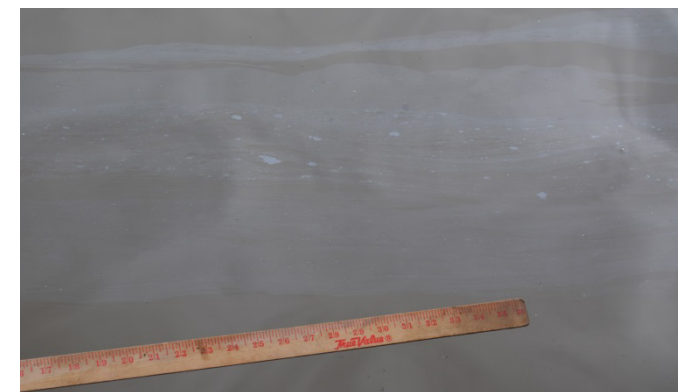
Rainbow Sheen Streamer Observation on 12/28/2013

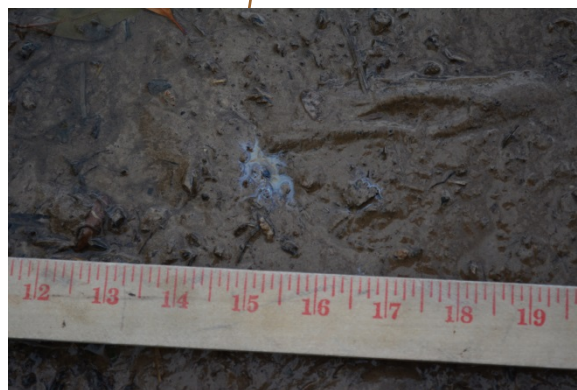
Rainbow Sheen Patch with Small Oil Spots (0.1-inch Wide) Observation on 12/23/2013
