Sheen Monitoring Report #11

Monitoring Period: Daily from 12/30/2013 through 01/05/2014

Mayflower Pipeline Incident Response

Mayflower, Arkansas

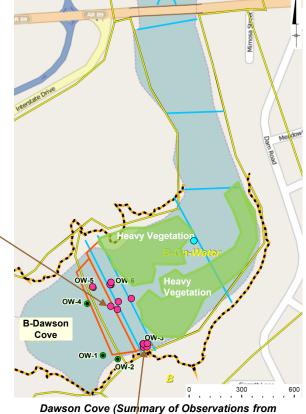
son Cove (Summary of Observations fi 12/30/2013 through 01/05/2014)

- One patch of brittle¹ metallic sheens observed.
- Thirteen streamers of non-brittle² rainbow sheens with small oil spots (nine with 0.25-inch, three with 0.1-inch, and one with 0.75-inch wide oil spots) observed.
