## Sheen Monitoring Report #14

# Mayflower Pipeline Incident Response

## Mayflower, Arkansas

**Monitoring Period:** Daily from 01/20/2014 through 01/26/2014

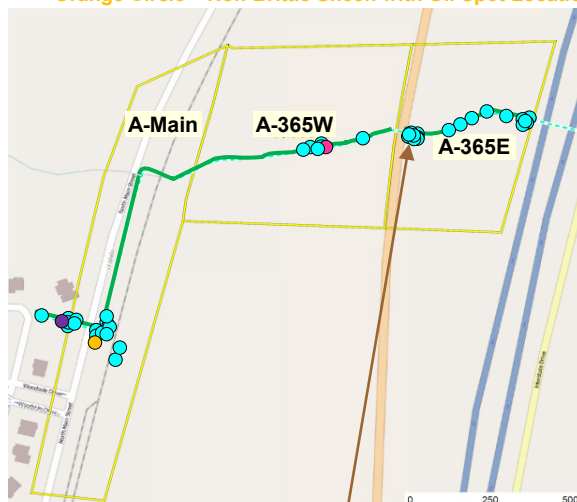
**Drainage Ways (Summary of Observations from 01/20/2014 through 01/26/2014)**

- A-Main
  - Two covers (no particular structure) and one patch/cover of silver gray sheens; three patches, and three covers metallic sheens; three patches and four covers of metallic/silver gray sheens; and one patch of rainbow sheens with 0.2-inch wide oil spot observed. Sheens broke apart when disturbed ("brittle")<sup>1</sup>.

- One patch/cover (no particular structure) of metallic sheens with 0.1-inch wide oil spot observed. Sheens did not break when disturbed ("non-brittle")<sup>2</sup>.

- A-365W
  - One cover (no particular structure) of brittle<sup>1</sup> silver gray sheens; one patch and two covers of brittle<sup>1</sup> metallic/silver gray sheens; and one cover and one patch of brittle<sup>1</sup> metallic sheens observed.

- One patch of non-brittle<sup>2</sup> metallic/silver gray sheens observed.
- A-365E
  - One patch and five covers (no particular structure) of brittle<sup>1</sup> silver gray sheens; eight patches, three covers, and one cover/patch of brittle<sup>1</sup> metallic/silver gray sheens; one cover of brittle<sup>1</sup> metallic/rainbow sheens; and one cover of brittle<sup>1</sup> metallic sheens observed.

**Mitigation:** Suspected petrogenic sheens were removed using absorbent materials.

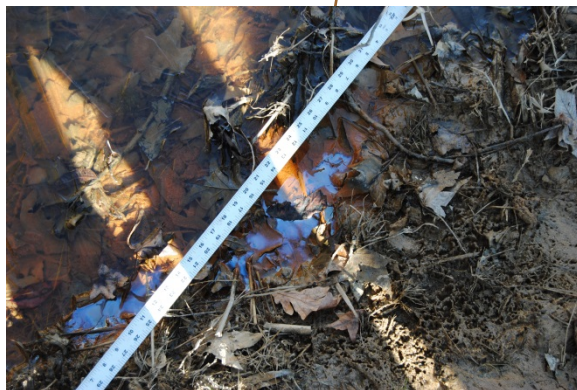
**Metallic/Silver Gray Sheen Patch Observation on 01/22/2014**

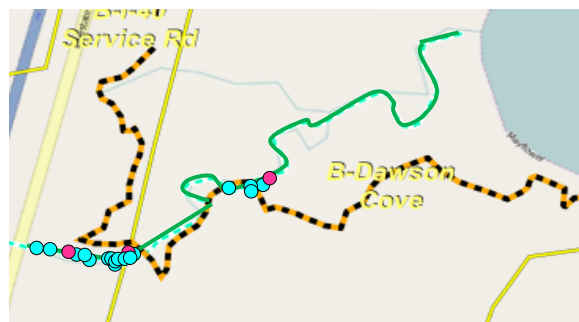
**Dawson Cove Inlet Channel (Summary of Observations from 01/20/2014 through 01/26/2014)**

- Four covers (no particular structure) of brittle<sup>1</sup> silver gray sheens; four covers, two covers/patches, and two patches of brittle<sup>1</sup> metallic/silver gray sheens; one patch and two covers of brittle<sup>1</sup> metallic/rainbow sheens; and one patch and one cover of brittle<sup>1</sup> metallic sheens observed.
- Two patches of metallic/rainbow sheens and one patch of metallic/silver gray sheens observed within ice. Since non-brittle<sup>2</sup> sheens were previously observed in these areas, these sheens were assumed non-brittle<sup>2</sup>.

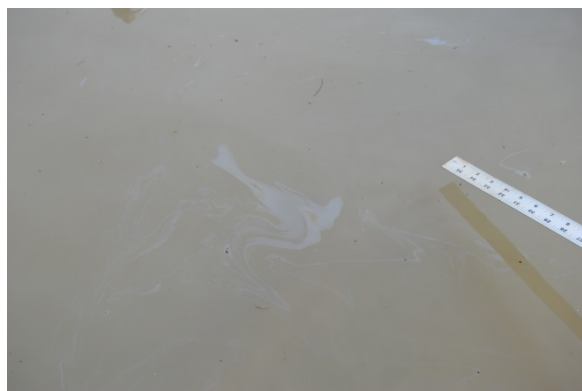
**Metallic/Rainbow Sheen Streamer with Oil Spots  
(0.1-inch Wide) on 01/14/2014**

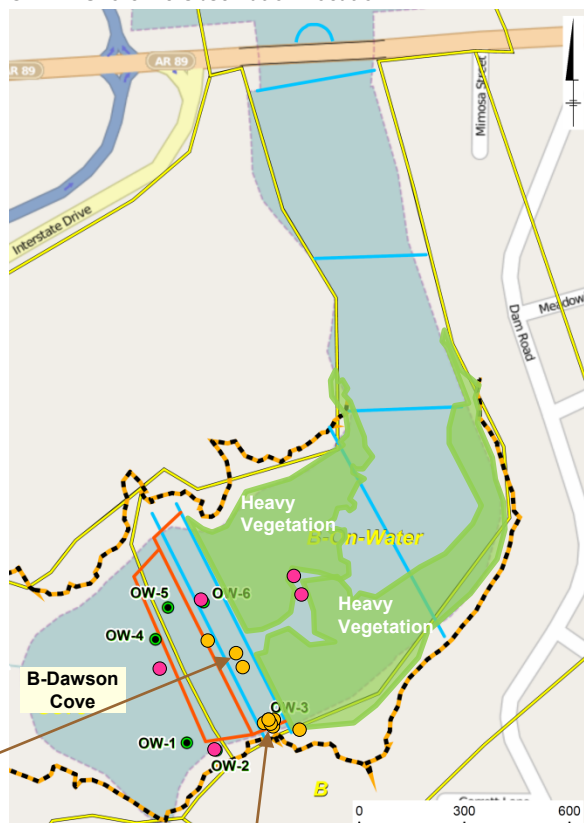
**Dawson Cove (Summary of Observations from  
01/20/2014 through 01/26/2014)**

- Two patches/streamers (with 0.1- to 0.75-inch wide oil spots), two patches, and two streamers (one with 0.25-inch wide oil spots) of non-brittle<sup>2</sup> silver gray sheens; one patch/streamer (with 0.1-inch wide oil spots) of non-brittle<sup>2</sup> rainbow/silver gray sheens; one patch/streamer (with 0.1- to 1-inch wide oil spots) and three streamers (one with 0.1-inch wide oil spots) of non-brittle<sup>2</sup> metallic/rainbow sheens; one patch/streamer of non-brittle<sup>2</sup> metallic/rainbow/silver gray sheens with 0.1- to 0.5-inch wide oil spots; and one patch/streamer of non-brittle<sup>2</sup> rainbow sheens with 0.05- to 0.5-inch wide oil spots observed.

- Two covers/streamers of non-brittle<sup>2</sup> silver gray sheens with 0.1- to 1.5-inch wide oil spots; and one patch/streamer of metallic/rainbow sheens with 0.1- to 0.5-inch wide oil spots observed within ice. Since non-brittle<sup>2</sup> sheens were previously observed in these areas, these sheens were assumed non-brittle<sup>2</sup>.

- Continue sheen monitoring in all areas.

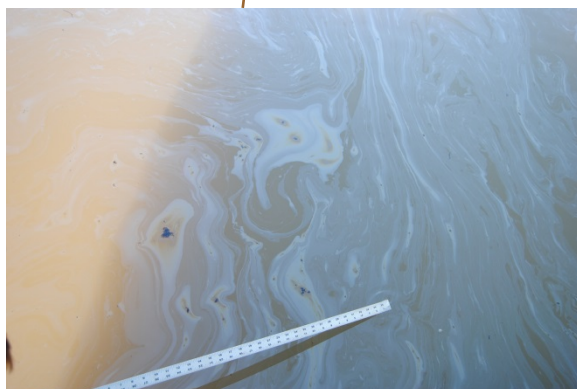
**Silver Gray Sheen Patch/Streamer with Oil Spot (0.1-  
to 0.75-inch Wide) Observation on 01/20/2014**
