Sheen Monitoring Report #18

Mayflower Pipeline Incident Response

Mayflower, Arkansas

Monitoring Period: Daily from 02/17/2014 through 02/23/2014.

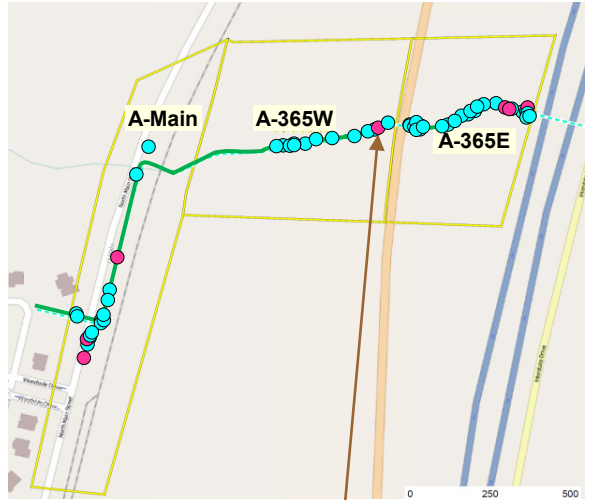
Drainage Ways (Summary of Observations from 02/17/2014 through 02/23/2014)

- A-Main
 - Five covers (no particular structure); one cover/patch, and two patches of silver gray sheens; one cover, one patch, and two covers/patches of rainbow/silver gray sheens; one cover of metallic/ silver gray sheens; and one cover/patch of rainbow sheens observed. Sheens broke apart when disturbed (“brittle”)¹.

- One patch and one patch/streamer/cover (no particular structure) of silver gray sheens observed. Sheens did not break when disturbed (“non-brittle”)².

- One streamer/cover (no particular structure) of brittle¹ and non-brittle² metallic/silver gray sheens observed (shown as non-brittle² on figure).
- A-365W

- Five covers (no particular structure), two patches/streamer, one patch, and one cover/patch of brittle¹ silver gray sheens; one streamer/patch of brittle¹ rainbow/silver gray sheens; one patch/cover of brittle¹ metallic/silver gray sheens; and one cover/patch of brittle¹ rainbow sheens observed.

- One patch/streamer of brittle¹ and non-brittle² rainbow/silver gray sheens observed (shown as non-brittle² on figure).
- A-365E
 - Eleven covers (no particular structure) and two covers/patches of brittle¹ silver gray sheens; four covers, four covers/patches, and one cover/patch/streamer of brittle¹ rainbow/silver gray sheens; one cover of brittle¹ silver gray/metallic/rainbow sheens; one cover of brittle¹ silver gray/metallic sheens; two covers/patches of brittle¹ rainbow sheens; and one cover/patch of brittle¹ metallic/rainbow sheens observed.

- One patch of non-brittle² metallic/silver gray sheens observed.
 - Two patches/streamers of brittle¹ and non-brittle² silver gray/rainbow sheens observed (shown as non-brittle² on figure).

Mitigation: Suspected petrogenic sheens were removed using absorbent materials.

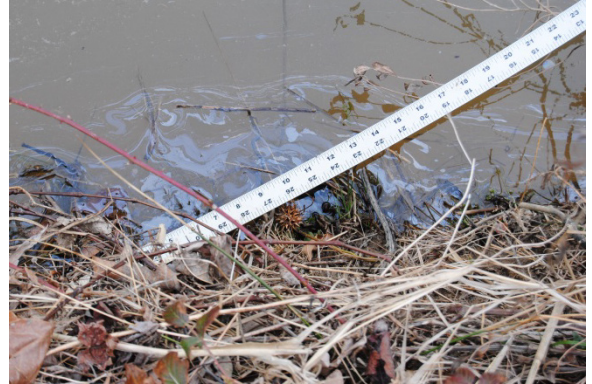
Rainbow/Silver Gray Sheen Patch/Streamer Observation on 02/19/2014

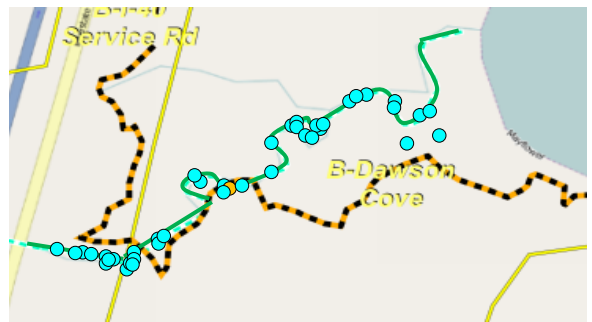
Dawson Cove Inlet Channel (Summary of Observations from 02/17/2014 through 02/23/2014)

- Seven covers (no particular structure) and three covers/patches of brittle¹ silver gray sheens; five covers, one cover/patch, and one patch of brittle¹ metallic/silver gray sheens; seven covers and three covers/patches of brittle¹ rainbow/silver gray sheens; three patches and two covers/patches of brittle¹ metallic/rainbow sheens; one patch and five covers/patches of brittle¹ rainbow sheens; and two covers/patches of brittle¹ metallic sheens observed.
- One patch of non-brittle² rainbow/silver gray sheens with 0.25-inch wide oil spots are observed.

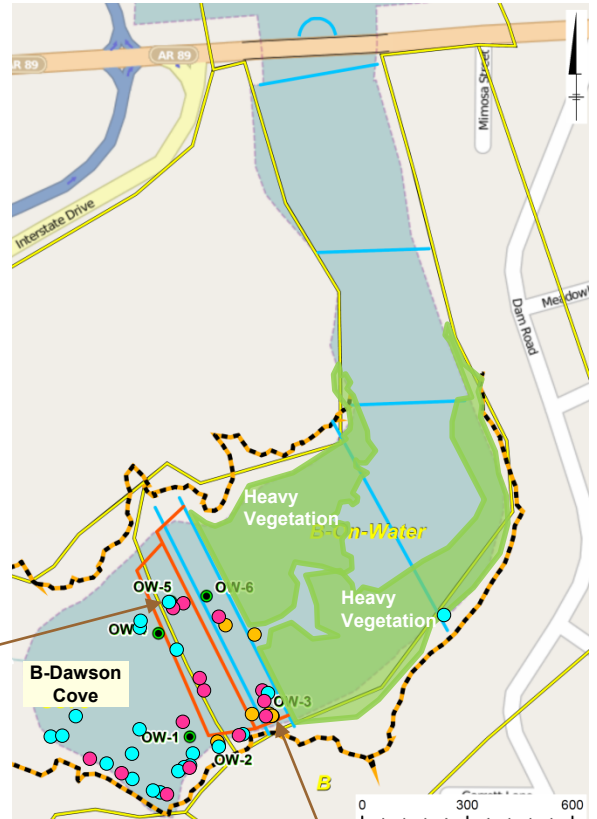
Dawson Cove (Summary of Observations from 02/17/2014 through 02/23/2014)

- Four patches, one cover (no particular structure), and two covers/patches of brittle¹ rainbow/silver gray sheens; five covers (no particular structure) and one patch of silver gray sheens; one cover of brittle¹ metallic sheens; one cover of brittle¹ silver gray/metallic/rainbow sheens; three covers/patches of brittle¹ metallic/rainbow sheens; and one cover/patch of brittle¹ rainbow sheens observed.

- One patch/streamer of silver gray sheens observed (shown as brittle¹ on figure).
- Four patches/streamers (two with 0.1- and 0.5-inch wide oil spots) and four streamers (one with 0.5-inch wide oil spots) of non-brittle² rainbow/silver gray sheens; two streamers (one with 0.05-inch wide oil spots) of non-brittle² silver gray sheens; one streamer and three patches/streamers of non-brittle² metallic/rainbow sheens; and one patch of non-brittle² dark/metallic/rainbow sheens observed.

- One patch/streamer (with 0.5-inch wide oil spots) and one patch of brittle¹ and non-brittle² rainbow/silver gray sheens; one patch/streamer of brittle¹ and non-brittle² silver gray sheens with 0.5-inch wide oil spots; and one patch/streamer/cover (no particular structure) of brittle¹ and non-brittle² rainbow sheens observed (shown as non-brittle² on figure).

- Continue sheen monitoring in all areas.

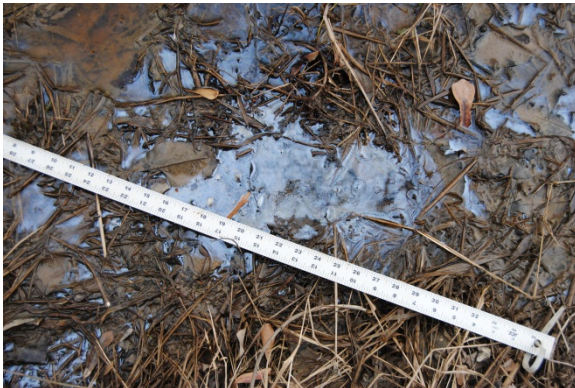
Metallic Sheen Cover Observation on 02/20/2014

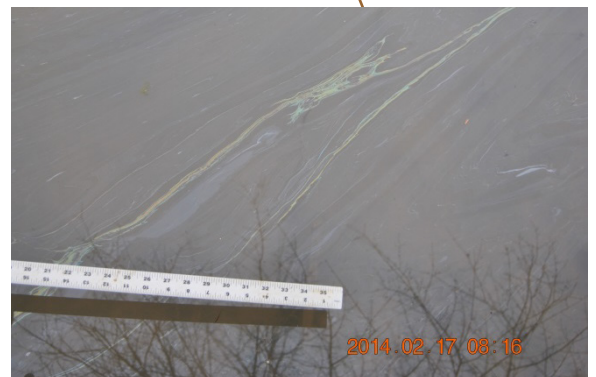
Rainbow/Silver Gray Sheen Patch/Streamer with Oil Spots (0.5-inch Wide) Observation on 02/17/2014
