## Sheen Monitoring Report #2

**Monitoring Period:** Daily from 10/28/2013 through 11/03/2013

## Mayflower Pipeline Incident Response

### Mayflower, Arkansas

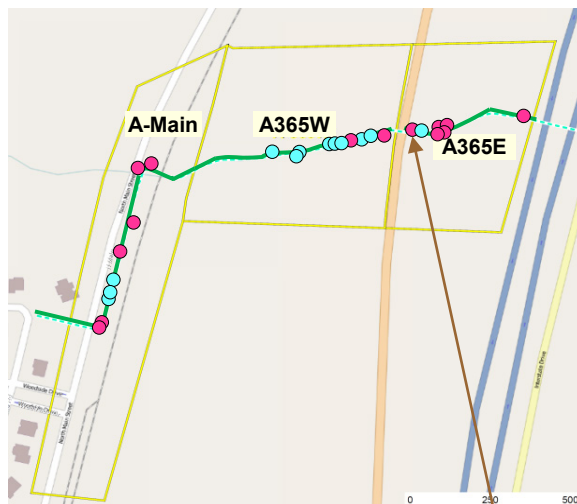
*Drainage Ways (Summary of Observations from 10/28/2013 to 11/3/2013)*

- A-Main
  - One patch of metallic/rainbow sheens and two patches of metallic sheens observed. Sheens broke apart when disturbed ("brittle")<sup>1</sup>.
  - Two covers (no particular structure), three patches, and one streamer of metallic sheens observed. Sheens did not break when disturbed ("non-brittle")<sup>2</sup>.
- A365W
  - One patch of brittle<sup>1</sup> metallic/rainbow sheens, five patches of brittle<sup>1</sup> metallic sheens, and two patches of brittle<sup>2</sup> rainbow sheens observed.
  - One streamer and one patch of non-brittle<sup>2</sup> metallic sheens observed.
- A365E
  - Four streamers and two covers (no particular structure) of non-brittle<sup>2</sup> metallic sheens observed.
  - One patch of brittle<sup>2</sup> metallic sheen observed.

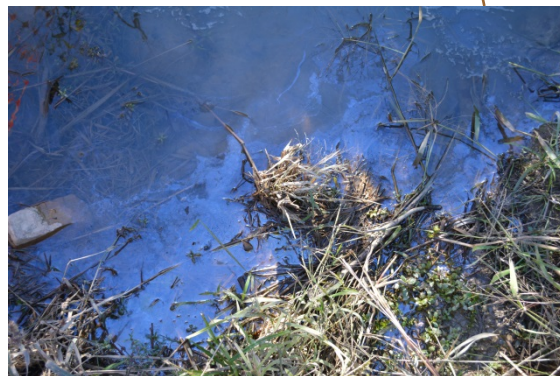
**Metallic Sheen Streamer Observation on 11/2/2013**

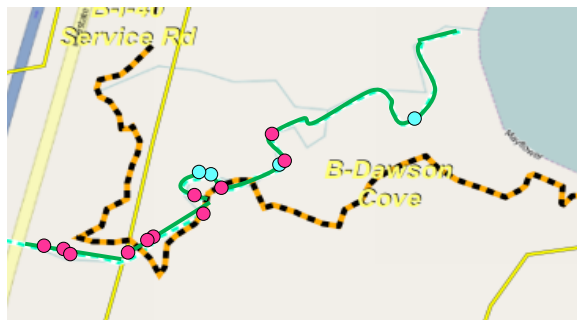
*Dawson Cove Inlet Channel (Summary of Observations from 10/28/2013 to 11/3/2013)*

- Three streamers of non-brittle<sup>2</sup> rainbow sheens, and five patches, one cover (no particular structure), and two streamers of non-brittle<sup>2</sup> metallic sheens observed. One streamer of rainbow sheen and one patch of metallic sheen were observed with some small oil spots.
- Four patches of brittle<sup>1</sup> metallic sheen observed.

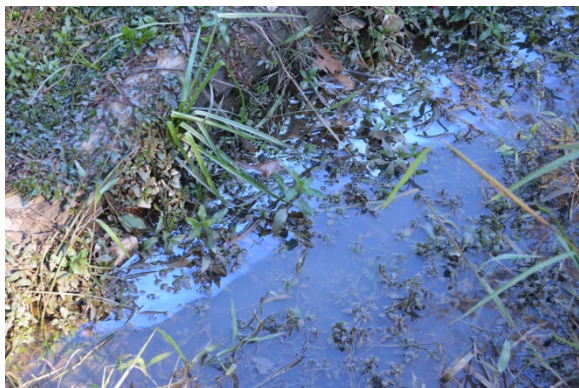
Metallic Sheen Patches Observation on 11/3/2013

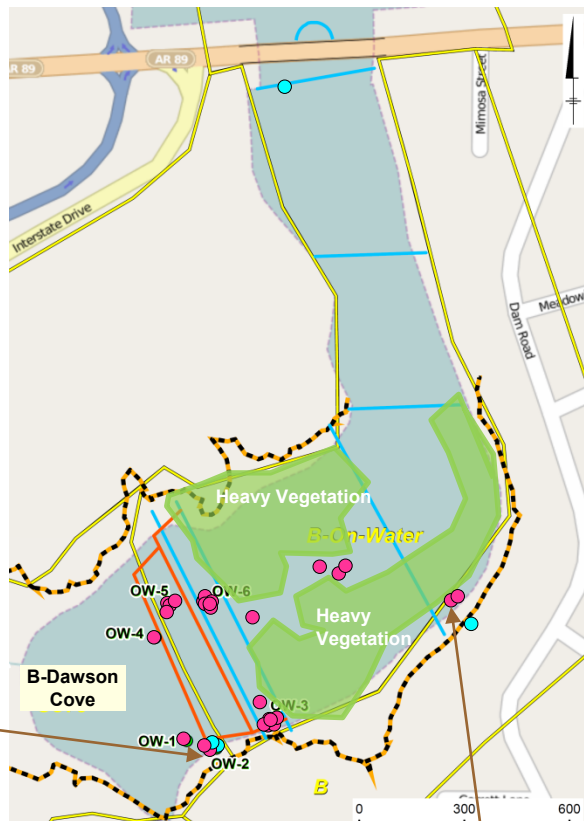
Dawson Cove (Summary of Observations from 10/28/2013 to 11/3/2013)

- Three patches/streamers, three patches, and four streamers of non-brittle<sup>2</sup> rainbow sheens with some small oil spots; six streamers, four patches/streamers, and three patches of non-brittle<sup>2</sup> metallic sheens; three non-brittle<sup>2</sup> streamers of metallic/rainbow sheens; and patches of non-brittle<sup>2</sup> sheen with some oil spots observed. Brown sheens were observed in B-On Water area.
- One patch/streamer and two patches of brittle<sup>1</sup> metallic sheens and one patch of brittle<sup>1</sup> rainbow sheens observed.

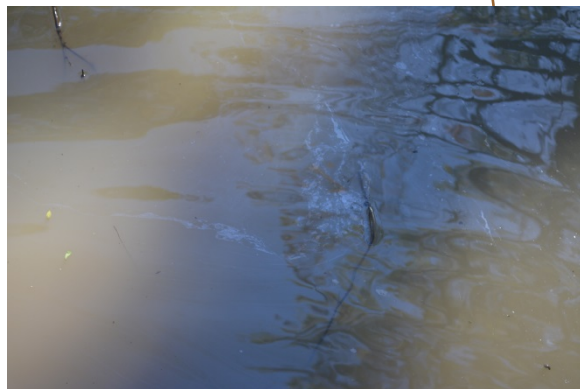
Brown Sheen Streamer Observation on 11/1/2013
