Sheen Monitoring Report #3

Mayflower Pipeline Incident Response

Mayflower, Arkansas

Monitoring Period: Daily from 11/4/2013 through 11/10/2013

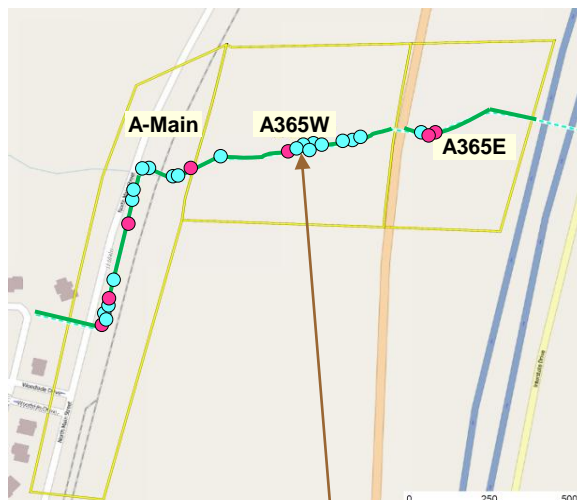
Drainage Ways (Summary of Observations from 11/4/2013 to 11/10/2013)

- A-Main
 - One patch of metallic/rainbow sheens, one streamer, five patches, and one cover (no particular structure) of metallic sheens; one patch of brown metallic sheen; and one patch of rainbow sheen observed. Sheens broke apart when disturbed ("brittle")¹.
 - Two streamers and two patches of metallic sheens observed. Sheens did not break when disturbed ("non-brittle")².
- A365W
 - One patch of brittle¹ metallic/rainbow sheens, and seven patches and one cover (no particular structure) of brittle¹ metallic sheens observed.
 - One patch of non-brittle² metallic sheens observed.
- A365E
 - One patch of brittle² metallic sheens observed.
 - One streamer of non-brittle² metallic sheens and one patch of non-brittle² rainbow sheens observed.

Mitigation: Suspected petrogenic sheens were removed using absorbent materials.

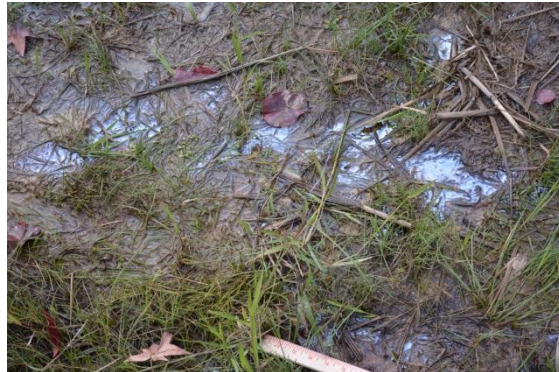
Metallic Sheen Patch Observation on 11/10/2013

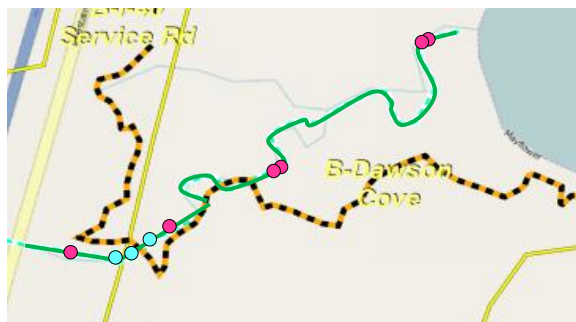
Dawson Cove Inlet Channel (Summary of Observations from 11/4/2013 to 11/10/2013)

- Two streamers and one patch of brittle¹ metallic sheen observed.
- Four streamers and two patches of non-brittle² metallic sheens observed.

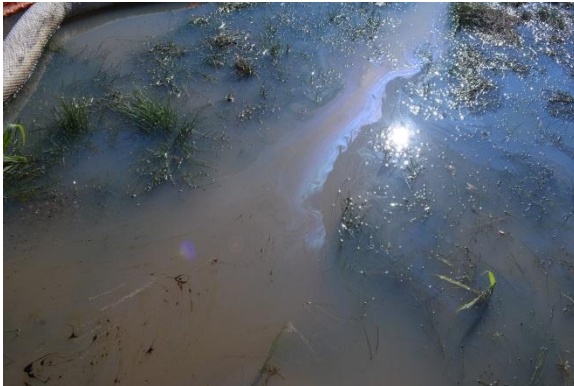
Metallic/Rainbow Sheen Patch/Streamer with Small Oil Spots Observation on 11/7/2013

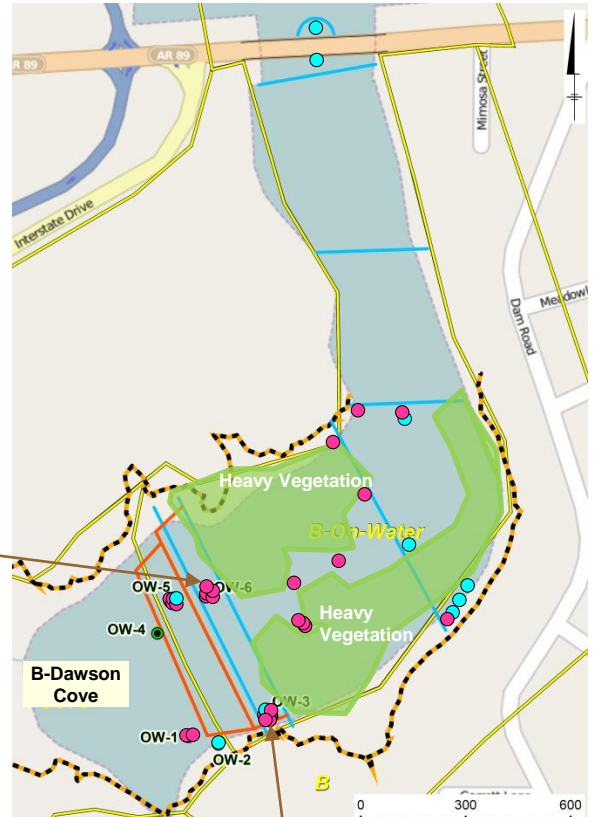
Dawson Cove (Summary of Observations from 11/4/2013 to 11/10/2013)

- Five patches, one patch/streamer, and two covers (no structure) of brittle¹ metallic sheens; one patch of brittle¹ rainbow sheens; and one patch/streamer of brittle¹ metallic/rainbow sheen observed.
- Eight patches (two with small oil spots [<1-inch wide]), six streamers, and two patches/streamers of non-brittle² metallic sheens; one patches, three streamers, and one patch/streamer of non-brittle² rainbow sheens with small oil spots (<1-inch wide); and two streamers, two patches/streamers, and two patches of non-brittle² metallic/rainbow sheens with small oil spots (<1-inch wide) observed.

- Continue sheen monitoring in all areas.

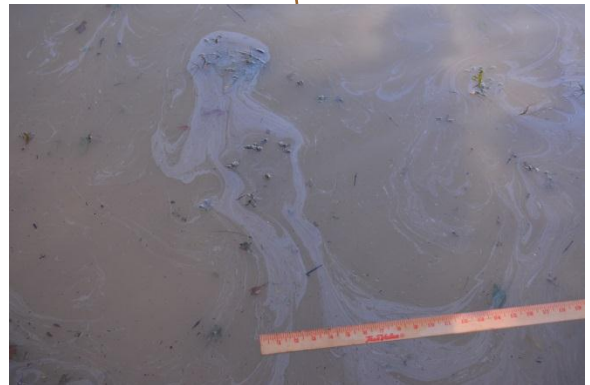
Metallic Sheen Streamer Observation on 11/8/2013
