Sheen Monitoring Report #1

Mayflower Pipeline Incident Response

Mayflower, Arkansas

Monitoring Period: Daily from 10/21/2013 through 10/27/2013

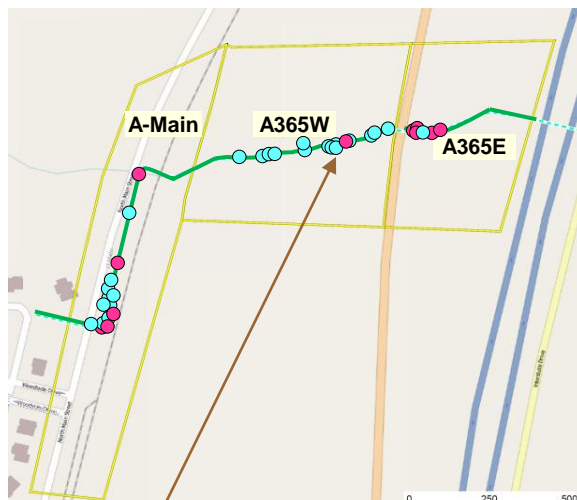
Drainage Ways (Summary of Observations from 10/21 to 10/27/2013)

- A-Main
 - Nine patches of metallic sheen and two cover/patch of rainbow sheen observed. Sheens broke apart when disturbed (“brittle”)¹.
 - Two patches of metallic sheen and three streamers/patches of metallic or rainbow sheen observed. Sheens did not break when disturbed (“non-brittle”)².
- A365W
 - Thirteen patches of brittle¹ metallic and rainbow sheens observed.
 - One non-brittle² streamer of metallic sheen observed.
- A365E
 - Two patches and one streamer of non-brittle² metallic sheen observed.
 - One streamer of rainbow sheen and two streamers/patches of rainbow/metallic/silver gray sheen observed.
 - Patch of brittle² rainbow sheen observed.

Mitigation: Suspected petrogenic sheens were addressed using absorbent materials.

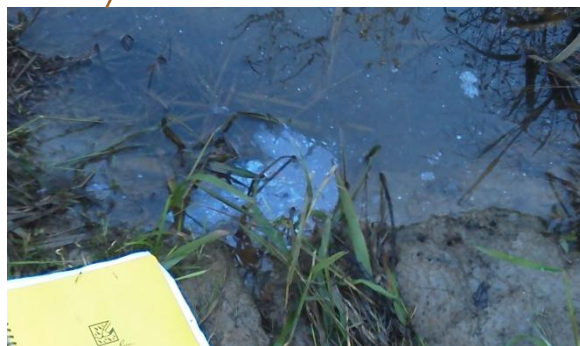
Metallic Sheen Observation on 10/24/2013

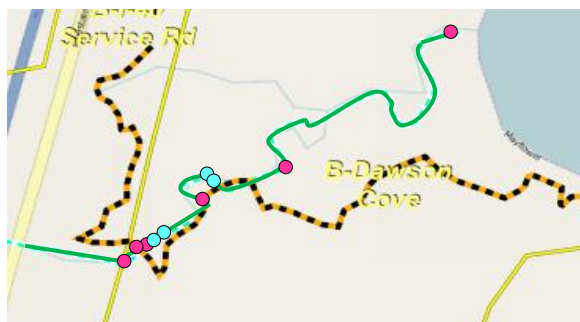
Dawson Cove Inlet Channel (Summary of Observations from 10/21 to 10/27/2013)

- Two streamers of brittle¹ rainbow and metallic sheens and two patches of brittle¹ metallic sheen observed.
- One patch of rainbow sheen and two streamers/patches of rainbow/metallic sheen observed.
- Four streamers/patches of non-brittle² rainbow/metallic and one cover of silver gray sheens observed.

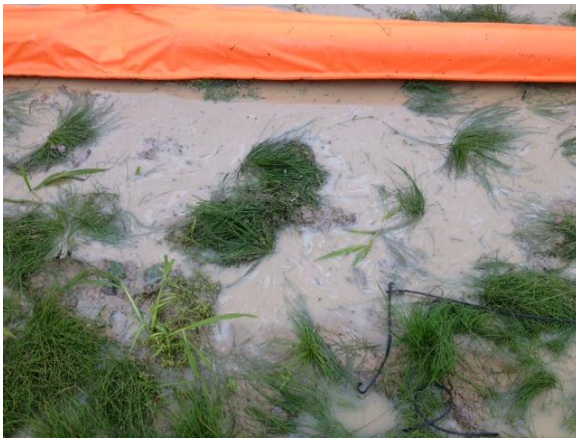
Rainbow Sheen Observation on 10/27/2013

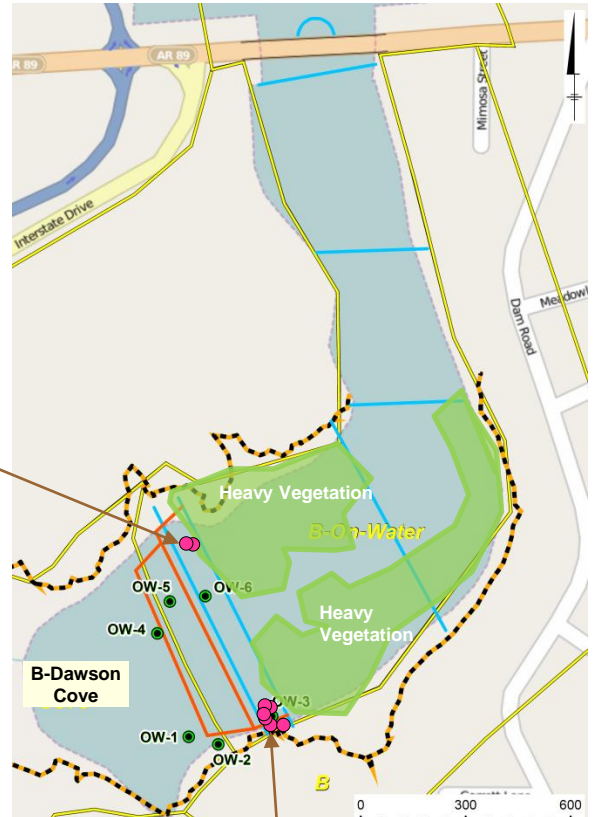
Dawson Cove (Summary of Observations from 10/21 to 10/27/2013)

- Two streamers and three patches of rainbow sheen, and three patches/streamers of rainbow/metallic sheen (some with small oil spots) observed.
- One patch of brittle¹ metallic sheen observed on 10/23/2013.

- Continue sheen monitoring in all areas. Improve photography by using polarizing camera lens.
- Start sheen sampling, up to 12 samples: one of both brittle and non-brittle sheens in A-Main, A365W, A365E, and inlet channel to Dawson Cove; and two of both brittle and non-brittle sheens in the open water area of Dawson Cove.

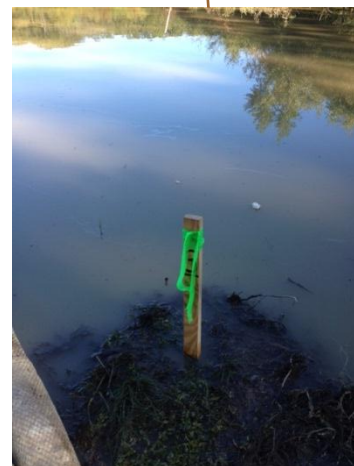
Rainbow Sheen Observation on 10/23/2013
