Sheen Monitoring Report #4

Mayflower Pipeline Incident Response

Mayflower, Arkansas

Monitoring Period: Daily from 11/11/2013 through 11/17/2013

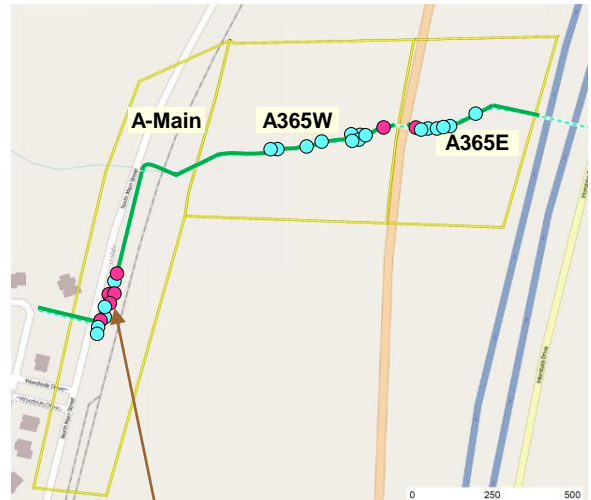
Drainage Ways (Summary of Observations from 11/11/2013 to 11/17/2013)

- A-Main
 - Two covers (no particular structure), one patch, and two streamers (shiny) of metallic sheens observed. Sheens broke apart when disturbed ("brittle")¹.
 - One cover (no particular structure), one patch, and one streamer of rainbow sheens; one patch of metallic sheens; and one cover (no particular structure) of silver gray sheens observed. Sheens did not break when disturbed ("non-brittle")².
- A365W
 - Seven patches and two covers (no particular structure) of brittle¹ metallic sheens observed.
 - One patch of non-brittle² metallic sheens observed.
- A365E
 - Two covers (no particular structure) and three patches of brittle¹ metallic sheens, and one patch of brittle¹ rainbow sheens observed.
 - One patch of non-brittle² rainbow sheens observed.

Mitigation: Suspected petrogenic sheens were removed using absorbent materials.

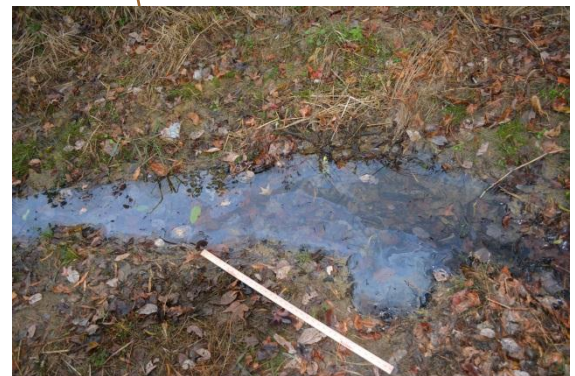
Silver Gray Sheen Cover Observation on 11/15/2013

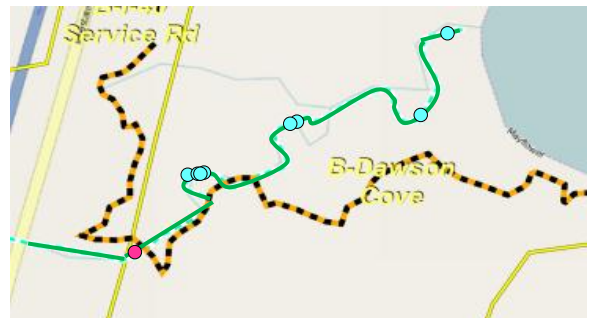
Dawson Cove Inlet Channel (Summary of Observations from 11/4/2013 to 11/10/2013)

- Three patches and three covers (no particular structure) of brittle¹ metallic sheens, one patch of brittle¹ rainbow sheens, and one patch of brittle¹ metallic/rainbow sheens observed.
- One patch of non-brittle² rainbow sheens with small oil spots (0.25-inch wide) observed.

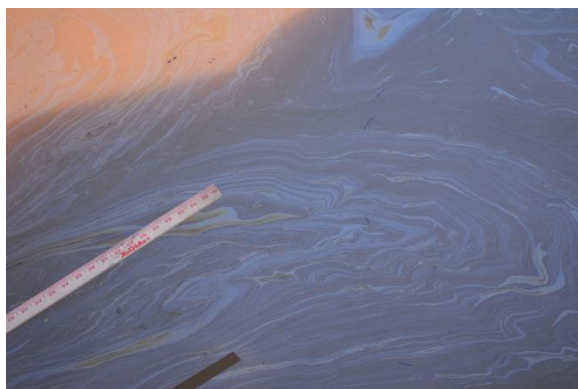
Rainbow Sheen Streamer with Small Oil Spots (0.25-inch Wide) Observation on 11/14/2013

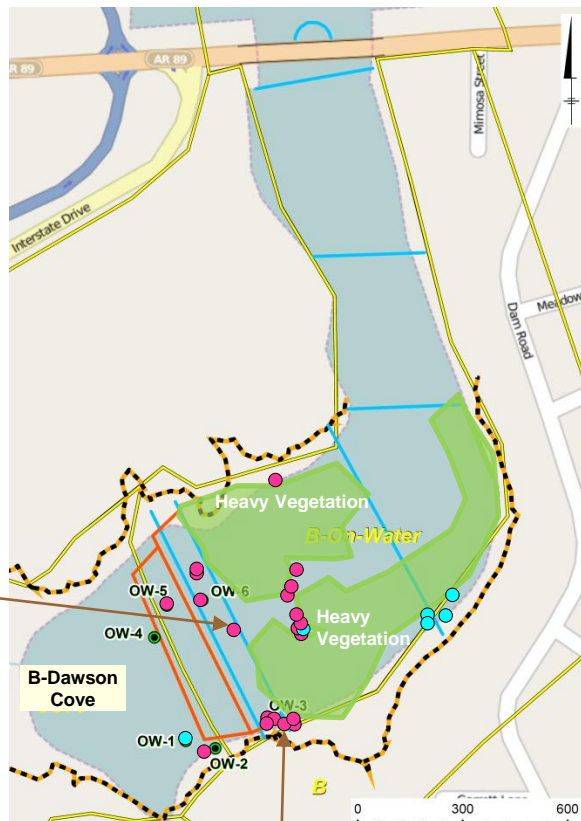
Dawson Cove (Summary of Observations from 11/11/2013 to 11/17/2013)

- Five patches and one cover (no particular structure) of brittle¹ metallic sheens observed.
- Two patches and five streamers with small oil spots of non-brittle² rainbow sheens (one streamer with 5-inch wide oil streamer at center); two streamers and one patch with small oil spots of non-brittle² dark/rainbow sheens; three streamers and two patches (two streamers and one patch with small oil spots) of non-brittle² metallic sheens; two streamers (with small oil spots) and one patch/streamer of non-brittle² metallic/rainbow sheens; and one patch and one patch/streamer (with small oil spots) of non-brittle² dark/metallic sheens observed. Observed oil spots were approximately 0.25-inch in width.

- Continue sheen monitoring in all areas.

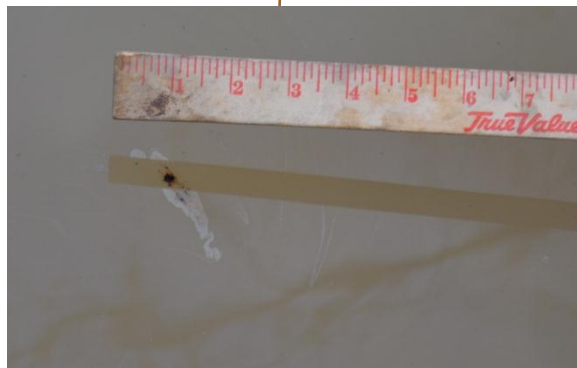
Dark/Rainbow Sheen Patch with Small Oil Spots (0.25-inch Wide) Observation on 11/16/2013
