Sheen Monitoring Report #5

Monitoring Period: Daily from 11/18/2013 through 11/24/2013

Mayflower Pipeline Incident Response

Mayflower, Arkansas

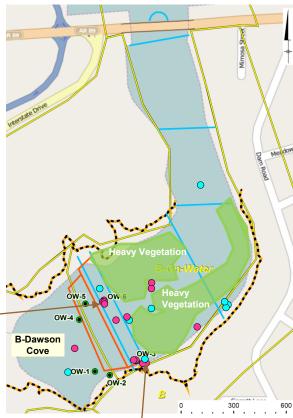
Dawson Cove (Summary of Observations from 11/18/2013 to 11/24/2013)

- Four patches and one patch/streamer of brittle¹ metallic sheens; one patch/streamer of brittle¹ metallic/rainbow sheens, and three streamers of brittle¹ dark/metallic/rainbow sheens (with 0.25 to 1-inch wide small oil spots) observed.
- One patch/streamer (with small oil spots) and one streamer of non-brittle² metallic/rainbow sheens; one patch/streamer and one patch (with small oil spots) of non-brittle² metallic sheens; one patch/streamer of non-brittle² dark/metallic/rainbow sheens (with small oil spots); one streamer of non-brittle² dark/rainbow sheens (with small oil spots); and five patches/streamers (with small oil spots), two streamers (with small oil spots), and one patch of non-brittle² rainbow sheens observed. Observed oil spots were approximately 0.25-inch in width.

• Continue sheen monitoring in all areas.
