**Appendix B**

Photographic Record

**SITE NAME: MAYFLOWER PIPELINE INCIDENT RESPONSE**  
**SITE LOCATION: MAYFLOWER, ARKANSAS**

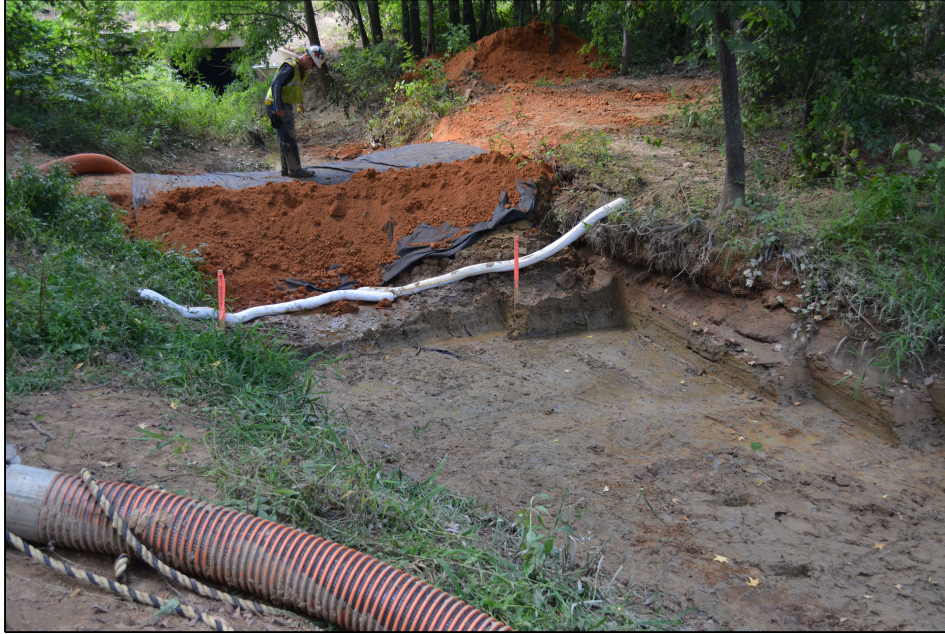
DESCRIPTION:  
Installation of temporary dam at the upstream end of the Inlet Channel

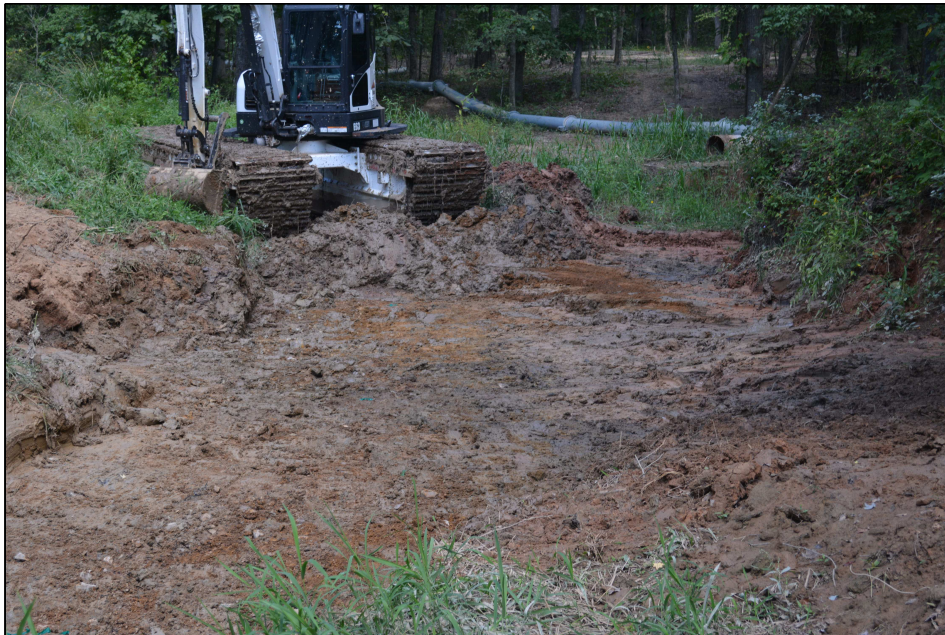
COMMENTS:  
Excavation activities at the Inlet Channel

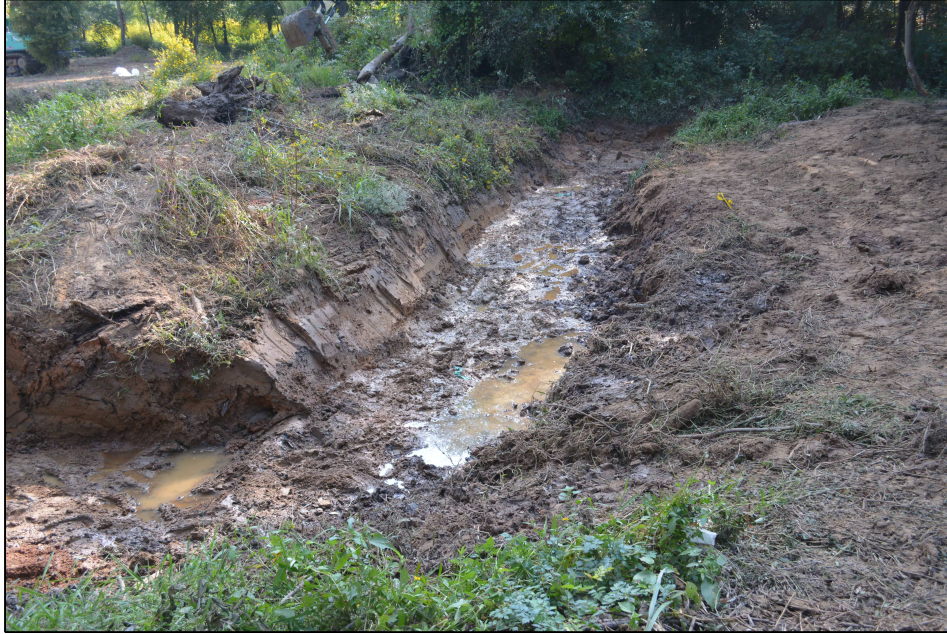
DESCRIPTION:  
Excavated area at the upstream end of the Inlet Channel

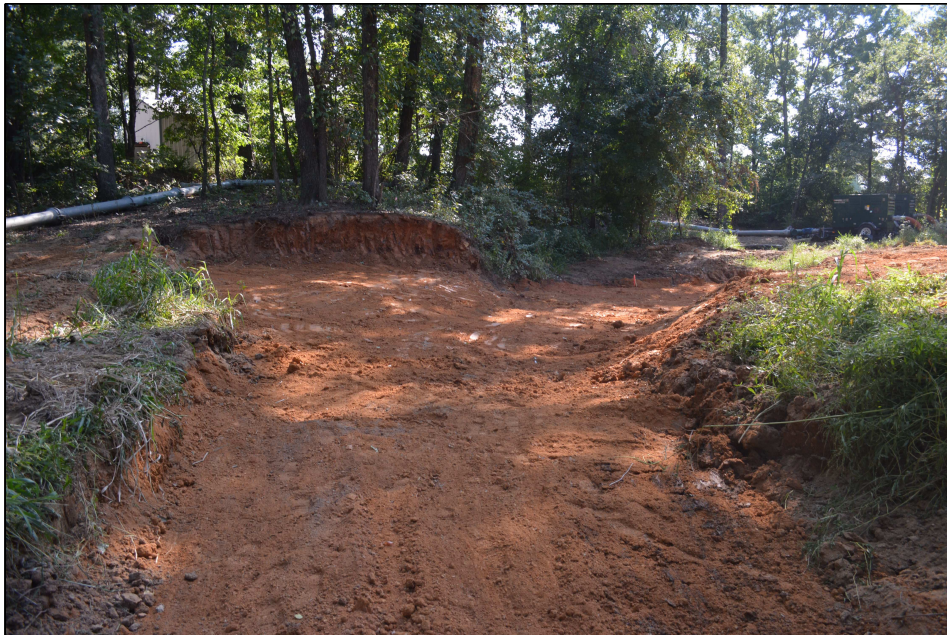
**COMMENTS:**  
Backfilled area at the upstream end of the Inlet Channel

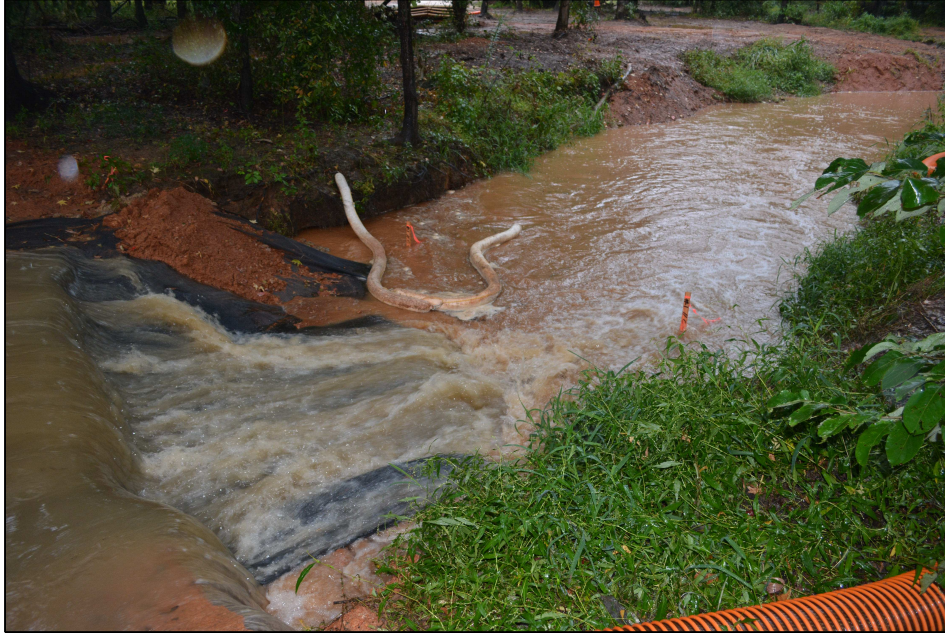
Water flowing over the temporary dam at the upstream end of the Inlet Channel, following a heavy rain event

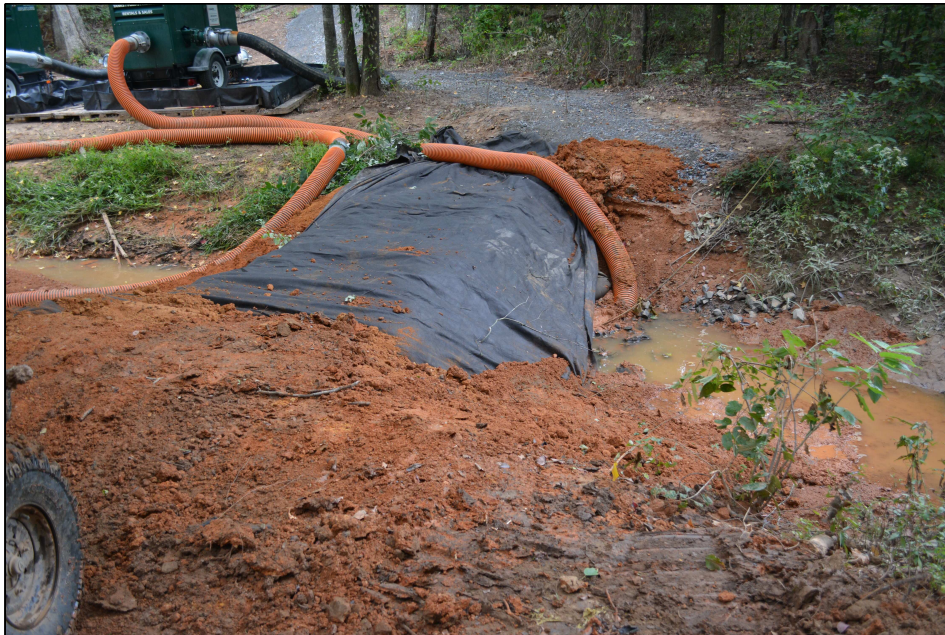
Repaired temporary dam at the upstream end of the Inlet Channel

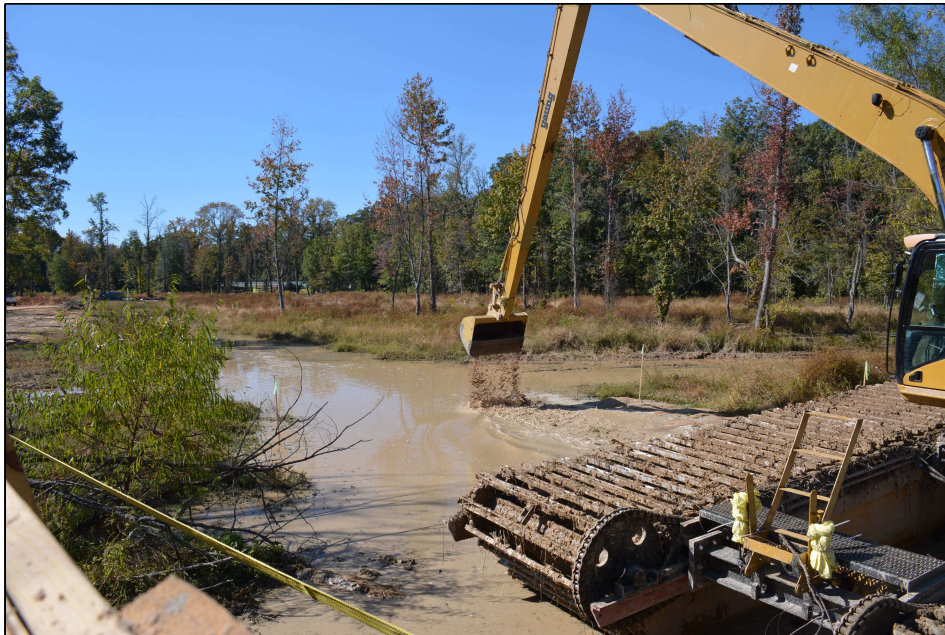
**COMMENTS:**  
Reactive cap placement in the Open Water Area

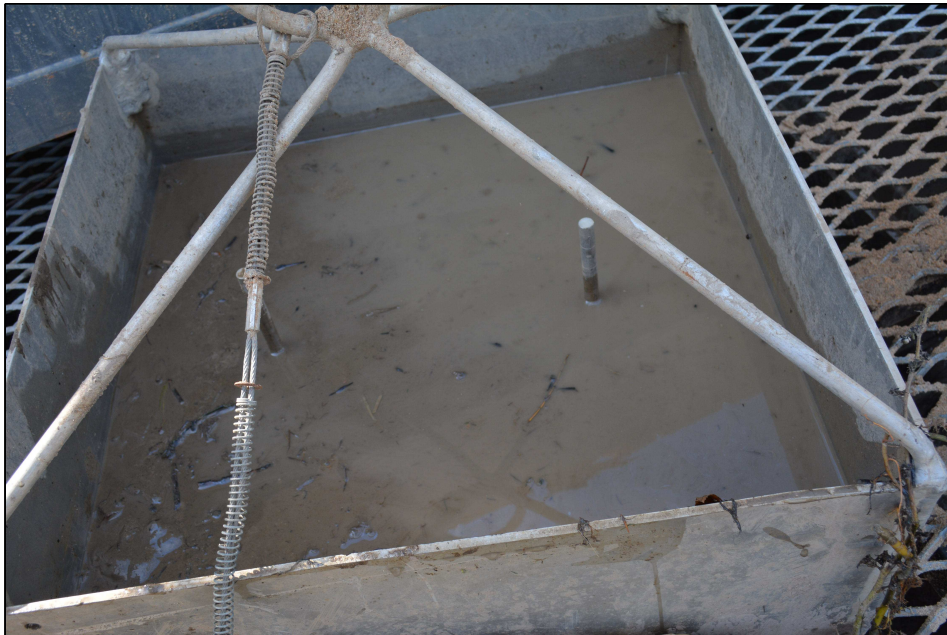
COMMENTS:  
Test pan retrieved from the Open Water Area to verify reactive cap thickness

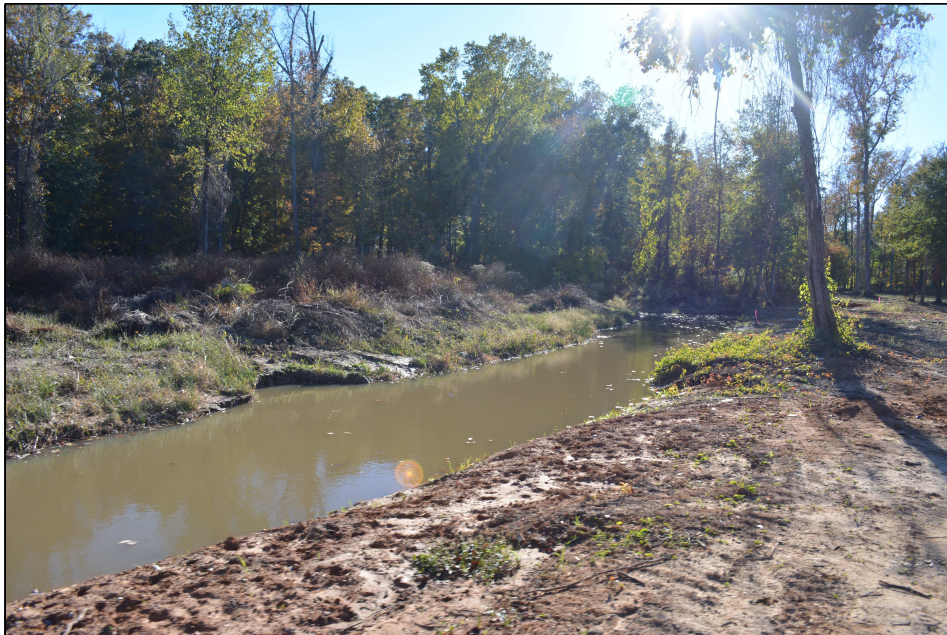
**COMMENTS:**  
Inlet Channel following completion of construction activities

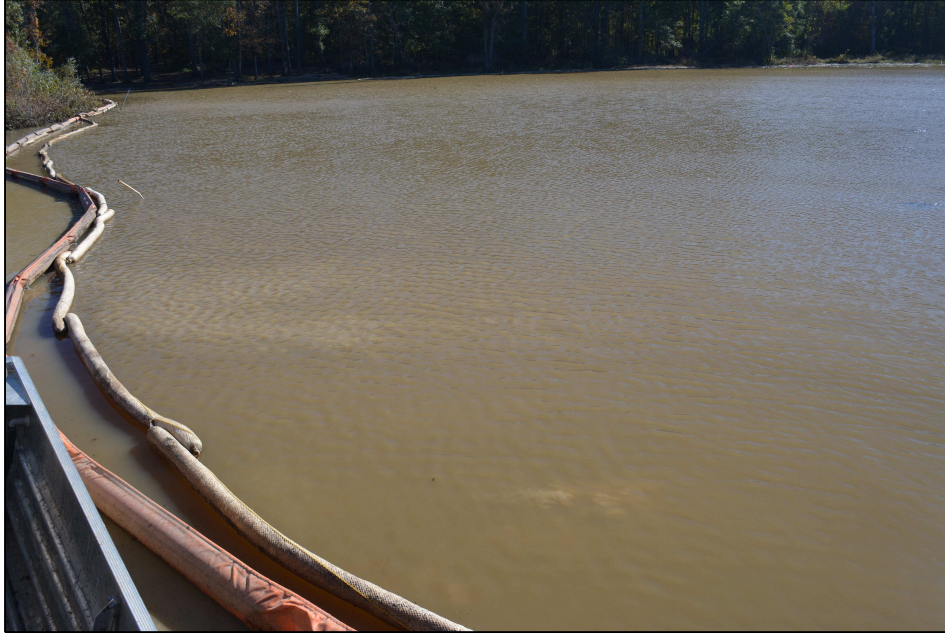
**DESCRIPTION:**  
Open Water Area following completion of construction activities

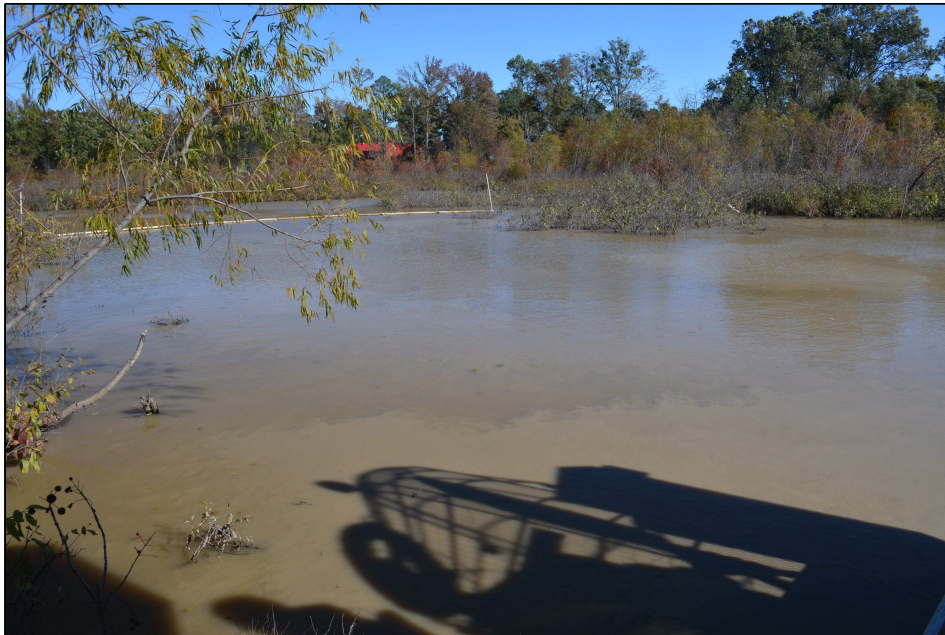
**COMMENTS:**  
Heavily Vegetated Area following completion of construction activities
