**Mitigation Action Completion
Report**

Mayflower Pipeline Incident Response
Mayflower, Arkansas

March 2015

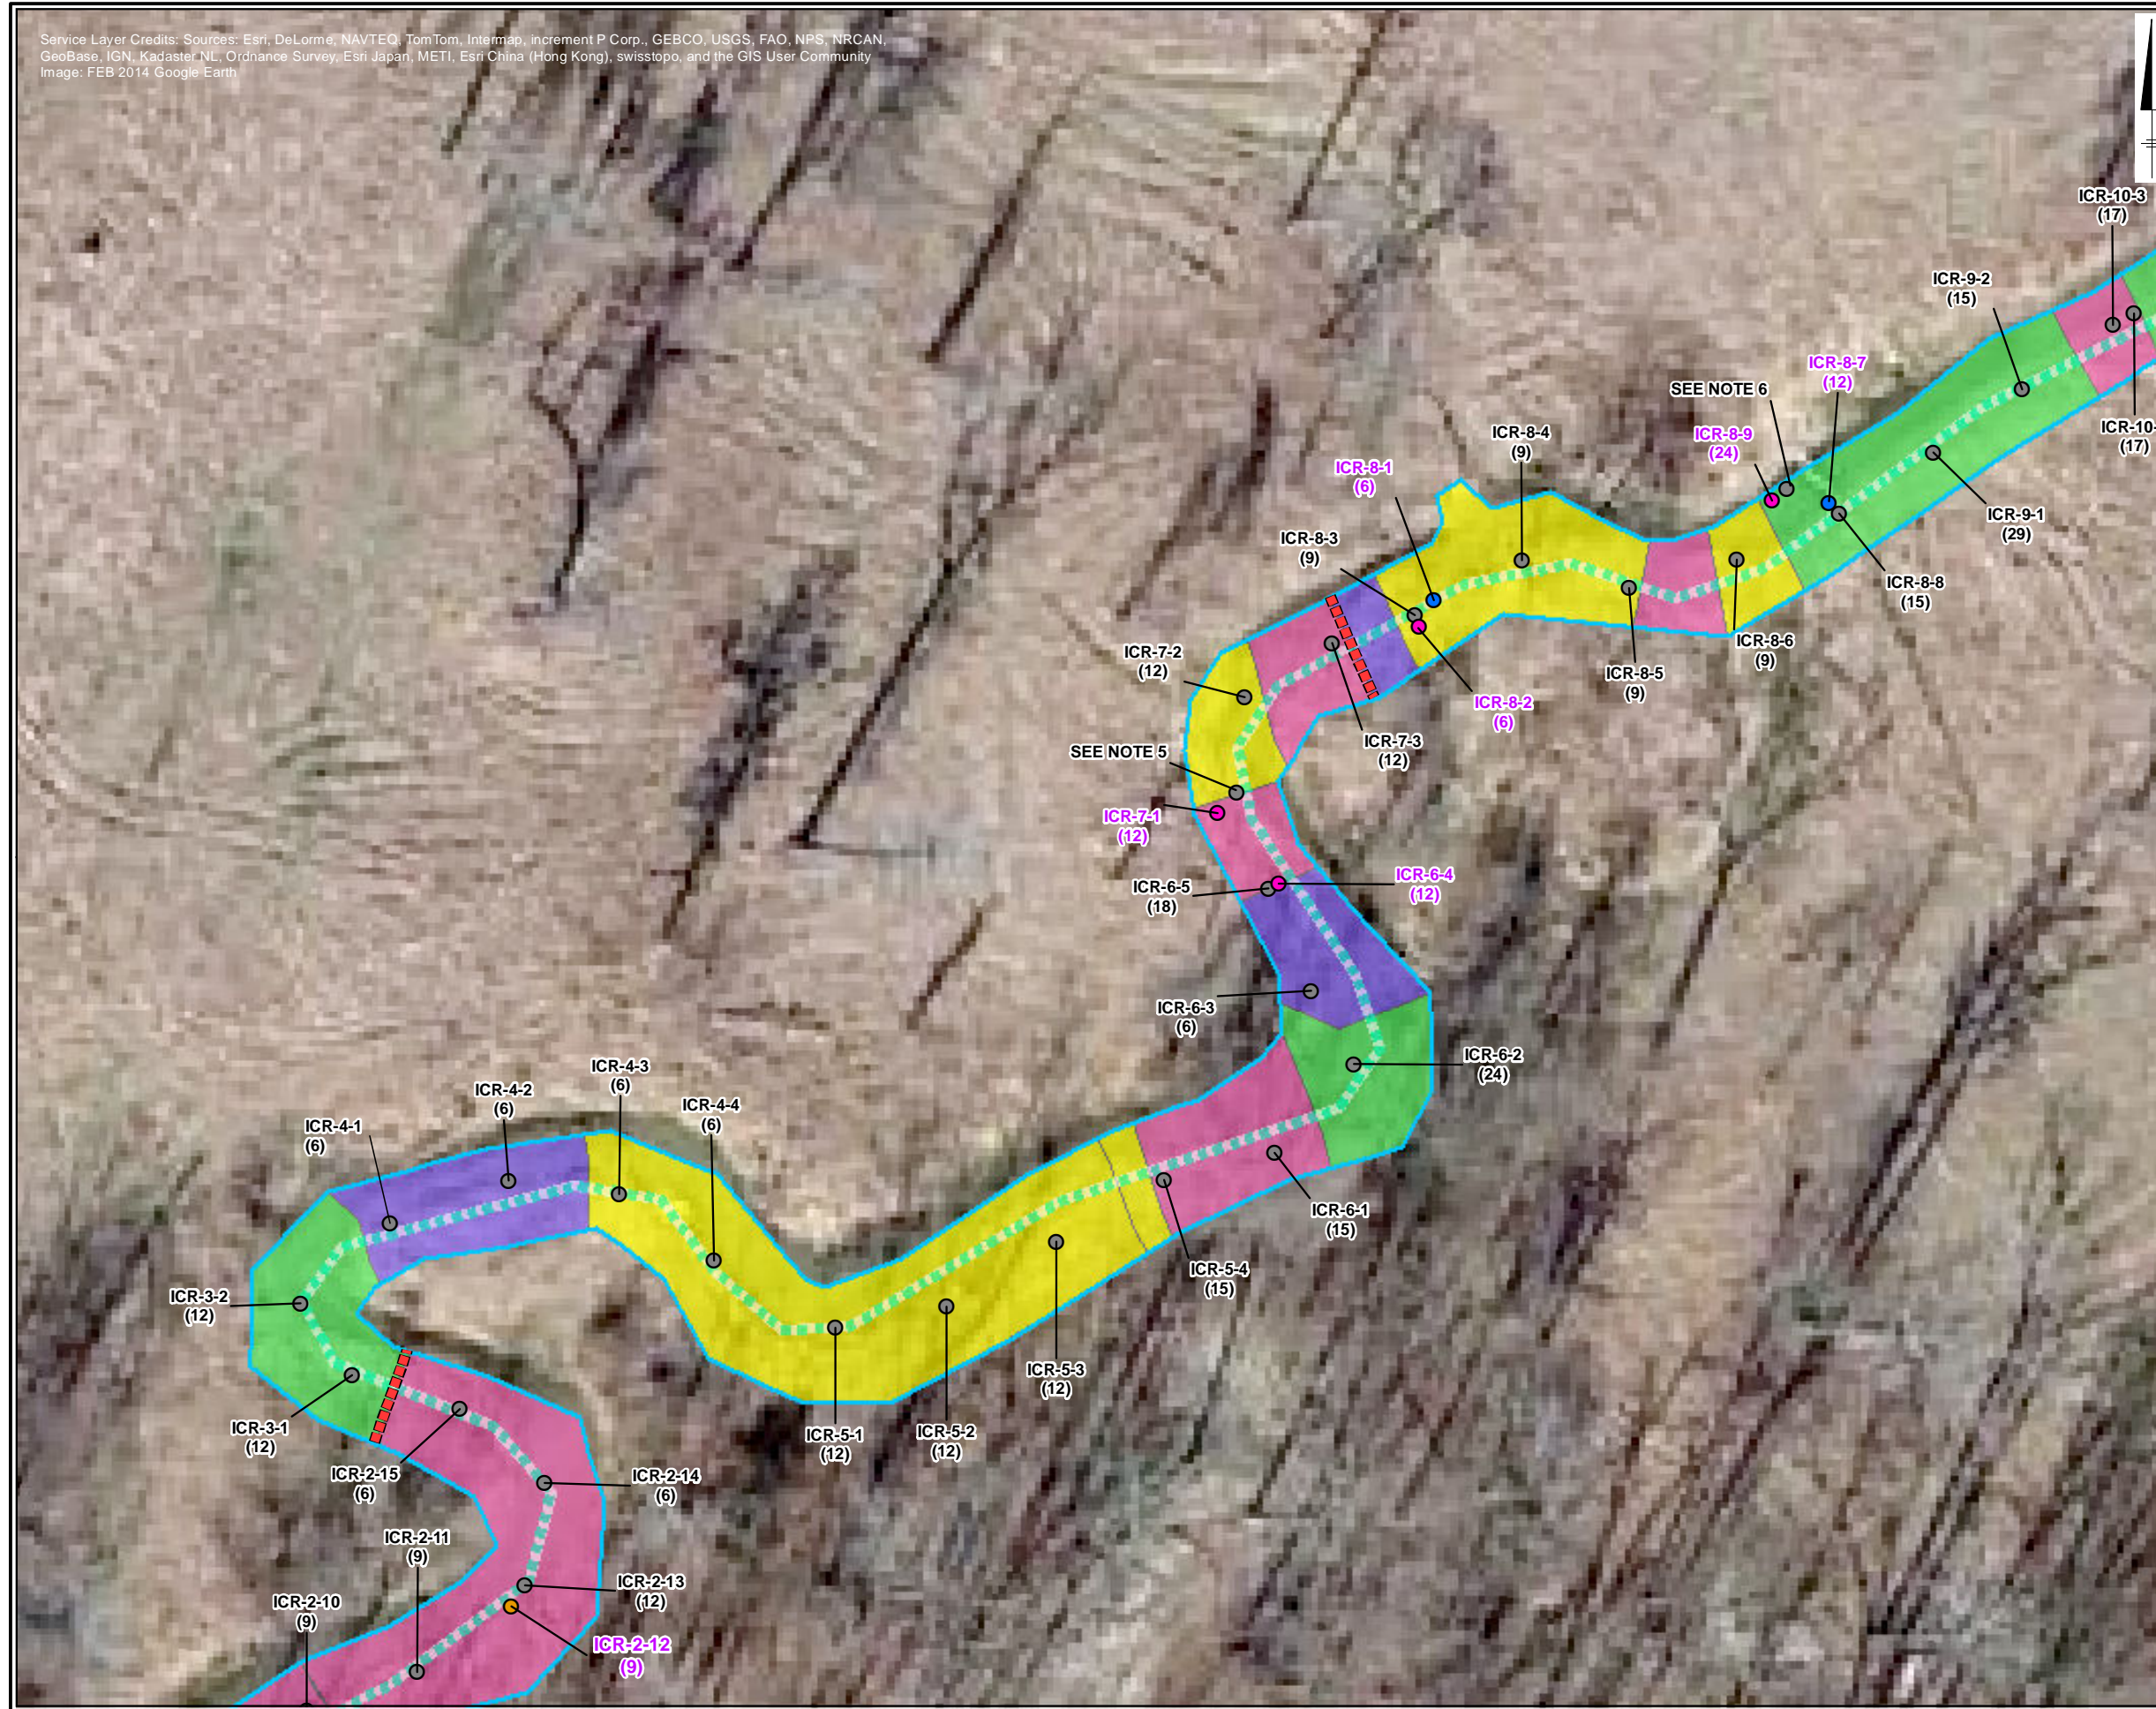
FIGURE
 2-2b

5. After additional excavation of area between samples ICR-6-4 and ICR-7-1, confirmation sample ICR-6-5 was collected near ICR-6-4 and visual observation was conducted at ICR-7-1. No sheen was observed following additional excavation.

6. Area near sample ICR-8-9 was visually observed after removing tree stump and additional material along the bank. No sheen was observed following additional excavation.

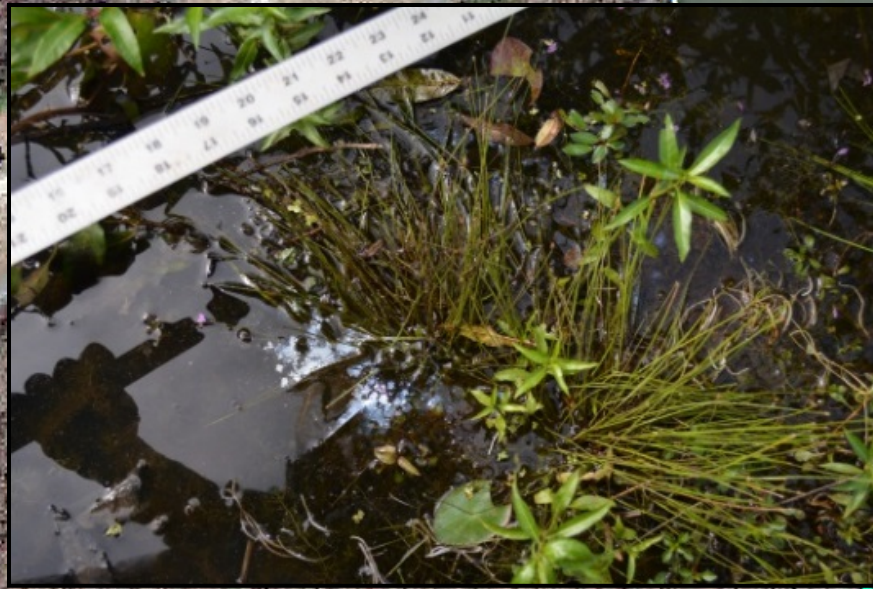
Cove-005 – Does not resemble crude oil

Patches of Brittle Silver Gray Sheen

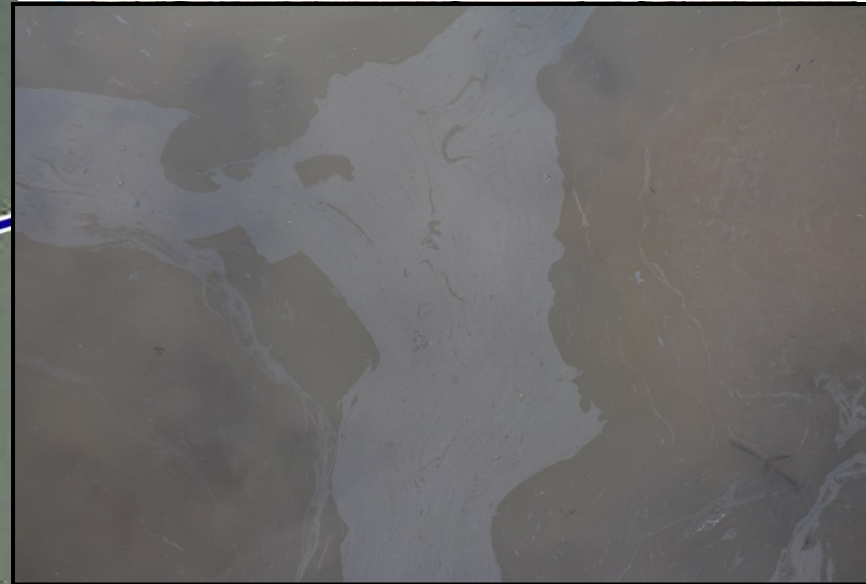
Cove-010 – Does not resemble crude oil

Cover (No Particular Structure) of Non-Brittle Silver Gray Sheen

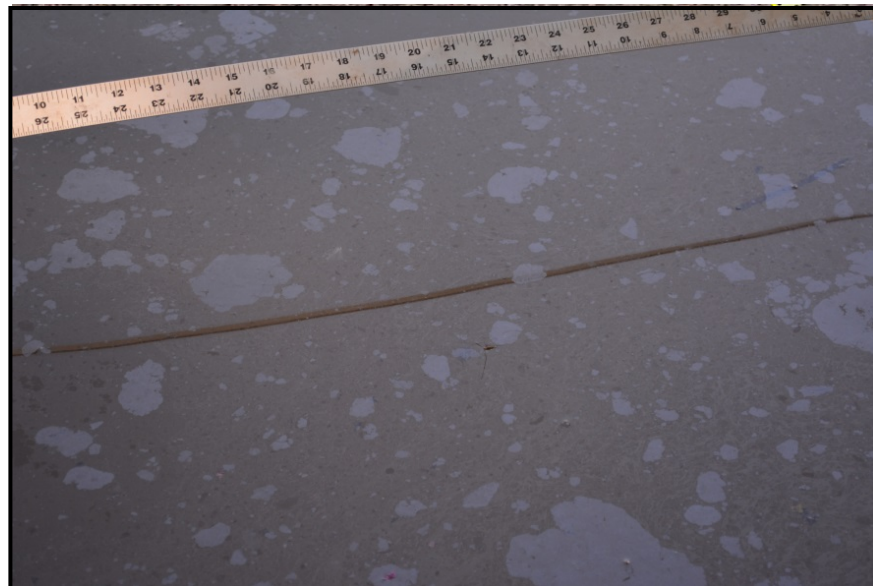
Cove-009 – Does not resemble crude oil

Patches of Non-Brittle Rainbow/Silver Gray Sheen
