**ExxonMobil Environmental Services  
Company**

**Mitigation Action Completion  
Report**

Mayflower Pipeline Incident Response  
Mayflower, Arkansas

April 2015

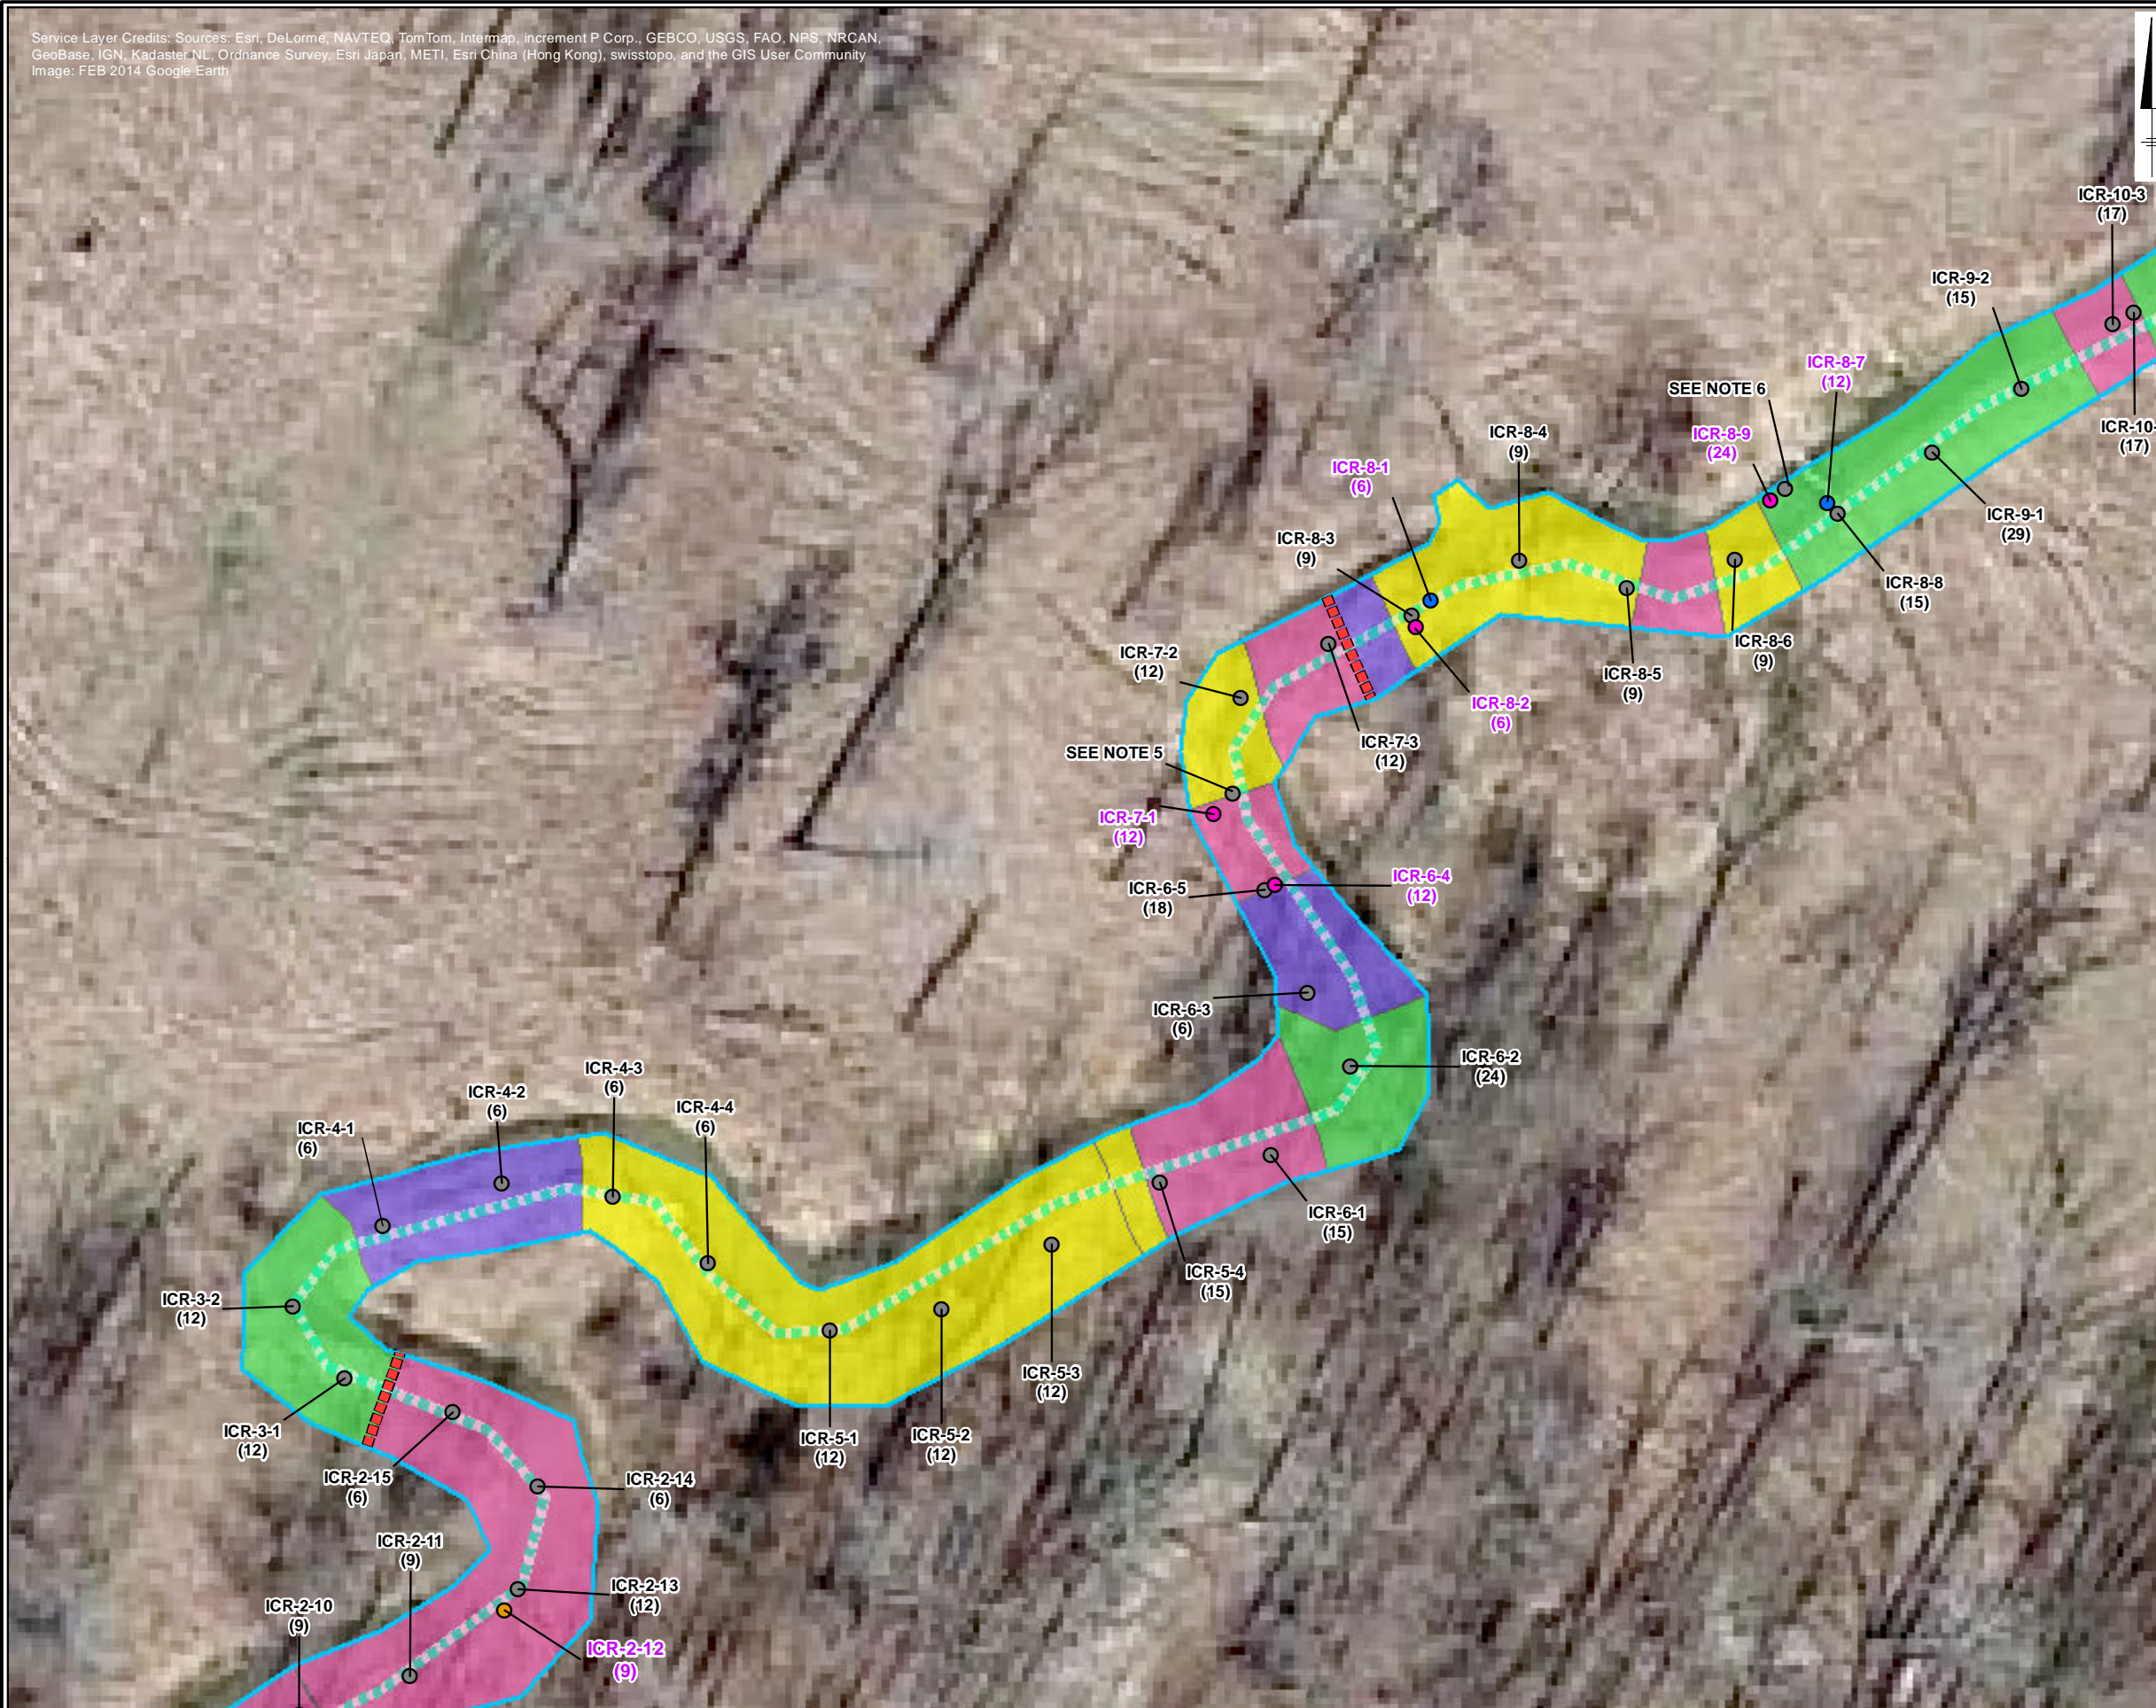
FIGURE  
 2-2b

4. If sheen was observed in the confirmation sample collected after first excavation, additional excavation was conducted and second confirmation sample was collected. In such cases, first confirmation sample is indicated using purple color.

5. After additional excavation of area between samples ICR-6-4 and ICR-7-1, confirmation sample ICR-6-5 was collected near ICR-6-4 and visual observation was conducted at ICR-7-1. No sheen was observed following additional excavation.

6. Area near sample ICR-8-9 was visually observed after removing tree stump and additional material along the bank. No sheen was observed following additional excavation.

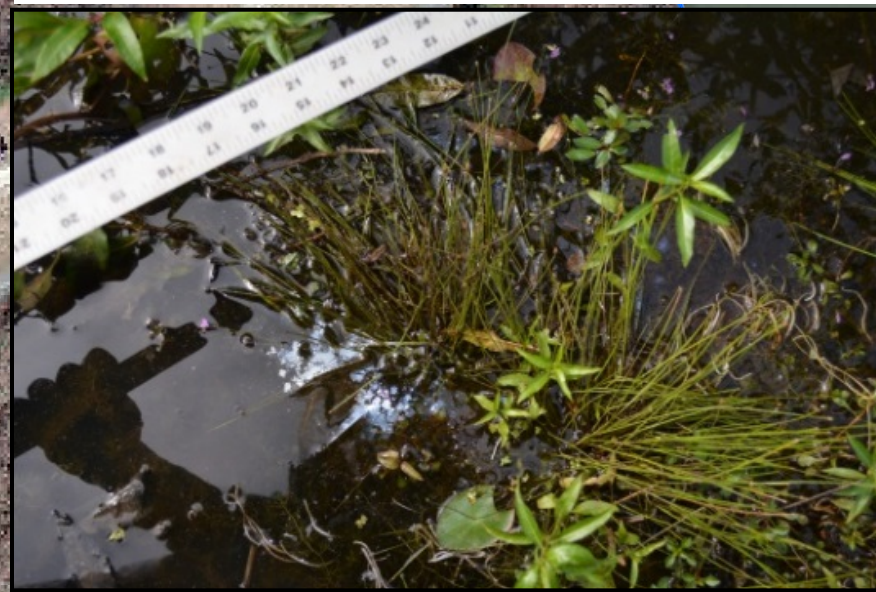
COVE-005 – Does not resemble crude oil

Patches of Brittle Silver Gray Sheen

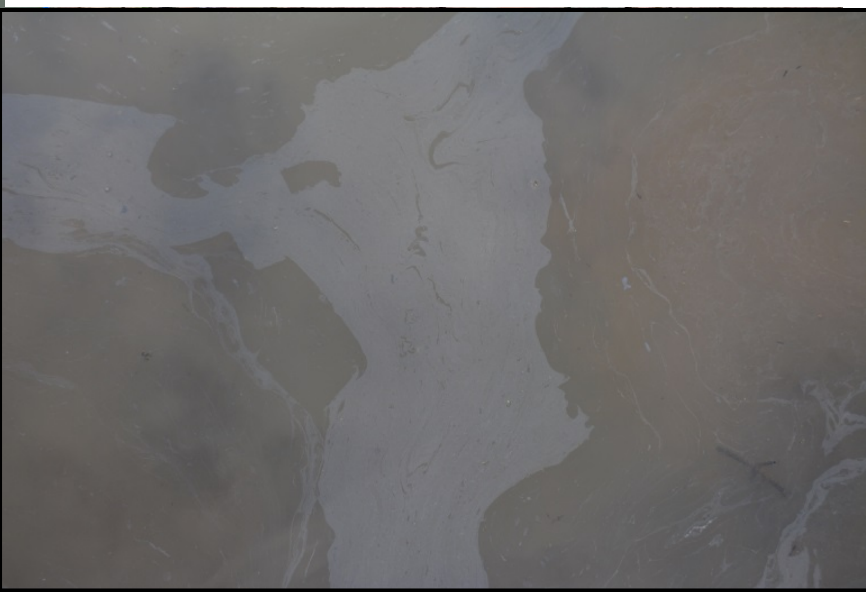
COVE-010 – Does not resemble crude oil

Cover (No Particular Structure) of Non-Brittle Silver Gray Sheen

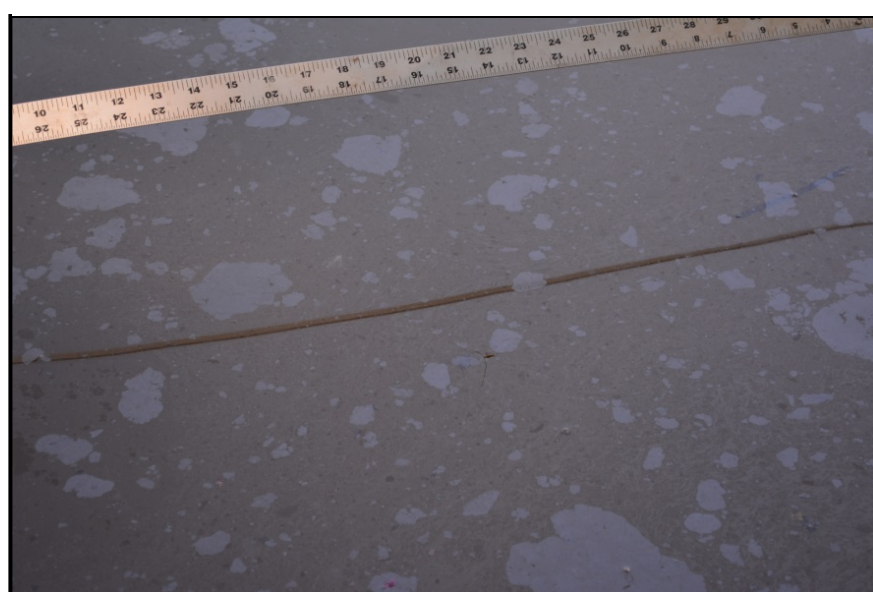
COVE-009 – Does not resemble crude oil

Patches of Non-Brittle Rainbow/Silver Gray Sheen

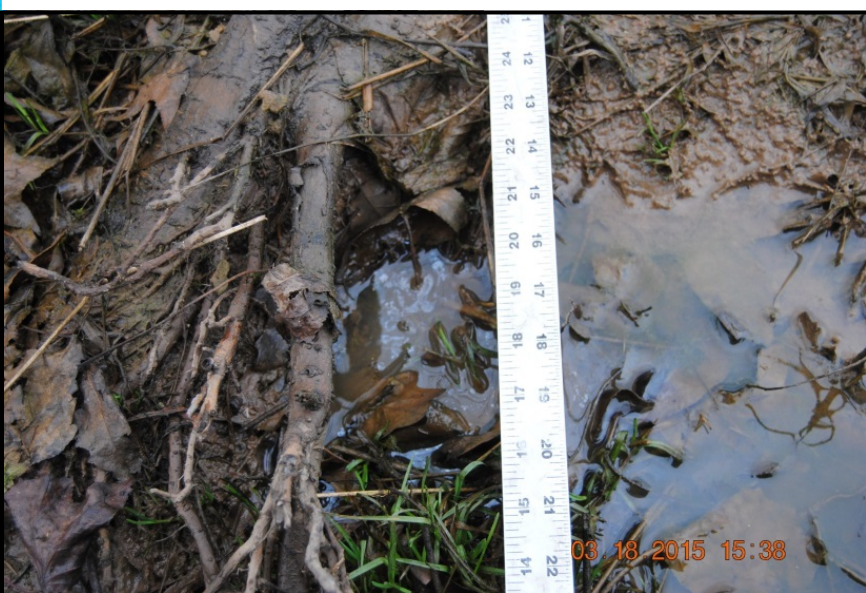
COVE-011 – Does not resemble crude oil (See Note 5)

Cover (No Particular Structure) of Brittle Silver Gray Sheen

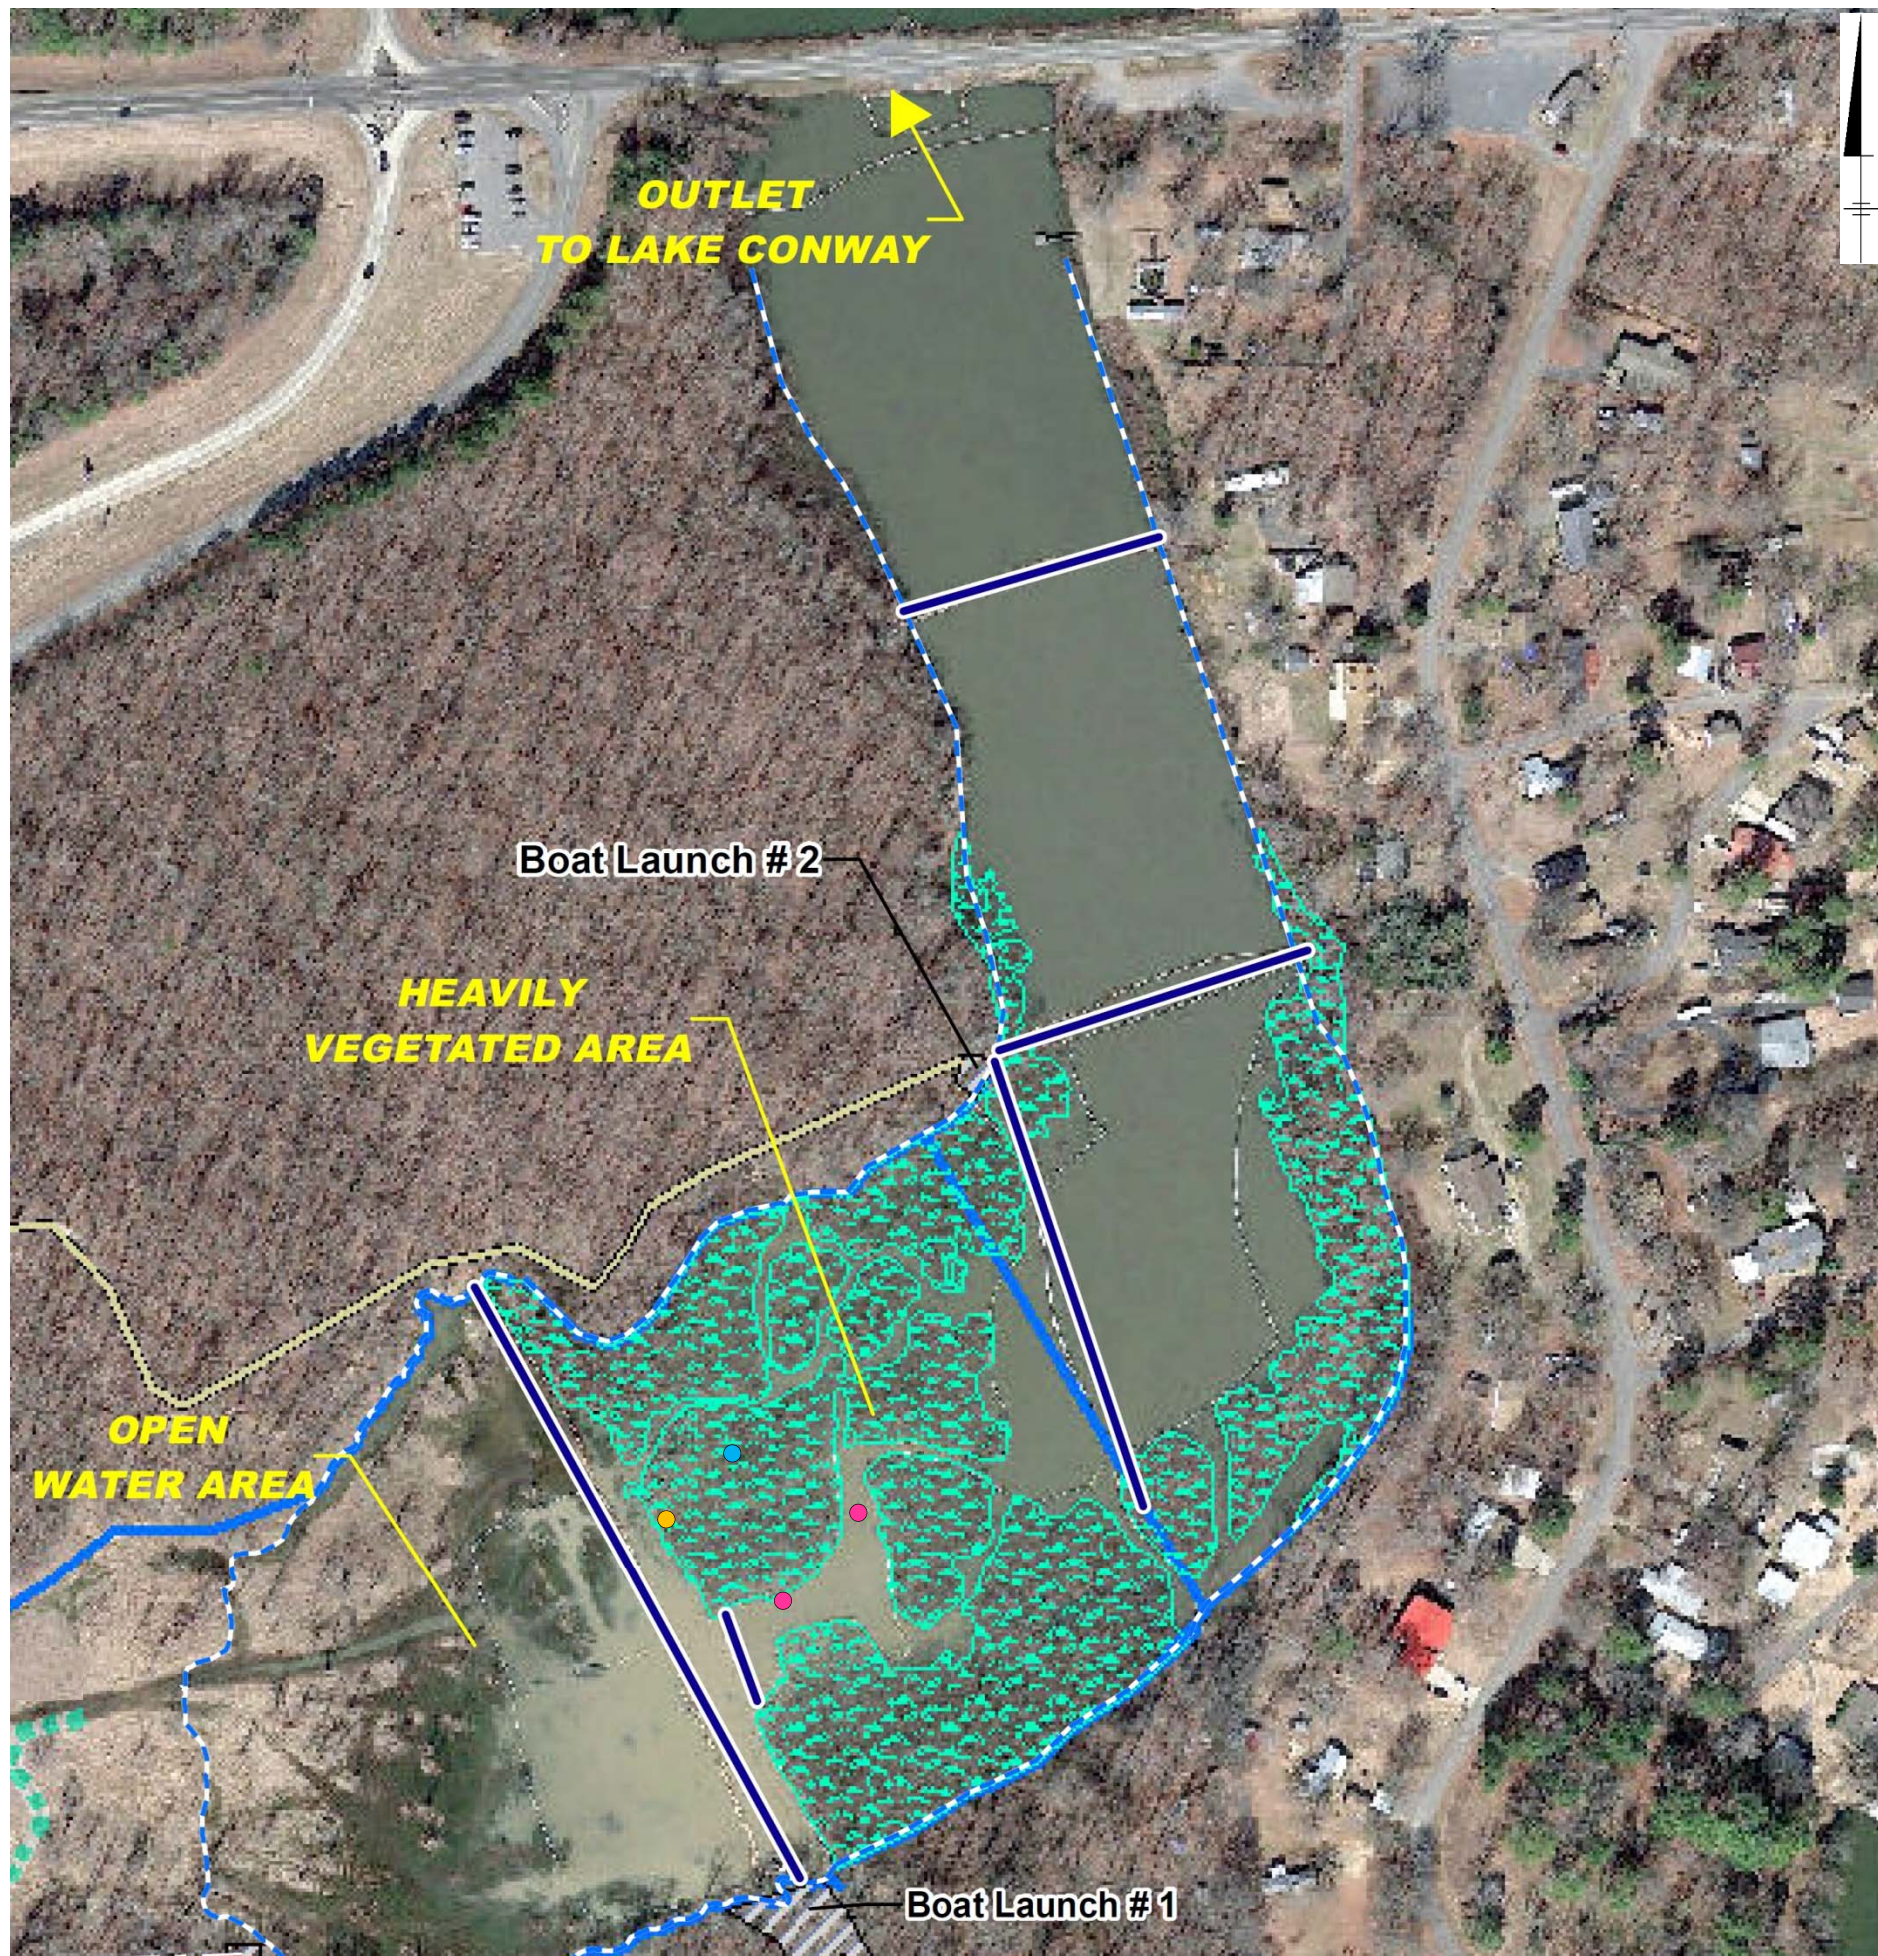
FIGURE  
 3-2

Following in-situ amendment placement in the Heavily Vegetated Area, sheen monitoring and removal activities were conducted in this area three times per week. During the construction activities, brittle and non-brittle sheens were observed at four locations within this area between October 23 and December 18, 2014. These sheens included patches/streamers of metallic/rainbow or silver gray-colored sheens. The results of the sheen monitoring within the Heavily Vegetated Area are summarized in Table 3-1 and shown on Figure 3-2.

3. Figure shows approximate location of sheens observed during sheen monitoring conducted between October 23 and December 18, 2014. No sheens were observed within the Heavily Vegetated Area during the post-construction sheen monitoring.
