**PRE-CERCLA SCREENING ASSESSMENT
FOR**

**Lewis Lumber and Manufacturing Company
136 West Mill Street
Cove, Polk County
Arkansas, 71937**

July 2018

**Prepared by:
Arkansas Department of Environmental Quality
5301 Northshore Drive
North Little Rock, AR 72118**

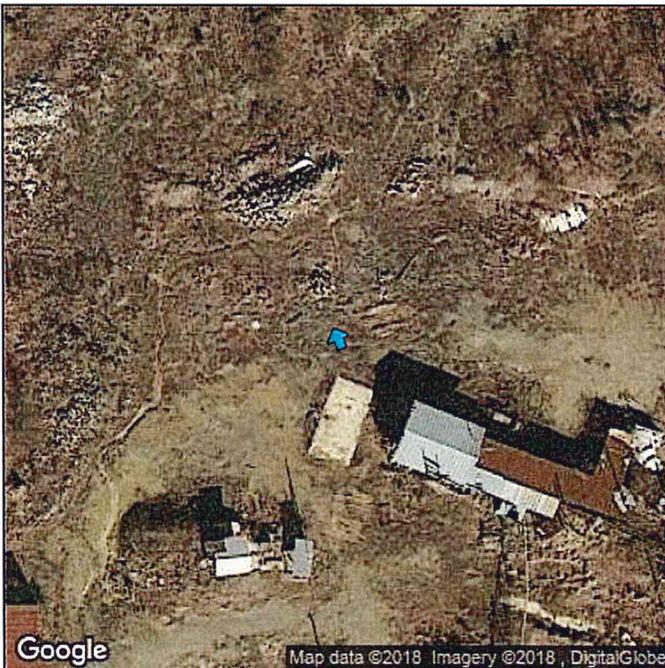
Attributes	
Photo Number	1
Facility	Lewis Lumber and Manufacturing Company
Event	Pre-CERCLA Screening Assessment
AFIN	57-00020
Photographer	Joshua Graham <i>JG</i>
Witness	Katie Kreps <i>KK</i>
Site Location	Cove, AR
Date/Time	5/30/2018 12:45:45 PM
Make	RICOH
Model	G700 SE
File Name	RIMG0032.JPG
Subject	Wooded area north of the site; staining and debris piles containing wood

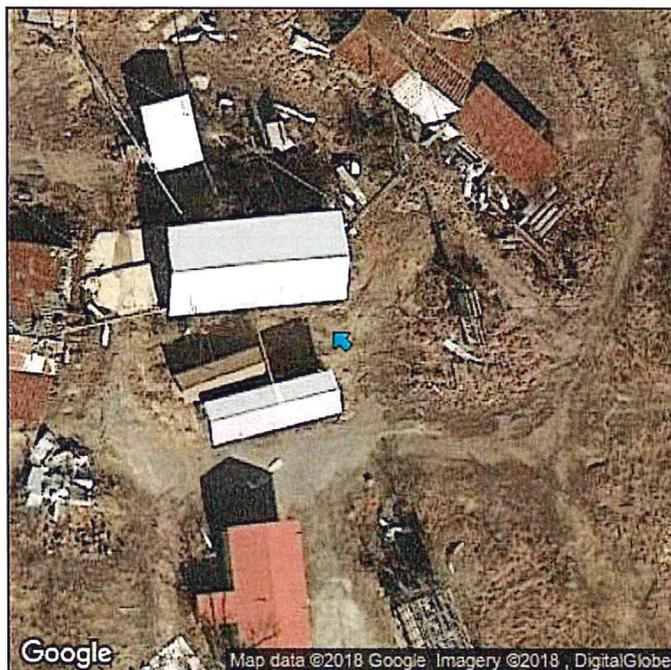
Attributes	
Photo Number	7
Facility	Lewis Lumber and Manufacturing Company
Event	Pre-CERCLA Screening Assessment
AFIN	57-00020
Photographer	Joshua Graham <i>JG</i>
Witness	Katie Kreps <i>KK</i>
Site Location	Cove, AR
Date/Time	5/30/2018 12:10:07 PM
Make	RICOH
Model	G700 SE
File Name	RIMG0012.JPG
Subject	Concrete foundation and demolition debris in location of former building on the north-central portion of the site

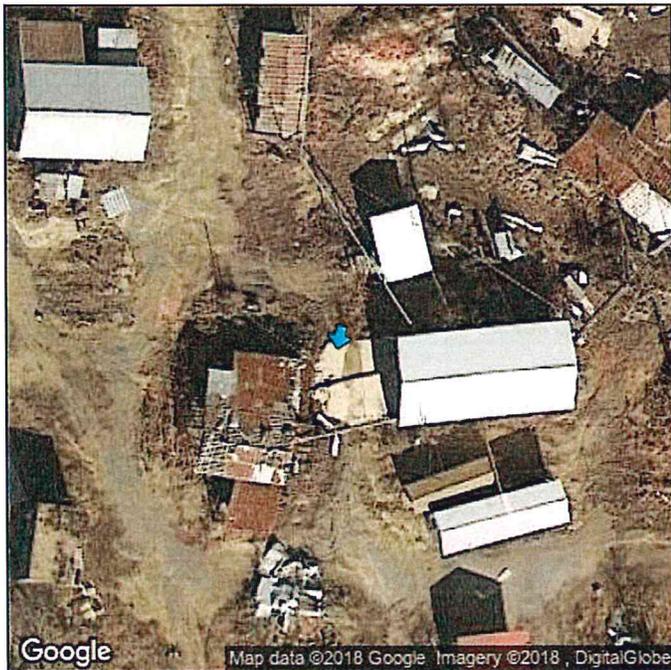
Attributes	
Photo Number	8
Facility	Lewis Lumber and Manufacturing Company
Event	Pre-CERCLA Screening Assessment
AFIN	57-00020
Photographer	Joshua Graham <i>JG</i>
Witness	Katie Kreps <i>KK</i>
Site Location	Cove, AR
Date/Time	5/30/2018 12:13:02 PM
Make	RICOH
Model	G700 SE
File Name	RIMG0015.JPG
Subject	Concrete foundation and demolition debris in location of former building on the north-central portion of the site

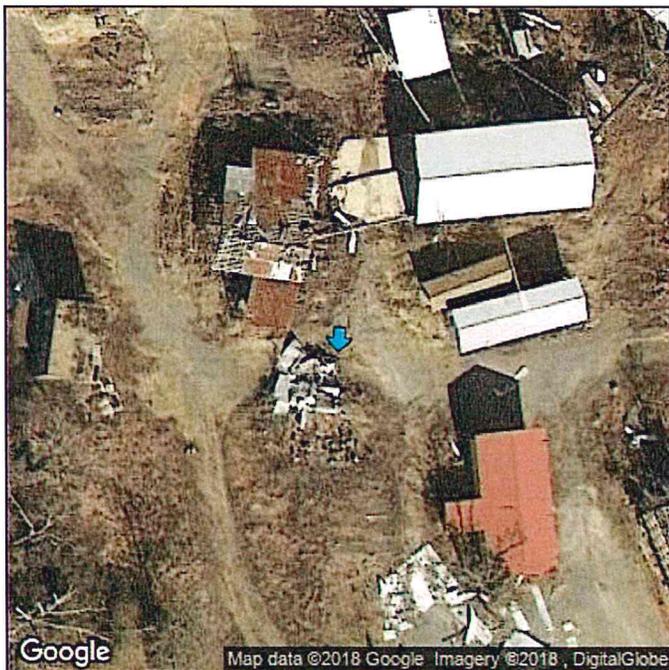
Attributes	
Photo Number	9
Facility	Lewis Lumber and Manufacturing Company
Event	Pre-CERCLA Screening Assessment
AFIN	57-00020
Photographer	Joshua Graham <i>JG</i>
Witness	Katie Kreps <i>KK</i>
Site Location	Cove, AR
Date/Time	5/30/2018 12:16:10 PM
Make	RICOH
Model	G700 SE
File Name	RIMG0016.JPG
Subject	Demolition debris in location of former building on the north-central portion of the site

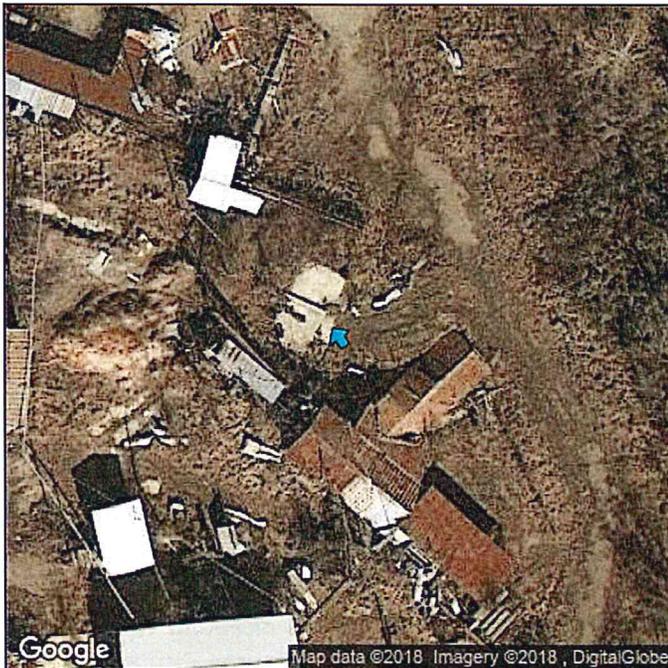
Attributes	
Photo Number	11
Facility	Lewis Lumber and Manufacturing Company
Event	Pre-CERCLA Screening Assessment
AFIN	57-00020
Photographer	Joshua Graham <i>JG</i>
Witness	Katie Kreps <i>KK</i>
Site Location	Cove, AR
Date/Time	5/30/2018 12:29:47 PM
Make	RICOH
Model	G700 SE
File Name	RIMG0025.JPG
Subject	Concrete foundation in location of former building on the north-central portion of the site

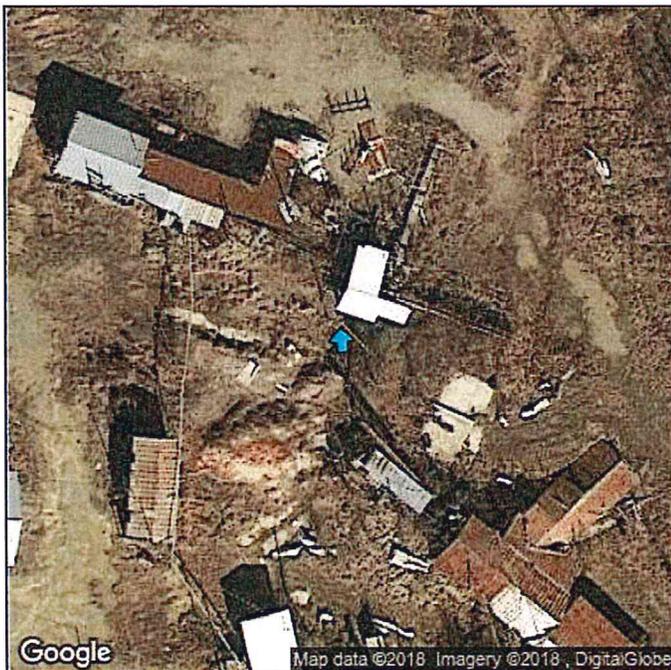
Attributes	
Photo Number	12
Facility	Lewis Lumber and Manufacturing Company
Event	Pre-CERCLA Screening Assessment
AFIN	57-00020
Photographer	Joshua Graham
Witness	Katie Kreps <i>KK</i>
Site Location	Cove, AR
Date/Time	5/30/2018 12:31:53 PM
Make	RICOH
Model	G700 SE
File Name	RIMG0027.JPG
Subject	Demolition debris and disturbed soil in location of former building on the northeast portion of the site

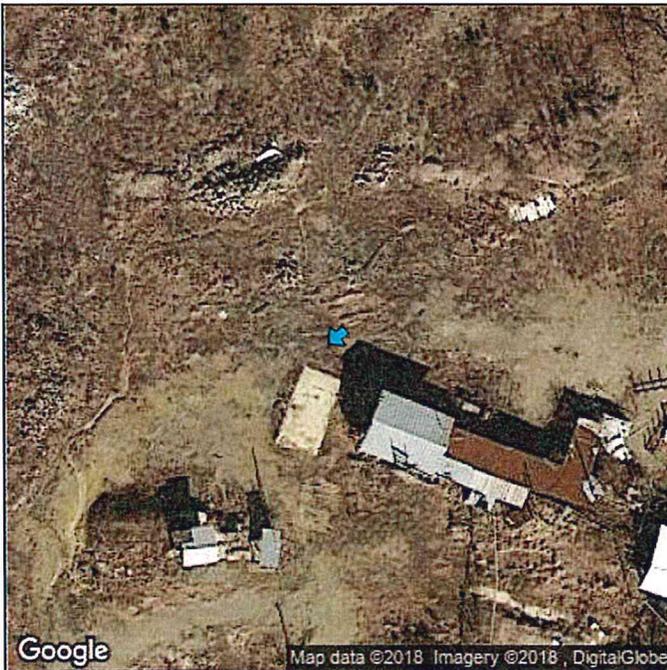
Attributes	
Photo Number	14
Facility	Lewis Lumber and Manufacturing Company
Event	Pre-CERCLA Screening Assessment
AFIN	57-00020
Photographer	Joshua Graham
Witness	Katie Kreps <i>KK</i>
Site Location	Cove, AR
Date/Time	5/30/2018 12:42:43 PM
Make	RICOH
Model	G700 SE
File Name	RIMG0031.JPG
Subject	Concrete foundation on the northern portion of the site

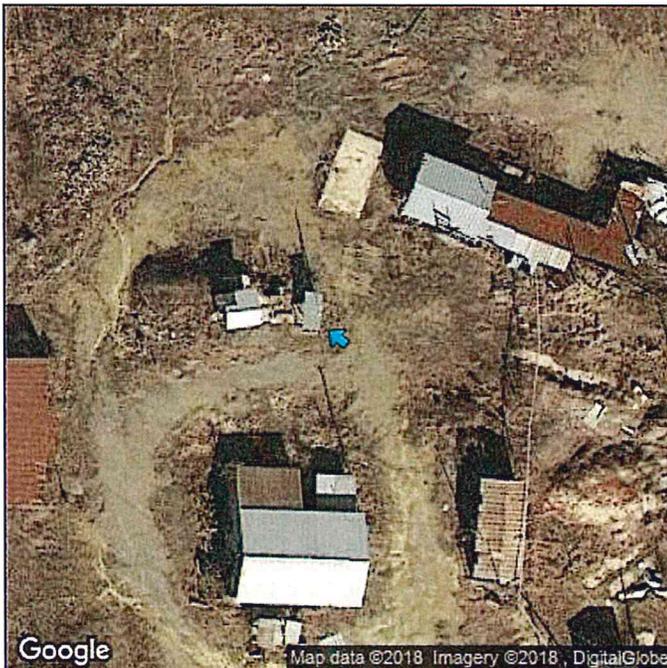
Attributes	
Photo Number	15
Facility	Lewis Lumber and Manufacturing Company
Event	Pre-CERCLA Screening Assessment
AFIN	57-00020
Photographer	Joshua Graham
Witness	Katie Kreps <i>KK</i>
Site Location	Cove, AR
Date/Time	5/30/2018 12:47:30 PM
Make	RICOH
Model	G700 SE
File Name	RIMG0033.JPG
Subject	Concrete foundation and demolition debris in location of former building on the northwest portion of the site

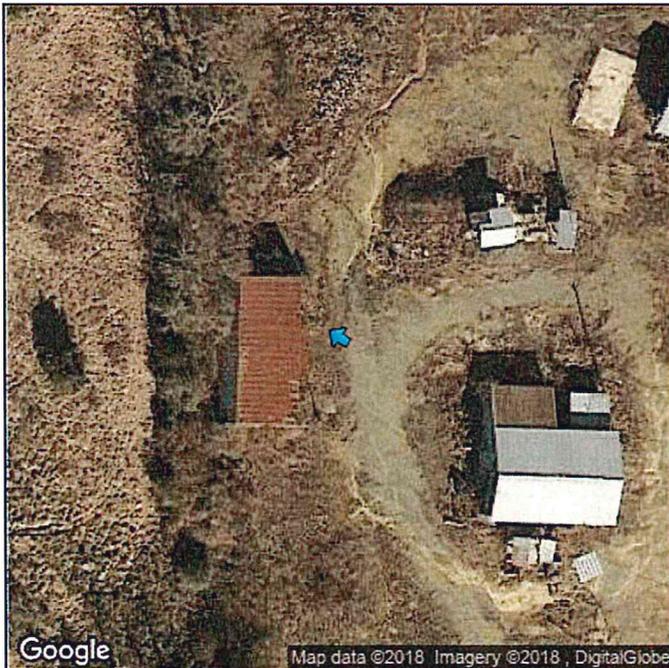
Attributes	
Photo Number	16
Facility	Lewis Lumber and Manufacturing Company
Event	Pre-CERCLA Screening Assessment
AFIN	57-00020
Photographer	Joshua Graham <i>JG</i>
Witness	Katie Kreps <i>KK</i>
Site Location	Cove, AR
Date/Time	5/30/2018 12:49:42 PM
Make	RICOH
Model	G700 SE
File Name	RIMG0034.JPG
Subject	Concrete foundation and demolition debris in location of former building on the northwest portion of the site

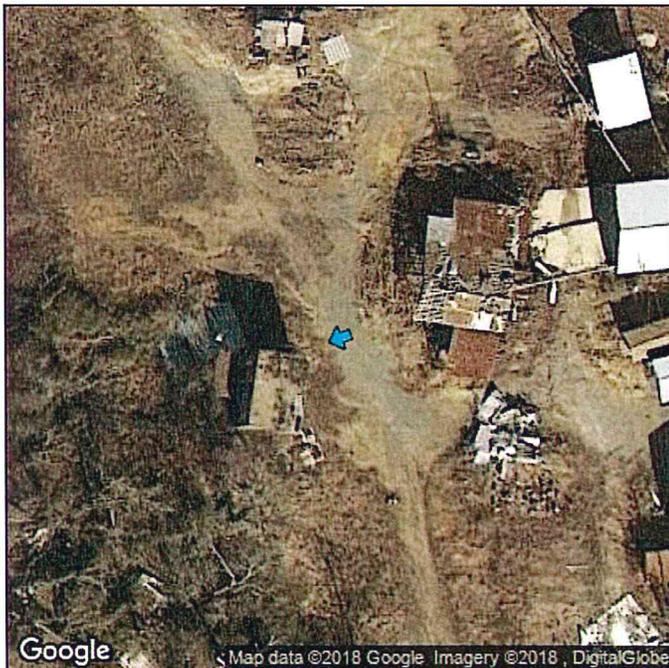
Attributes	
Photo Number	17
Facility	Lewis Lumber and Manufacturing Company
Event	Pre-CERCLA Screening Assessment
AFIN	57-00020
Photographer	Joshua Graham <i>JG</i>
Witness	Katie Kreps <i>KL</i>
Site Location	Cove, AR
Date/Time	5/30/2018 12:57:47 PM
Make	RICOH
Model	G700 SE
File Name	RIMG0040.JPG
Subject	Concrete foundation and demolition debris in location of former building on the west portion of the site

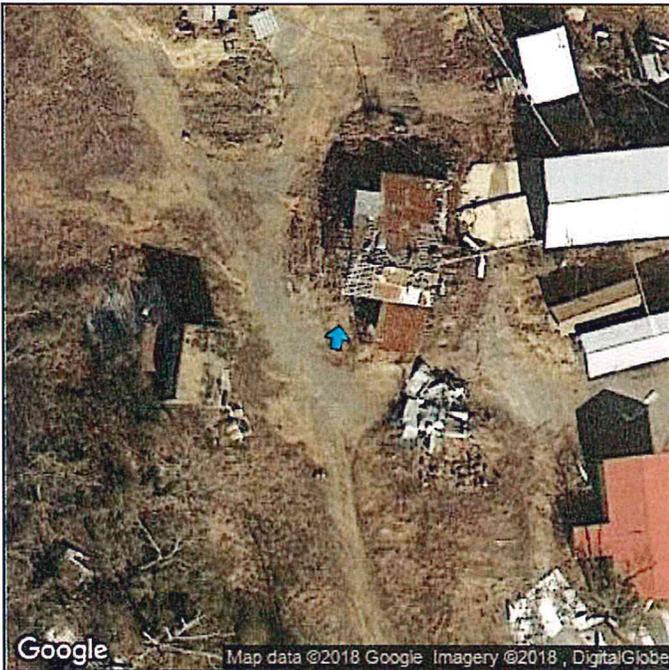
Attributes	
Photo Number	18
Facility	Lewis Lumber and Manufacturing Company
Event	Pre-CERCLA Screening Assessment
AFIN	57-00020
Photographer	Joshua Graham <i>JG</i>
Witness	Katie Kreps <i>KK</i>
Site Location	Cove, AR
Date/Time	5/30/2018 12:58:33 PM
Make	RICOH
Model	G700 SE
File Name	RIMG0041.JPG
Subject	Demolition debris in location of former building on the north-central portion of the site

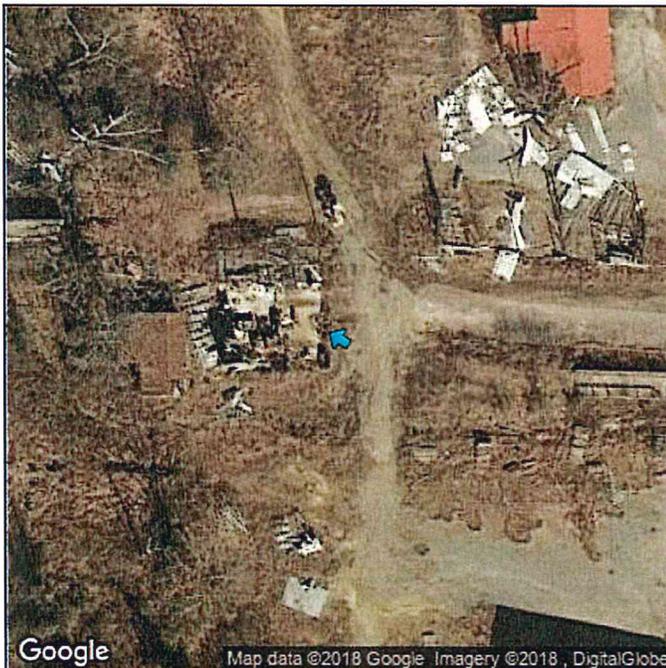
Attributes	
Photo Number	20
Facility	Lewis Lumber and Manufacturing Company
Event	Pre-CERCLA Screening Assessment
AFIN	57-00020
Photographer	Joshua Graham <i>JG</i>
Witness	Katie Kreps <i>KE</i>
Site Location	Cove, AR
Date/Time	5/30/2018 1:03:09 PM
Make	RICOH
Model	G700 SE
File Name	RIMG0045.JPG
Subject	Concrete foundation with staining in location of former building on the west portion of the site

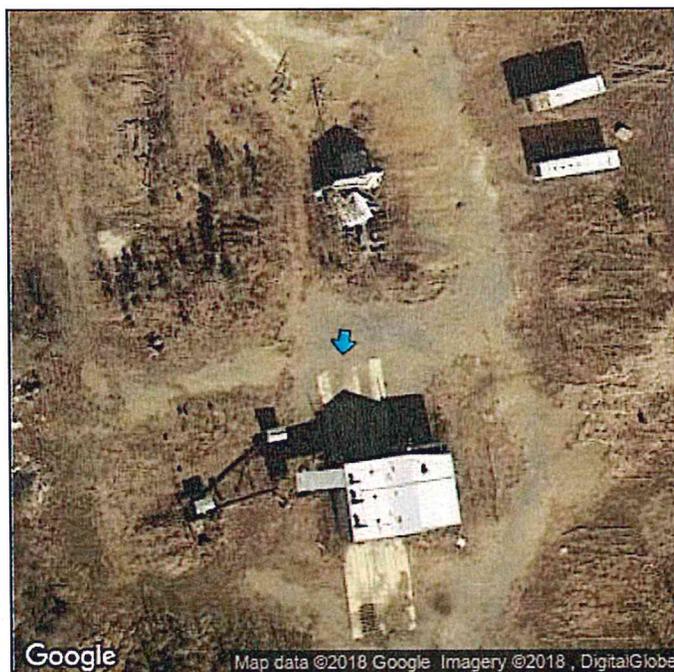
Attributes	
Photo Number	22
Facility	Lewis Lumber and Manufacturing Company
Event	Pre-CERCLA Screening Assessment
AFIN	57-00020
Photographer	Joshua Graham
Witness	Katie Kreps <i>KK</i>
Site Location	Cove, AR
Date/Time	5/30/2018 1:21:01 PM
Make	RICOH
Model	G700 SE
File Name	RIMG0062.JPG
Subject	Concrete foundation in location of former Dry Kiln on the southern portion of the site

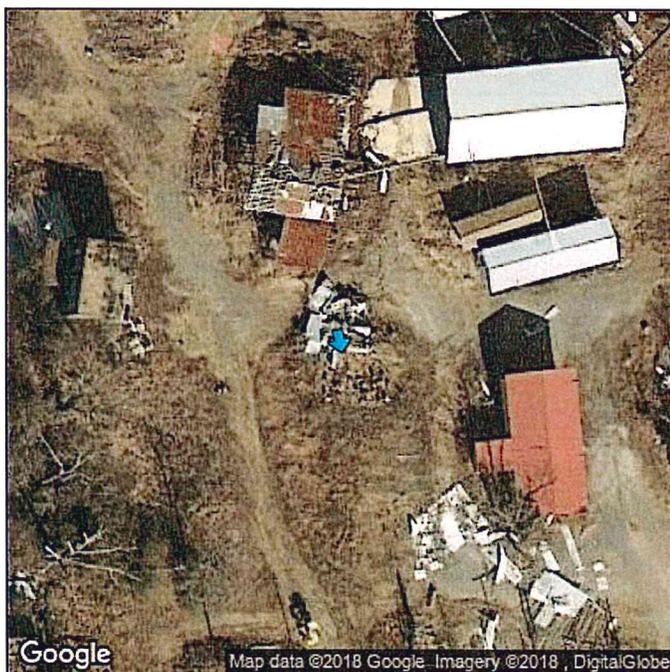
Attributes	
Photo Number	23
Facility	Lewis Lumber and Manufacturing Company
Event	Pre-CERCLA Screening Assessment
AFIN	57-00020
Photographer	Joshua Graham <i>JG</i>
Witness	Katie Kreps <i>KK</i>
Site Location	Cove, AR
Date/Time	5/30/2018 12:17:29 PM
Make	RICOH
Model	G700 SE
File Name	RIMG0017.JPG
Subject	Empty 5-gallon hydraulic fluid buckets in debris pile on the north-central portion of the site

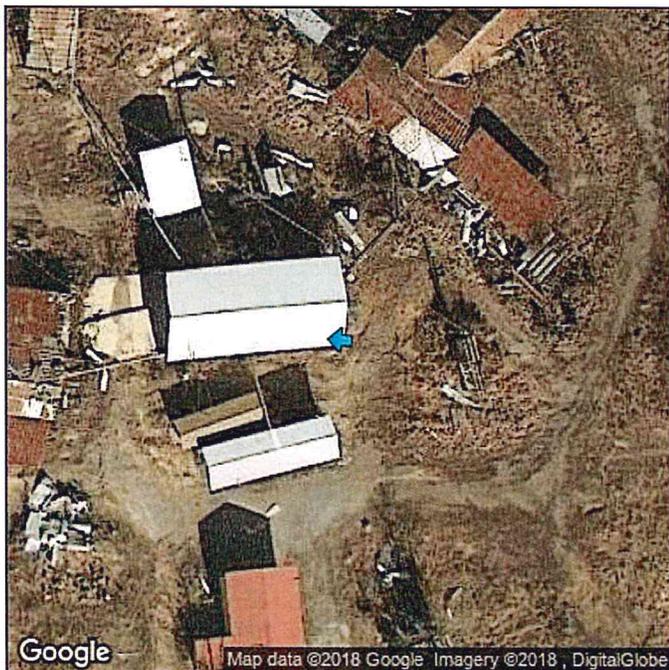
Attributes	
Photo Number	25
Facility	Lewis Lumber and Manufacturing Company
Event	Pre-CERCLA Screening Assessment
AFIN	57-00020
Photographer	Joshua Graham <i>JG</i>
Witness	Katie Kreps <i>KK</i>
Site Location	Cove, AR
Date/Time	5/30/2018 12:11:18 PM
Make	RICOH
Model	G700 SE
File Name	RIMG0013.JPG
Subject	Broken universal waste bulb near debris pile on the north-central portion of the site

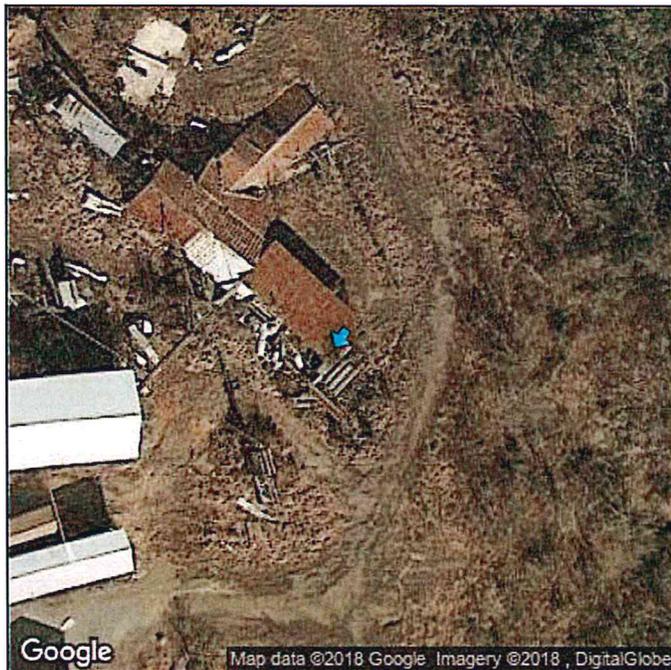
Attributes	
Photo Number	32
Facility	Lewis Lumber and Manufacturing Company
Event	Pre-CERCLA Screening Assessment
AFIN	57-00020
Photographer	Joshua Graham <i>JG</i>
Witness	Katie Kreps <i>KK</i>
Site Location	Cove, AR
Date/Time	5/30/2018 12:23:15 PM
Make	RICOH
Model	G700 SE
File Name	RIMG0020.JPG
Subject	Areas of staining and burn piles on the northeast portion of the site

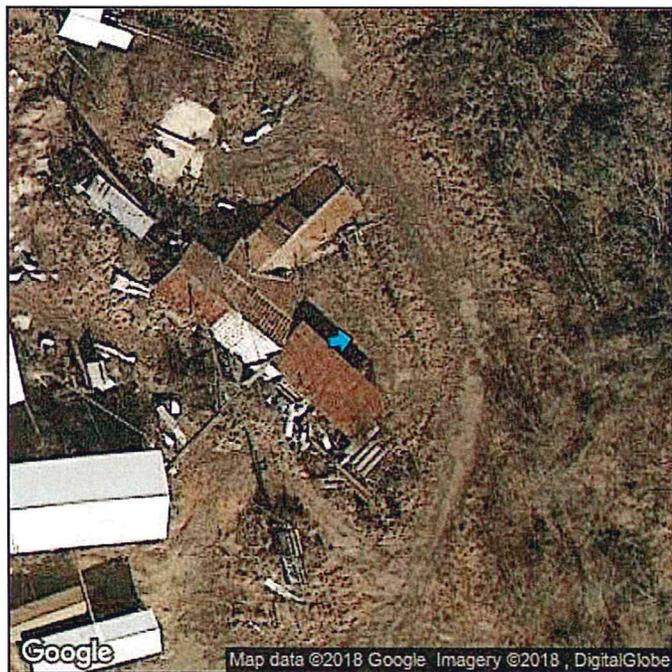
Attributes	
Photo Number	33
Facility	Lewis Lumber and Manufacturing Company
Event	Pre-CERCLA Screening Assessment
AFIN	57-00020
Photographer	Joshua Graham
Witness	Katie Kreps <i>KK</i>
Site Location	Cove, AR
Date/Time	5/30/2018 12:24:43 PM
Make	RICOH
Model	G700 SE
File Name	RIMG0021.JPG
Subject	Area of staining on the northeast portion of the site

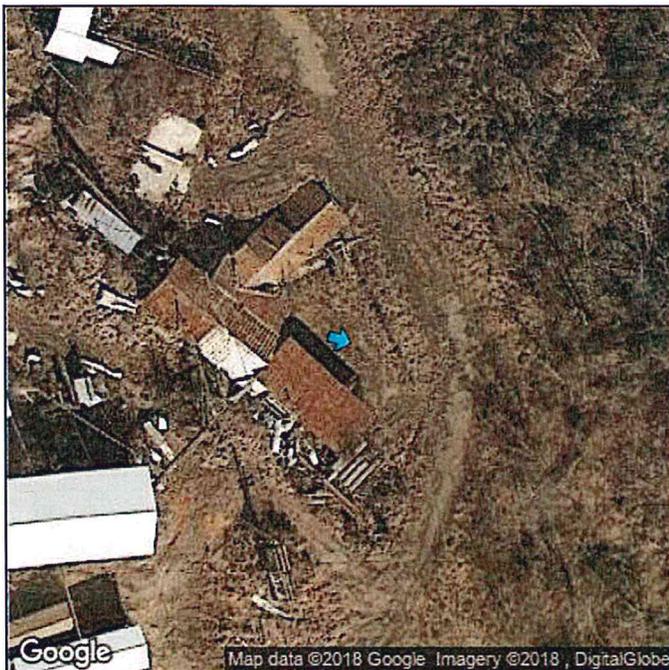
Attributes	
Photo Number	34
Facility	Lewis Lumber and Manufacturing Company
Event	Pre-CERCLA Screening Assessment
AFIN	57-00020
Photographer	Joshua Graham
Witness	Katie Kreps <i>KK</i>
Site Location	Cove, AR
Date/Time	5/30/2018 12:24:56 PM
Make	RICOH
Model	G700 SE
File Name	RIMG0022.JPG
Subject	Area of staining on the northeast portion of the site

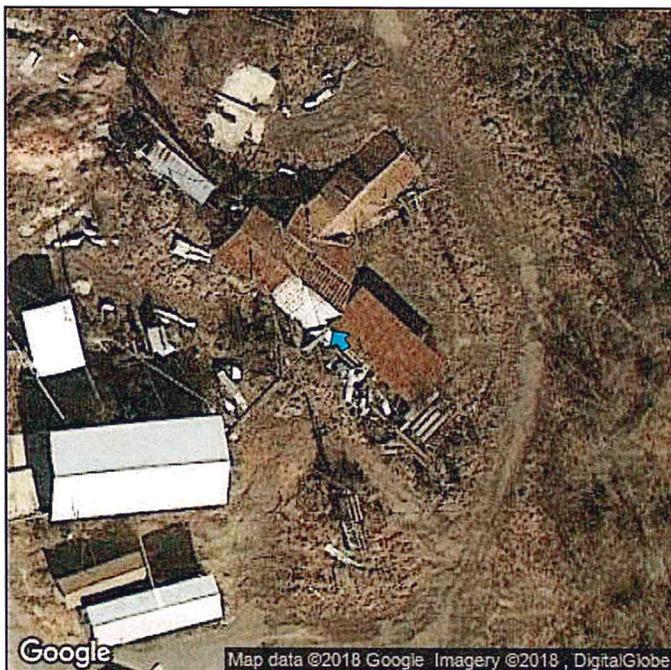
Attributes	
Photo Number	35
Facility	Lewis Lumber and Manufacturing Company
Event	Pre-CERCLA Screening Assessment
AFIN	57-00020
Photographer	Joshua Graham
Witness	Katie Kreps <i>KK</i>
Site Location	Cove, AR
Date/Time	5/30/2018 12:27:31 PM
Make	RICOH
Model	G700 SE
File Name	RIMG0024.JPG
Subject	Staining and demolition debris on the northeast portion of the site

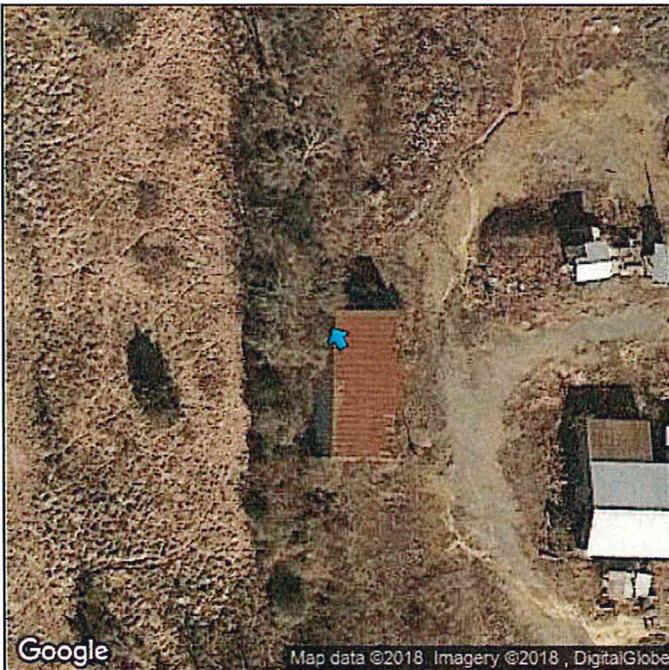
Attributes	
Photo Number	36
Facility	Lewis Lumber and Manufacturing Company
Event	Pre-CERCLA Screening Assessment
AFIN	57-00020
Photographer	Joshua Graham
Witness	Katie Kreps <i>KK</i>
Site Location	Cove, AR
Date/Time	5/30/2018 12:51:40 PM
Make	RICOH
Model	G700 SE
File Name	RIMG0035.JPG
Subject	Staining and debris on concrete foundation on the northwest portion of the site

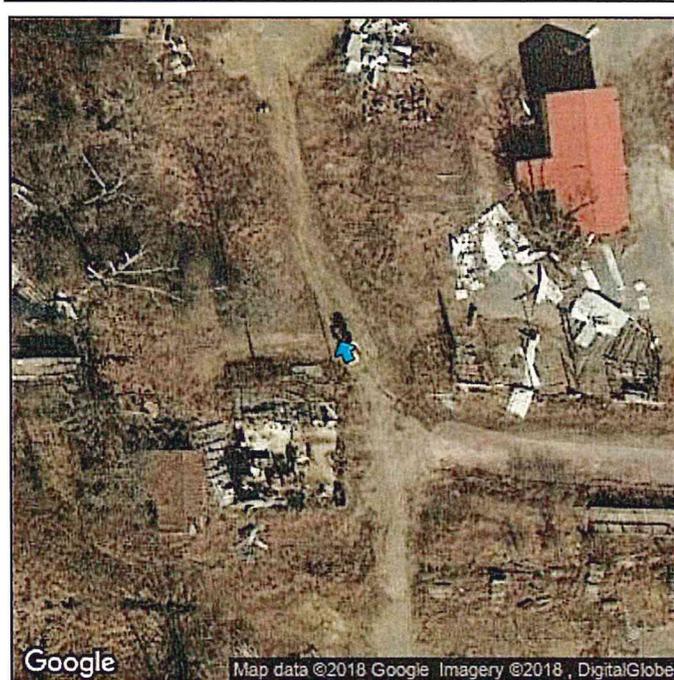
Attributes	
Photo Number	37
Facility	Lewis Lumber and Manufacturing Company
Event	Pre-CERCLA Screening Assessment
AFIN	57-00020
Photographer	Joshua Graham <i>JG</i>
Witness	Katie Kreps <i>KK</i>
Site Location	Cove, AR
Date/Time	5/30/2018 1:00:08 PM
Make	RICOH
Model	G700 SE
File Name	RIMG0042.JPG
Subject	Staining on the west portion of the site

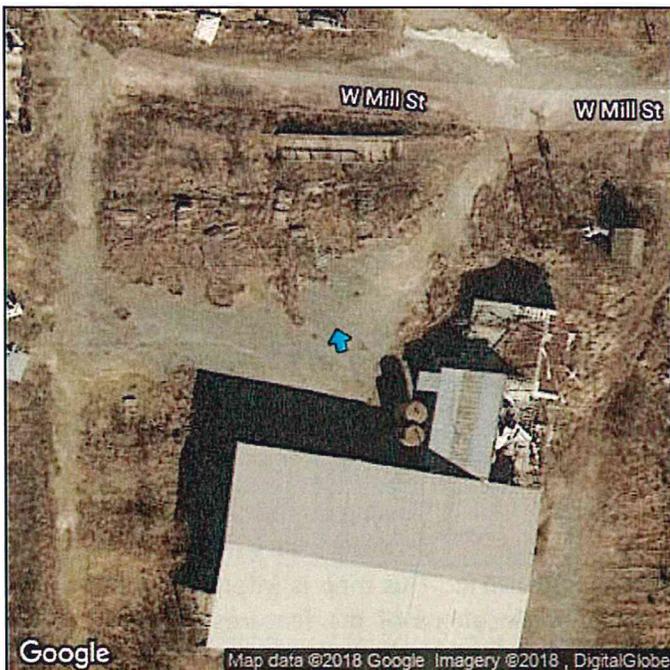
Attributes	
Photo Number	38
Facility	Lewis Lumber and Manufacturing Company
Event	Pre-CERCLA Screening Assessment
AFIN	57-00020
Photographer	Joshua Graham
Witness	Katie Kreps <i>KK</i>
Site Location	Cove, AR
Date/Time	5/30/2018 1:05:28 PM
Make	RICOH
Model	G700 SE
File Name	RIMG0048.JPG
Subject	Staining on the southern portion of the site, north of the CCA Treatment Building

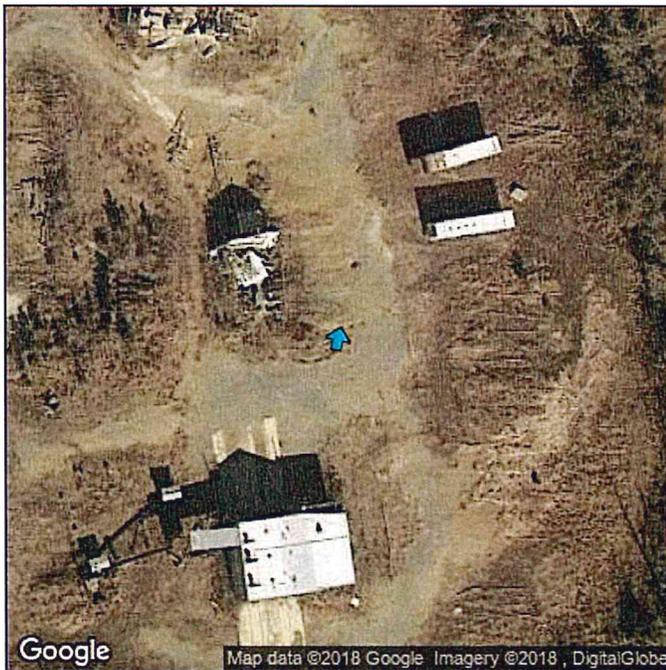
Attributes	
Photo Number	39
Facility	Lewis Lumber and Manufacturing Company
Event	Pre-CERCLA Screening Assessment
AFIN	57-00020
Photographer	Joshua Graham
Witness	Katie Kreps <i>KK</i>
Site Location	Cove, AR
Date/Time	5/30/2018 1:20:12 PM
Make	RICOH
Model	G700 SE
File Name	RIMG0061.JPG
Subject	Staining on the south-central portion of the site

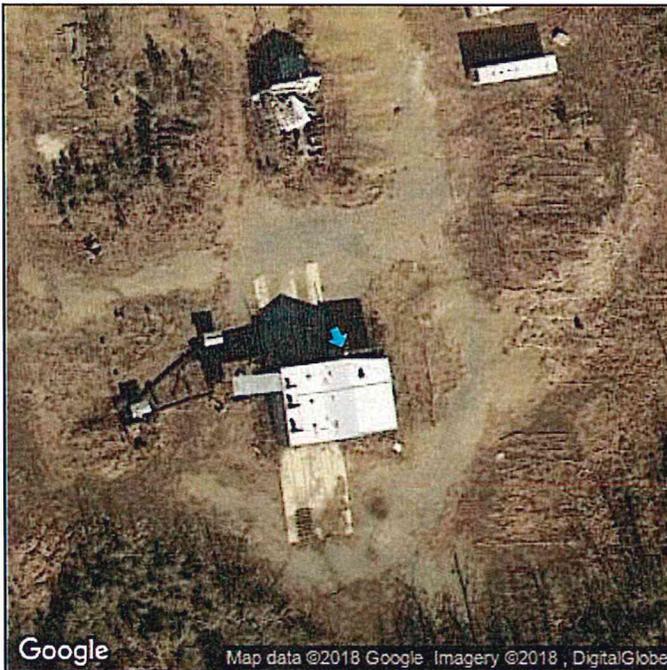
Attributes	
Photo Number	40
Facility	Lewis Lumber and Manufacturing Company
Event	Pre-CERCLA Screening Assessment
AFIN	57-00020
Photographer	Joshua Graham
Witness	Katie Kreps <i>KK</i>
Site Location	Cove, AR
Date/Time	5/30/2018 1:22:04 PM
Make	RICOH
Model	G700 SE
File Name	RIMG0063.JPG
Subject	Staining on concrete foundation of the former Dry Kiln on the southern portion of the site

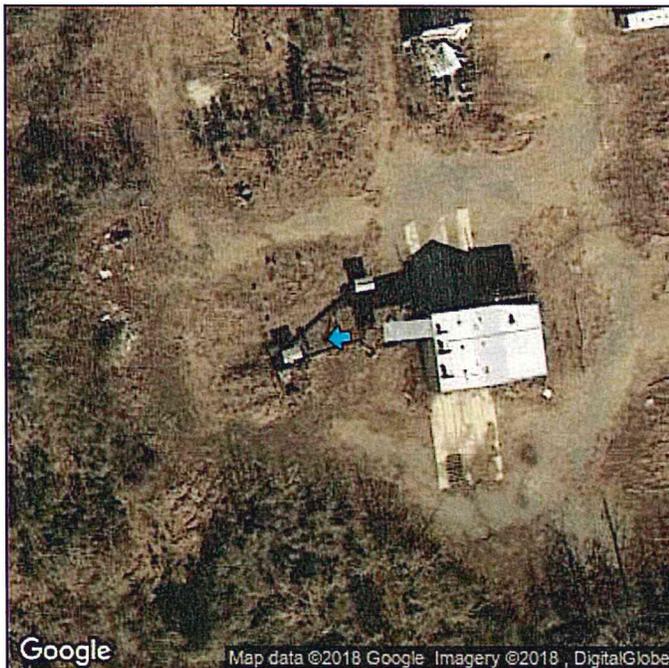
Attributes	
Photo Number	41
Facility	Lewis Lumber and Manufacturing Company
Event	Pre-CERCLA Screening Assessment
AFIN	57-00020
Photographer	Joshua Graham <i>JG</i>
Witness	Katie Kreps <i>KK</i>
Site Location	Cove, AR
Date/Time	5/30/2018 1:23:58 PM
Make	RICOH
Model	G700 SE
File Name	RIMG0065.JPG
Subject	Staining west of the former Dry Kiln on the southern portion of the site

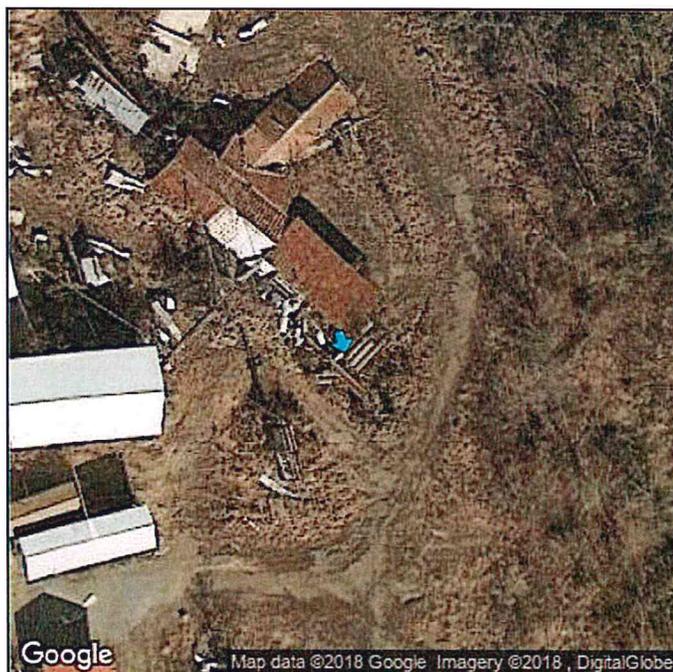
Attributes	
Photo Number	42
Facility	Lewis Lumber and Manufacturing Company
Event	Pre-CERCLA Screening Assessment
AFIN	57-00020
Photographer	Joshua Graham
Witness	Katie Kreps <i>KK</i>
Site Location	Cove, AR
Date/Time	5/30/2018 12:21:59 PM
Make	RICOH
Model	G700 SE
File Name	RIMG0019.JPG
Subject	Burn pile on the northeast portion of the site

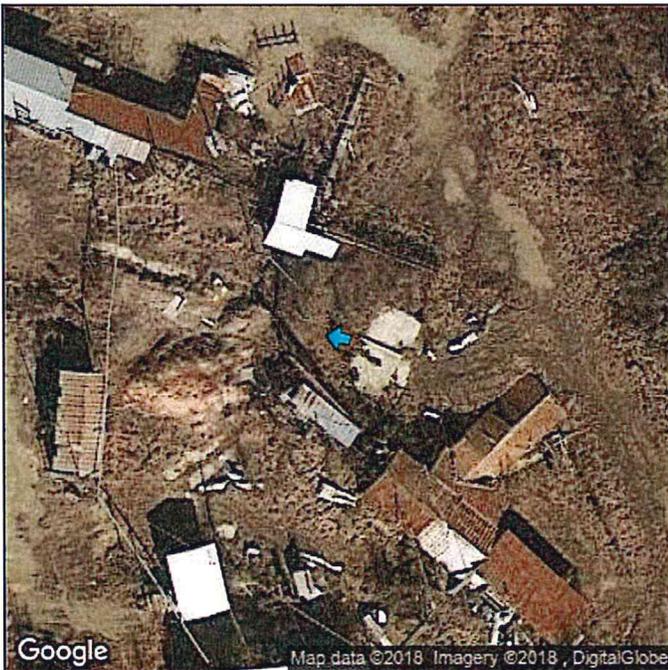
Attributes	
Photo Number	44
Facility	Lewis Lumber and Manufacturing Company
Event	Pre-CERCLA Screening Assessment
AFIN	57-00020
Photographer	Joshua Graham
Witness	Katie Kreps <i>KK</i>
Site Location	Cove, AR
Date/Time	5/30/2018 12:30:57 PM
Make	RICOH
Model	G700 SE
File Name	RIMG0026.JPG
Subject	Large sawdust pile and areas of disturbed soil on the north-central portion of the site

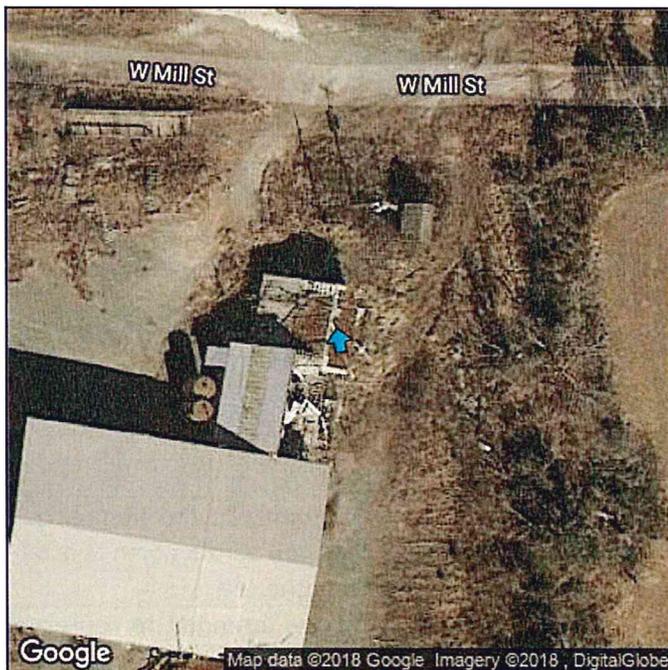
Attributes	
Photo Number	45
Facility	Lewis Lumber and Manufacturing Company
Event	Pre-CERCLA Screening Assessment
AFIN	57-00020
Photographer	Joshua Graham
Witness	Katie Kreps <i>KK</i>
Site Location	Cove, AR
Date/Time	5/30/2018 1:32:15 PM
Make	RICOH
Model	G700 SE
File Name	RIMG0073.JPG
Subject	Staining on concrete near the CCA Treatment Building

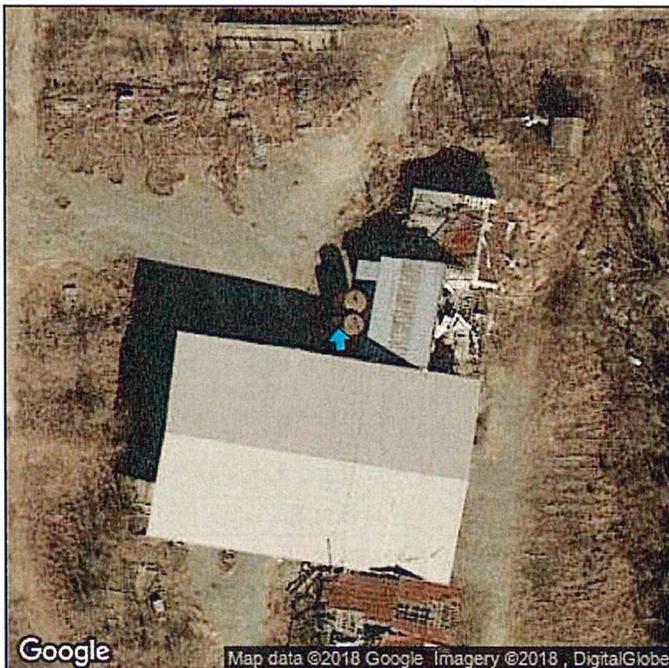
The CCA Treatment Building is a grouping of buildings on the southern portion of the site that were adjoined over time. Areas of staining accompanied by hydrocarbon and chemical odors were located in numerous areas in and around the CCA Treatment Building (Refer to Photographic Log, Photo 45). Three large aboveground storage tanks (ASTs) labeled “Wood Chemicals Group CCA-C (50%) Wood Preservative” (“CCA Tanks”) are located within a concrete containment area under a portion of the CCA Treatment Building (Refer to Photographic Log, Photo 46). During site reconnaissance, all three CCA Tanks were empty. Green staining was visible on the CCA Tanks and inside the concrete containment area. In addition, during site reconnaissance, the concrete containment area surrounding the CCA Tanks contained a liquid presumed to be rainwater (Refer to Photographic Log, Photo 47).

Attributes	
Photo Number	47
Facility	Lewis Lumber and Manufacturing Company
Event	Pre-CERCLA Screening Assessment
AFIN	57-00020
Photographer	Joshua Graham
Witness	Katie Kreps <i>KK</i>
Site Location	Cove, AR
Date/Time	5/30/2018 1:09:25 PM
Make	RICOH
Model	G700 SE
File Name	RIMG0050.JPG
Subject	Green staining on the CCA Tanks and inside the concrete containment area with liquid

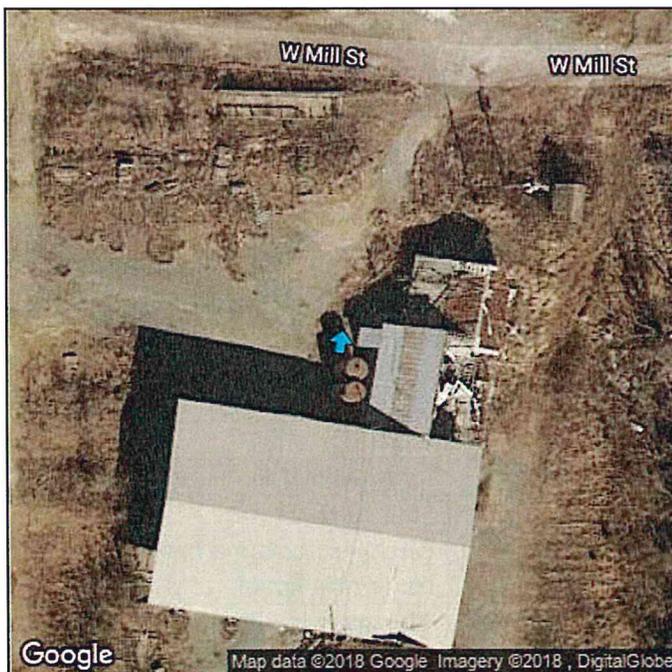
Concrete saddles for additional former ASTs are located north of the CCA Tanks (Refer to Photographic Log, Photo 48). A concrete catch/recirculation basin with a metal tank and sump on each side is located south of the CCA Tanks (Refer to Photographic Log, Photo 49). The concrete catch/recirculation basin was stained and contained liquid presumed to be rainwater during site reconnaissance. A covered concrete drip pad and treatment area is located south of the catch/recirculation basin. During site reconnaissance, staining was visible on the concrete drip pad and treatment area; in particular, dense green staining was located on the south portion of the concrete drip pad (Refer to Photographic Log, Photos 50 and 51). An approximately 18,000-gallon underground concrete containment area is located east of the CCA Tanks (Refer to Photographic Log, Photo 52). During site reconnaissance, the approximately 18,000-gallon underground concrete containment area contained liquid presumed to be rainwater with sheen on the surface (Refer to Photographic Log, Photo 53).

Attributes	
Photo Number	48
Facility	Lewis Lumber and Manufacturing Company
Event	Pre-CERCLA Screening Assessment
AFIN	57-00020
Photographer	Joshua Graham
Witness	Katie Kreps <i>KK</i>
Site Location	Cove, AR
Date/Time	5/30/2018 1:11:16 PM
Make	RICOH
Model	G700 SE
File Name	RIMG0052.JPG
Subject	Concrete saddles for ASTs north of the CCA Tanks

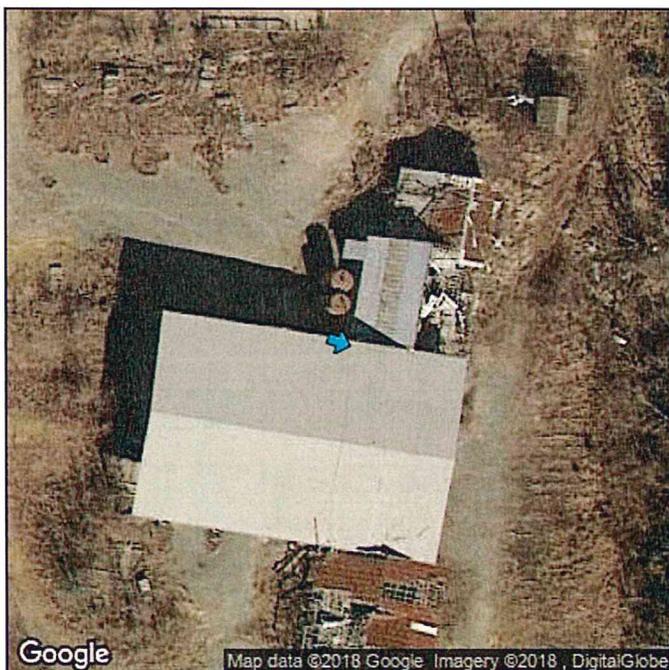
Attributes	
Photo Number	49
Facility	Lewis Lumber and Manufacturing Company
Event	Pre-CERCLA Screening Assessment
AFIN	57-00020
Photographer	Joshua Graham
Witness	Katie Kreps <i>KK</i>
Site Location	Cove, AR
Date/Time	5/30/2018 1:13:35 PM
Make	RICOH
Model	G700 SE
File Name	RIMG0055.JPG
Subject	Stained concrete catch/recirculation basin containing liquid

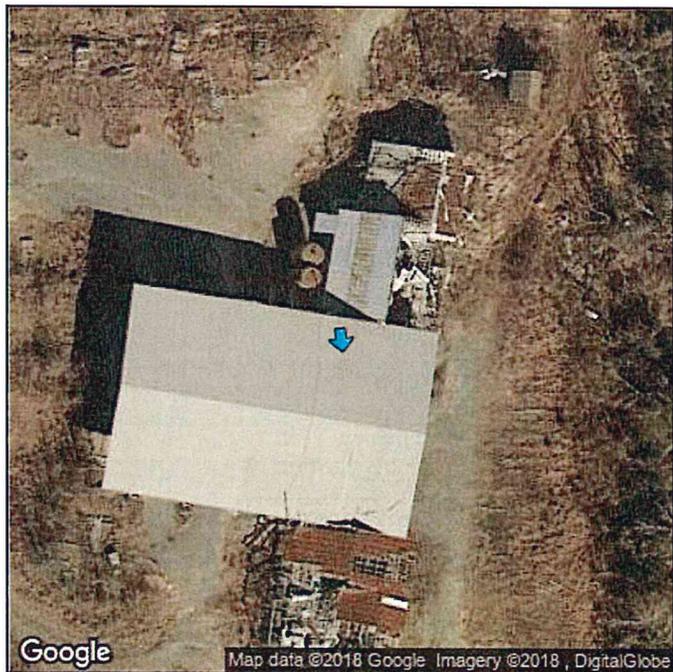
Attributes	
Photo Number	50
Facility	Lewis Lumber and Manufacturing Company
Event	Pre-CERCLA Screening Assessment
AFIN	57-00020
Photographer	Joshua Graham
Witness	Katie Kreps <i>KK</i>
Site Location	Cove, AR
Date/Time	5/30/2018 1:14:57 PM
Make	RICOH
Model	G700 SE
File Name	RIMG0057.JPG
Subject	Covered concrete drip pad and treatment area with staining

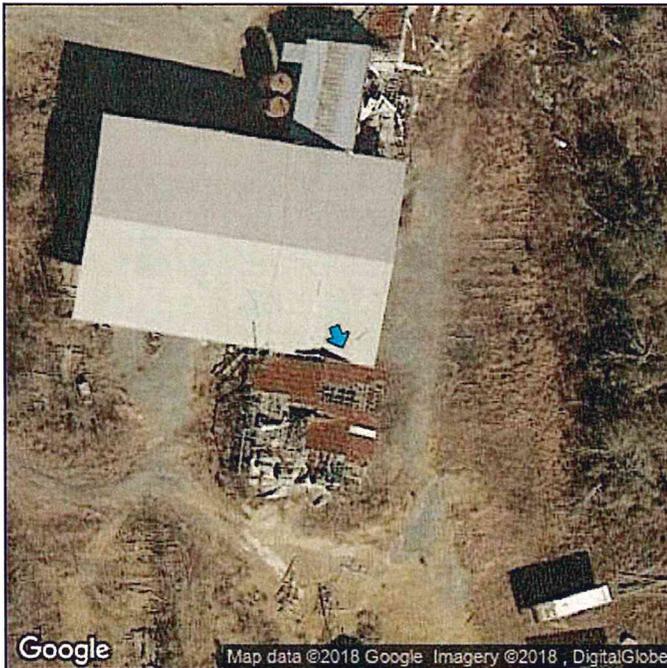
Attributes	
Photo Number	51
Facility	Lewis Lumber and Manufacturing Company
Event	Pre-CERCLA Screening Assessment
AFIN	57-00020
Photographer	Joshua Graham <i>JG</i>
Witness	Katie Kreps <i>KK</i>
Site Location	Cove, AR
Date/Time	5/30/2018 1:17:36 PM
Make	RICOH
Model	G700 SE
File Name	RIMG0059.JPG
Subject	Dense green staining on the south portion of the concrete drip pad
