**TO:** Katie Kreps  
Brownfield & Site Assessment Supervisor  
Office of Land Resources, Assessment and Remediation  
Arkansas Energy & Environment, Division of Environmental Quality

**FROM:** Adam Smith, Asbestos Inspector, Harbor

**DATE:** December 20, 2019

**RE:** Asbestos Survey – Former JT Parsons Cabinet Company  
420 West Ohlendorf Road, Osceola, AR 72370

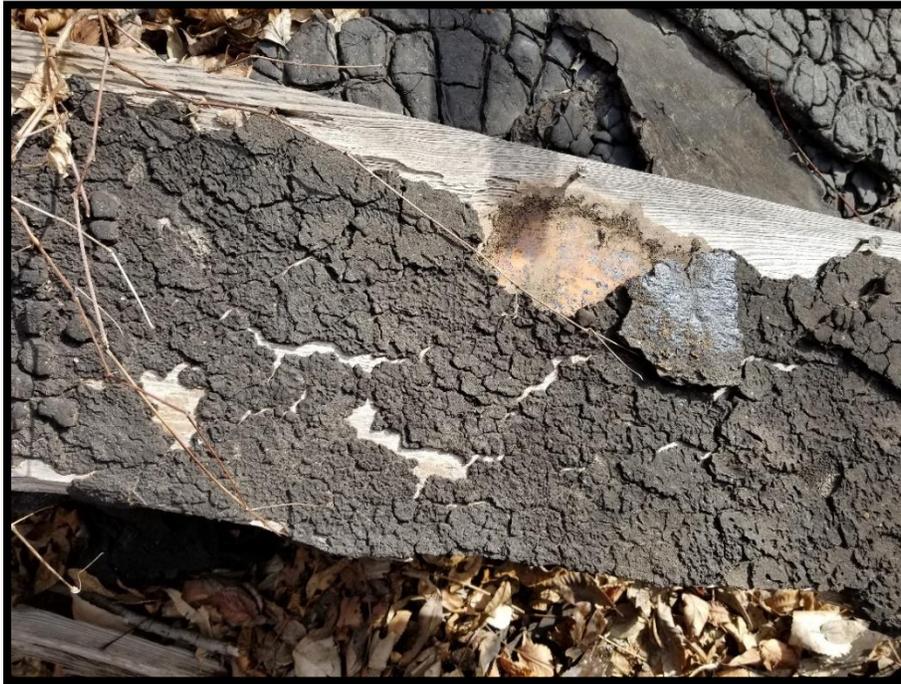
**Sample No.** R-01

**PHOTOGRAPH 1: *Roofing Material***

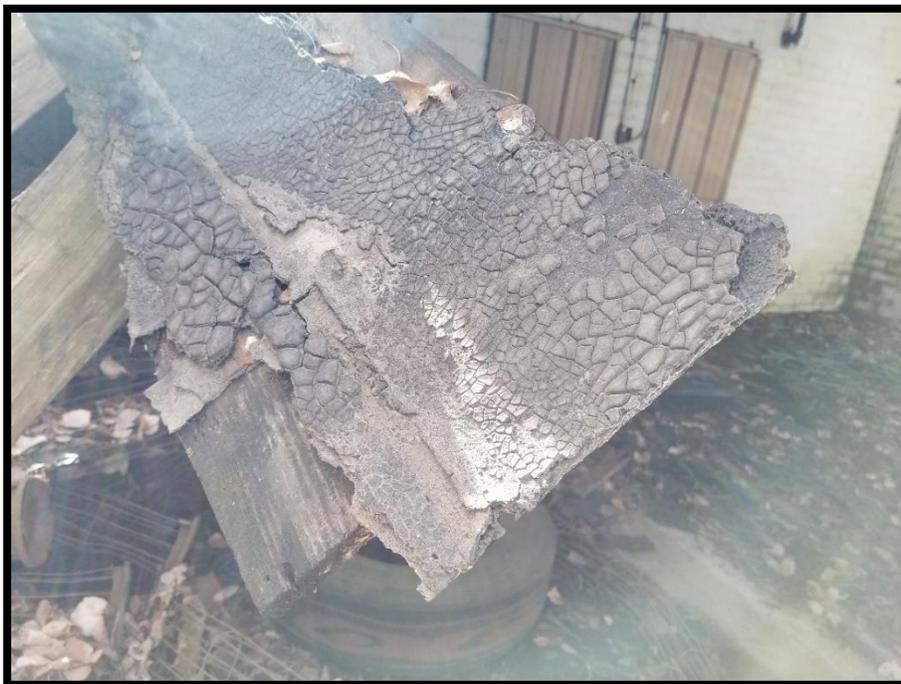
**Sample No.** R-02

**PHOTOGRAPH 2: *Roofing Material***

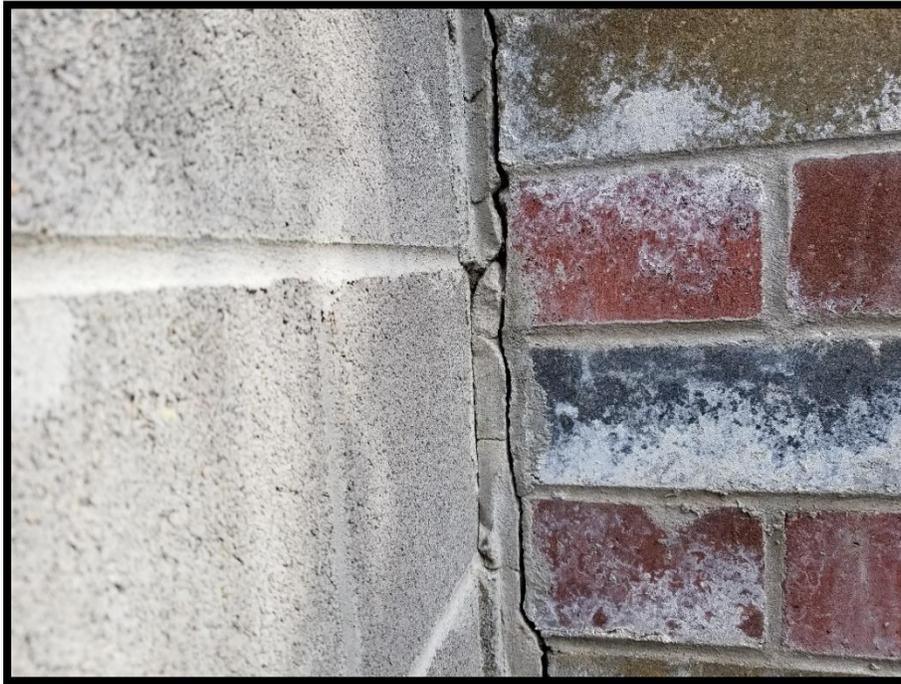
**Sample No.** BM-01

**PHOTOGRAPH 3: *Brick Mortar***

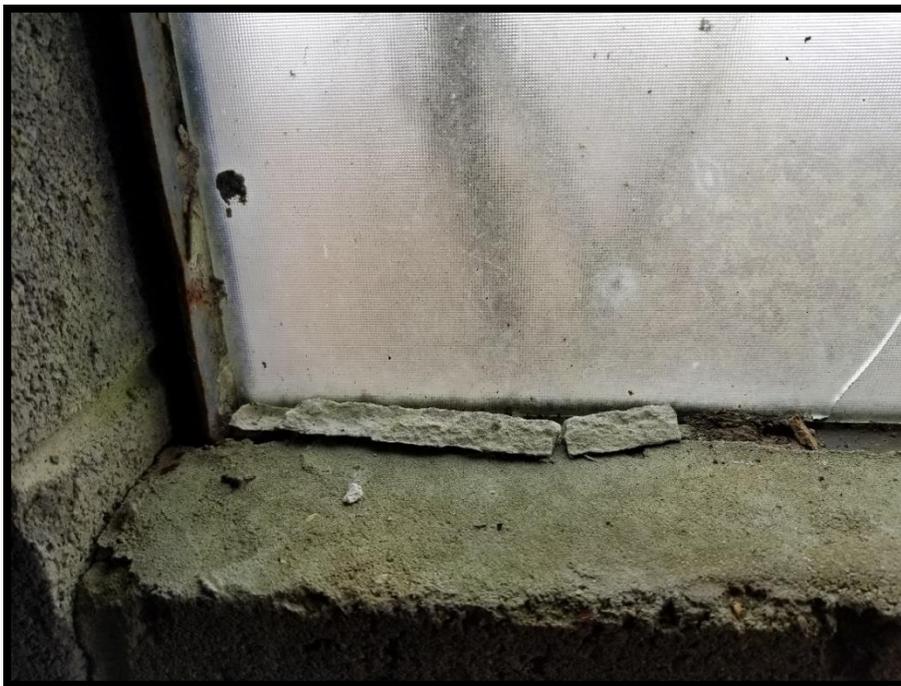
**Sample No.** WG-01

**PHOTOGRAPH 4: *Window Glazing***

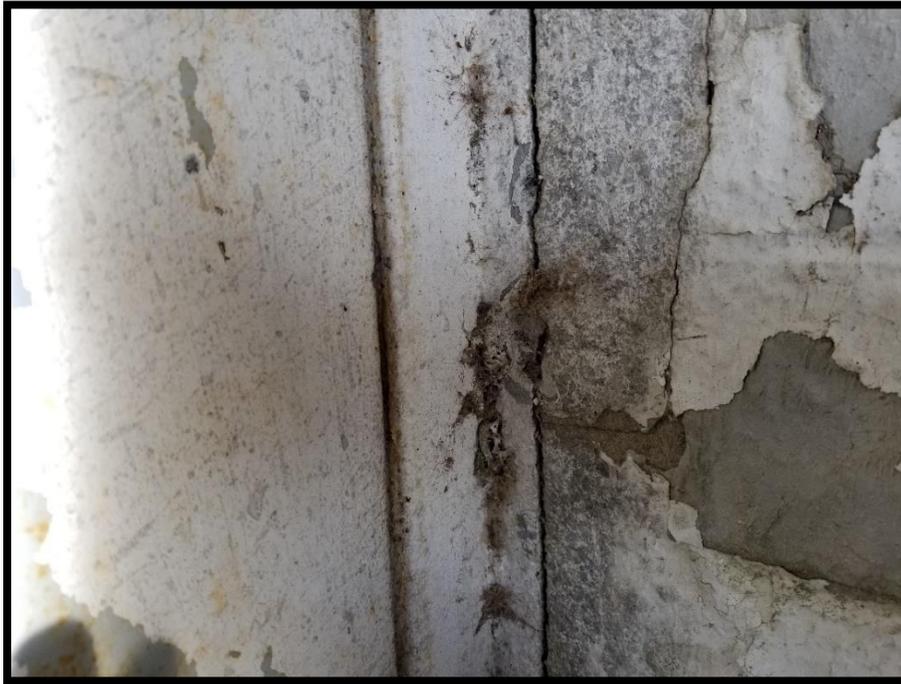
**Sample No.** BM-02

**Samples BM-02, FT-01, M-01, R-04, and FT-02 contain asbestos above regulated limits. Sample BM-02 appeared to be a block wall repair patch and not part of the original construction of the building. Harbor has determined that this patched area is different from the other brick mortar sampled as the laboratory analysis indicates. Only this area of the building should be handled as ACM during renovation and demolition operations.**

**PHOTOGRAPH 5: *Brick Mortar***

Harbor recommends following DEQ regulations during renovation or demolition. If the materials have the potential to become friable or will be removed by sanding, grinding, cutting or abrading during the renovation project, a project design will be required, along with appropriately certified workers and contracting company. A notice of intent (NOI), along with a copy of the asbestos survey, is required to be filed with DEQ a minimum of 10 days prior to beginning work.

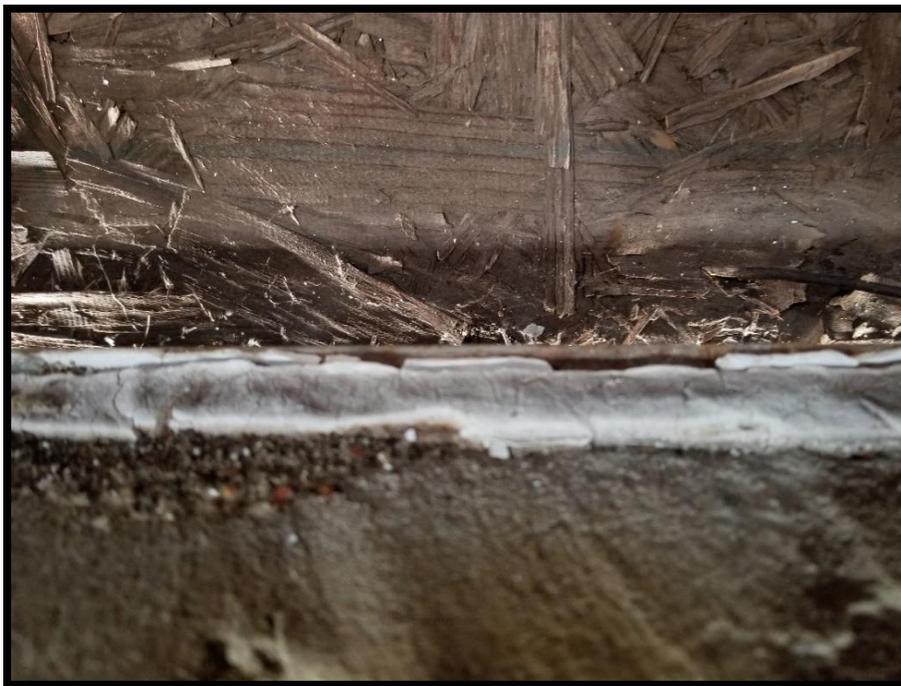
**Sample No.** WG-02

**PHOTOGRAPH 6: *Window Glazing***

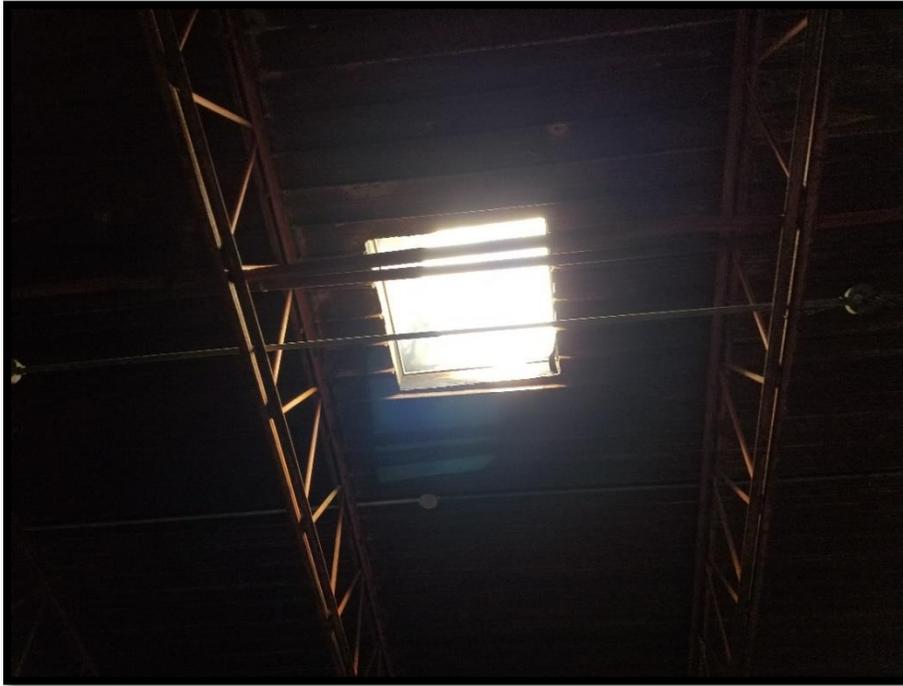
**Sample No.** SL-01

**PHOTOGRAPH 7: *Skylight Material***

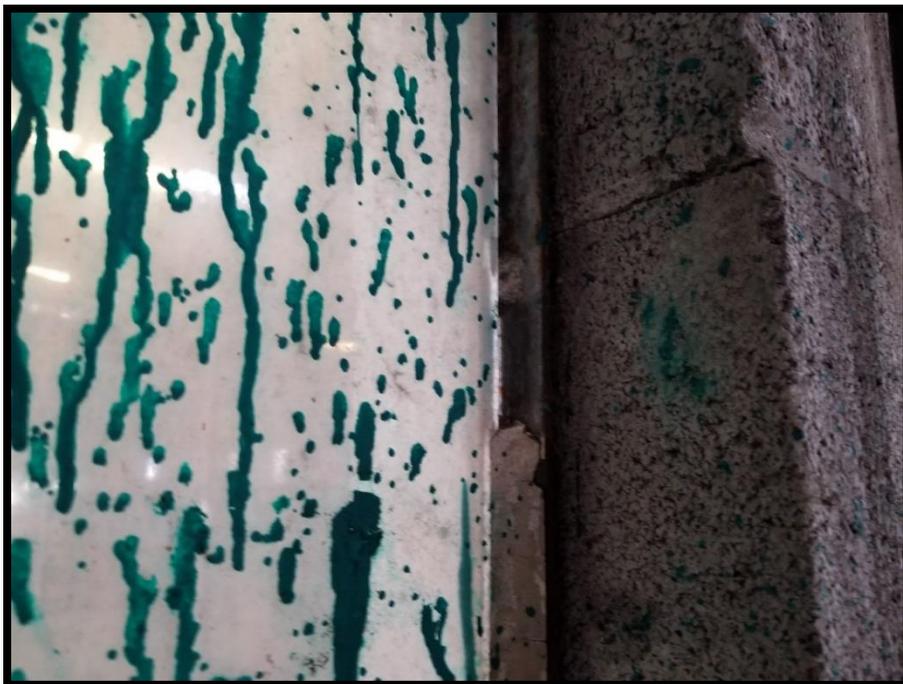
**Sample No.** WG-03

**PHOTOGRAPH 8: *Window Glazing***

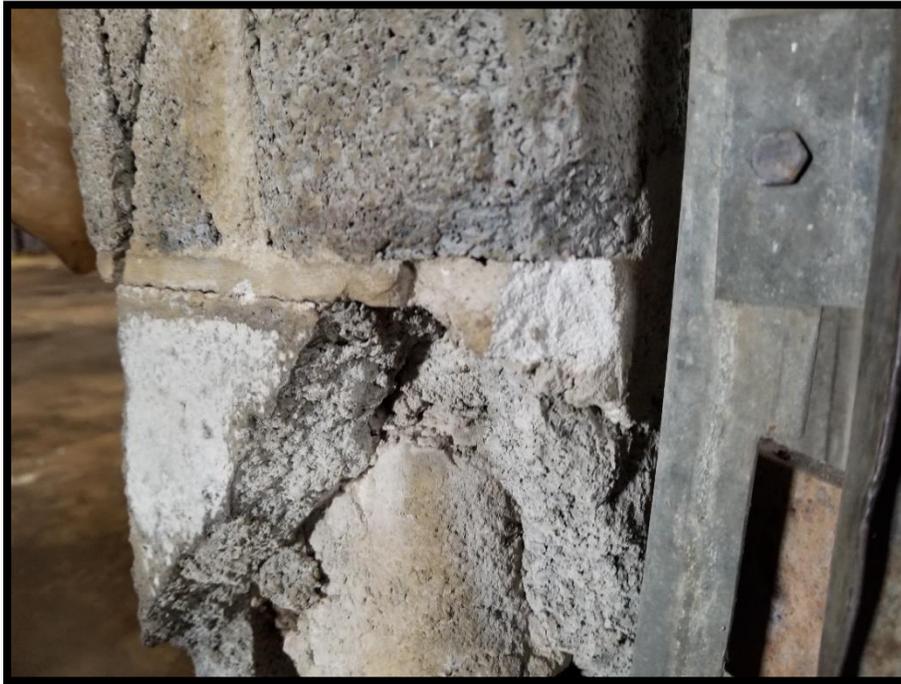
**Sample No.** BM-03

**PHOTOGRAPH 9: *Brick Mortar***

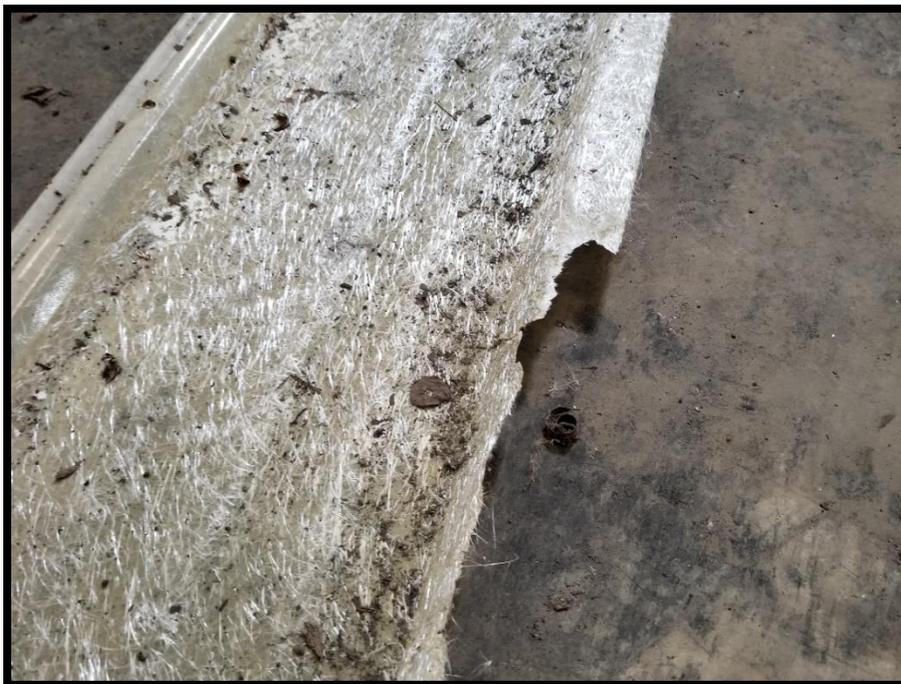
**Sample No's.** TP-01

**PHOTOGRAPH 10: *Translucent Panel***

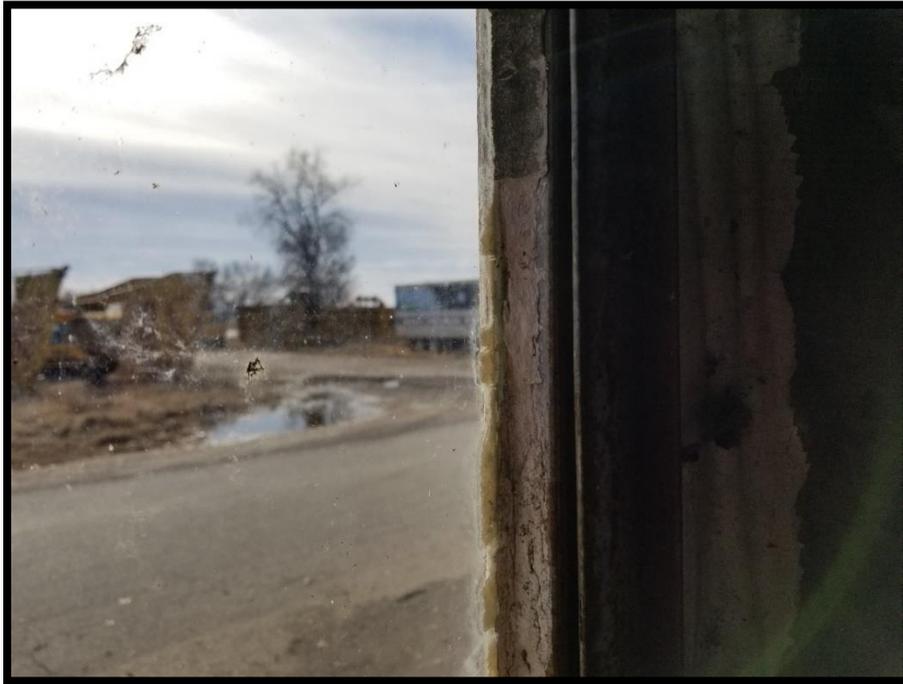
**PHOTOGRAPH 11: *Window Glazing***

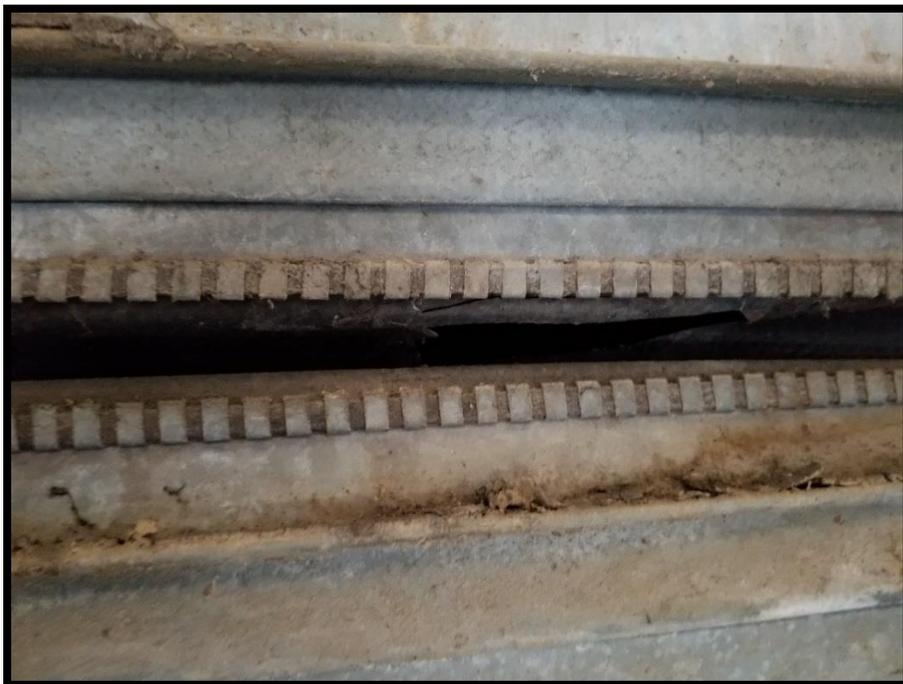
**PHOTOGRAPH 12: *Flexible Duct Connector***

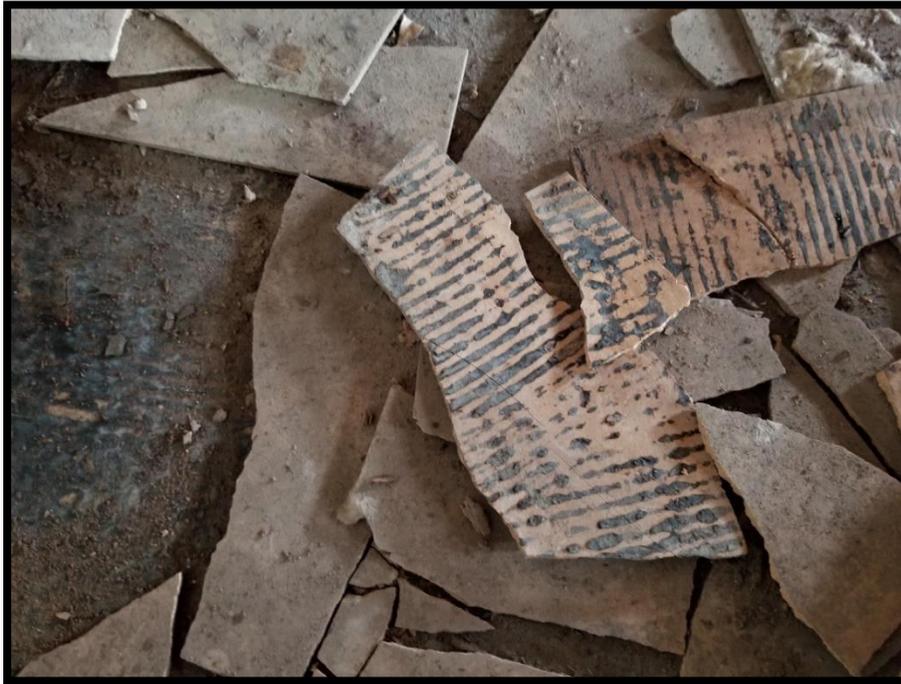
**Sample No.** FT-01

**PHOTOGRAPH 13: *Tan 9" x 9" Floor Tile w/ Black Mastic***

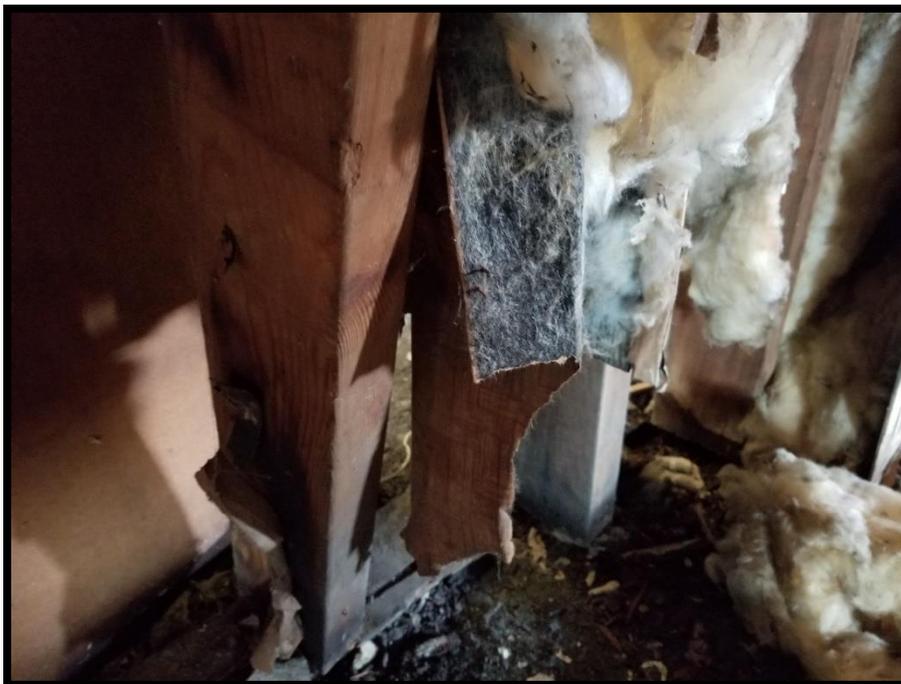
**Sample No.** BI-01

**PHOTOGRAPH 14: *Batt Insulation Backing***

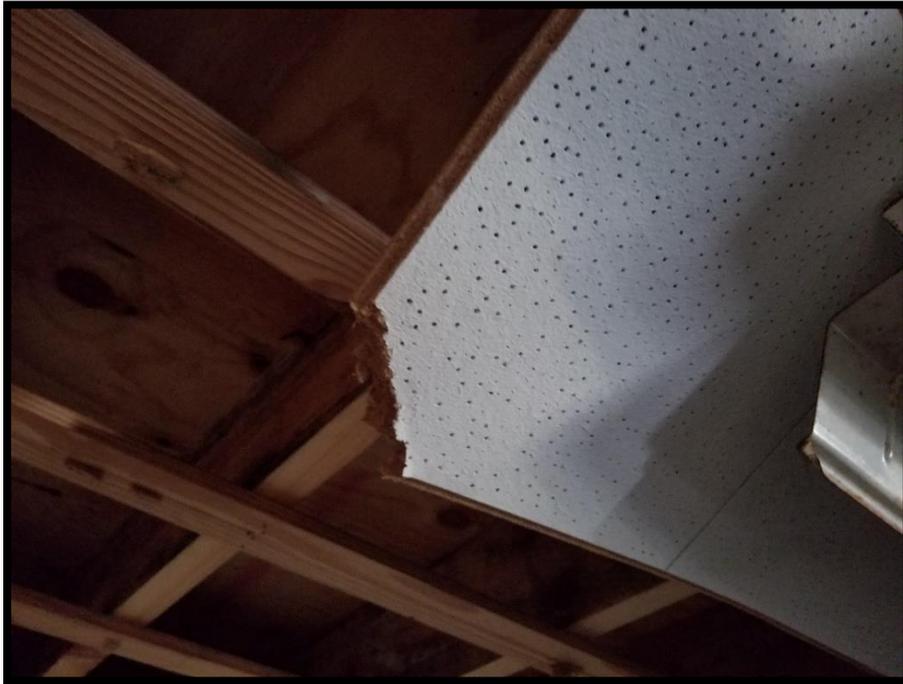
**Sample No.** CT-01

**PHOTOGRAPH 15: 12" x 12" Ceiling Tile**

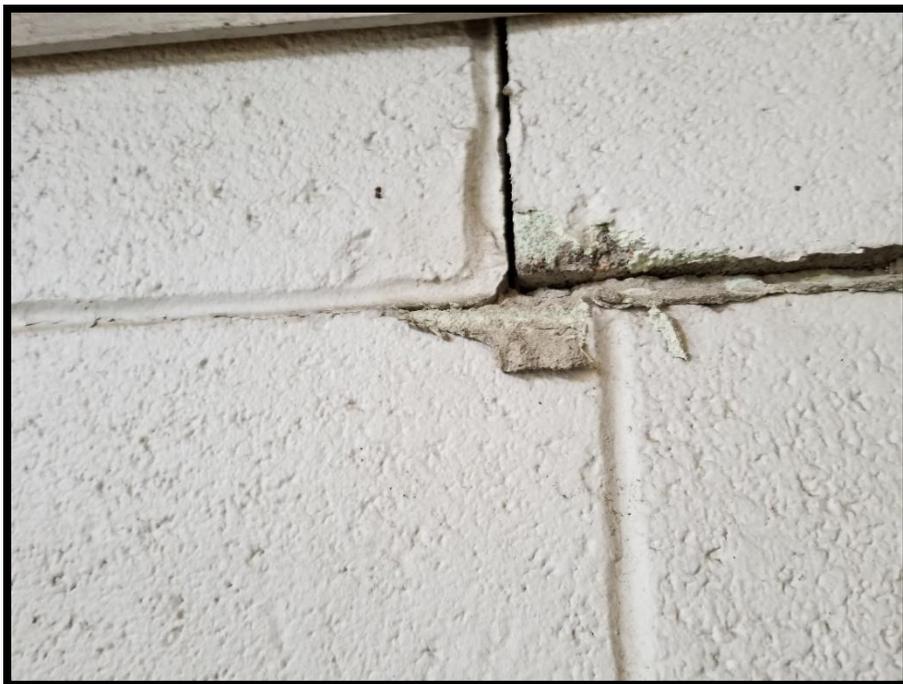
**Sample No.** BM-04

**PHOTOGRAPH 16: Brick Mortar**

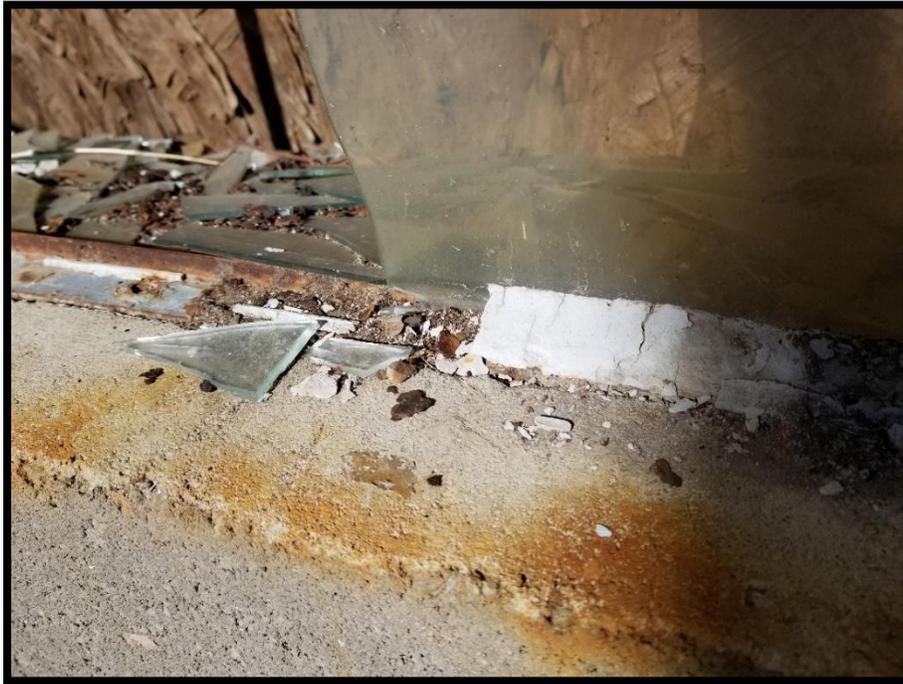
**Sample No.** WG-05

**PHOTOGRAPH 17: *Window Glazing***

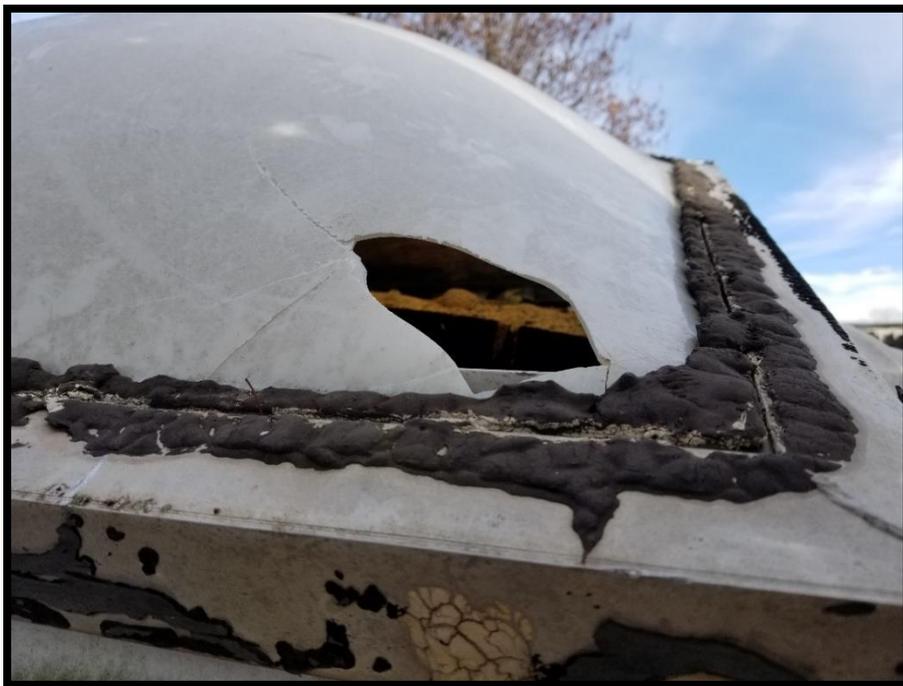
**Sample No.** SL-02

**PHOTOGRAPH 18: *Skylight Material***

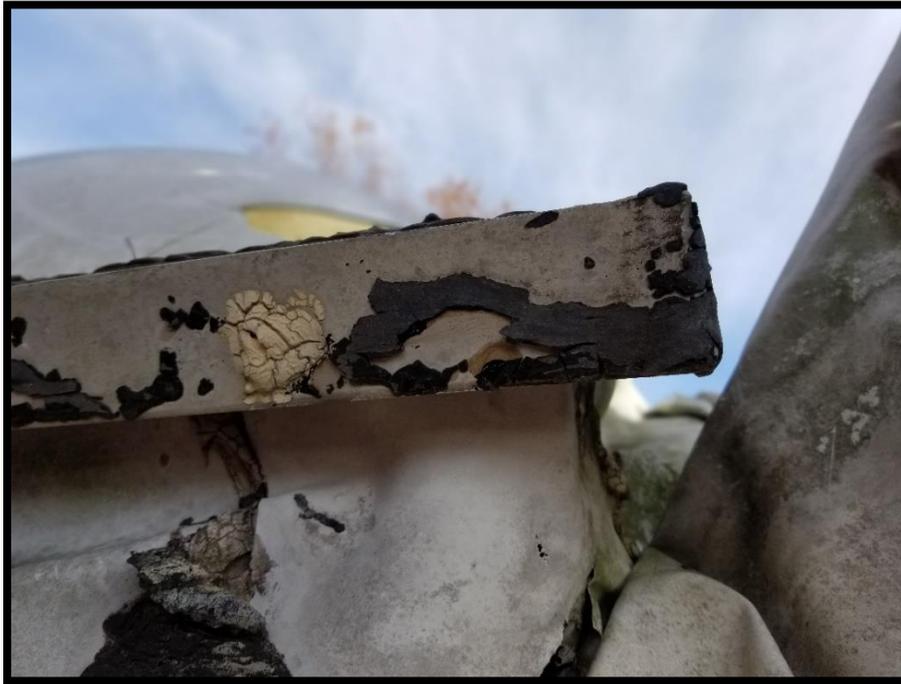
**Sample No.** M-01

**PHOTOGRAPH 19: Skylight Mastic**

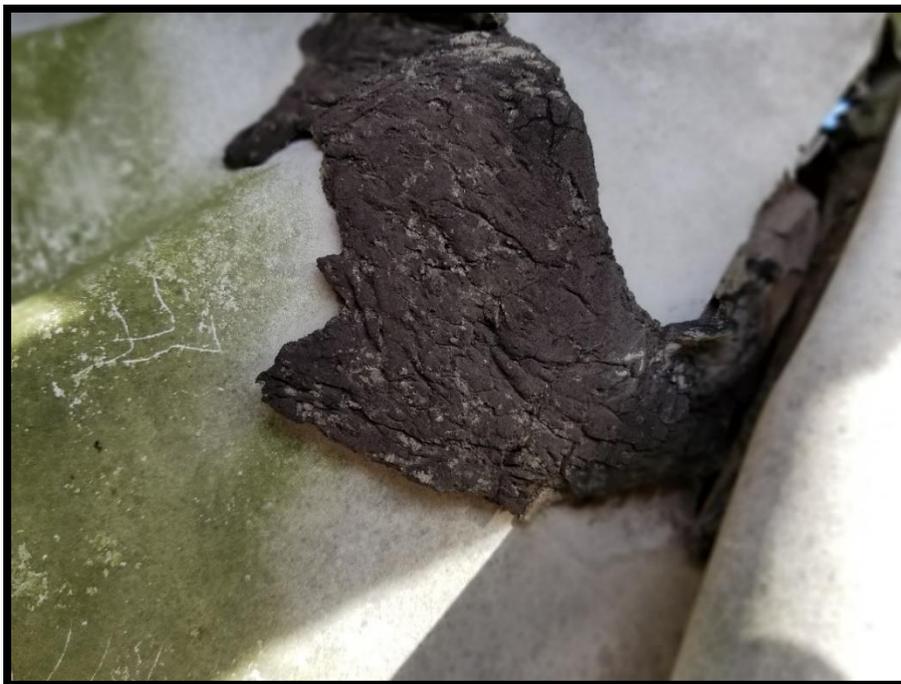
**Sample No.** R-03

**PHOTOGRAPH 20: Roofing Material**

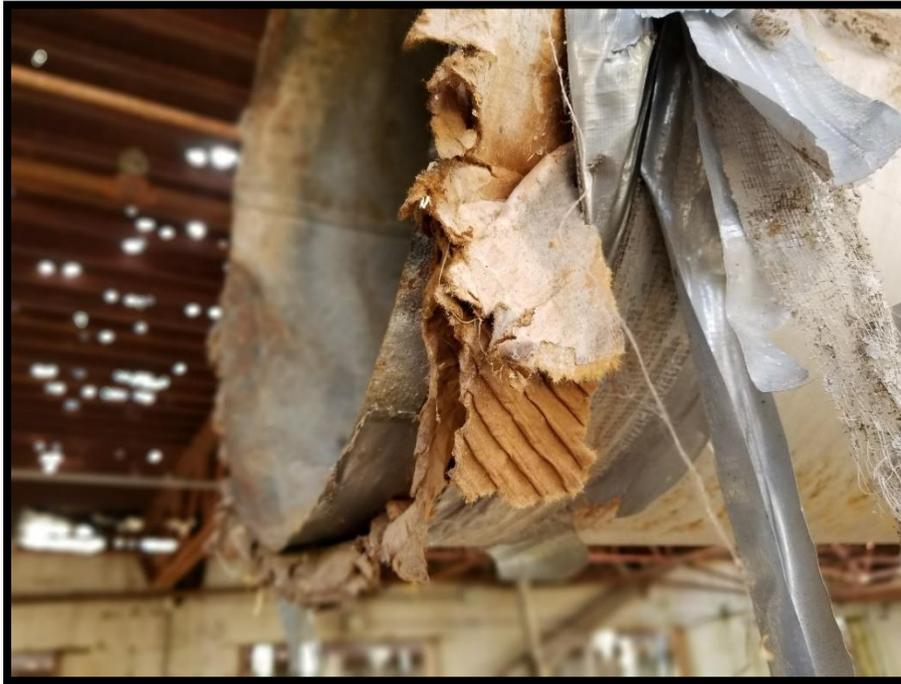
**Sample No.** PW-01

**PHOTOGRAPH 21: *Pipe Wrap Joint***

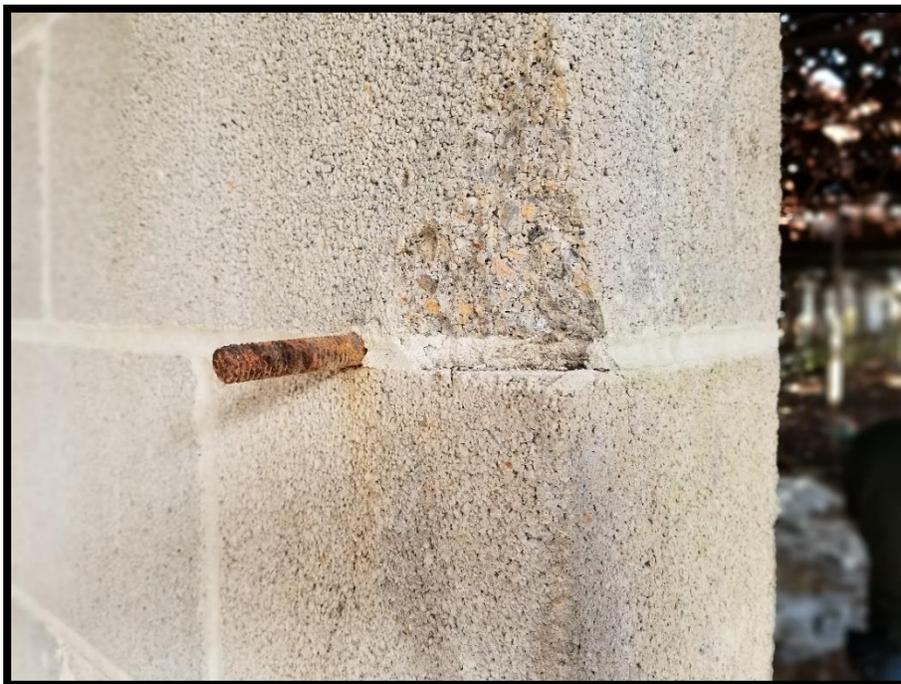
**Sample No.** BM-05

**PHOTOGRAPH 22: *Brick Mortar***

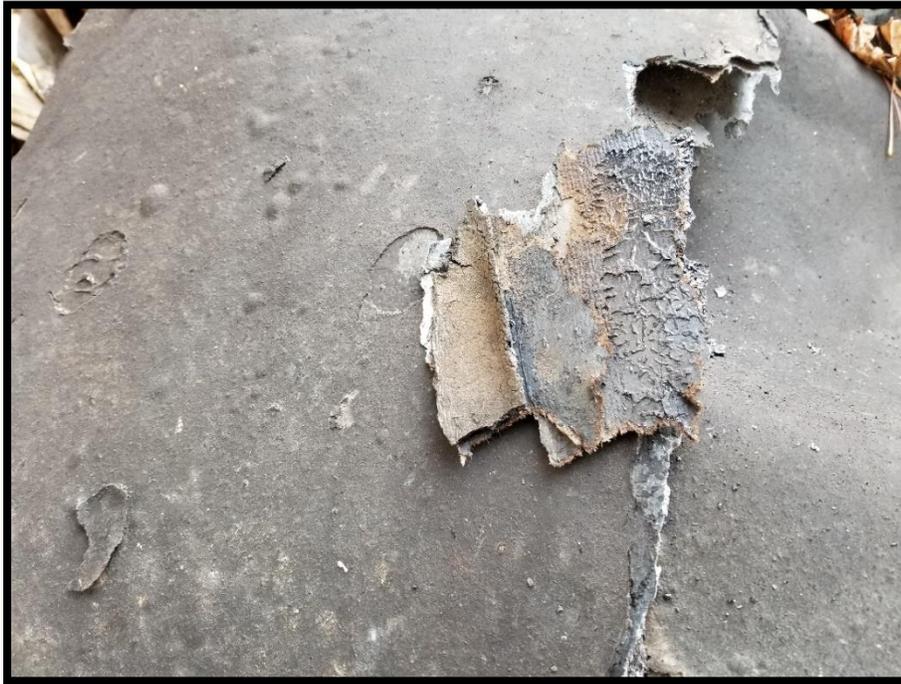
**Sample No.** R-04

**PHOTOGRAPH 23: *Roofing Material***

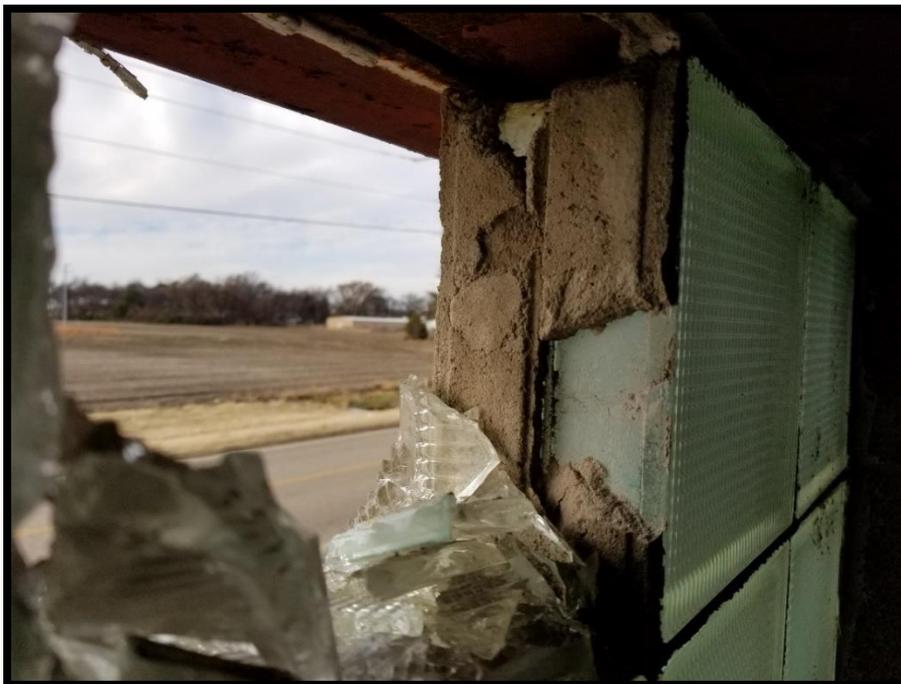
**Sample No.** WG-06

**PHOTOGRAPH 24: *Window Glazing at Glass Block Window***

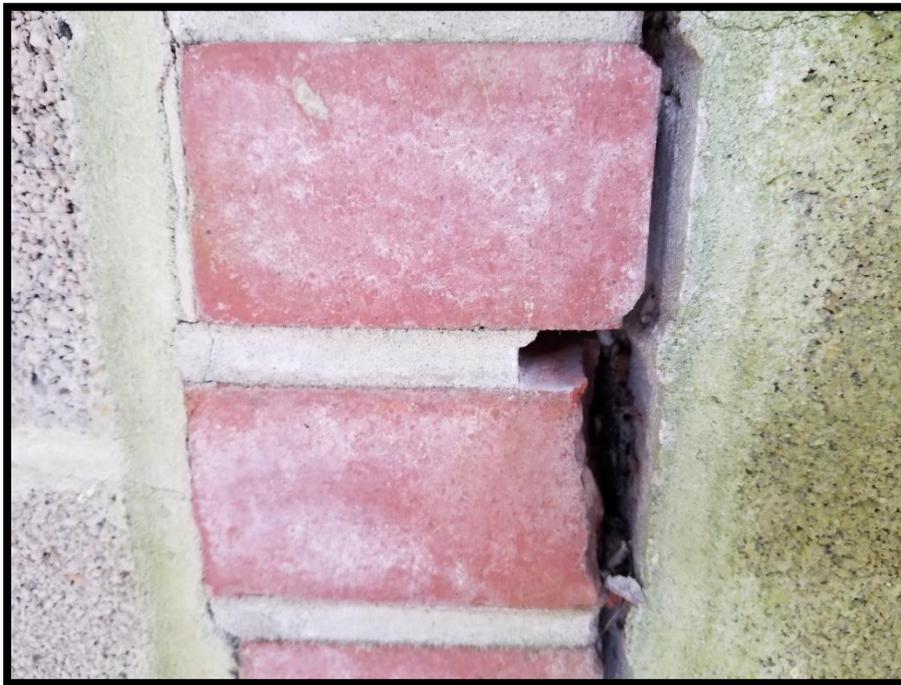
**Sample No.** BM-07

**PHOTOGRAPH 26: *Brick Mortar at red brick - interior***

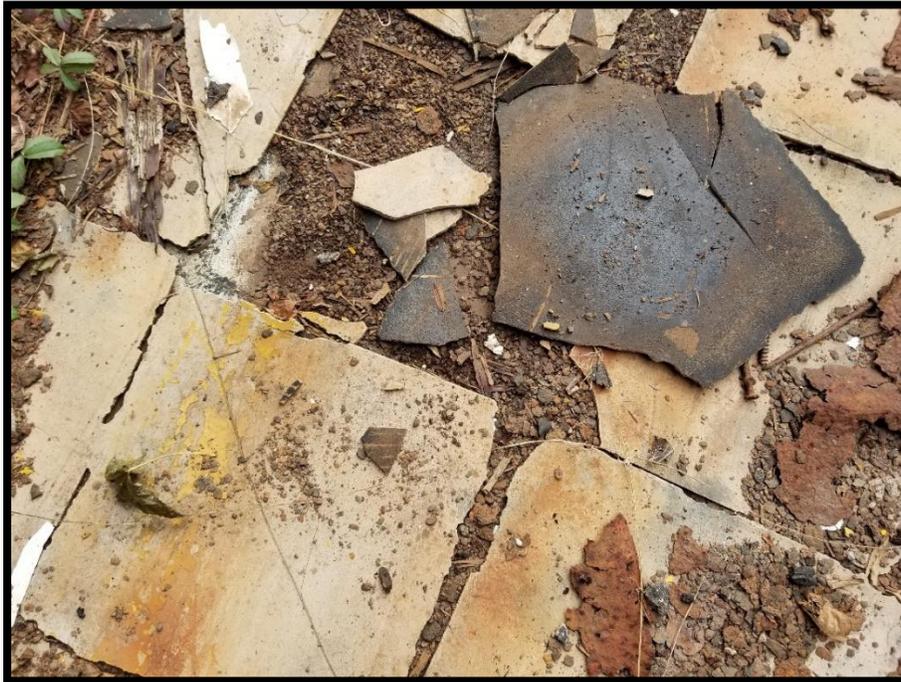
**PHOTOGRAPH 27: 9" x 9" Tan Floor Tile w/ Yellow and Black Mastic**  
Sample No. FT-02      Date: December 3, 2019      Photographer: Adam Smith, Inspector 015579

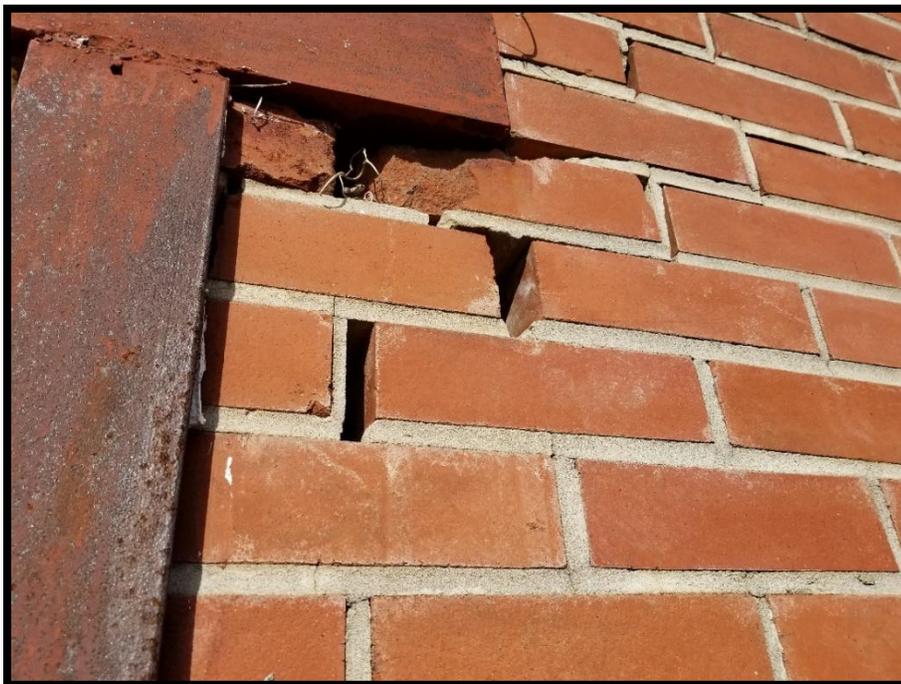
**PHOTOGRAPH 28: Brick Mortar at red brick - exterior**  
Sample No. BM-08      Date: December 3, 2019      Photographer: Adam Smith, Inspector 015579
