# **TARGETED BROWNFIELDS ASSESSMENT**

## **Phase II Environmental Site Assessment Luxora Elementary School 406 Washington Avenue Luxora, Arkansas 72358**

**September 9, 2024**

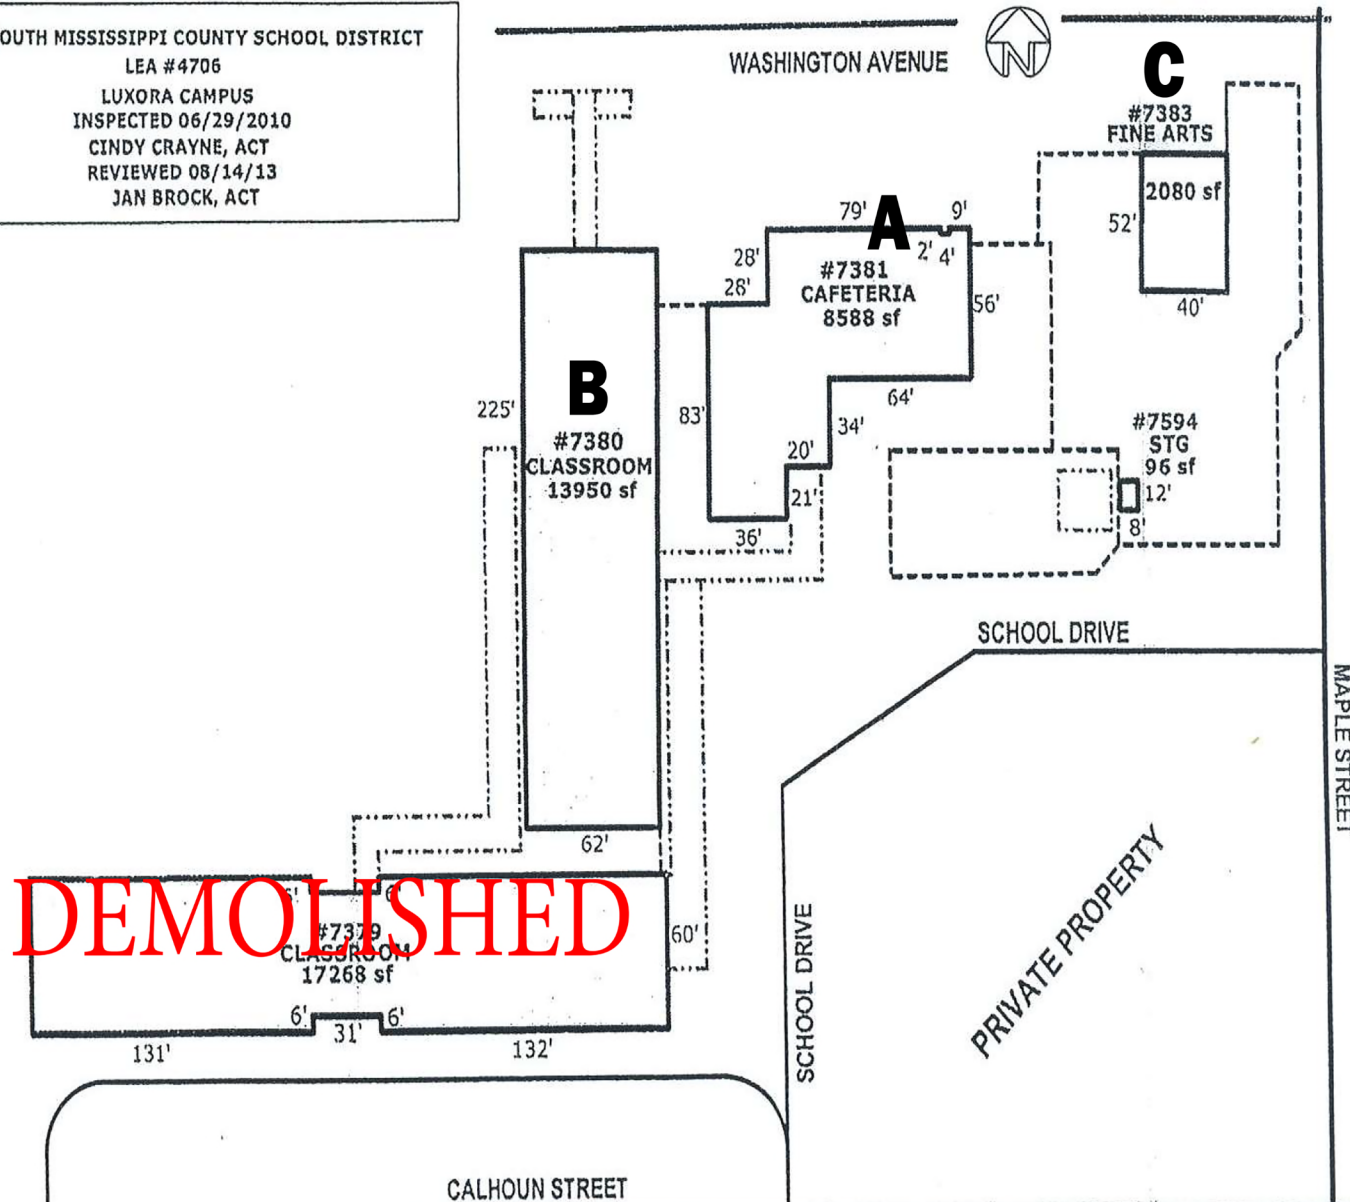
Figure 3: Site Diagram  
406 Washington Avenue  
Luxora, AR 72358

ACM is present at the Subject Property in the 13,950-square foot classroom building (Figure 3, Building #7380, also referred to as Building B). The white 12x12 floor tile and associated mastic, sheetrock joint compound and the transite panels are considered Category I and Category II Non-Friable ACM in their current condition and state. The mudded pipe elbows identified in the boiler room are considered friable ACM. All ACM identified at the Subject Property was noted to be in fair to good condition at the time of the inspection.

There are three options with respect to ACM located on the property: (1) management in place, (2) removal, or (3) a combination of management in place and removal. It is recommended that prior to reoccupation of Building B that an Asbestos Operations and Maintenance Plan be developed by an Arkansas Certified Asbestos Management Planner. An abatement design should be developed prior to renovations and/or demolition of Building B. Should renovations and/or demolition be performed, then a licensed asbestos abatement contractor should be used to properly remove the asbestos before the renovations and/or demolition. For compliance with the EPA's NESHAP Standard, a notification of building material removal should be submitted to ADEQ at least 10 working days prior to commencement of any work activities. All friable asbestos removal over the NESHAP threshold will require an approved asbestos project design, asbestos project checklist, and a 10-day notification process prior to abatement activities.

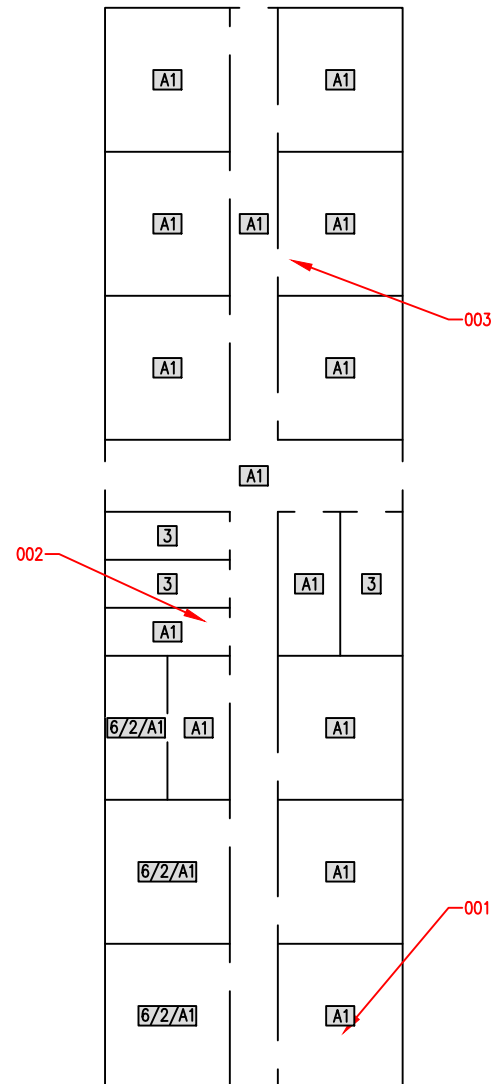
| Sample ID | Material Description | Asbestos % Type |
|---|---|---|
| LMS-24-220-001 | Layer 1 - White 12x12 Floor Tile | 2% Chrysotile |
