**RE: Hazardous Material Survey Report
54 E. Military Road
Marion, Arkansas**

Hazardous Materials Survey

54 E. Military Road

Project No. 251310.00

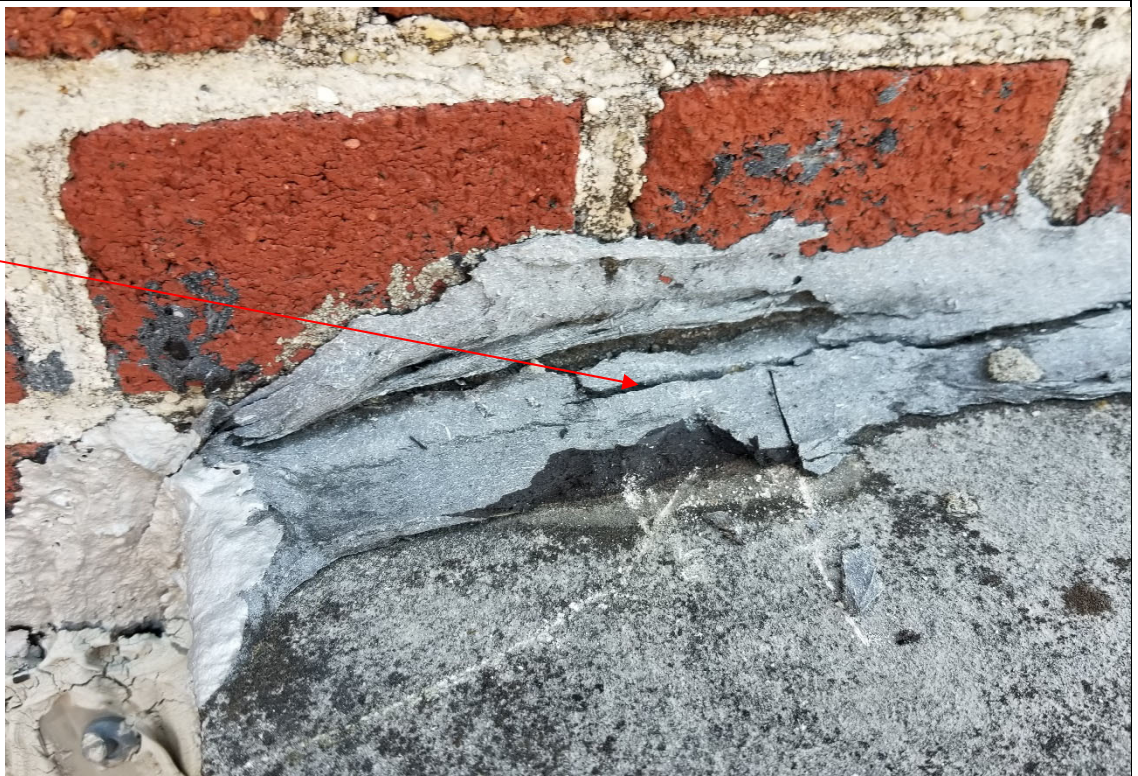
Gray Roof Mastic

Tested Positive for
Asbestos

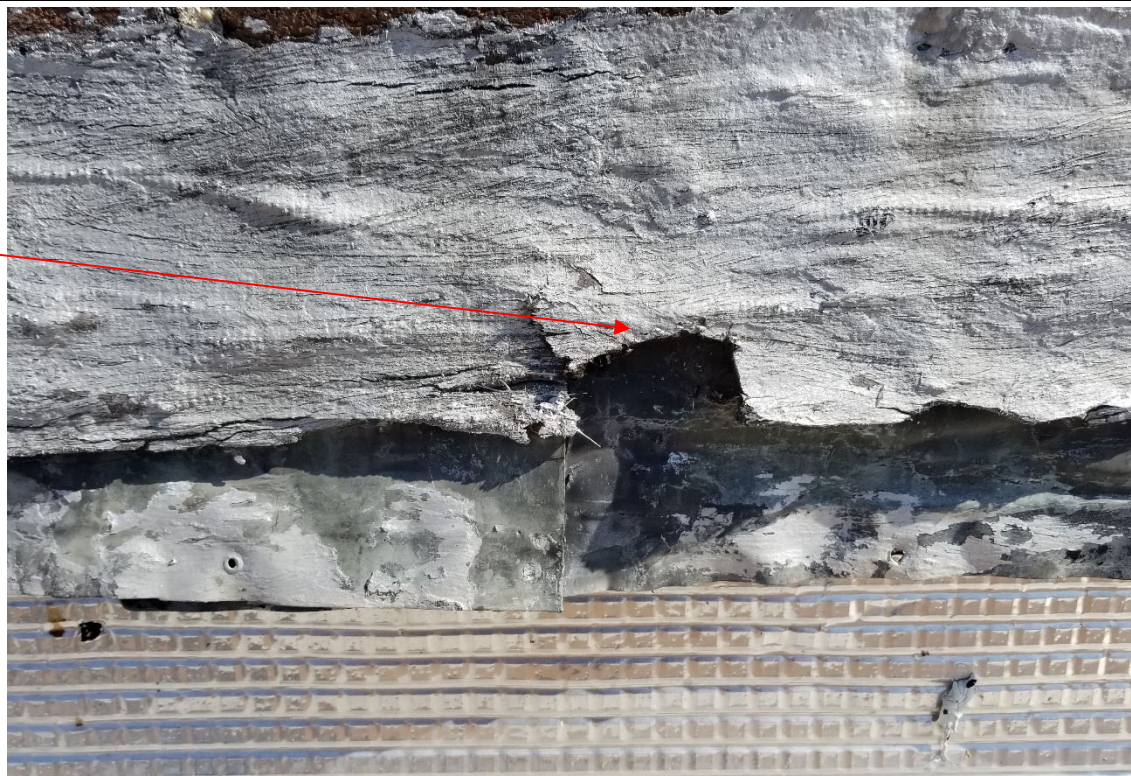
Description:
Sample: M-04
Black Roof Mastic

Tested Positive for
Asbestos

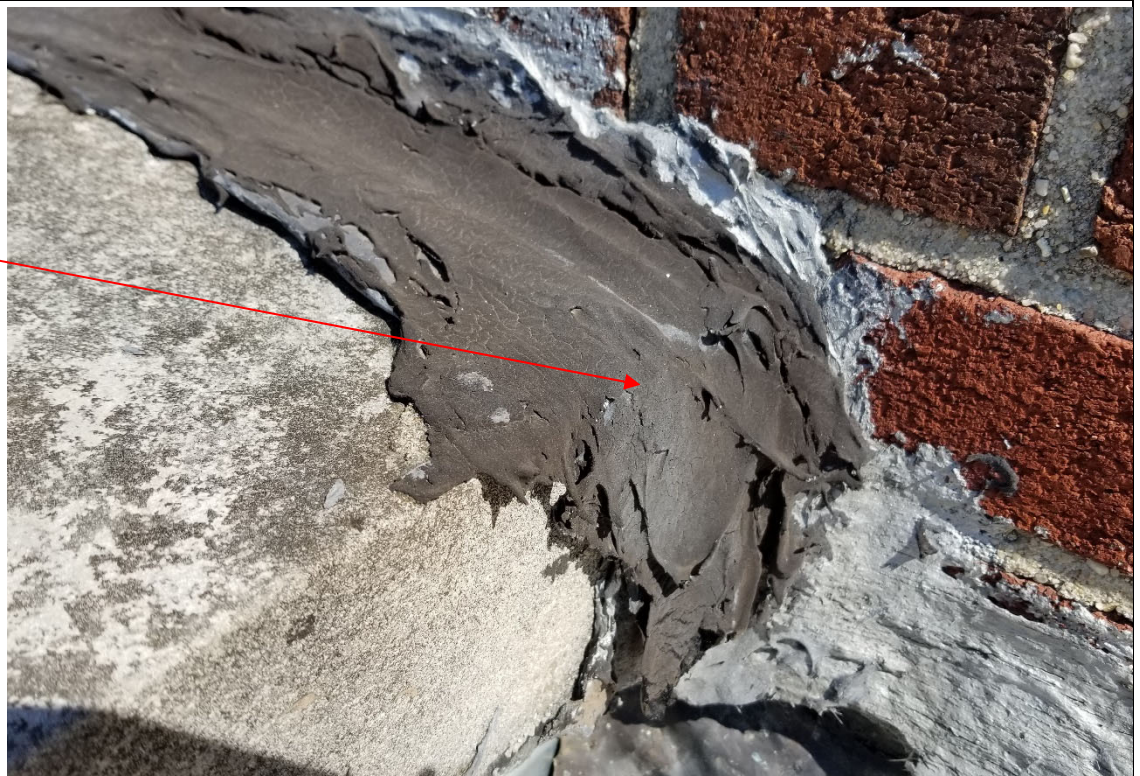
Black Roof Mastic

Tested Positive for
Asbestos

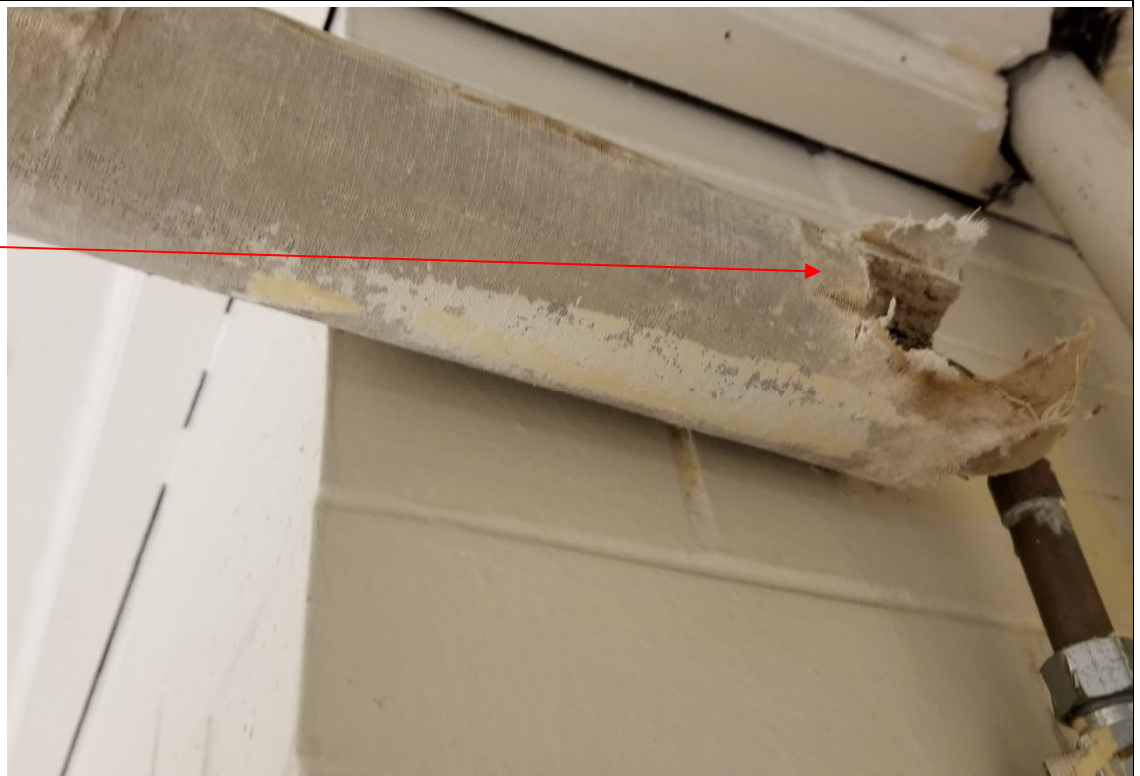
1" TSI Pipe Insulation

Tested Positive for
Asbestos

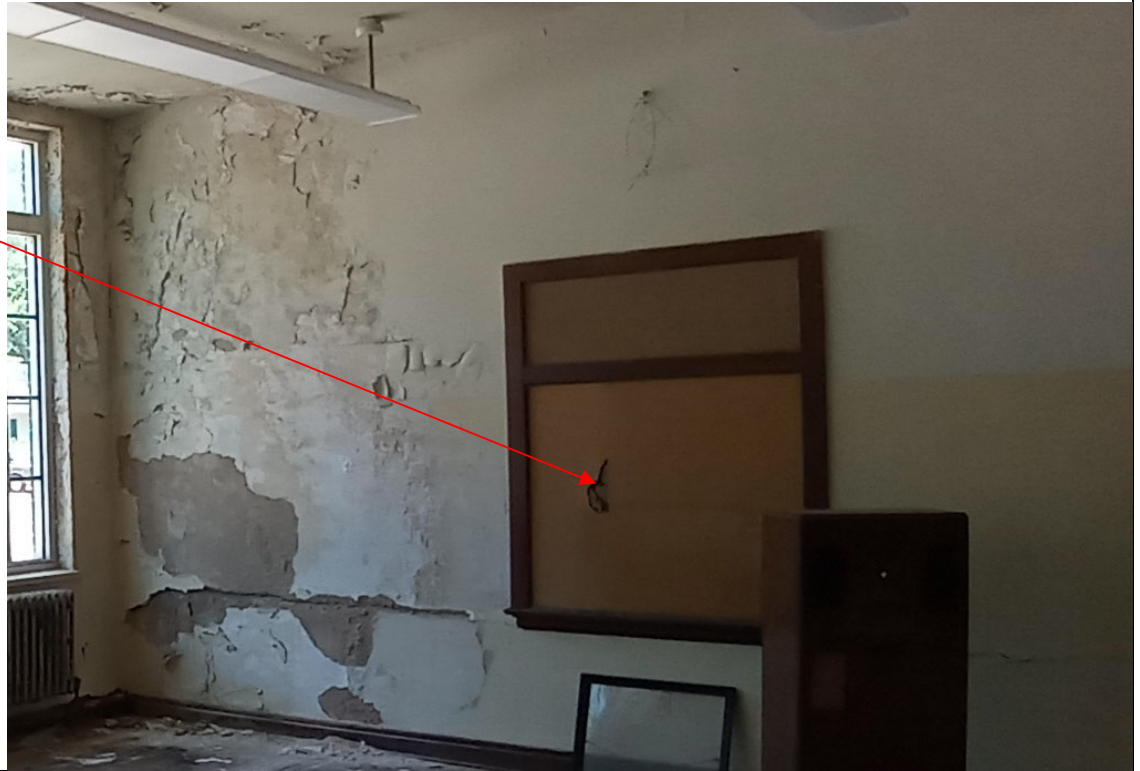
Chalk Board Mastic

Tested Positive for
Asbestos

- Asbestos containing mastic was identified behind chalk and cork boards and could also be found in glue dots behind these boards. This mastic is a non-friable Category I material. If these boards are to be removed as or disturbed as a component of this renovation, they should be removed by a licensed abatement contractor using proper abatement methods and disposed of as asbestos containing waste at a landfill that accepts asbestos. Asbestos waste manifests should be kept for records.

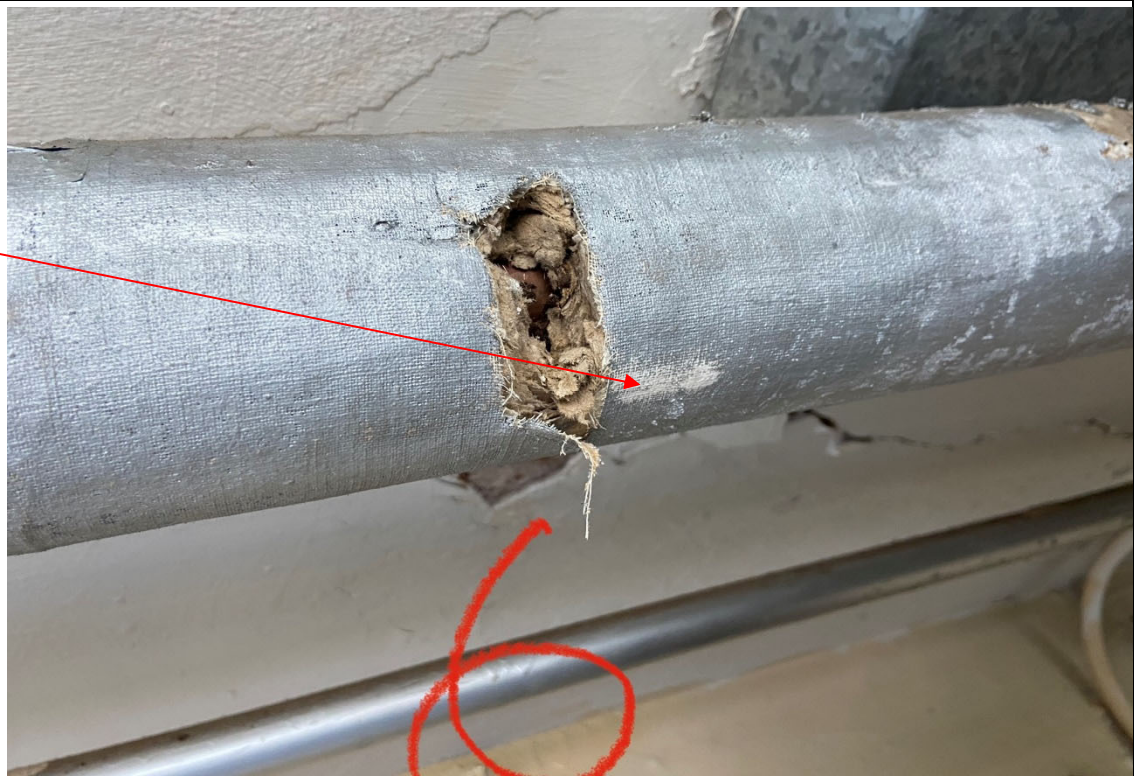
2" TSI Pipe Insulation

Tested Positive for
Asbestos

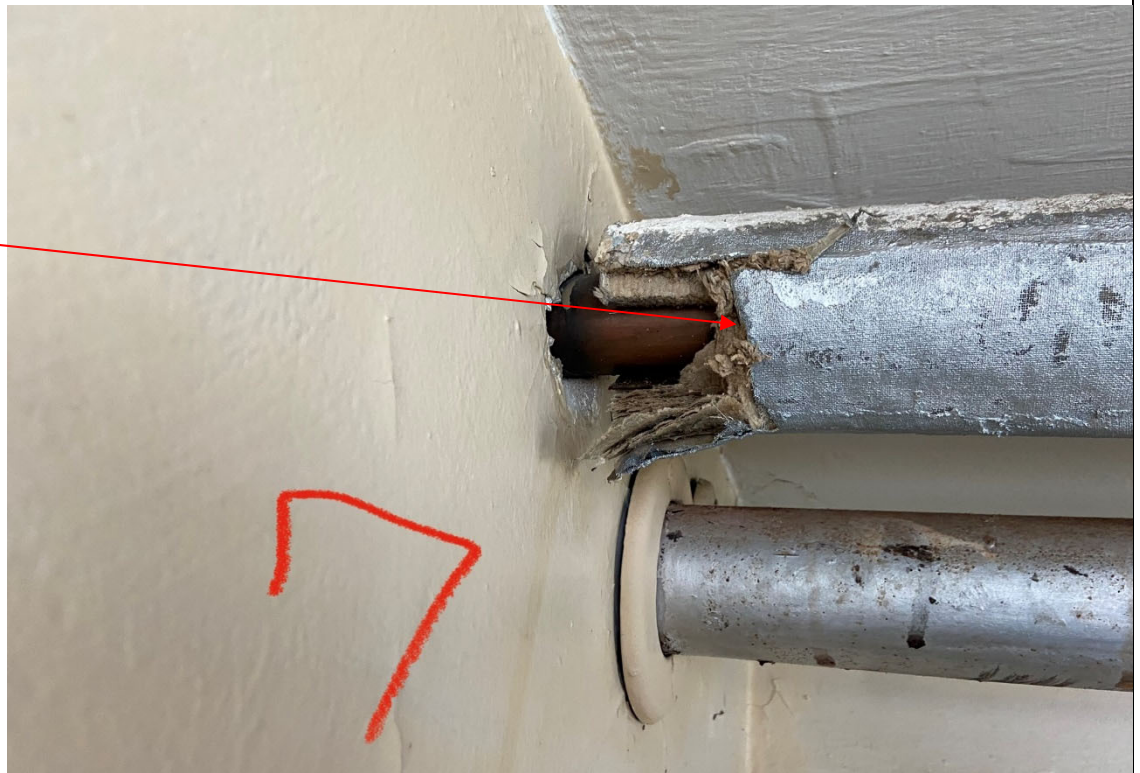
4" TSI Pipe Insulation

Tested Positive for
Asbestos

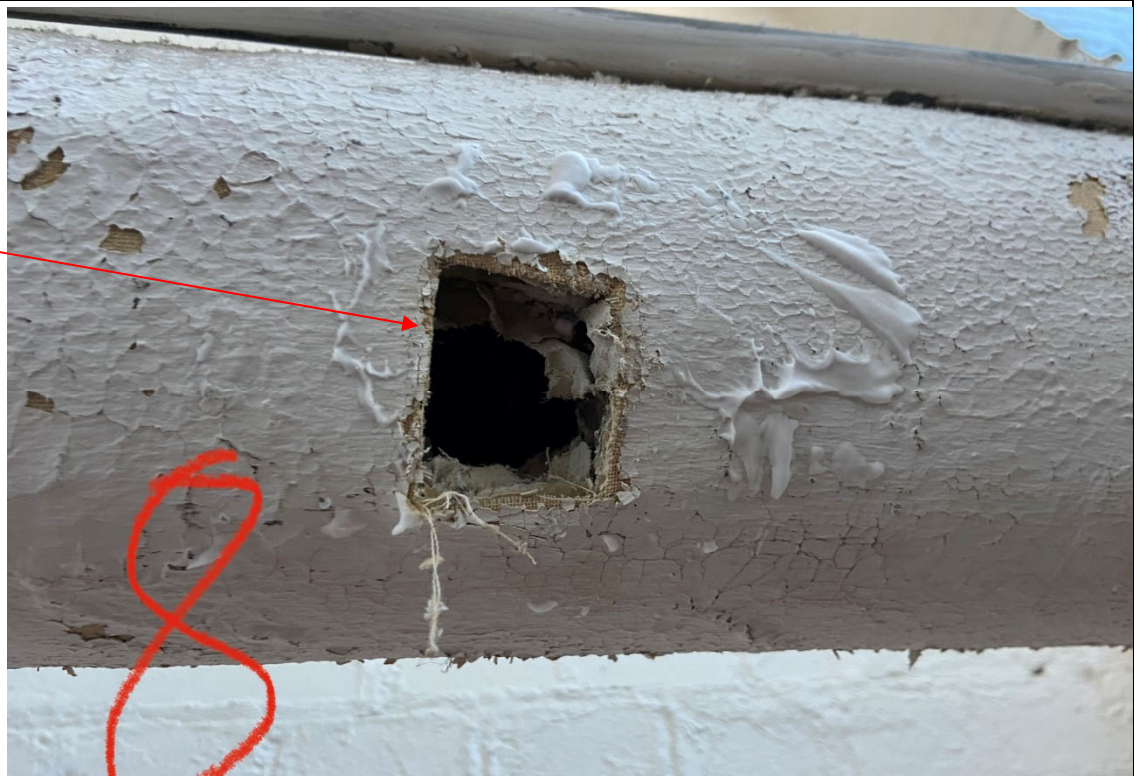
4" TSI Pipe Insulation

Tested Positive for
Asbestos

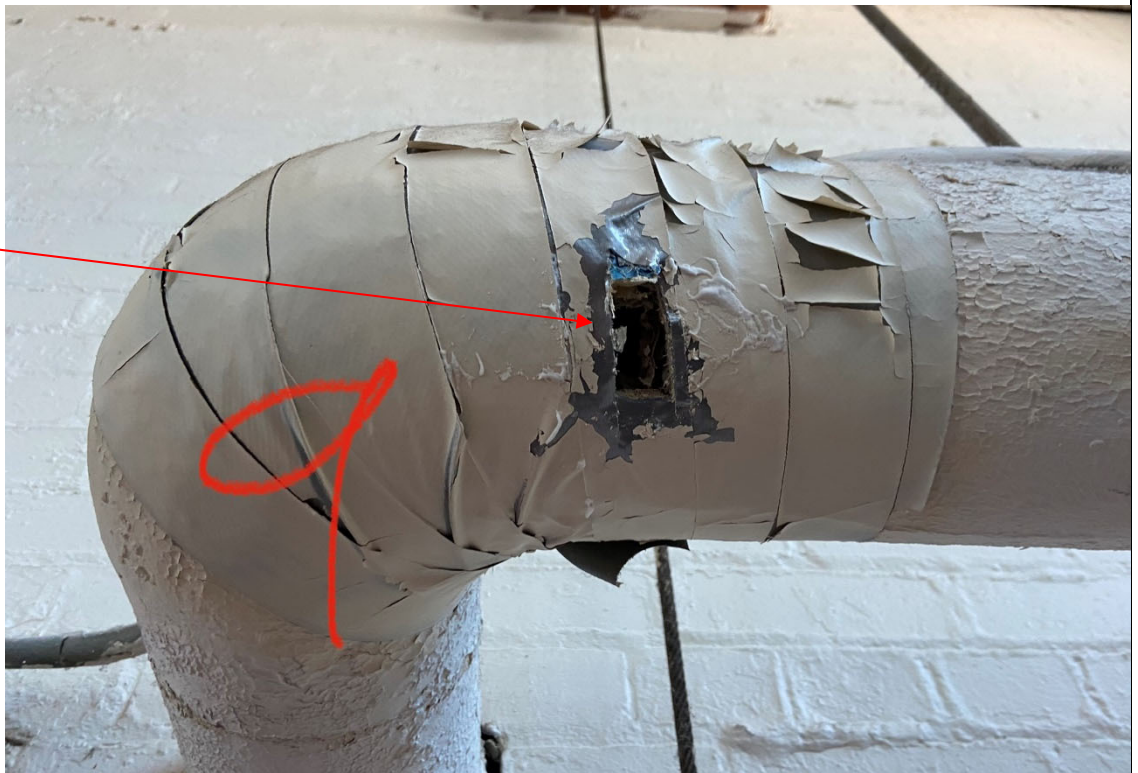
4" TSI Pipe Elbow

Tested Positive for
Asbestos

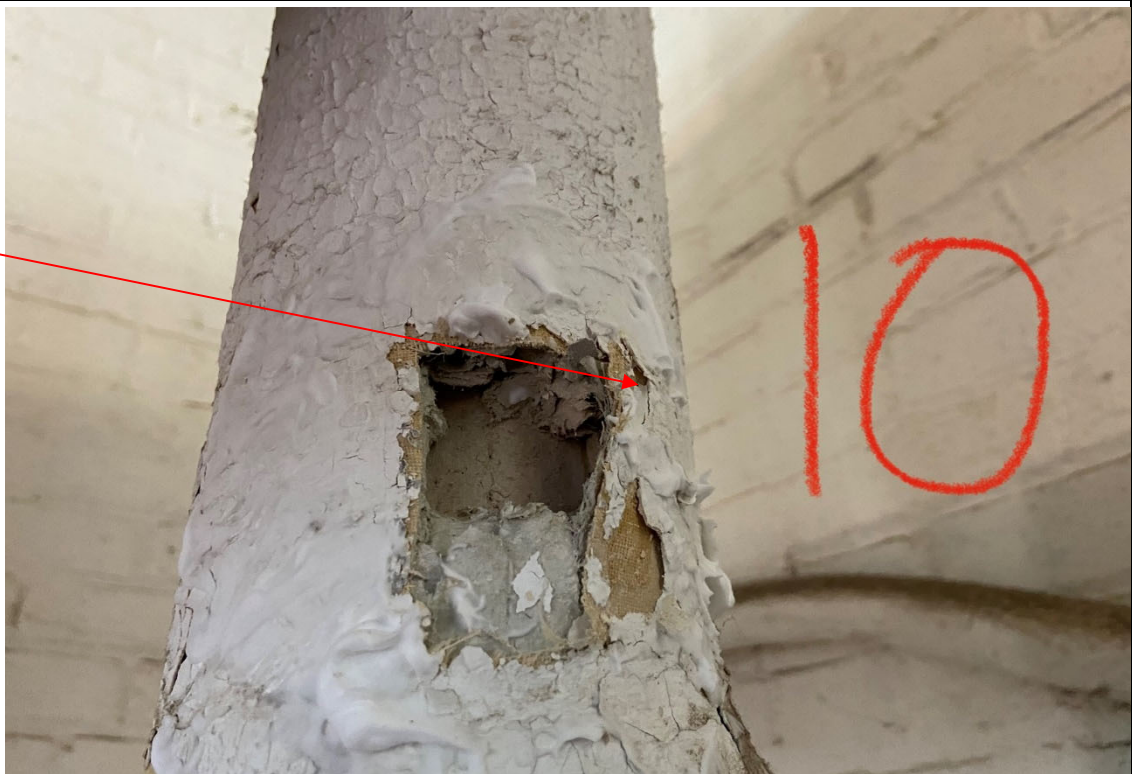
2" TSI Pipe Insulation

Tested Positive for
Asbestos

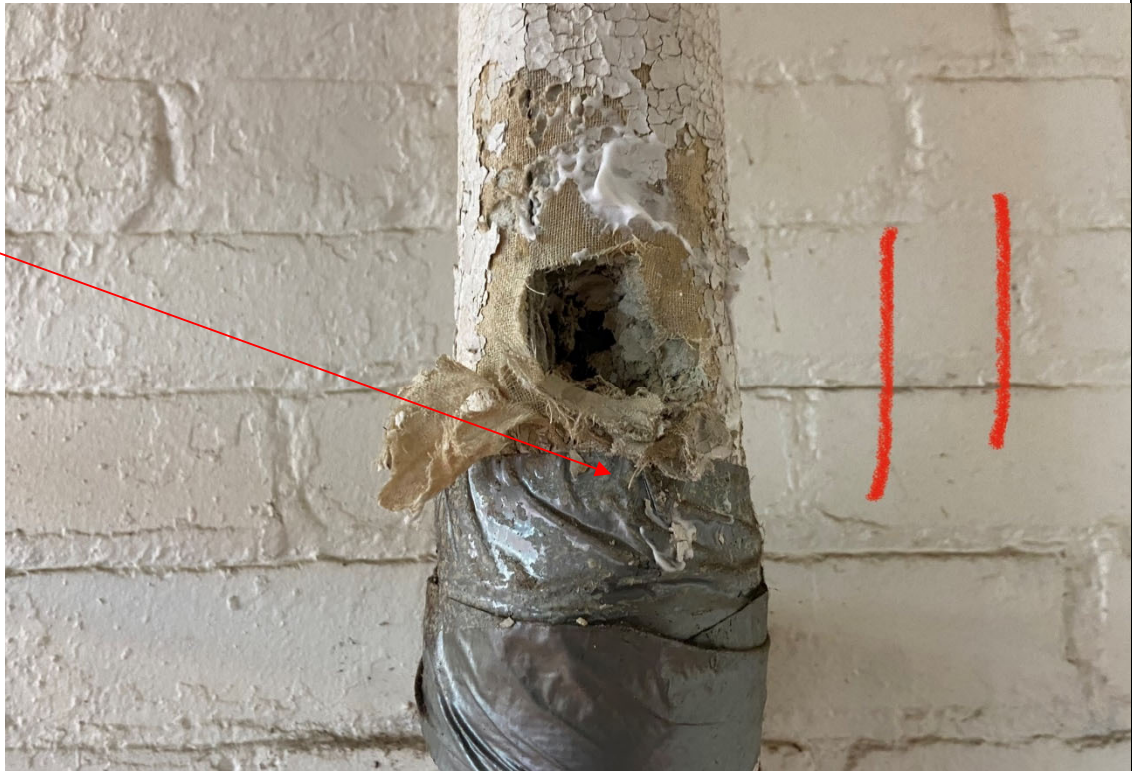
2" TSI Pipe Insulation

Tested Positive for
Asbestos

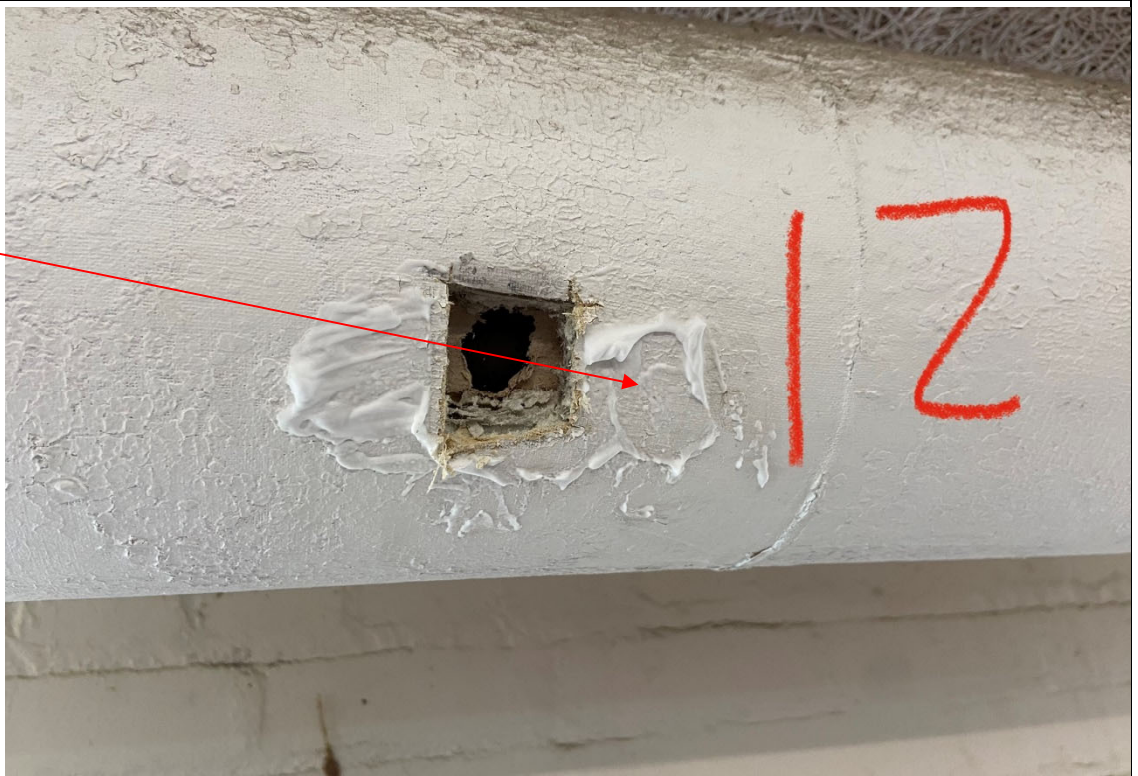
4" TSI Pipe Insulation

Tested Positive for
Asbestos

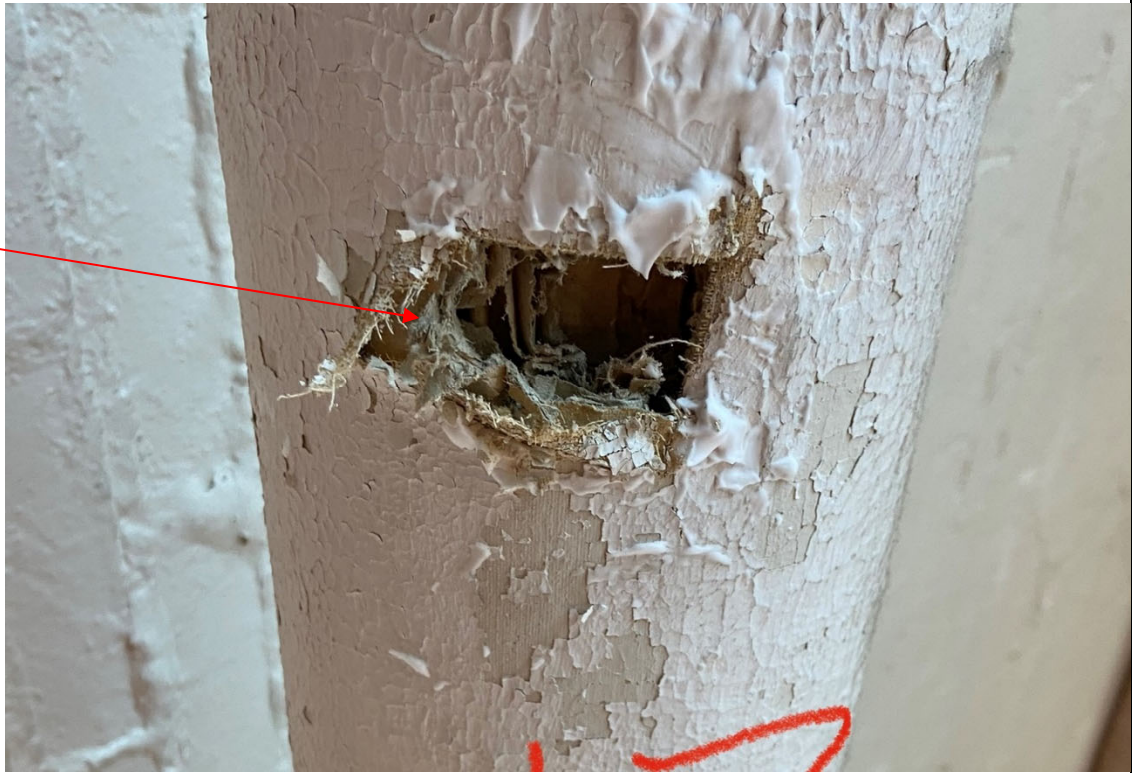
4" TSI Pipe Insulation

Tested Positive for
Asbestos

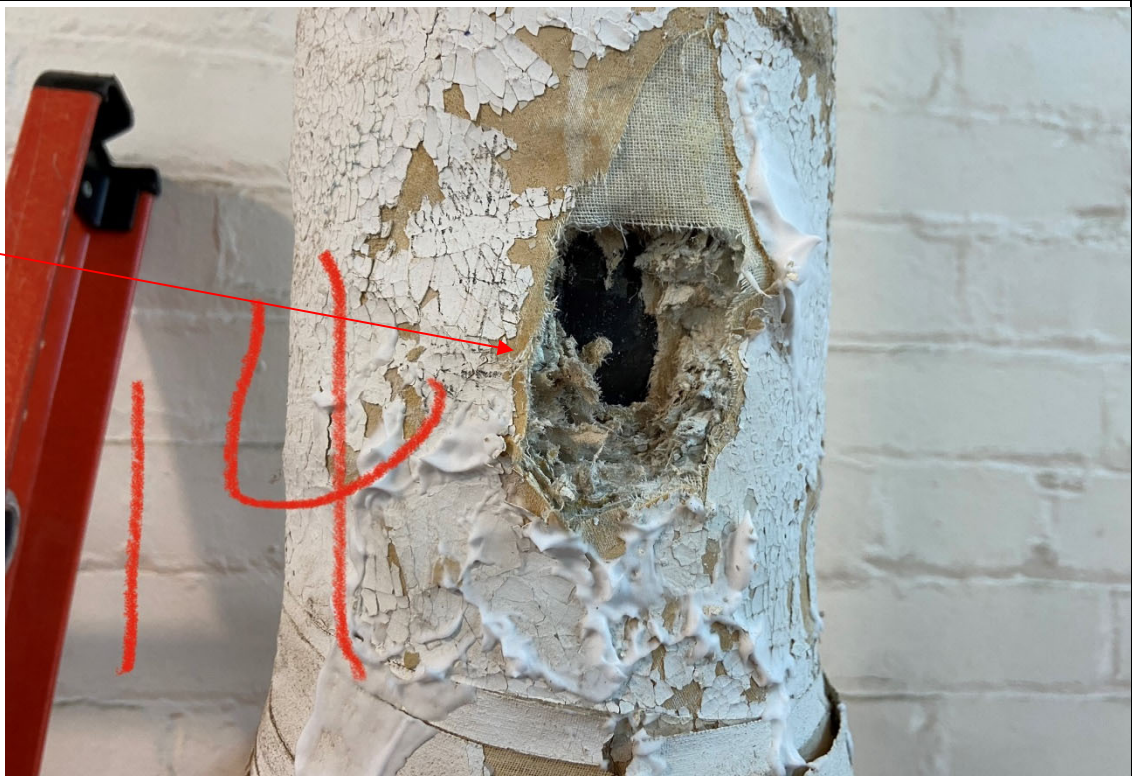
4" TSI Pipe Insulation

Tested Positive for
Asbestos

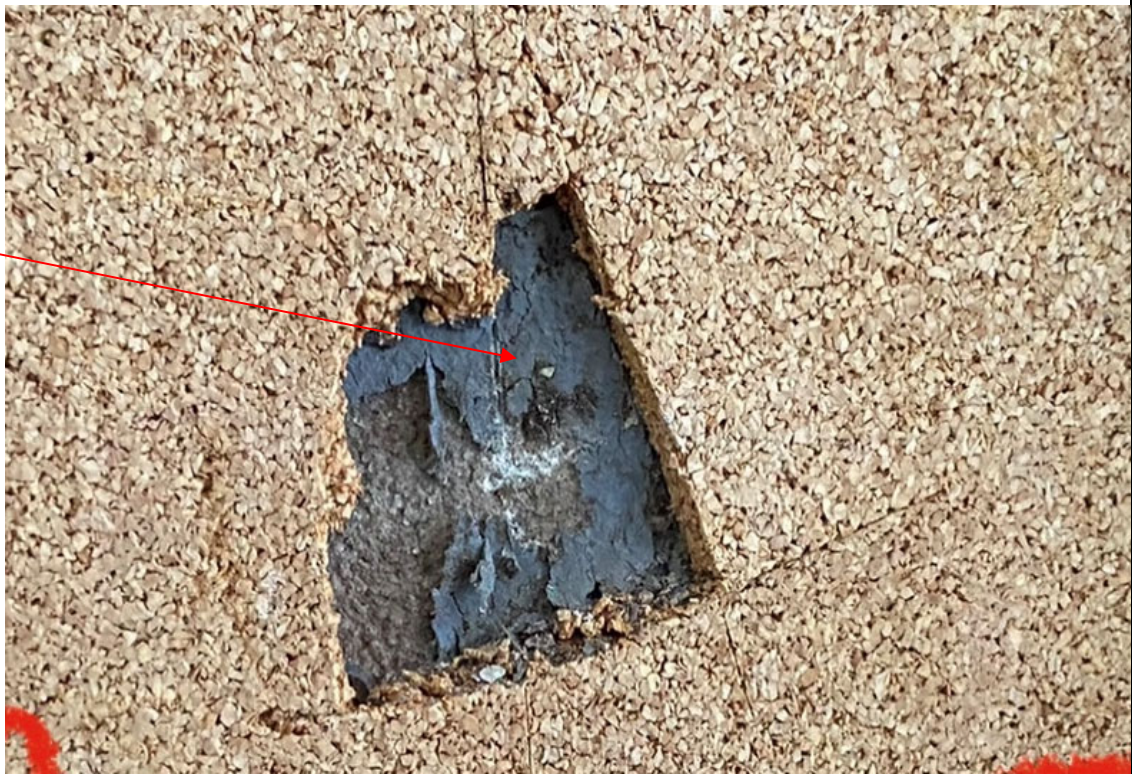
Chalk Board Mastic

Tested Positive for
Asbestos

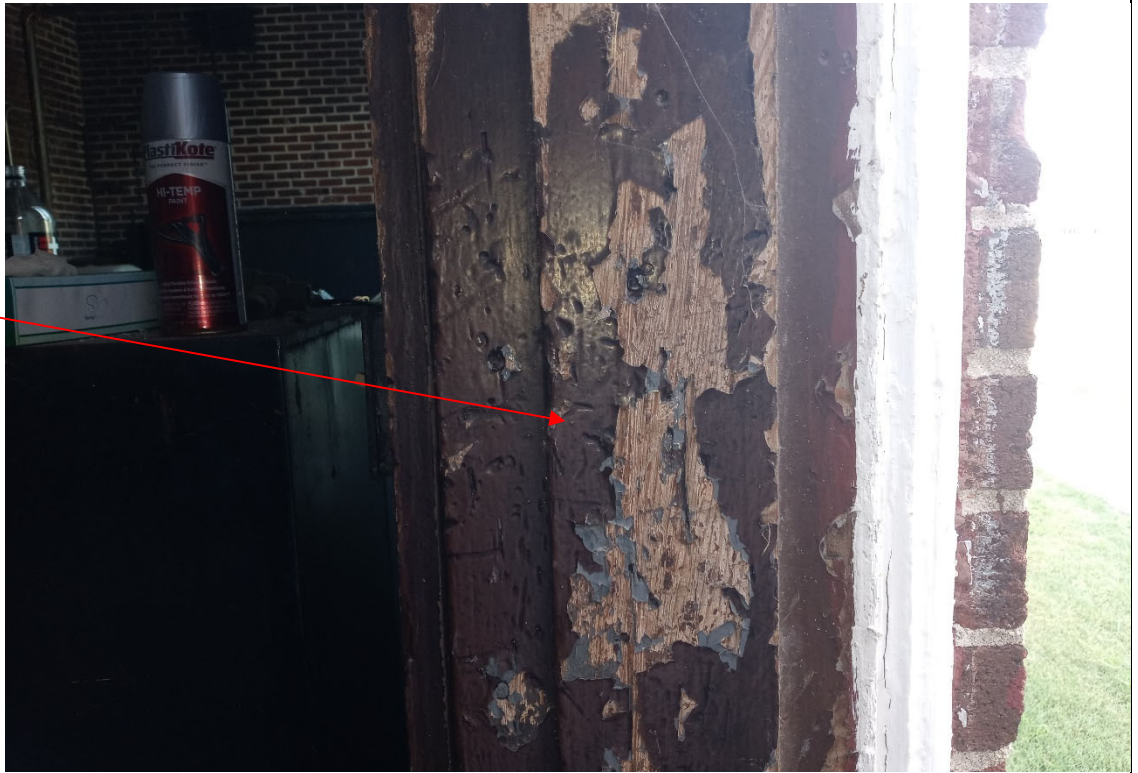
Brown Door Jamb

**Tested Positive for
Lead-Based Paint**

- Lead-based paint was found on the exterior and interior components in a deteriorated condition. It is recommended that these components be either scraped clean of lead-based paint or encapsulated by a contractor licensed to perform lead-based paint activities prior to the renovation to ensure that deteriorated paint will not chip or flake off during renovation activities.

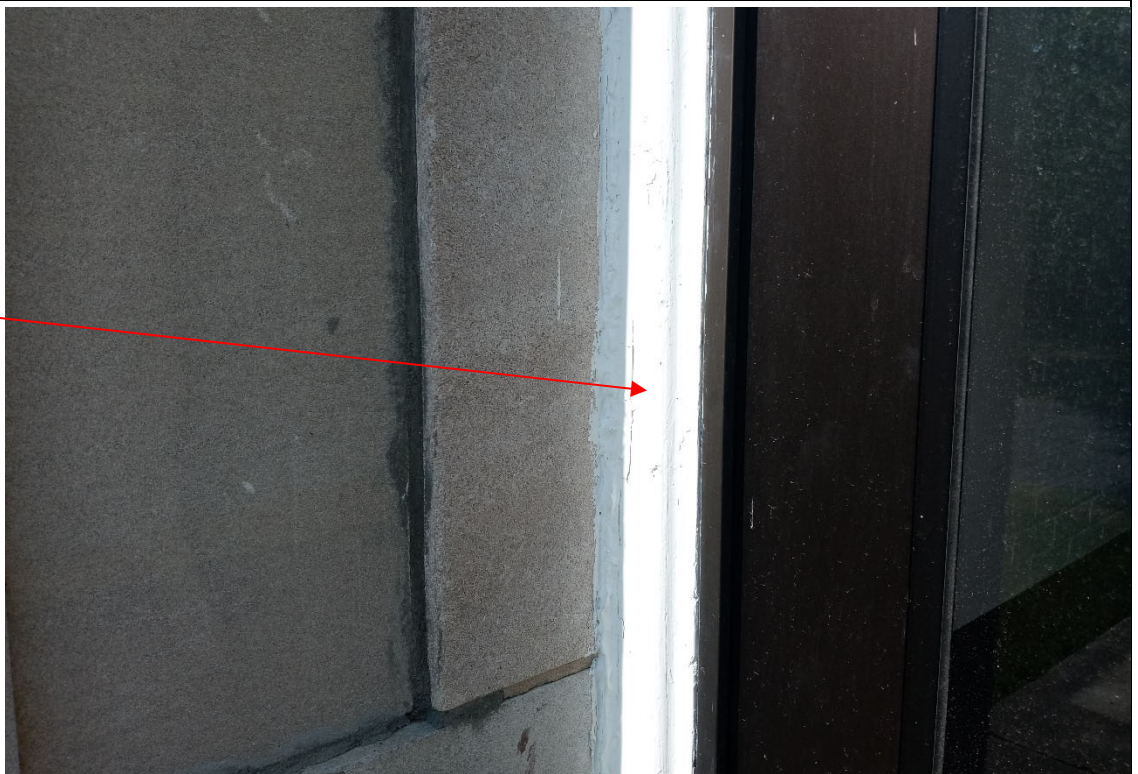
White Door Casing

**Tested Positive for
Lead-Based Paint**

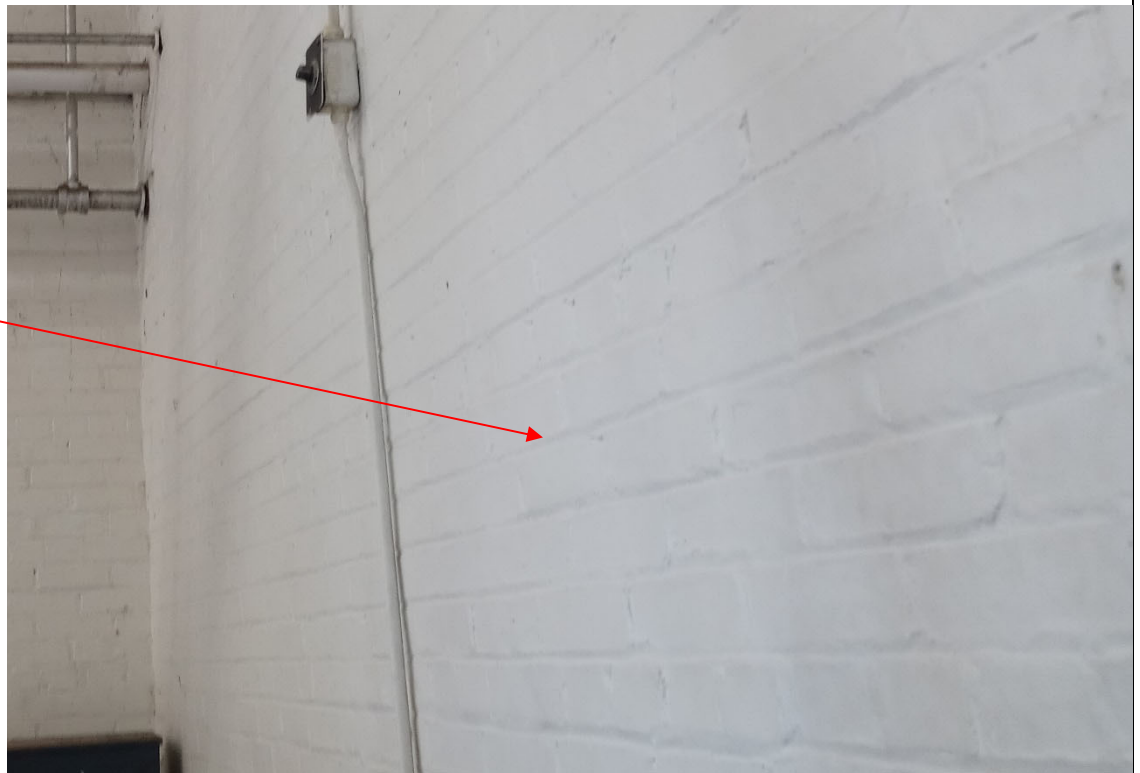
White Brick Wall

**Tested Positive for
Lead-Based Paint**

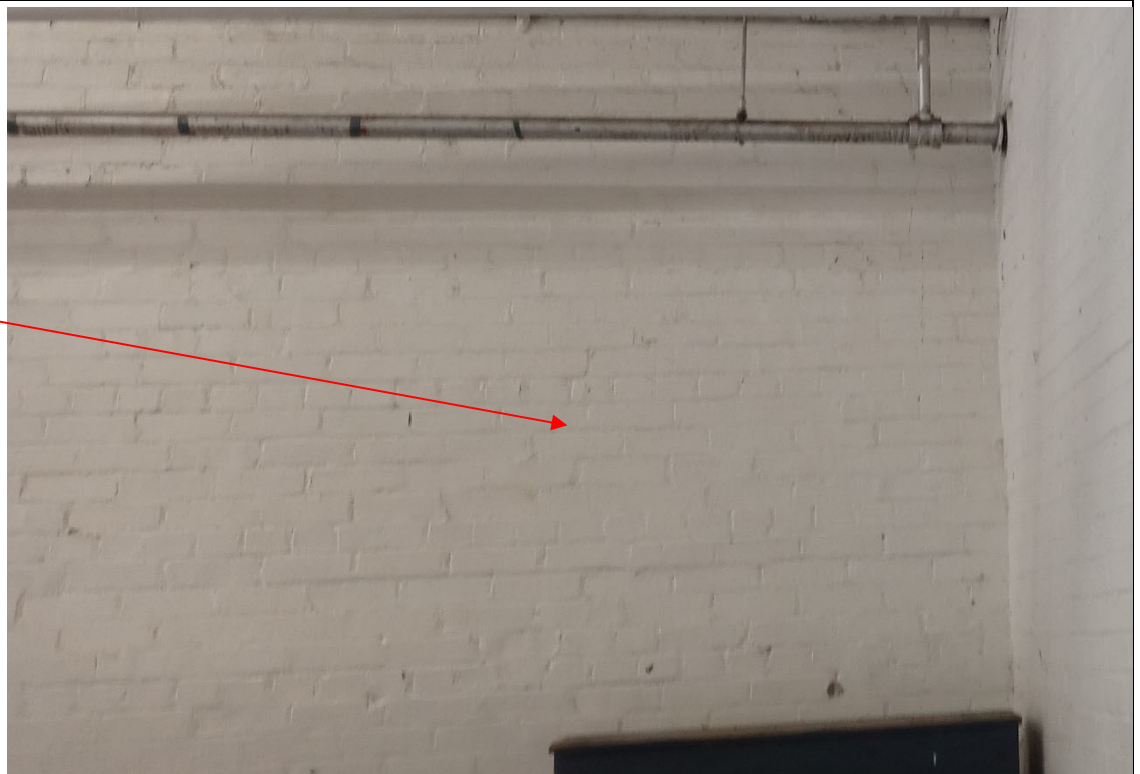
White Brick Wall

**Tested Positive for
Lead-Based Paint**

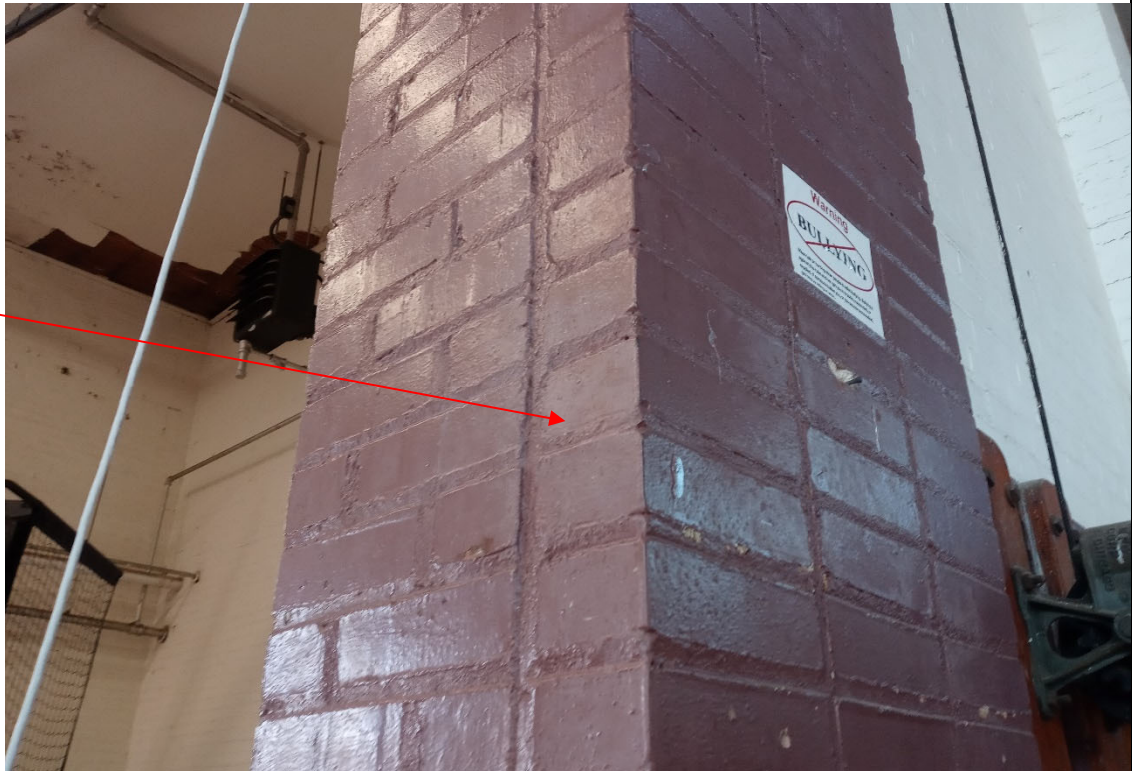
Burgandy Brick Wall

**Tested Positive for
Lead-Based Paint**

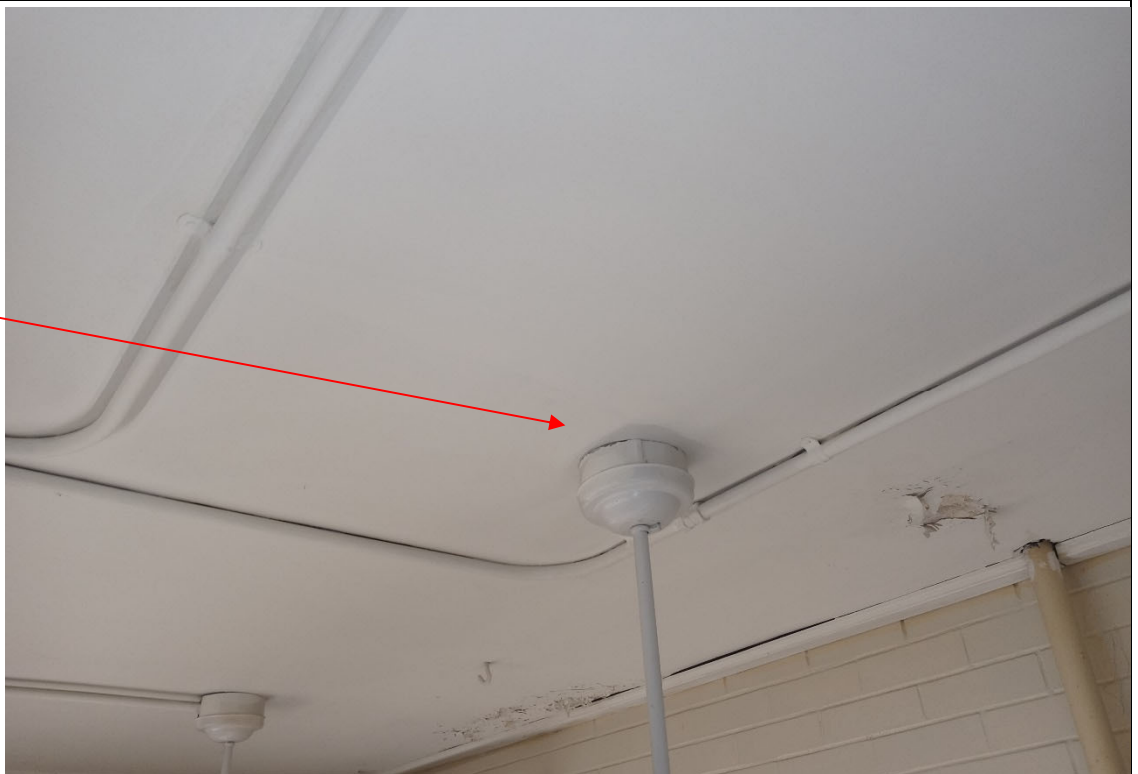
White Plaster Ceiling

**Tested Positive for
Lead-Based Paint**

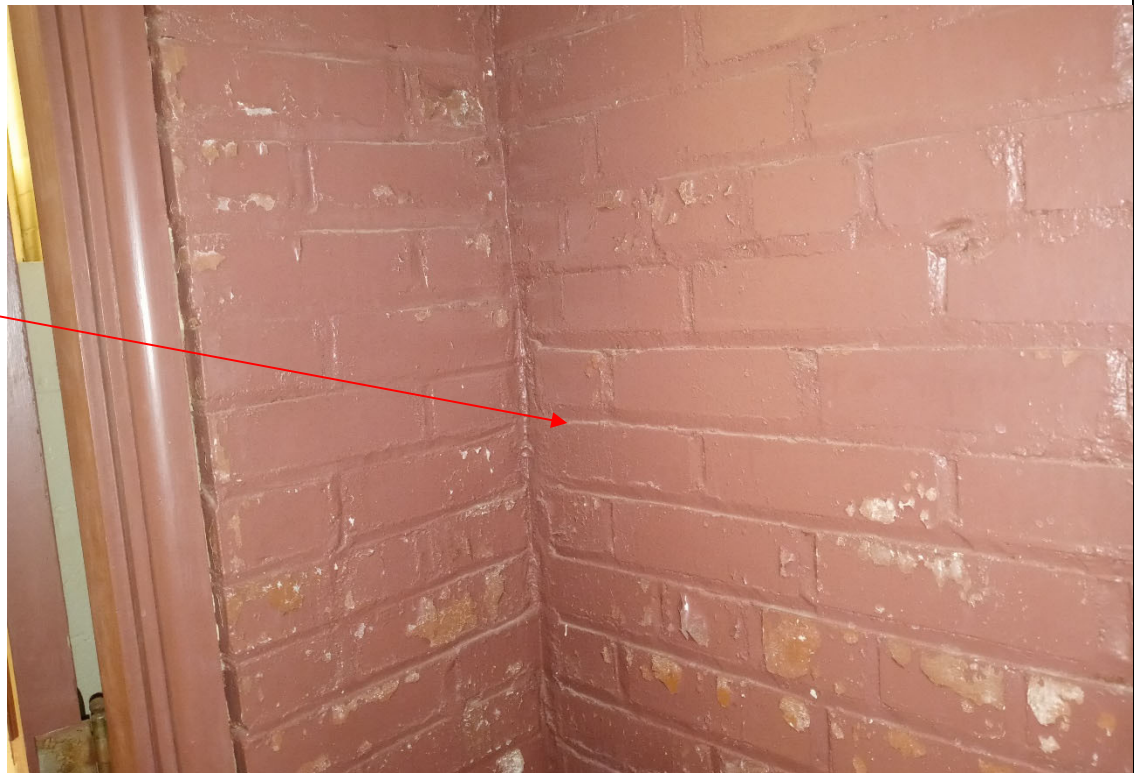
Burgandy Brick Wall

**Tested Positive for
Lead-Based Paint**

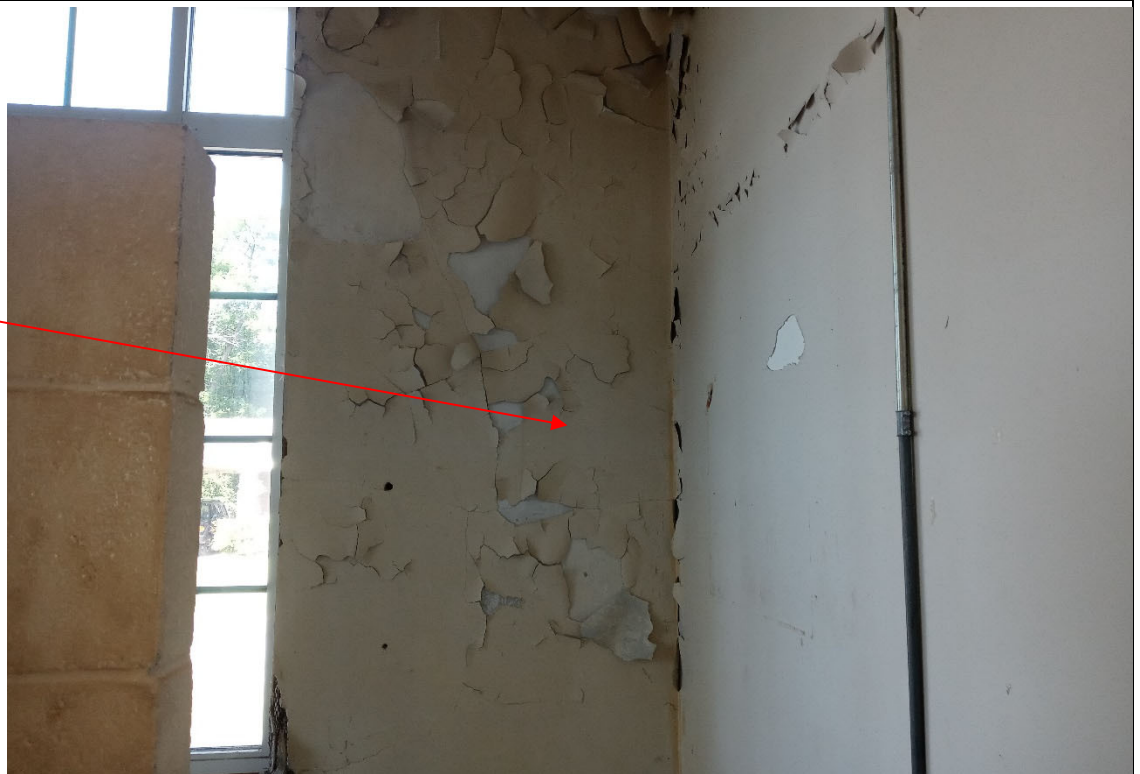
White Plaster Wall

**Tested Positive for
Lead-Based Paint**

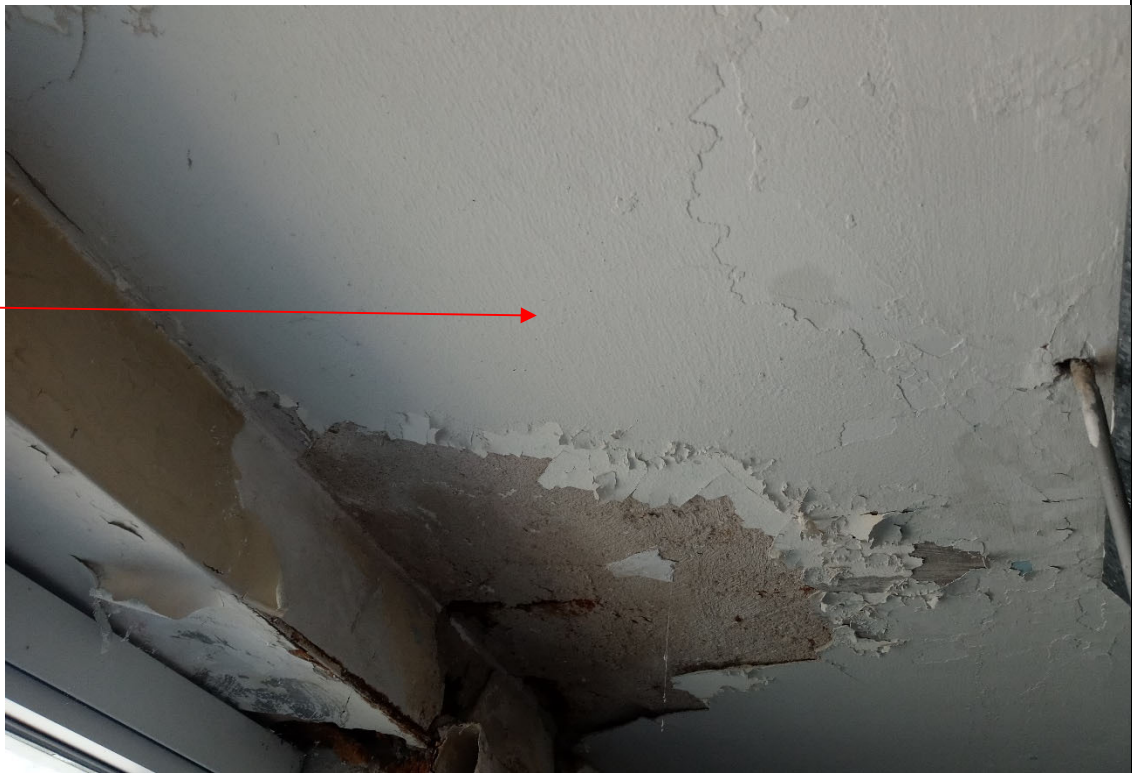
White Plaster Ceiling

**Tested Positive for
Lead-Based Paint**

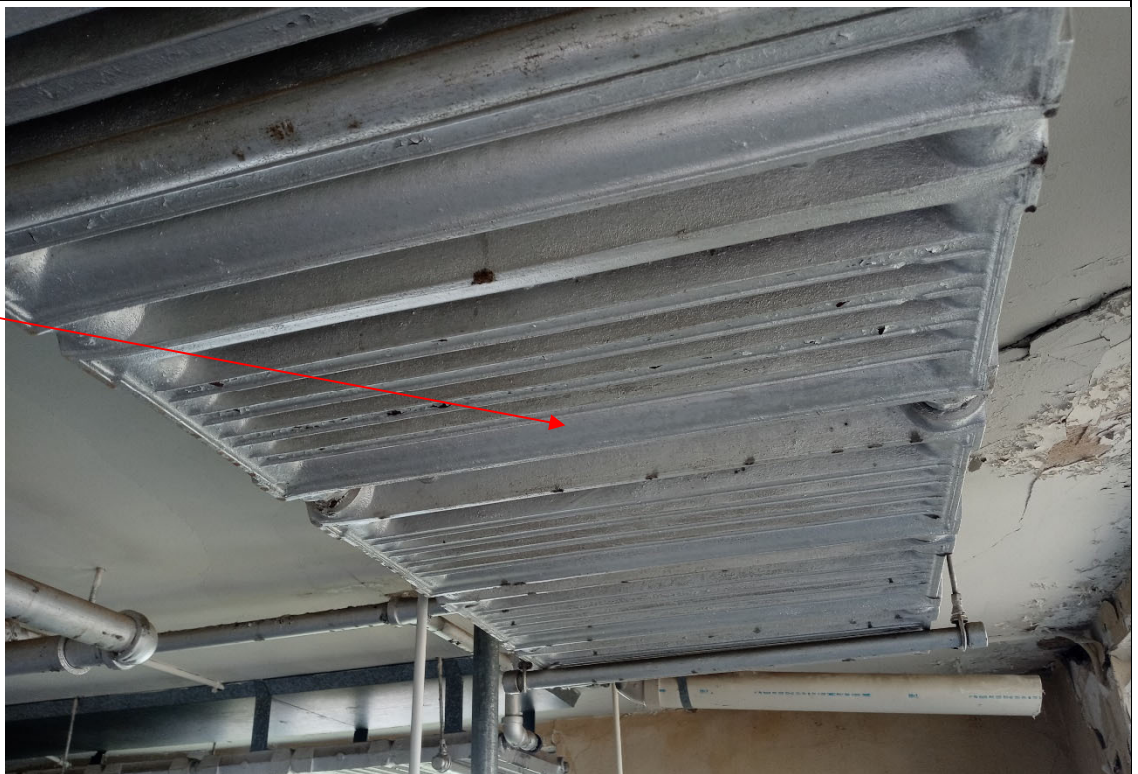
Silver Metal Radiator

**Tested Positive for
Lead-Based Paint**
