**RE: Hazardous Material Survey Report
54 E. Military Road
Marion, Arkansas**

Hazardous Materials Survey

54 E. Military Road

Project No. 251310.00

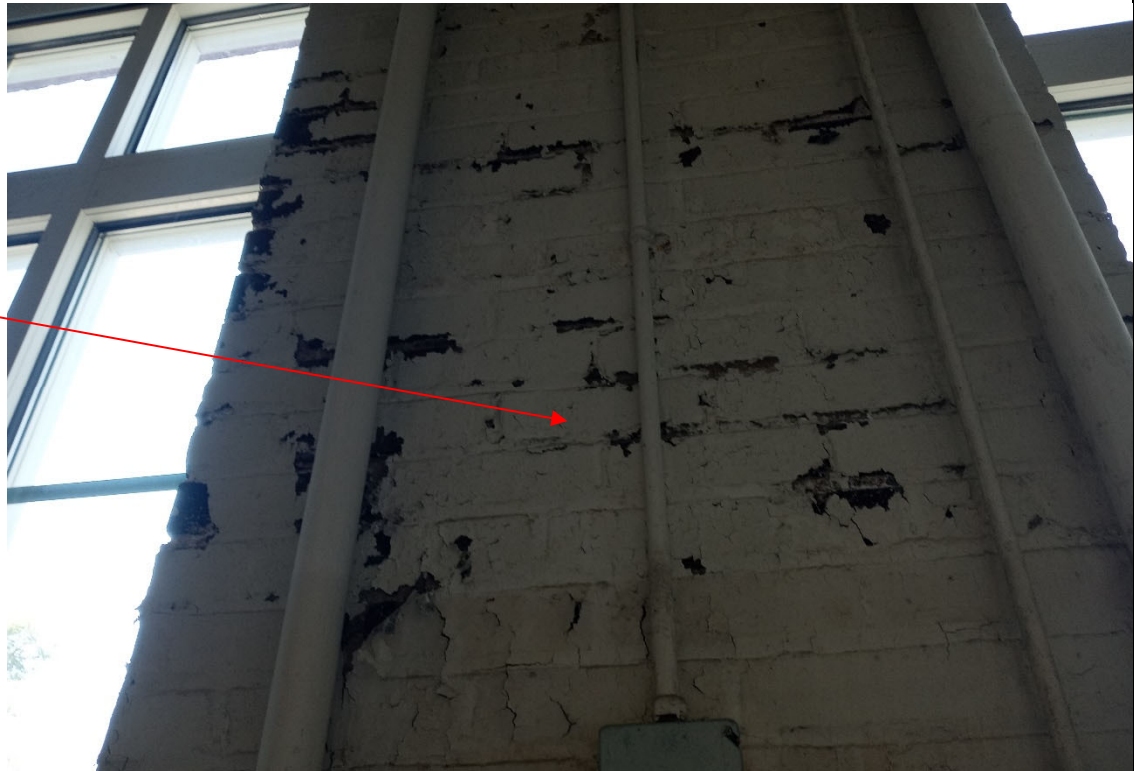
White Brick Wall

**Tested Positive for
Lead-Based Paint**

- Lead-based paint was found on the exterior and interior components in a deteriorated condition. It is recommended that these components be either scraped clean of lead-based paint or encapsulated by a contractor licensed to perform lead-based paint activities prior to the renovation to ensure that deteriorated paint will not chip or flake off during renovation activities.

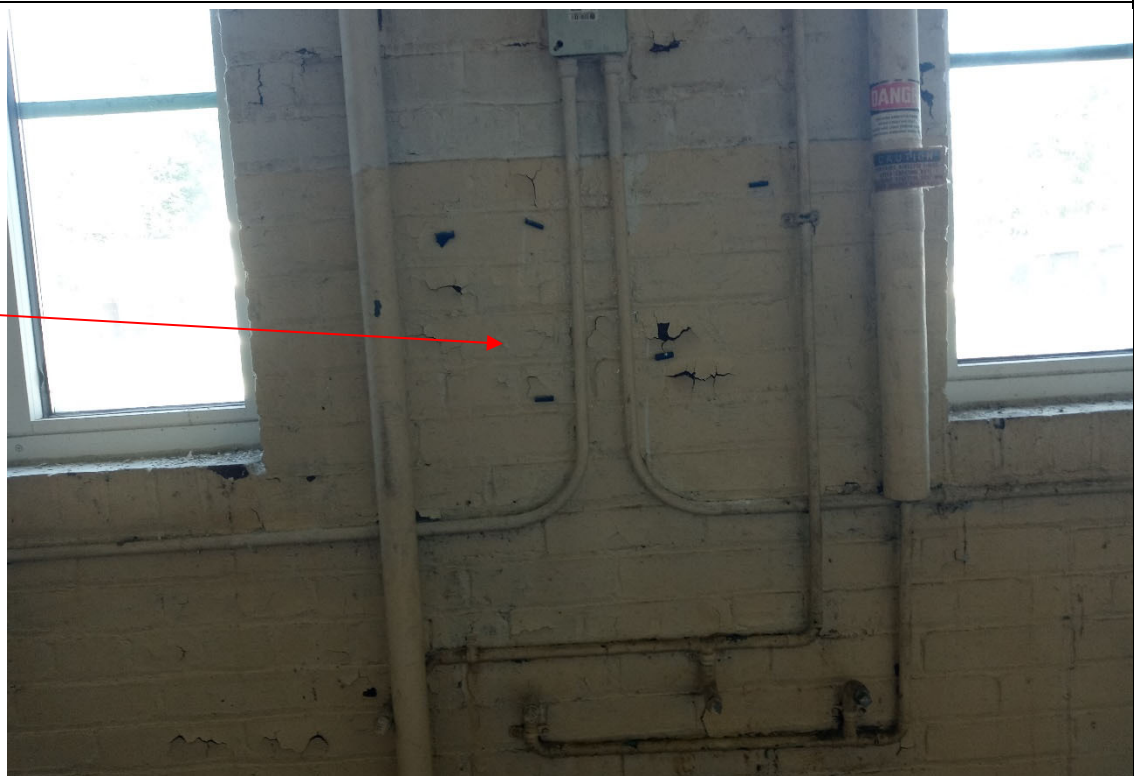
Yellow Brick Wall

**Tested Positive for
Lead-Based Paint**

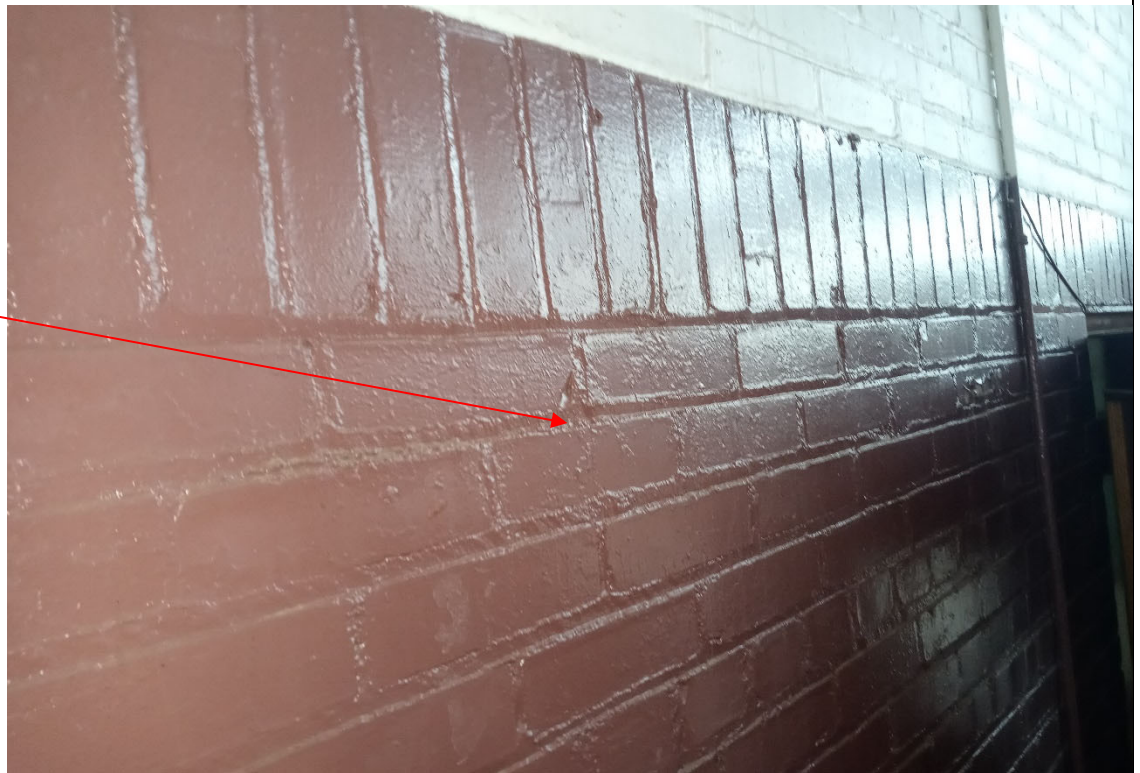
Burgandy Brick Wall

**Tested Positive for
Lead-Based Paint**

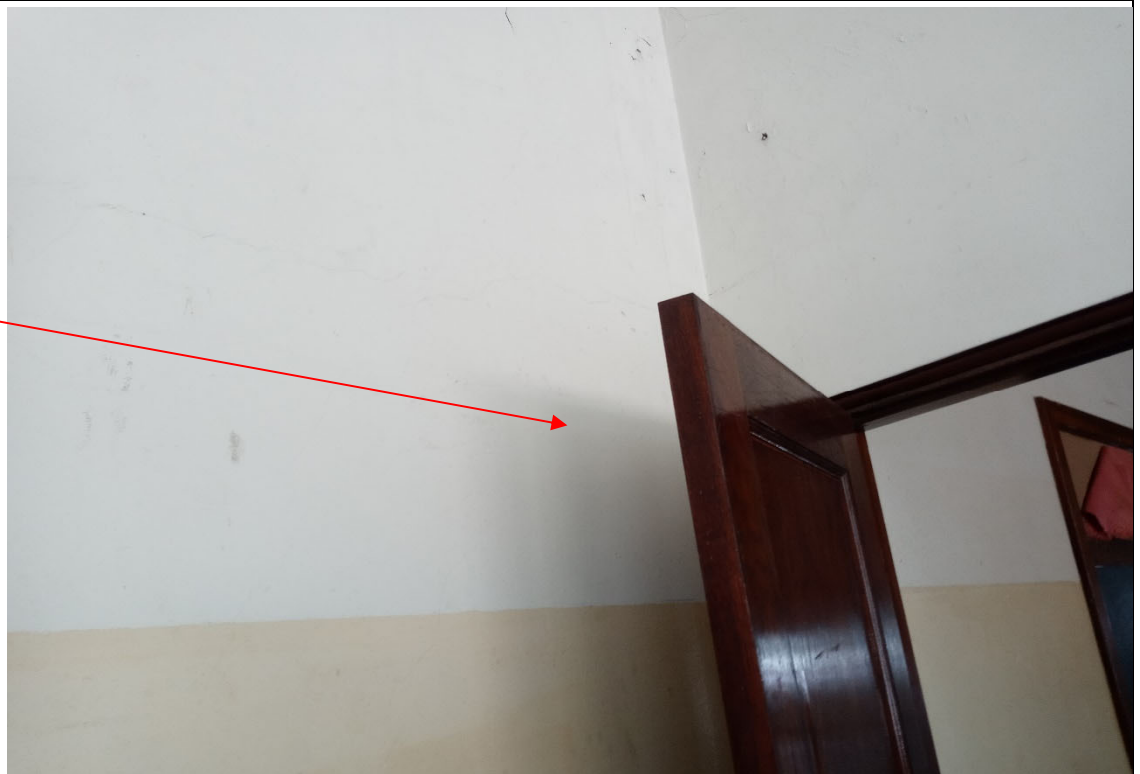
White Plaster Wall

**Tested Positive for
Lead-Based Paint**

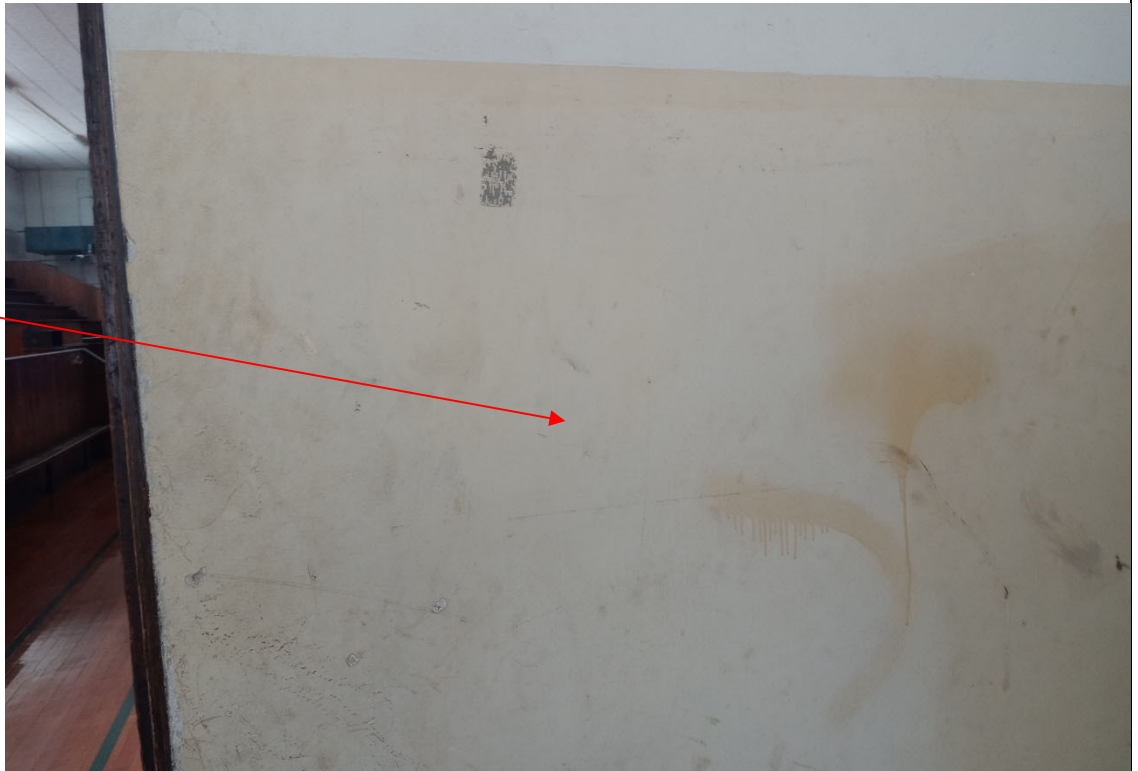
Yellow Plaster Wall

**Tested Positive for
Lead-Based Paint**

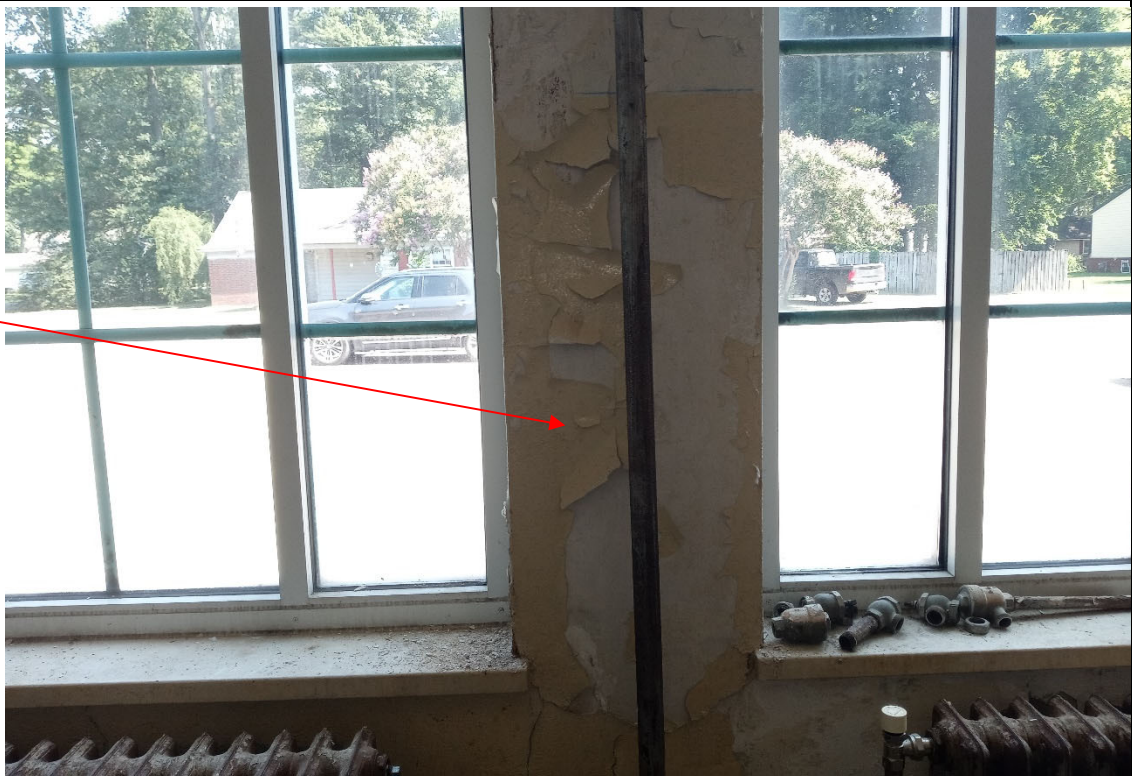
White Plaster Wall

**Tested Positive for
Lead-Based Paint**

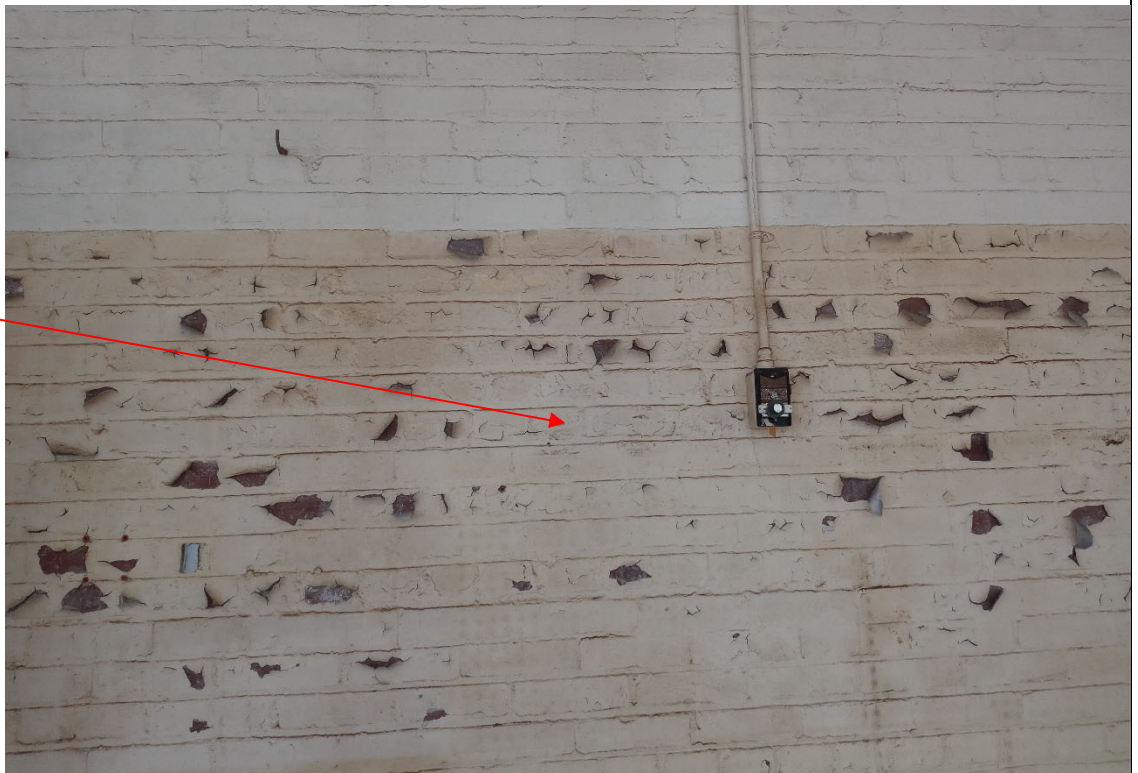
Yellow Brick Wall

**Tested Positive for
Lead-Based Paint**

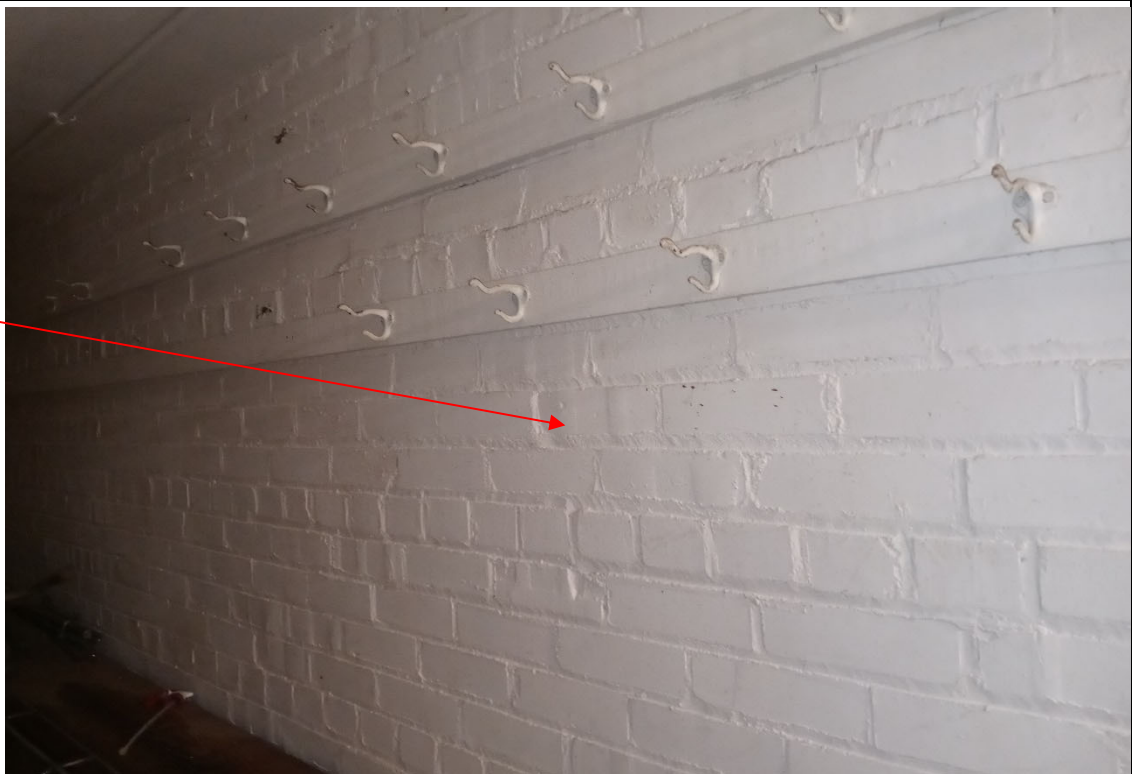
White Brick Wall

**Tested Positive for
Lead-Based Paint**

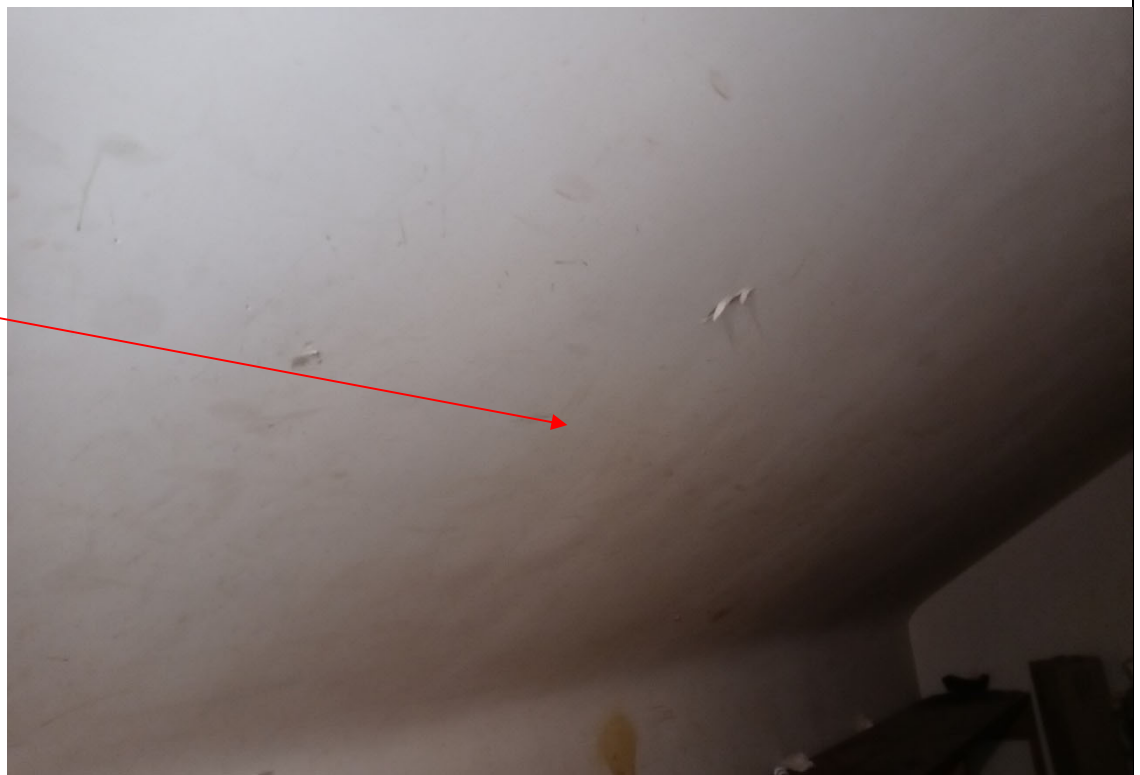
White Plaster Ceiling

**Tested Positive for
Lead-Based Paint**

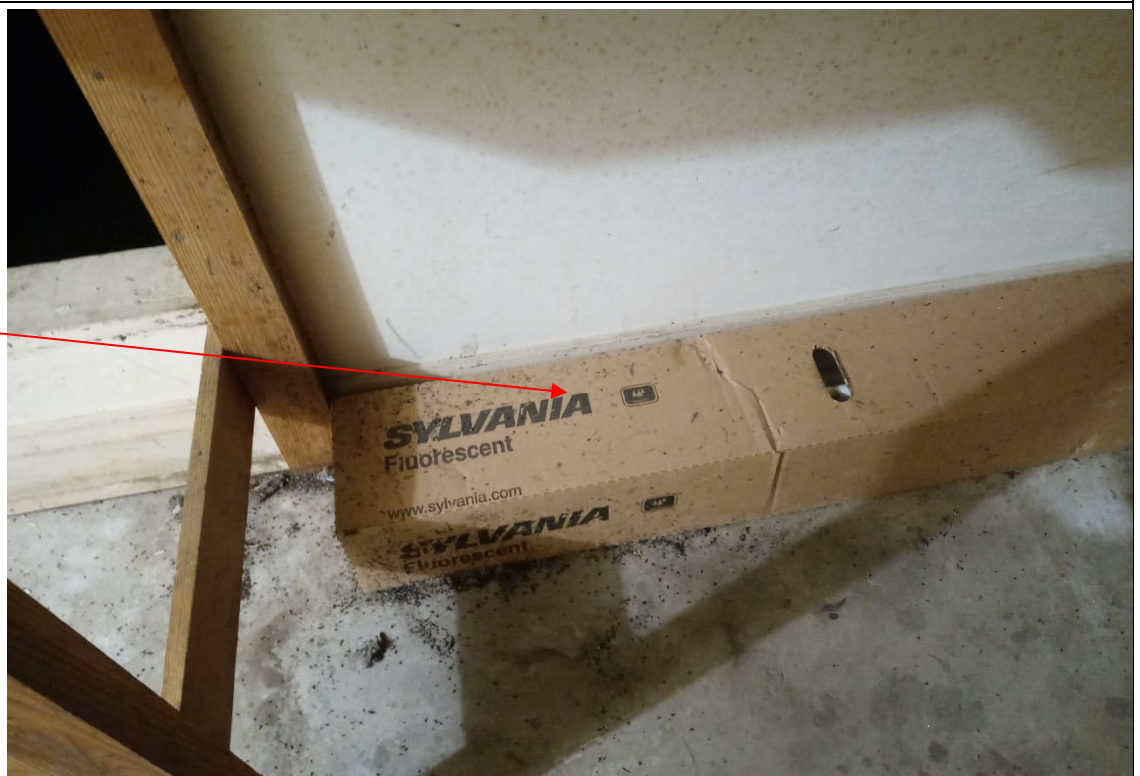
Six (6) mercury containing fluorescent light bulbs were observed in a storage area and not in the light fixtures.

Hazardous Materials:

Mercury-containing
Fluorescent Bulb
Example

Prior to demolition activity impacting these mercury-containing lamps, they should be removed and disposed of as universal hazardous waste as per state and federal regulations.

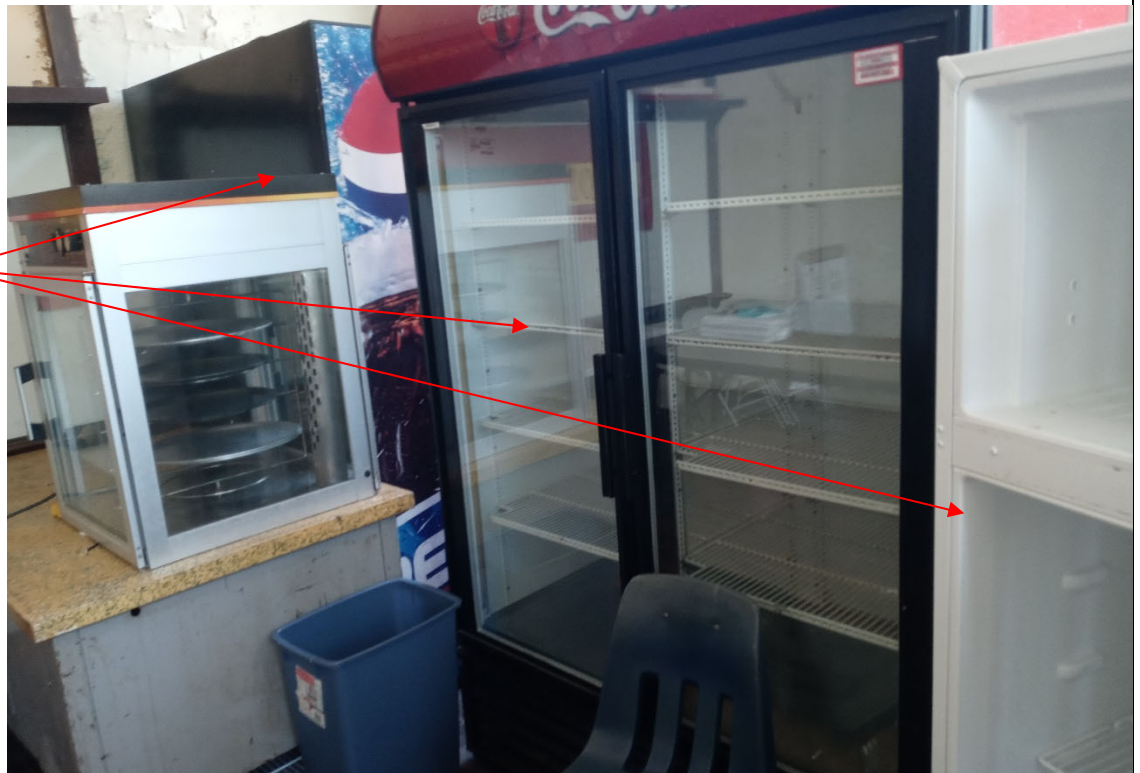
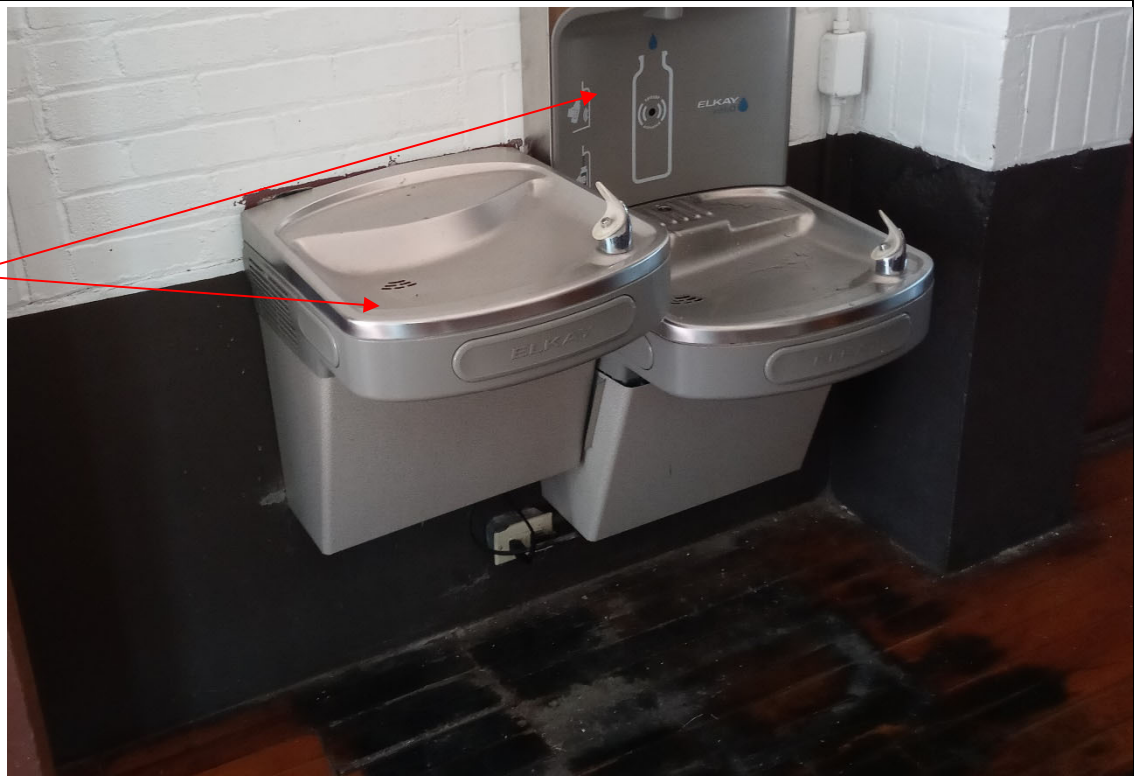
Two (2) water fountains, and three (3) stand-alone refrigerators were found at the property. These systems may contain refrigerants.

Hazardous Materials:

Refrigerants in
Appliances Example

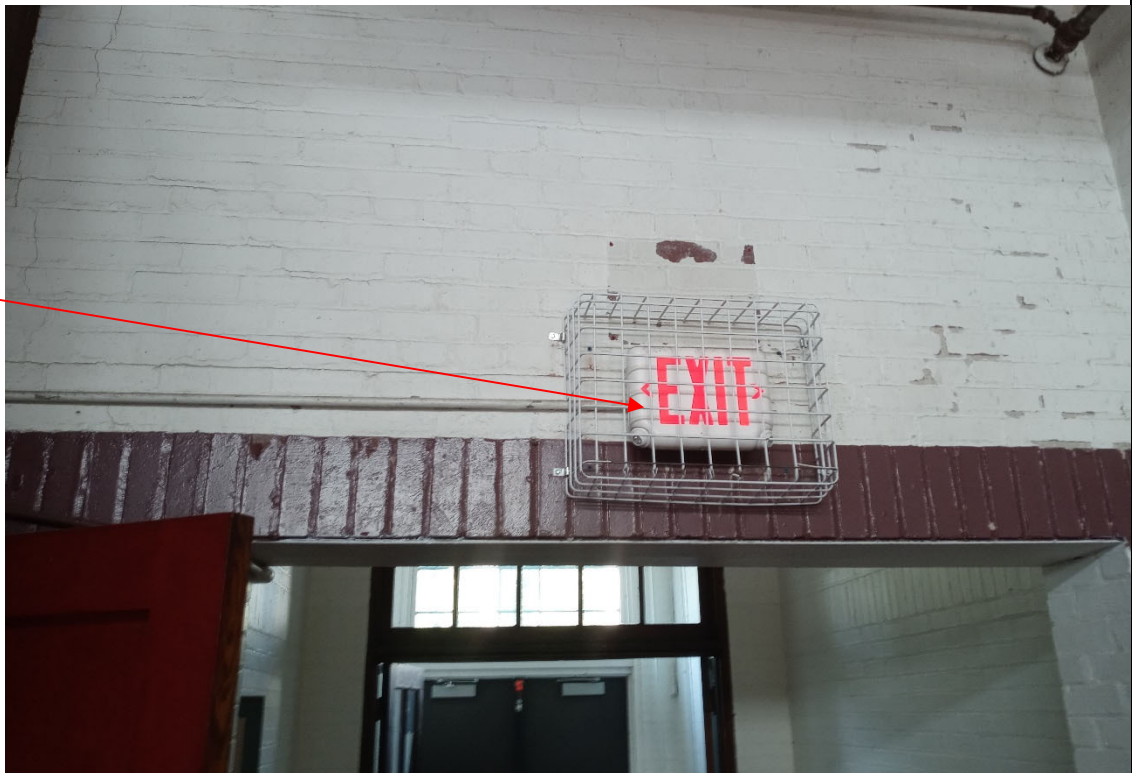
Four (4) powered exit signs were observed at the property. Exit signs of this type likely contain heavy metal containing back up batteries which will need to be disposed of properly if they will be removed as a component of the demolition.

Hazardous Materials:

Exit Sign with Batteries
Example

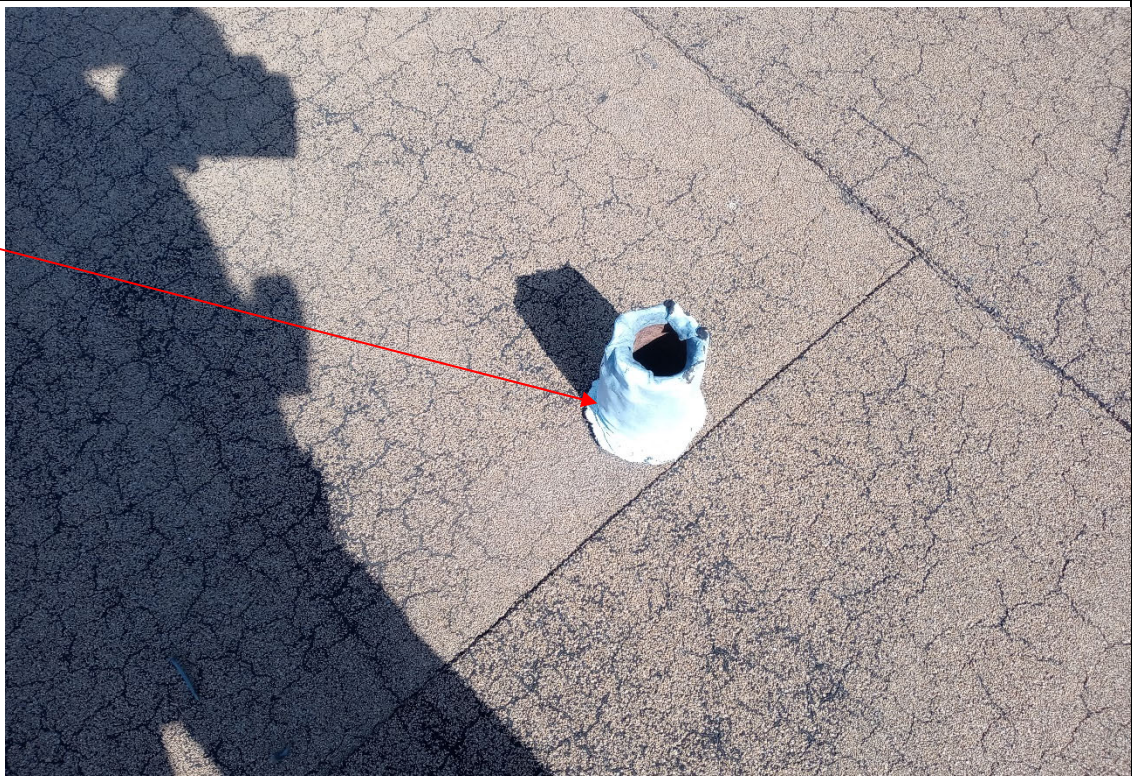
Roof pipe-penetrations were observed to have lead pipe-flashing boots. Lead is a toxic hazardous waste that must be managed and disposed of in accordance with Resource Conservation and Recovery Act (RCRA). These lead materials should be removed or handled using proper personal protective equipment or have a properly equipped contractor do so. Lead waste must be disposed of as hazardous waste at a disposal facility that accepts lead waste.

Hazardous Materials:

Lead Flashing Example

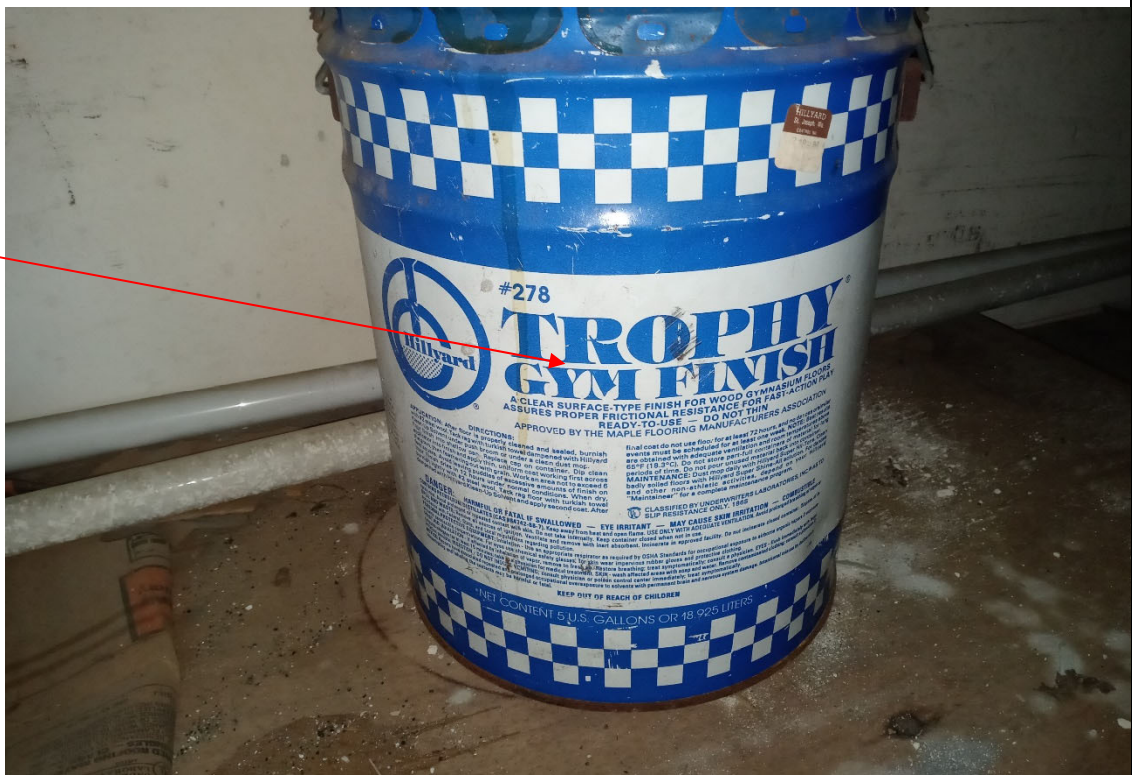
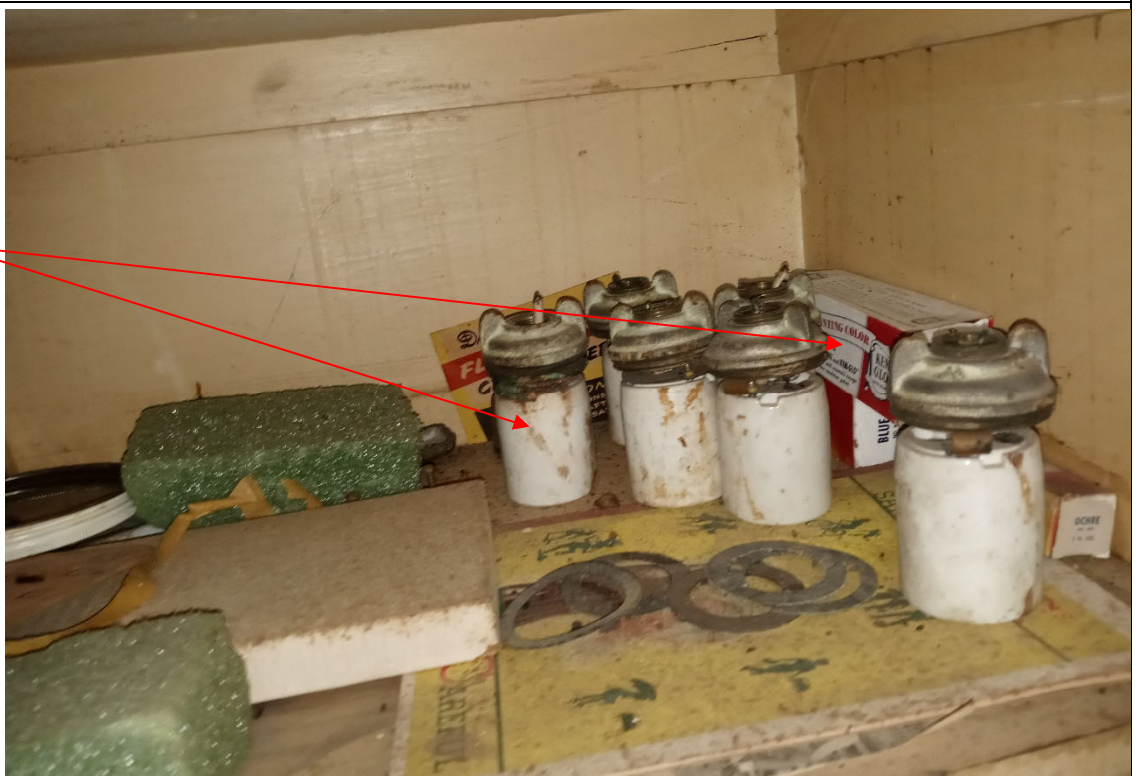
Numerous miscellaneous chemicals were found in the areas surveyed. Chemicals observed included fire suppression chemicals in fire extinguishers, paints, paint additives, and other cleaning chemicals. These materials should be profiled to determine the proper disposal method and determine if they are considered a hazardous waste, special waste, or whether they can be recycled.

Hazardous Materials:

Chemicals Example

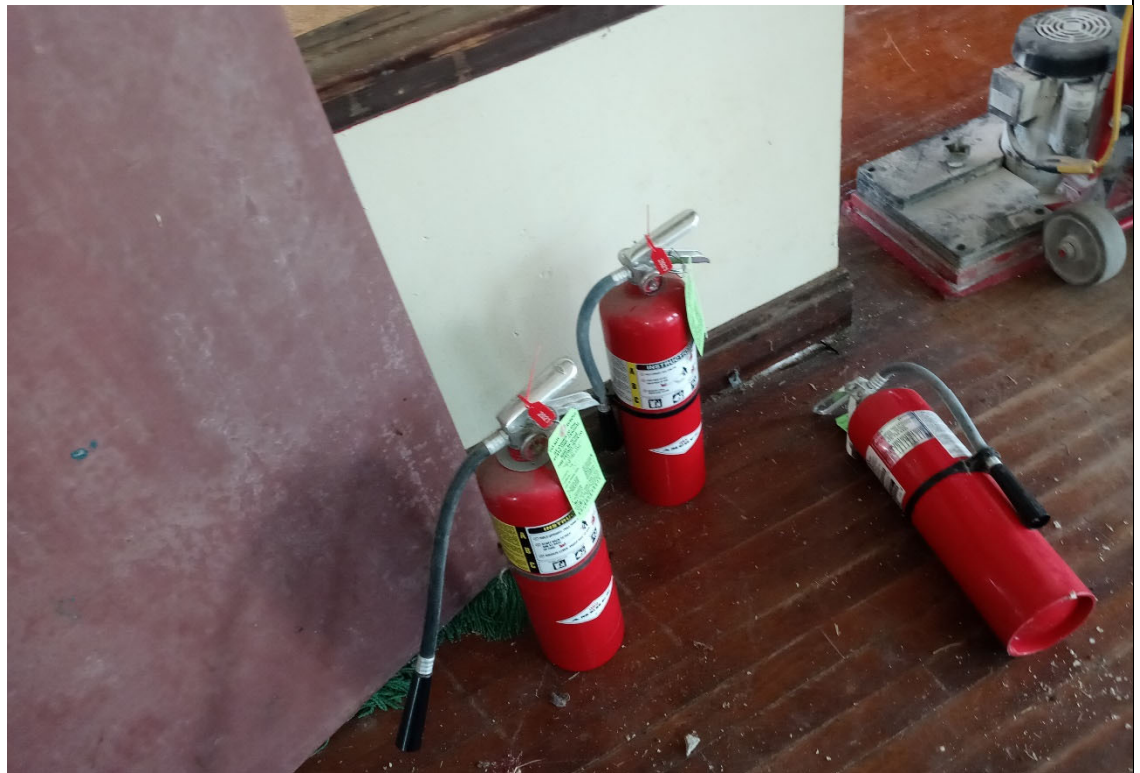
Hazardous Materials:

Fire Extinguisher
Example

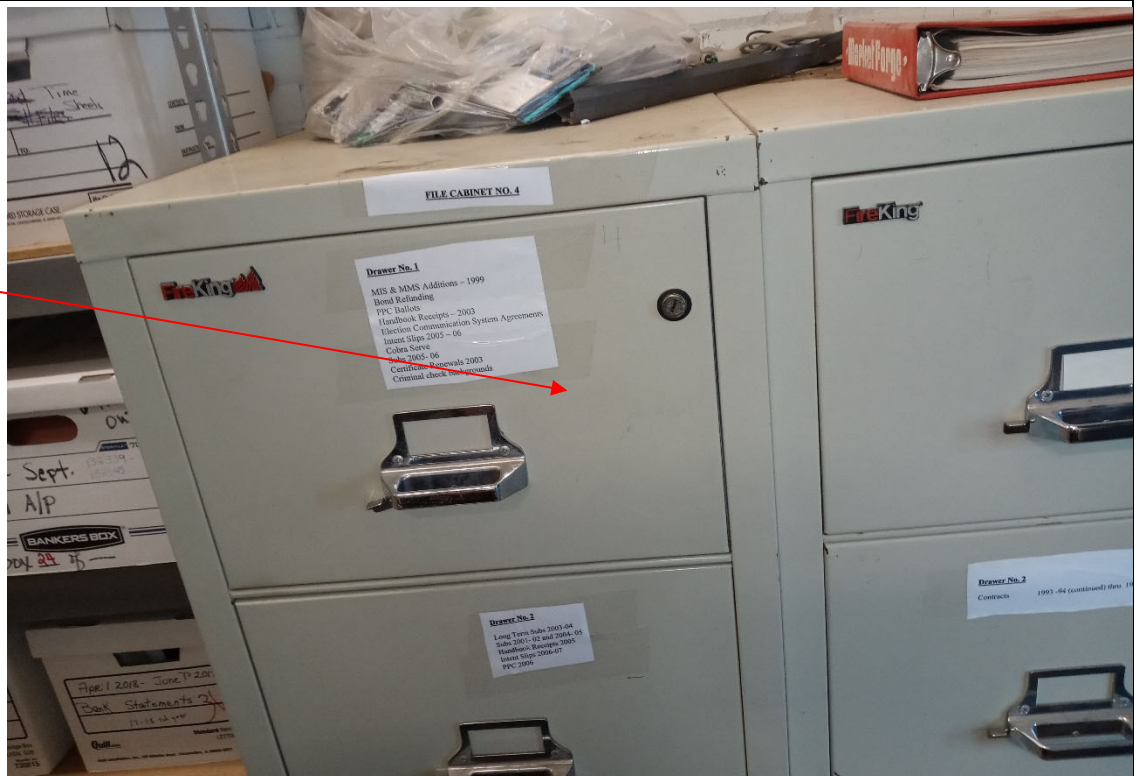
Five (5) fire-resistant file cabinets were observed on site and have the potential to contain asbestos or other hazardous materials. If these cabinets are to be disposed of during the renovation, we recommend that these materials be wrapped and removed from the buildings by a licensed asbestos abatement contractor and disposed of as asbestos containing material.

Hazardous Materials:

Fire Resistant File
Cabinet Example

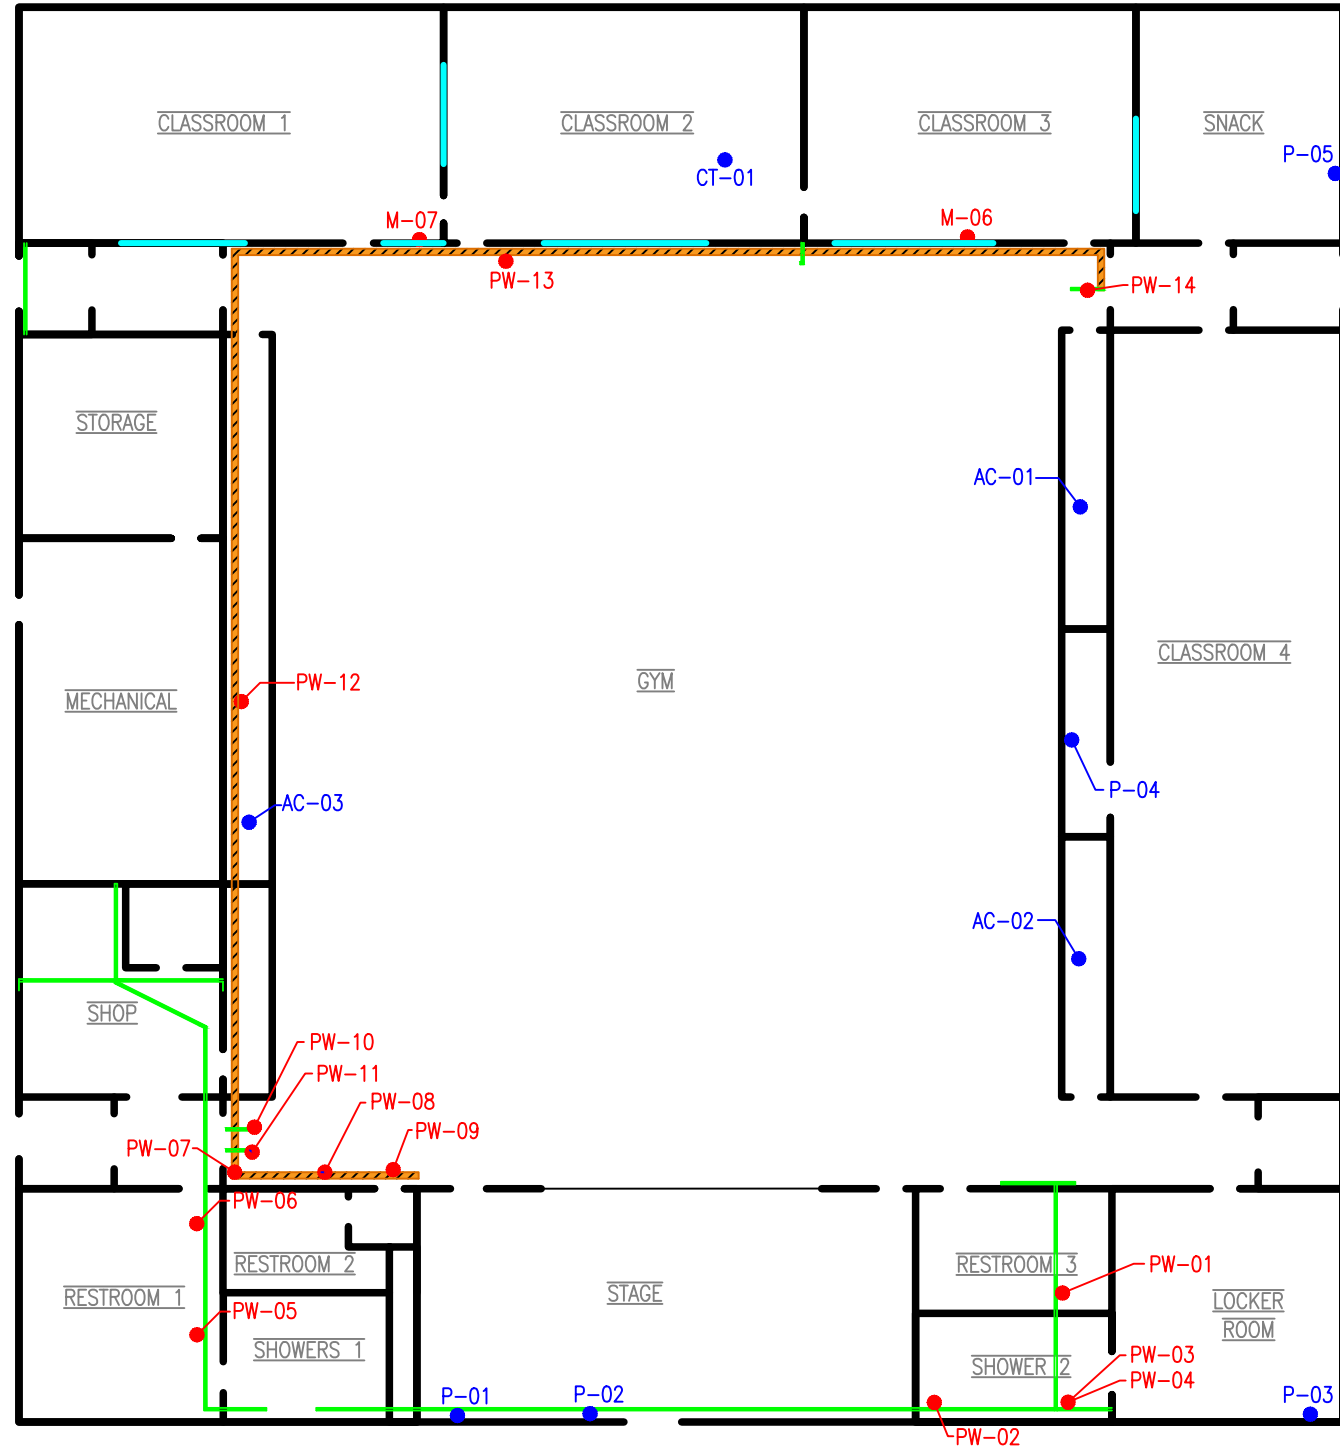
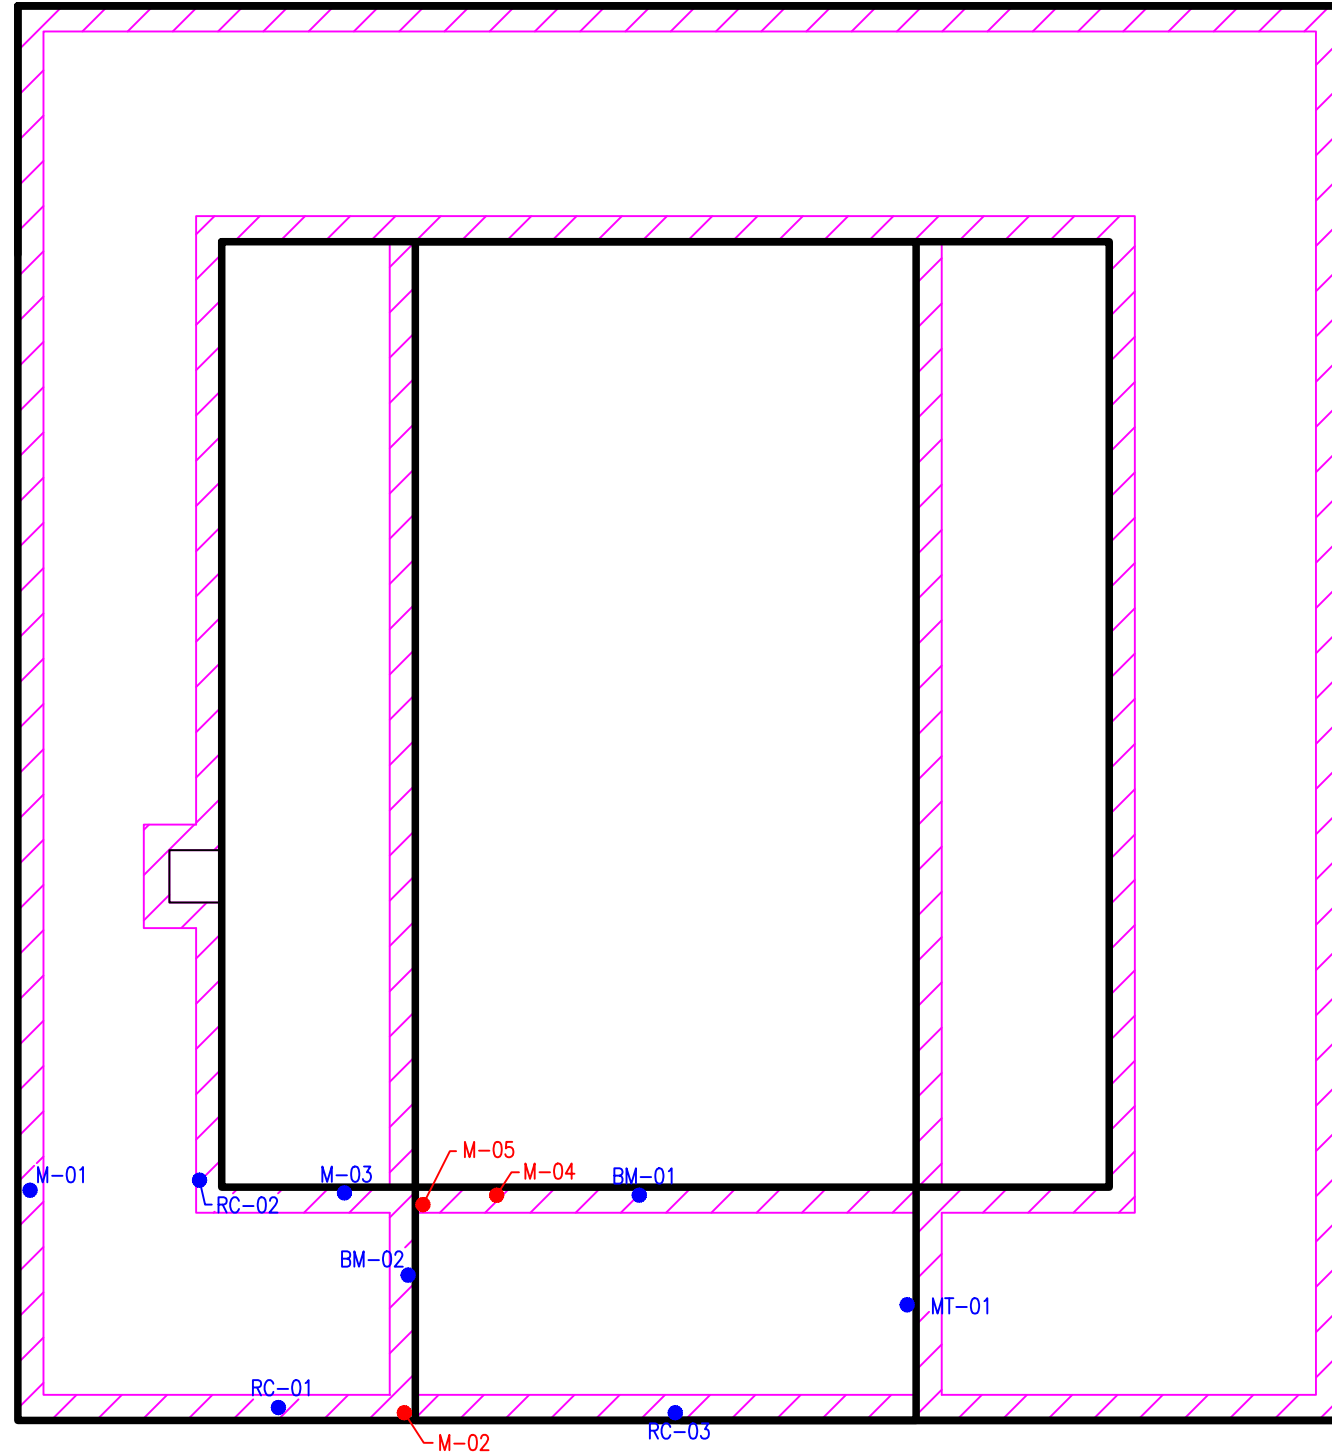
54 E. MILITARY RD.
FIRST FLOOR
HAZARDOUS MATERIAL SURVEY

DESCRIPTION:
ACM SAMPLE LOCATIONS
