**QUALITY ASSURANCE
PROJECT PLAN –
ASBESTOS AND LEAD-
BASED PAINT
ABATEMENT
REVISION 1**

MARION GYMNASIUM
MARION, ARKANSAS

FEBRUARY 2023

**RE: Hazardous Material Survey Report
54 E. Military Road
Marion, Arkansas**

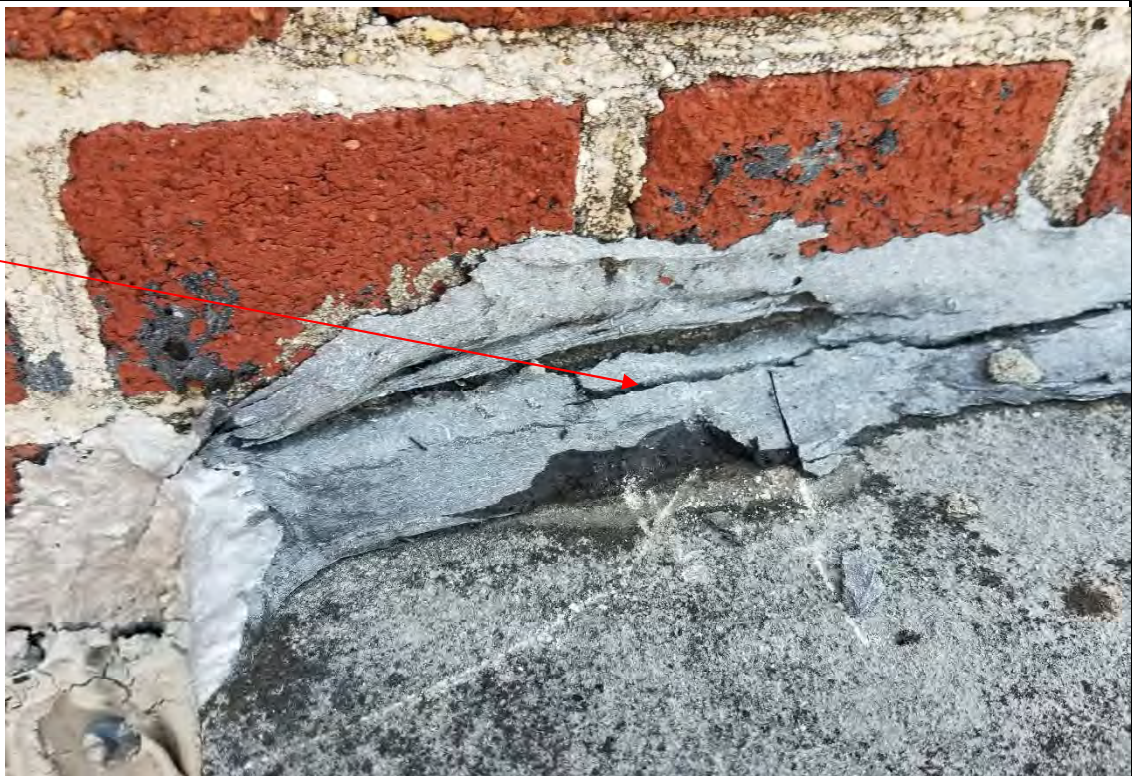
Gray Roof Mastic

Tested Positive for
Asbestos

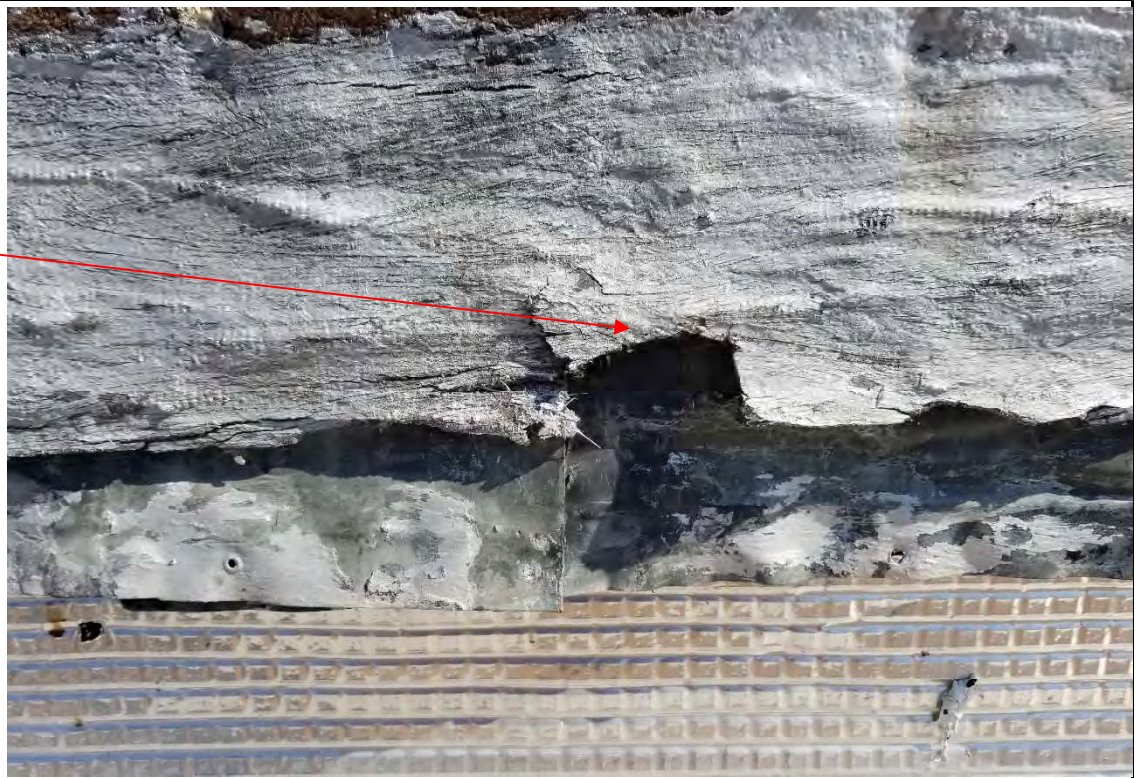
Black Roof Mastic

Tested Positive for
Asbestos

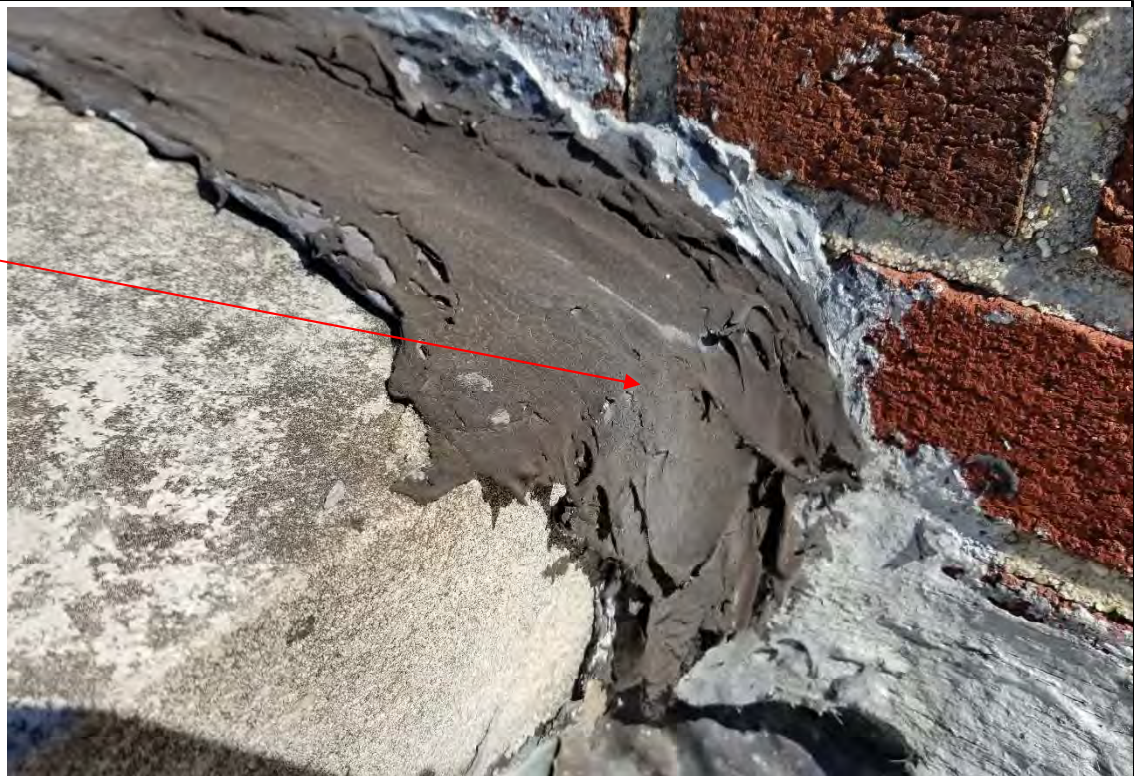
Black Roof Mastic

Tested Positive for
Asbestos

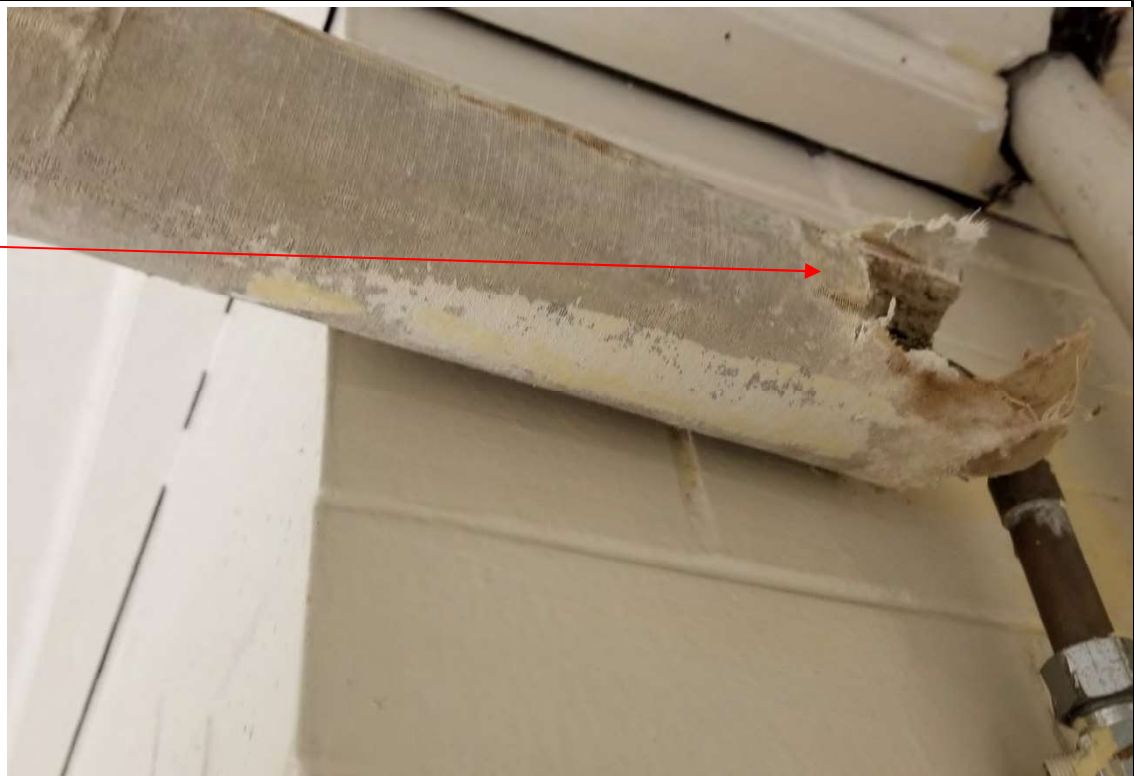
1" TSI Pipe Insulation

Tested Positive for
Asbestos

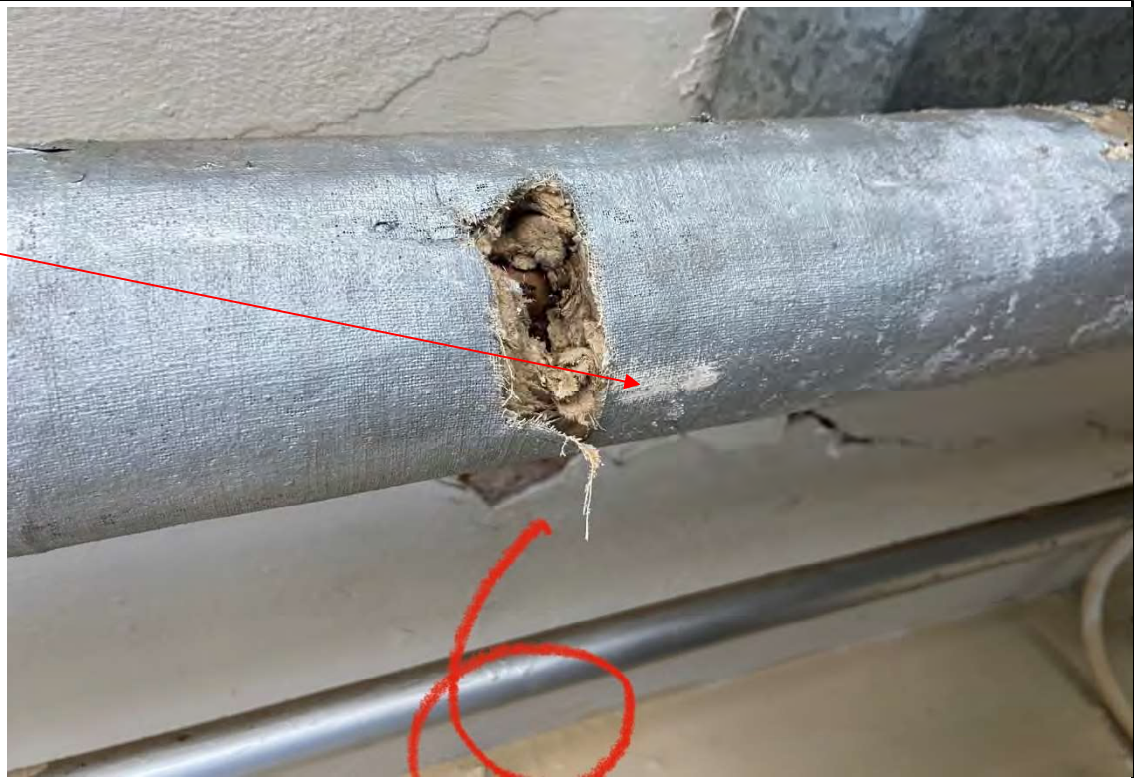
2" TSI Pipe Insulation

Tested Positive for
Asbestos

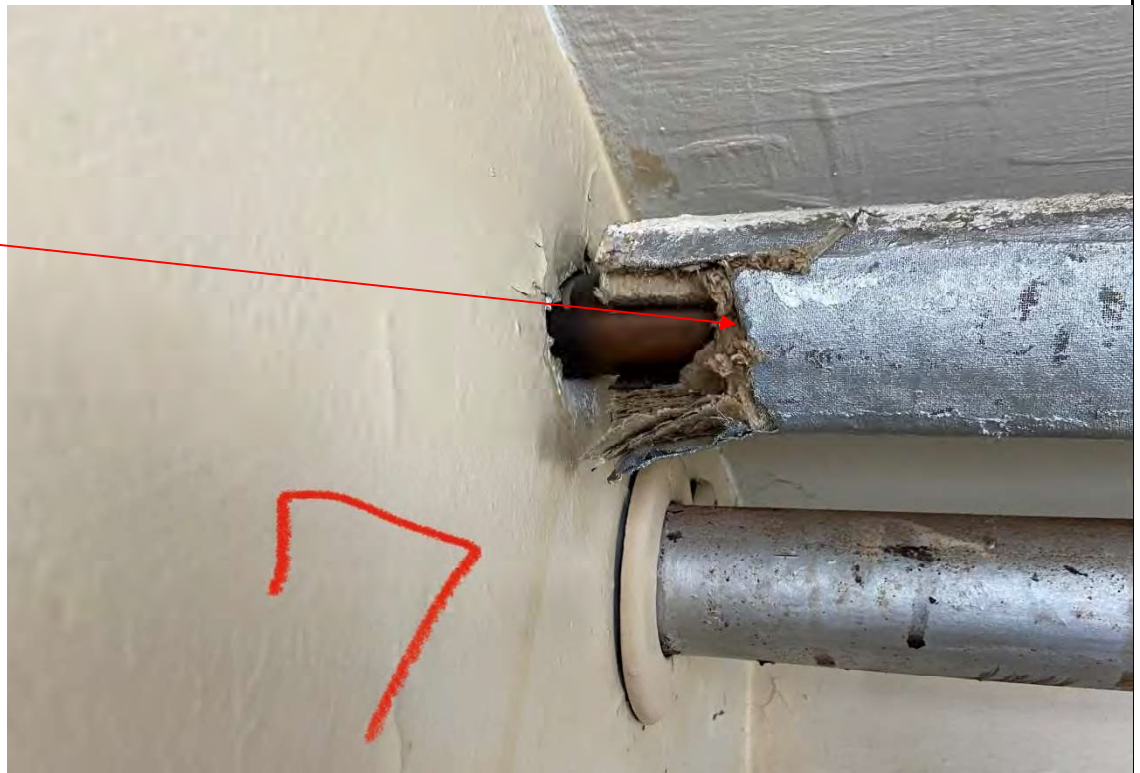
4" TSI Pipe Insulation

Tested Positive for
Asbestos

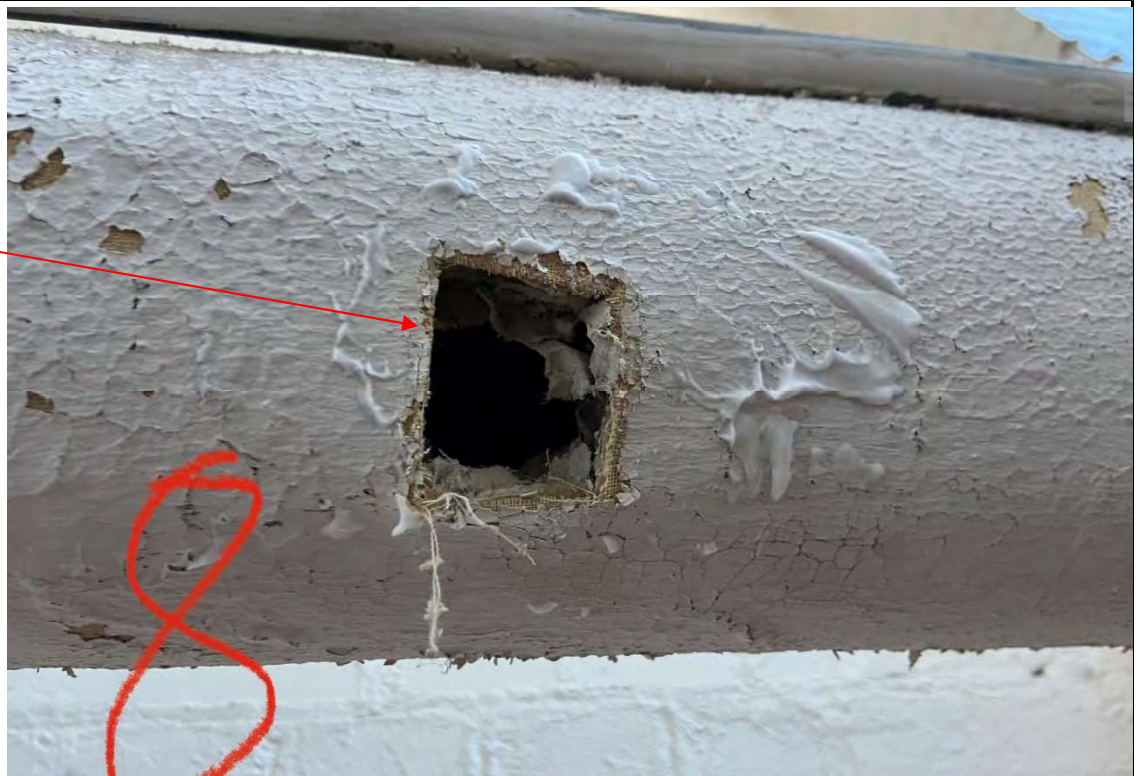
4" TSI Pipe Insulation

Tested Positive for
Asbestos

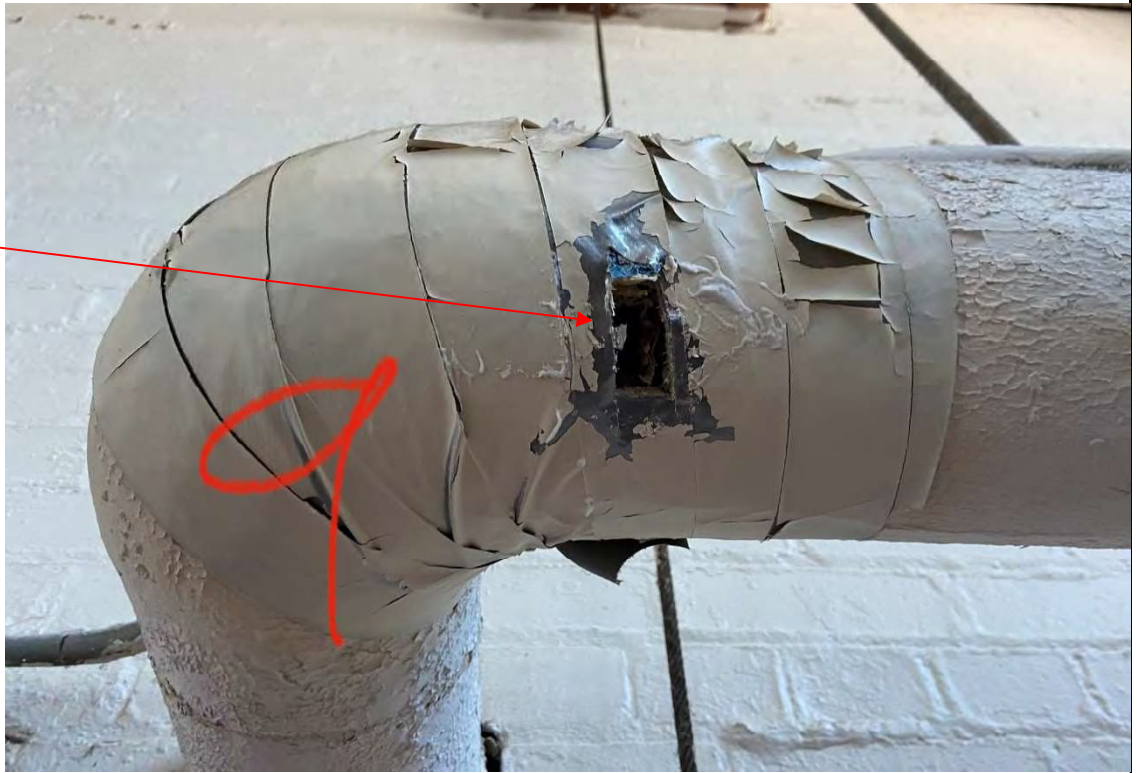
4" TSI Pipe Elbow

Tested Positive for
Asbestos

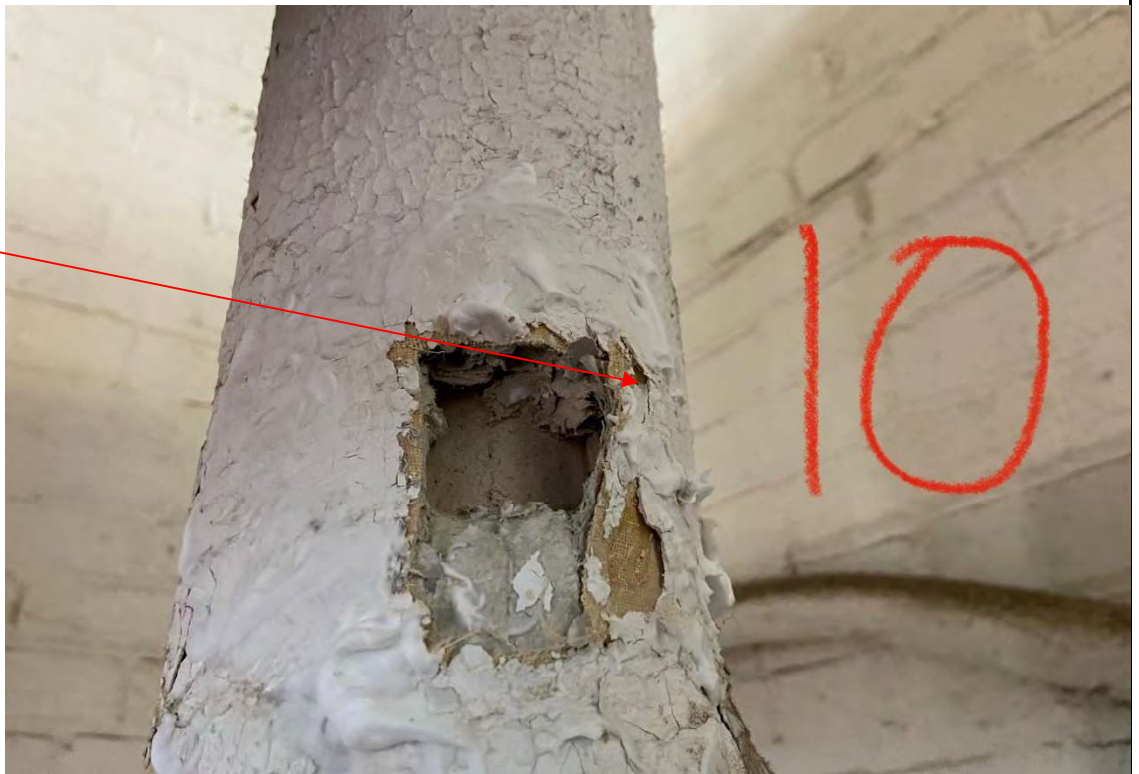
2" TSI Pipe Insulation

Tested Positive for
Asbestos

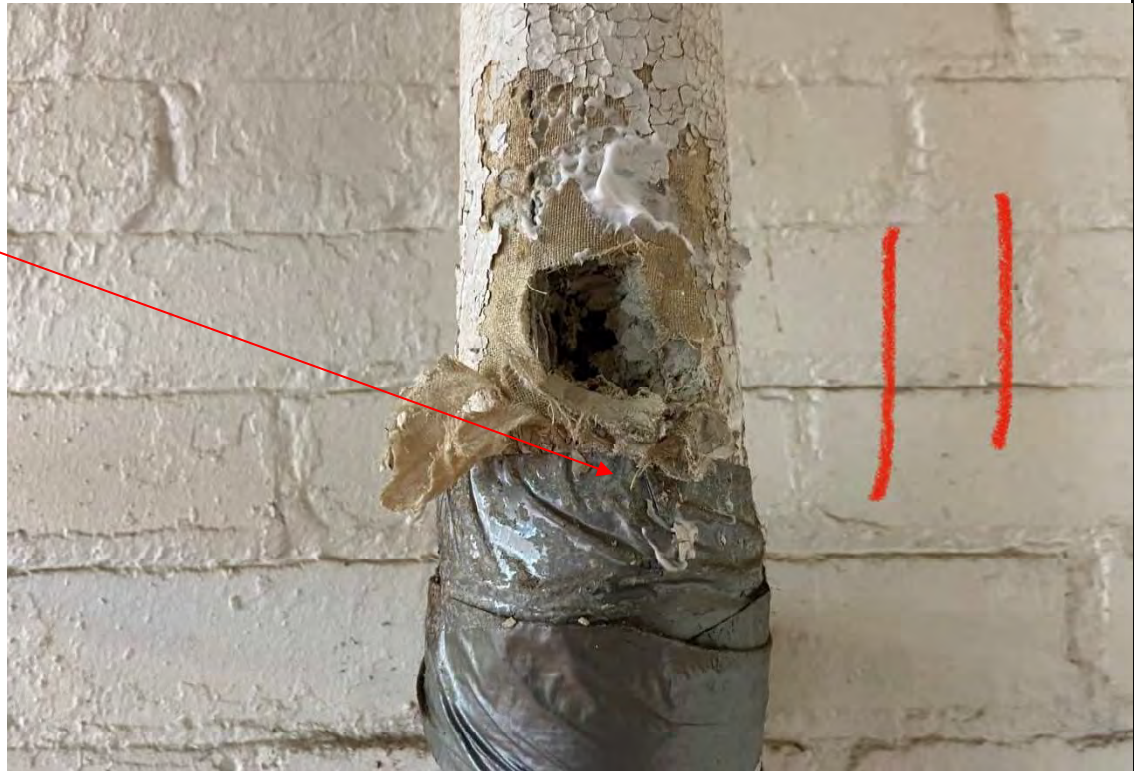
2" TSI Pipe Insulation

Tested Positive for
Asbestos

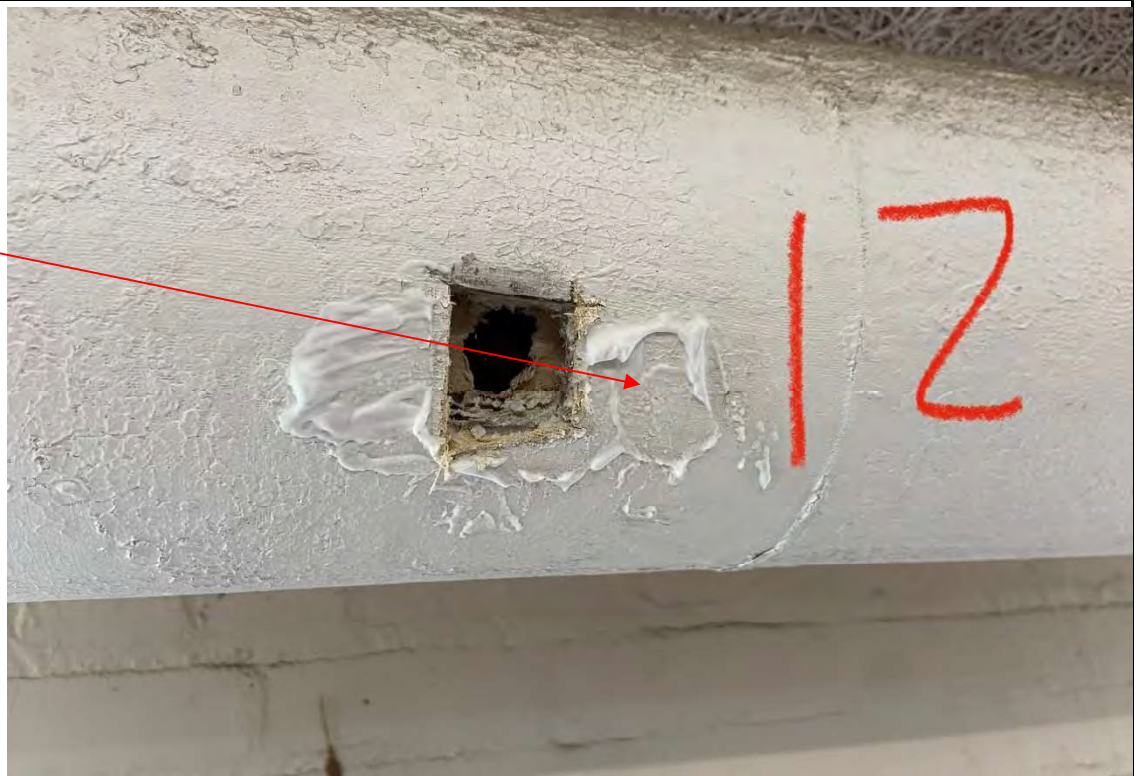
4" TSI Pipe Insulation

Tested Positive for
Asbestos

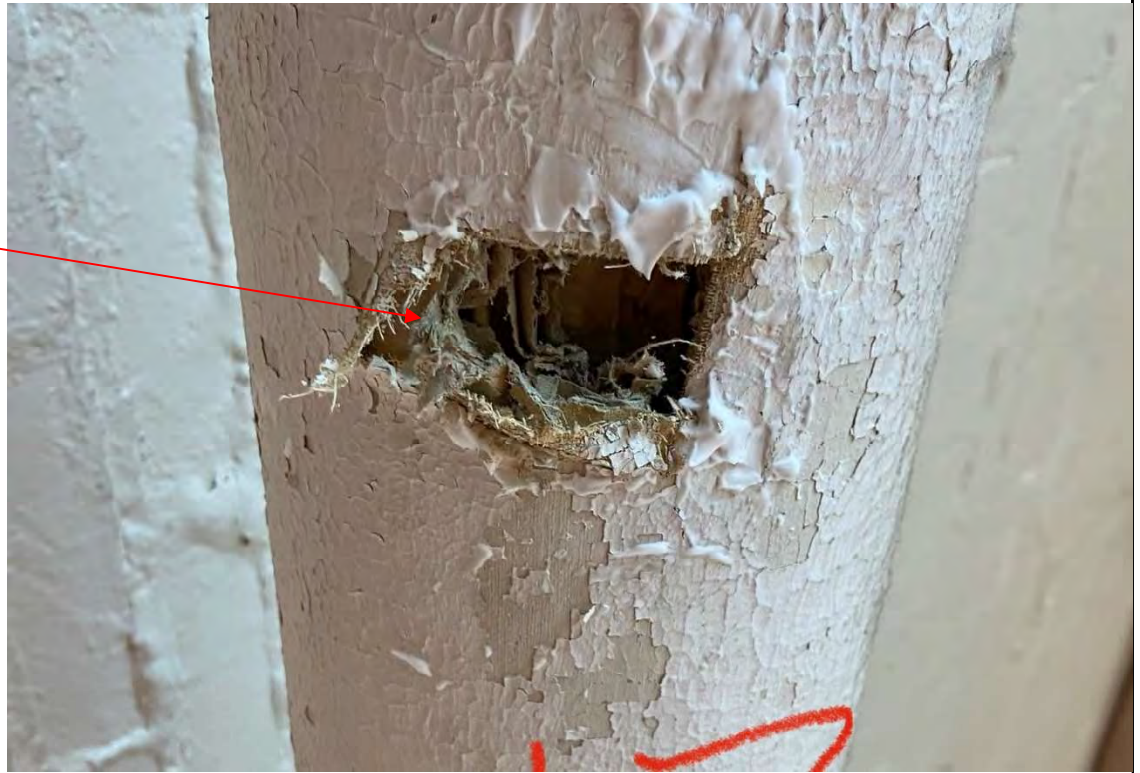
4" TSI Pipe Insulation

Tested Positive for
Asbestos

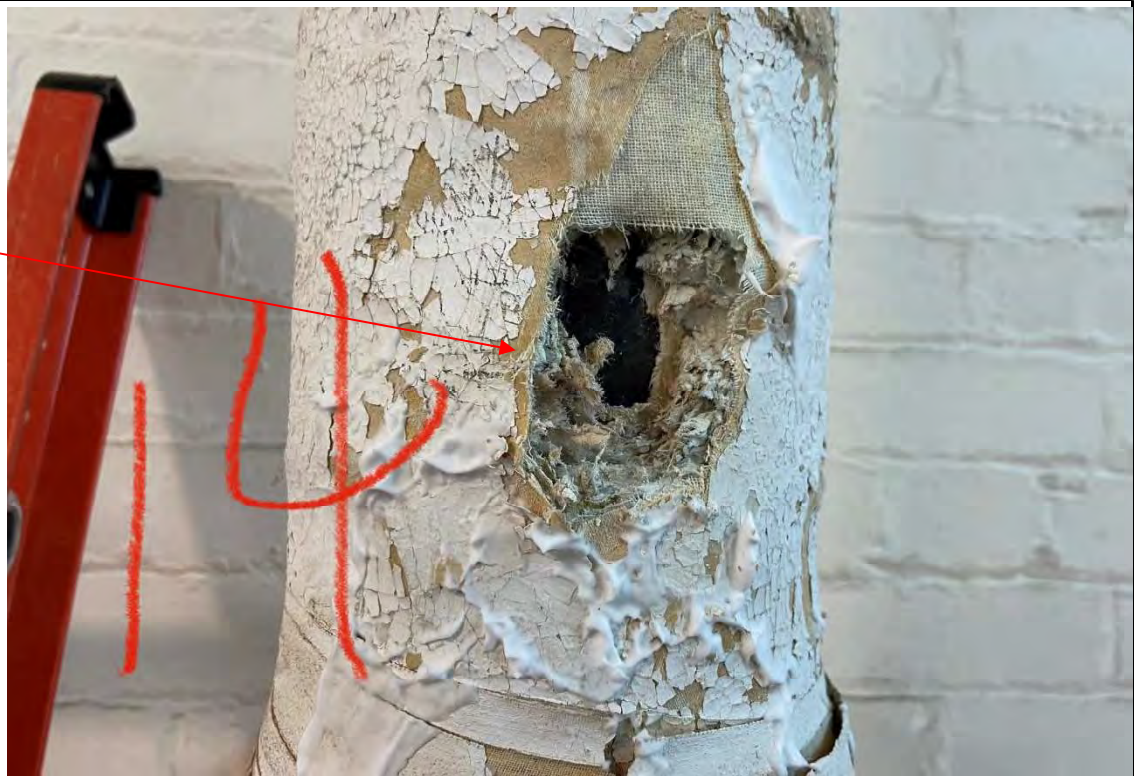
4" TSI Pipe Insulation

Tested Positive for
Asbestos

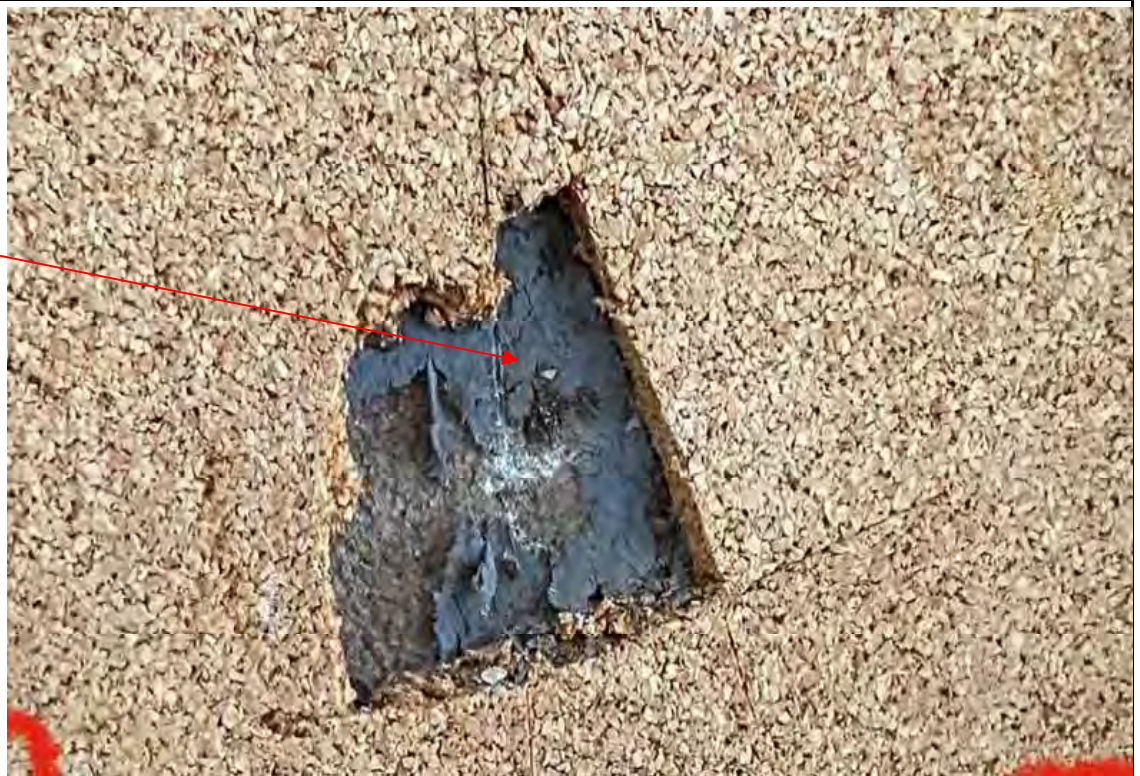
Chalk Board Mastic

Tested Positive for
Asbestos

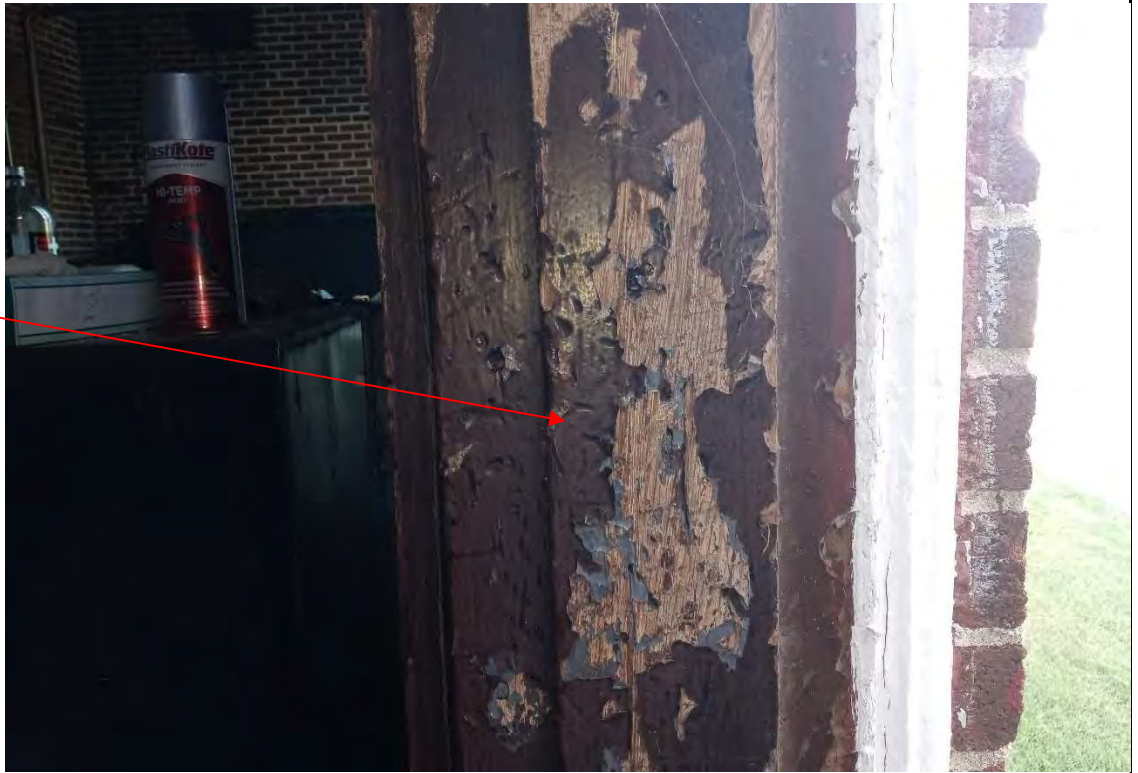
Brown Door Jamb

**Tested Positive for
Lead-Based Paint**

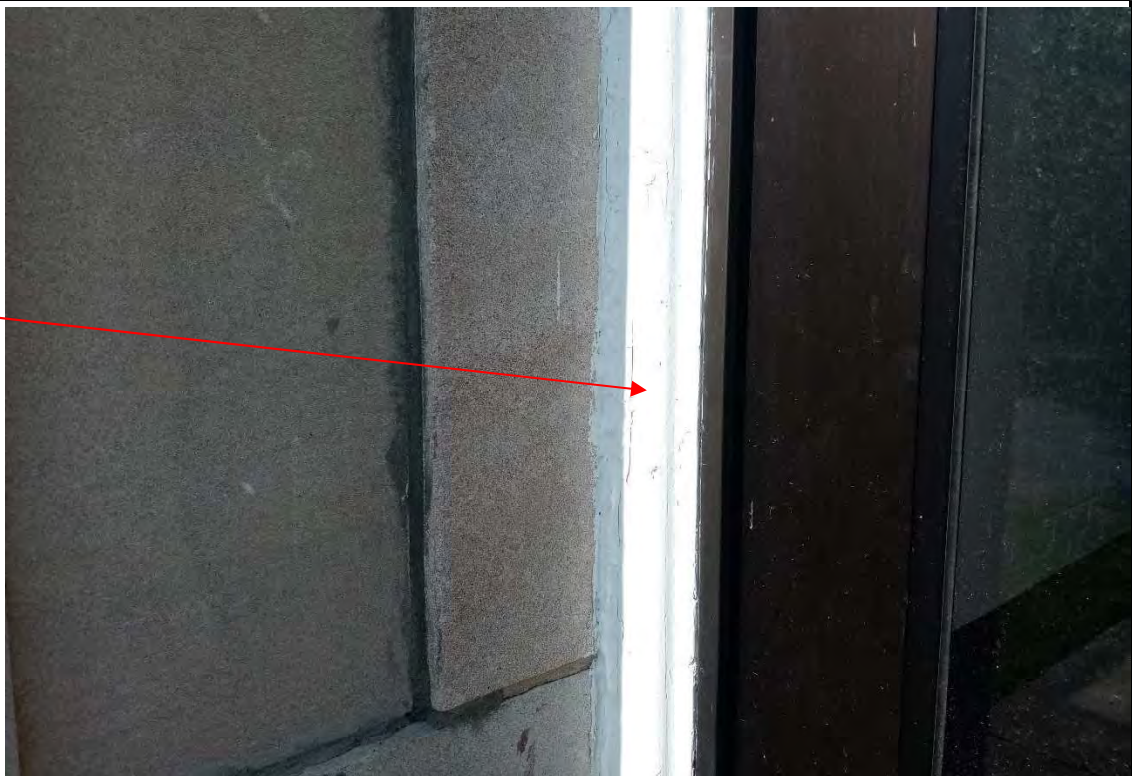
White Door Casing

**Tested Positive for
Lead-Based Paint**

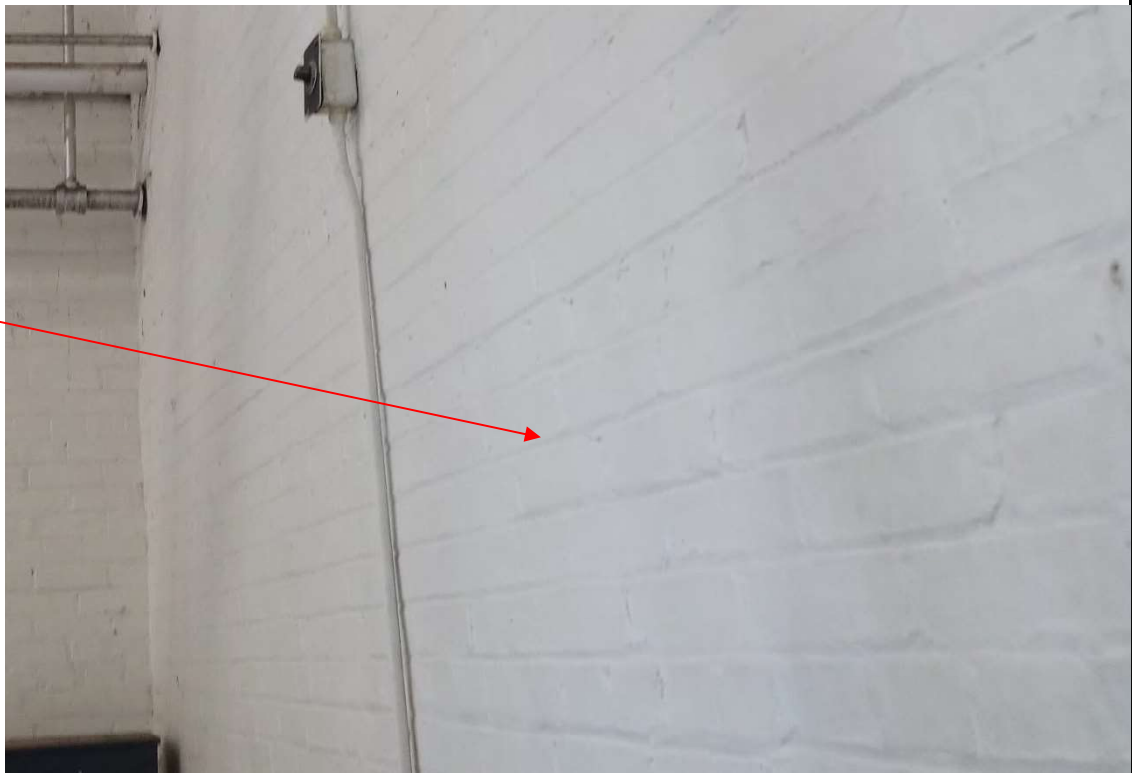
White Brick Wall

**Tested Positive for
Lead-Based Paint**

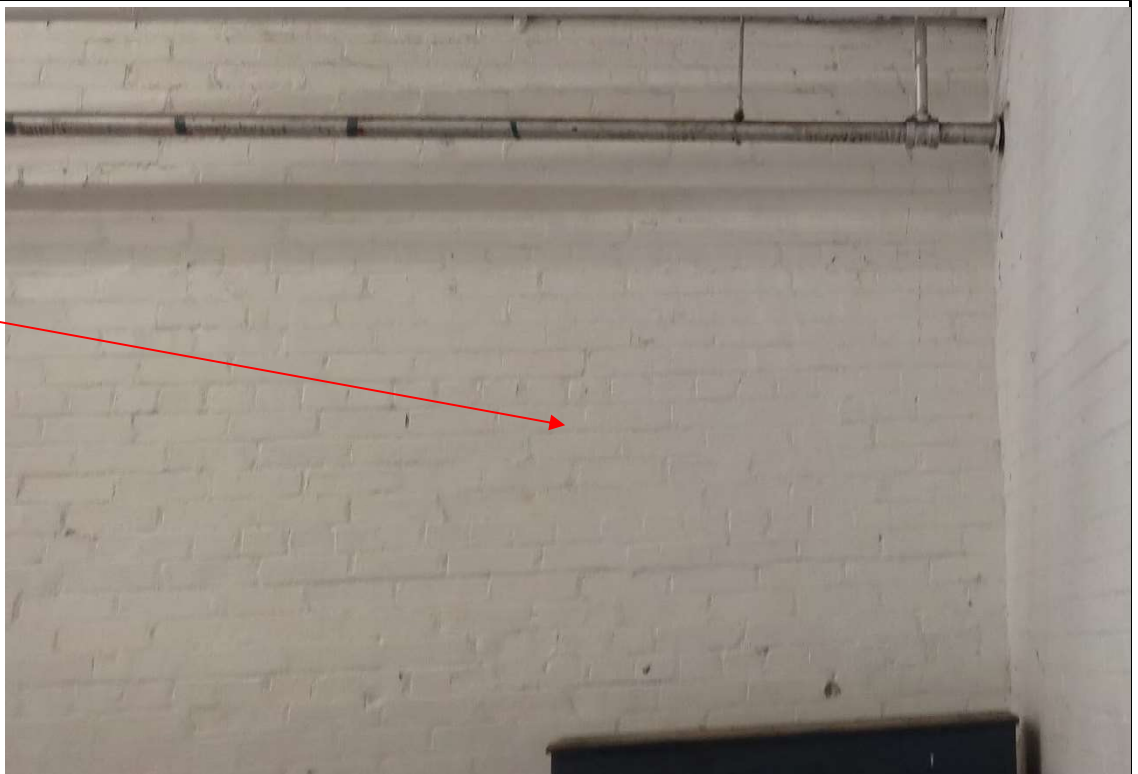
White Brick Wall

**Tested Positive for
Lead-Based Paint**

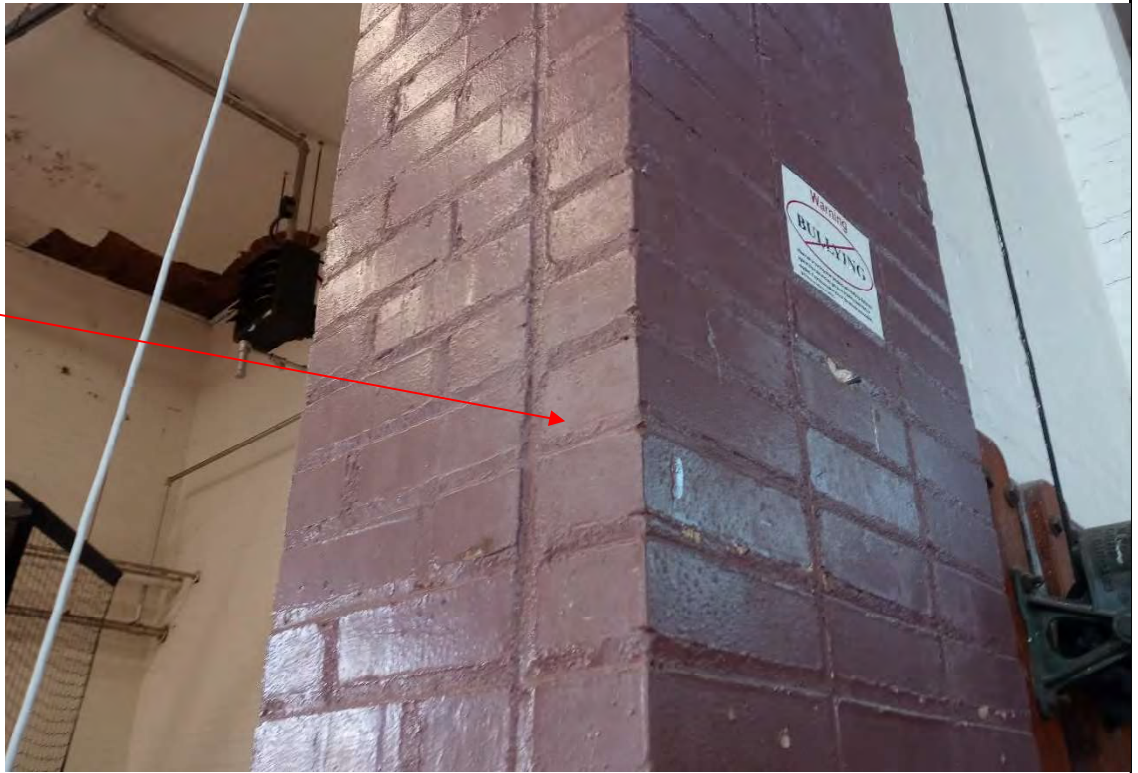
Burgandy Brick Wall

**Tested Positive for
Lead-Based Paint**

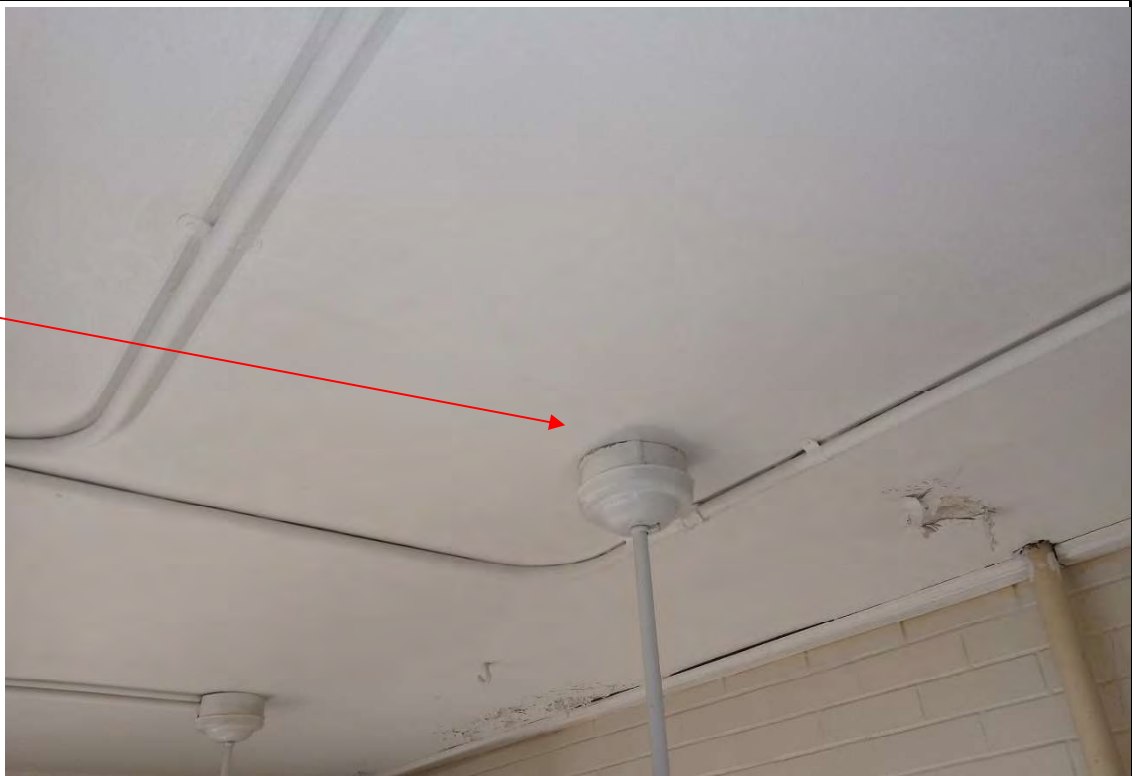
White Plaster Ceiling

**Tested Positive for
Lead-Based Paint**

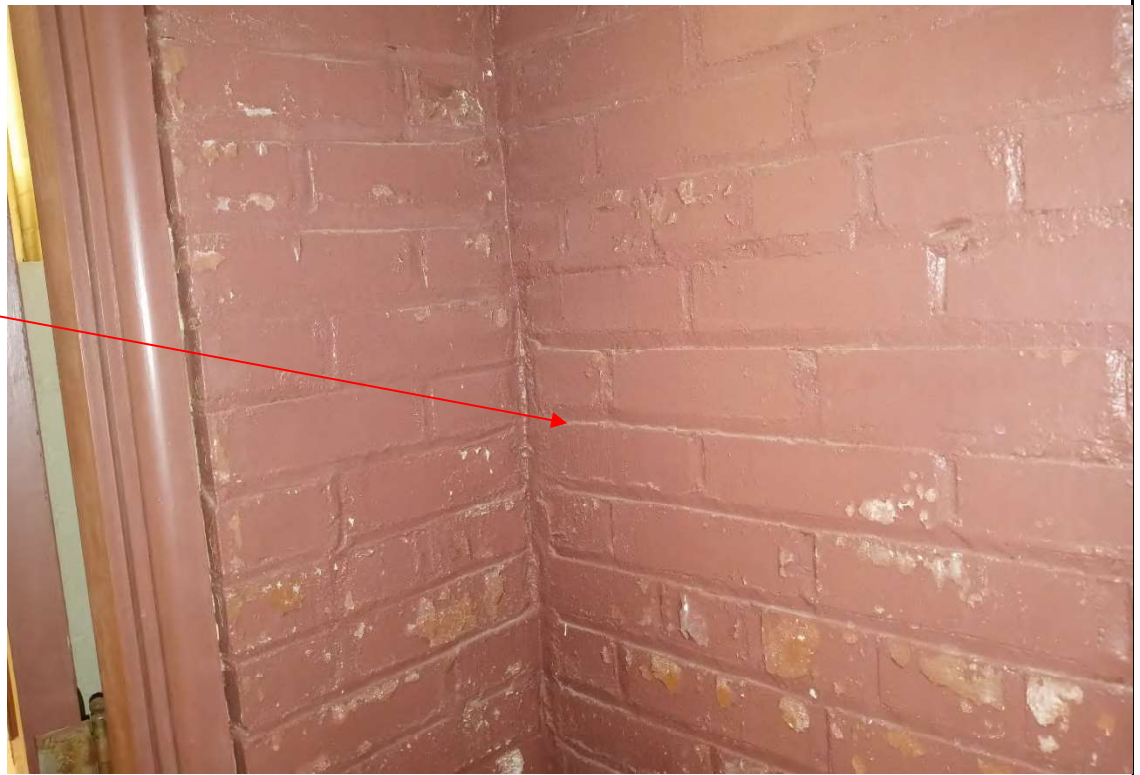
Burgandy Brick Wall

**Tested Positive for
Lead-Based Paint**

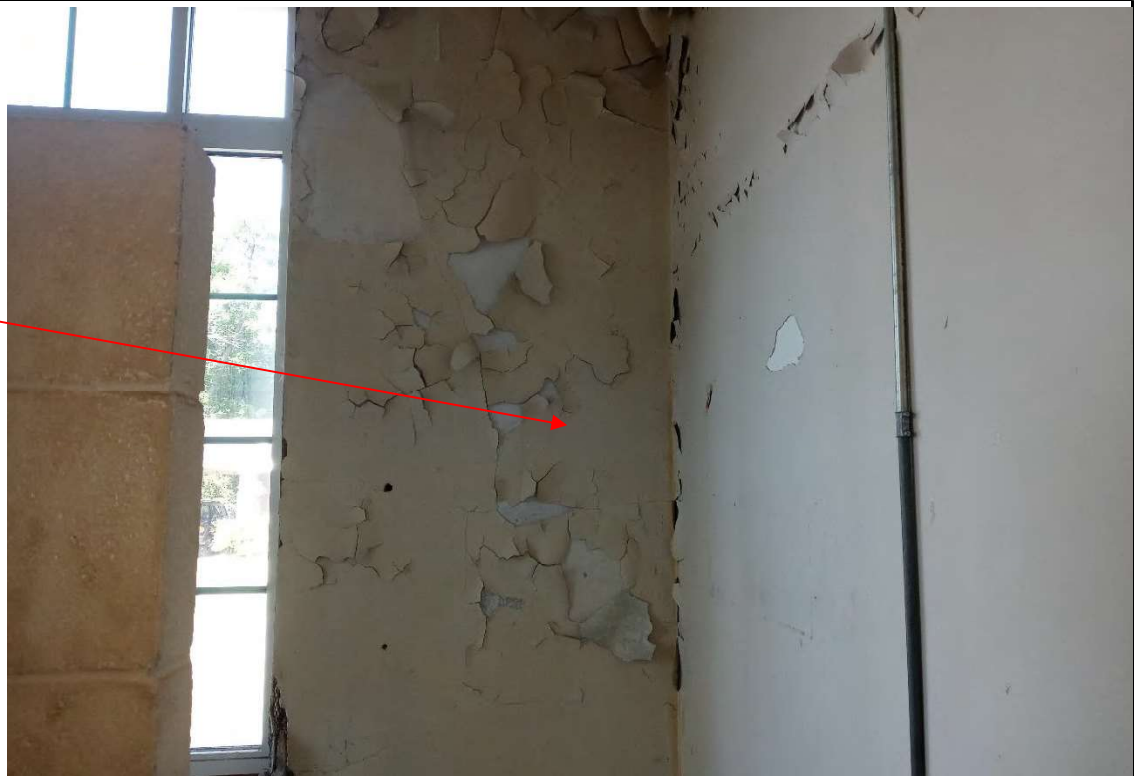
White Plaster Wall

**Tested Positive for
Lead-Based Paint**

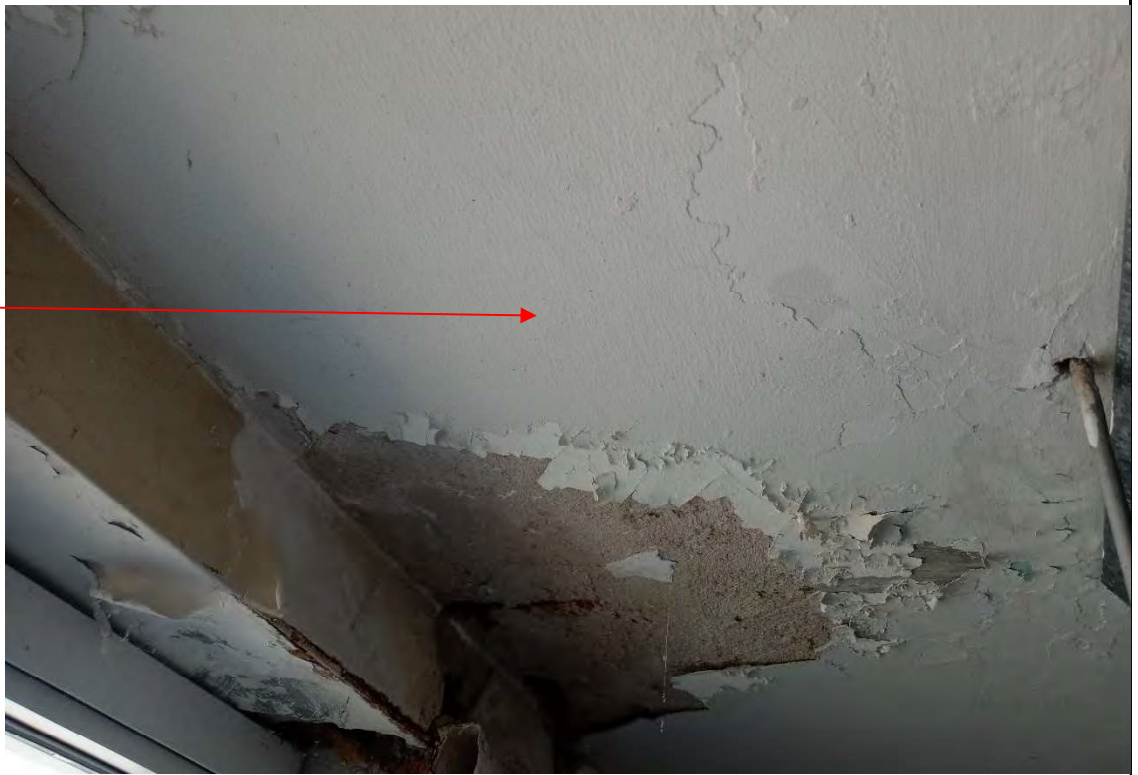
White Plaster Ceiling

**Tested Positive for
Lead-Based Paint**

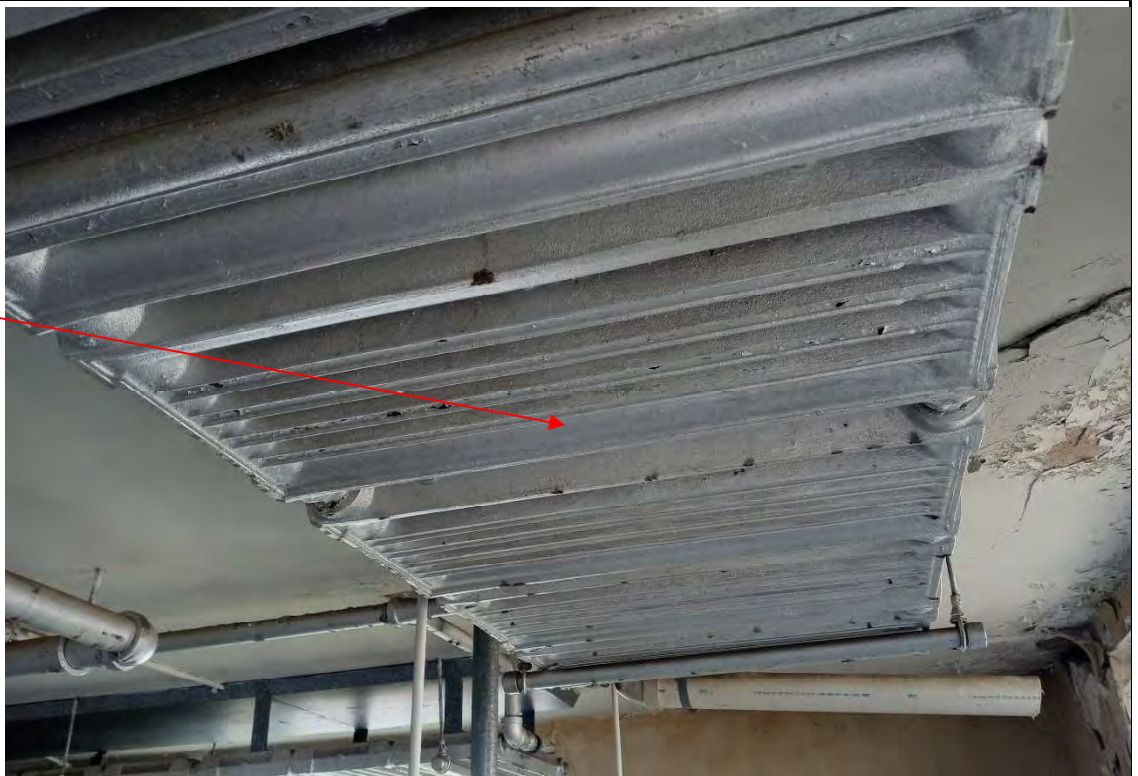
Silver Metal Radiator

**Tested Positive for
Lead-Based Paint**

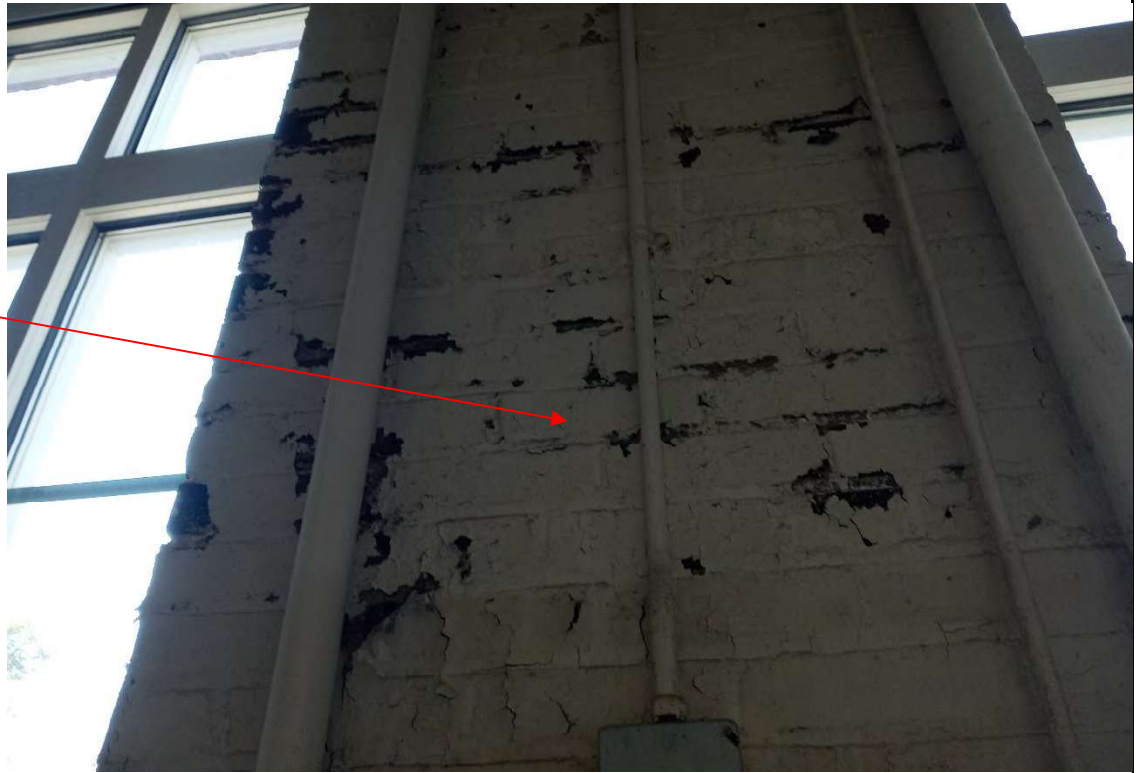
White Brick Wall

**Tested Positive for
Lead-Based Paint**

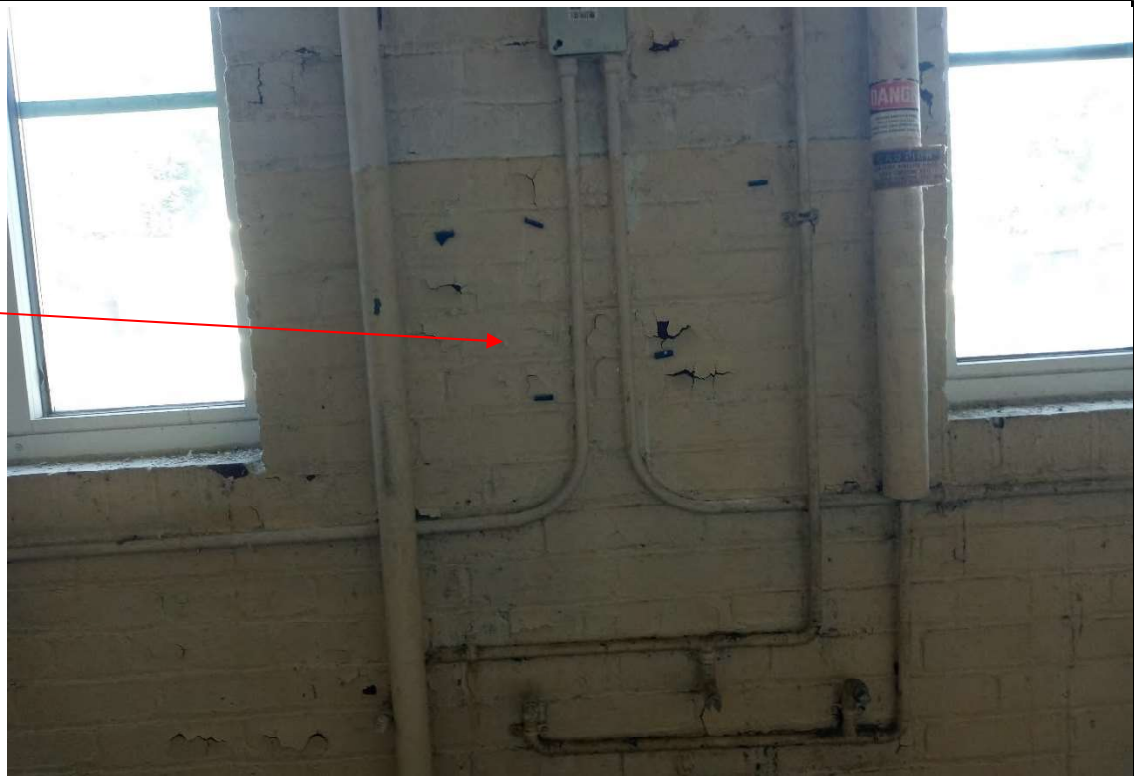
Yellow Brick Wall

**Tested Positive for
Lead-Based Paint**
