**QUALITY ASSURANCE
PROJECT PLAN –
ASBESTOS AND LEAD-
BASED PAINT
ABATEMENT
REVISION 1**

MARION GYMNASIUM
MARION, ARKANSAS

FEBRUARY 2023

**RE: Hazardous Material Survey Report
54 E. Military Road
Marion, Arkansas**

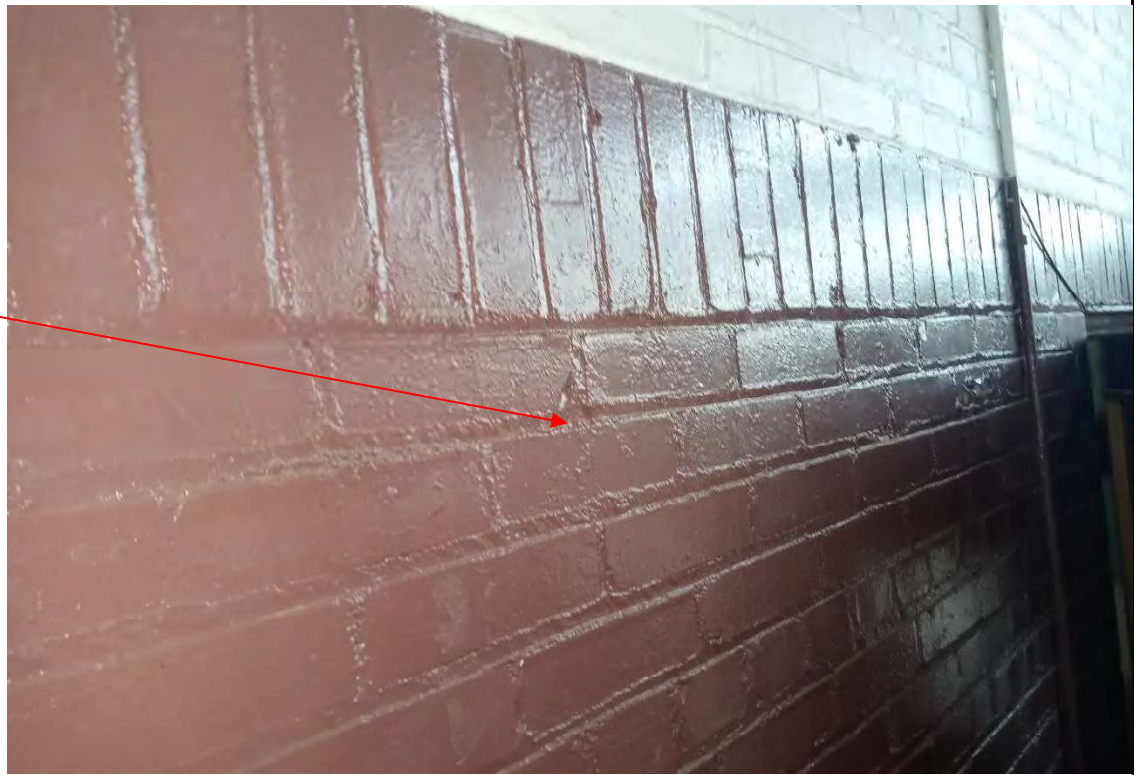
Burgandy Brick Wall

**Tested Positive for
Lead-Based Paint**

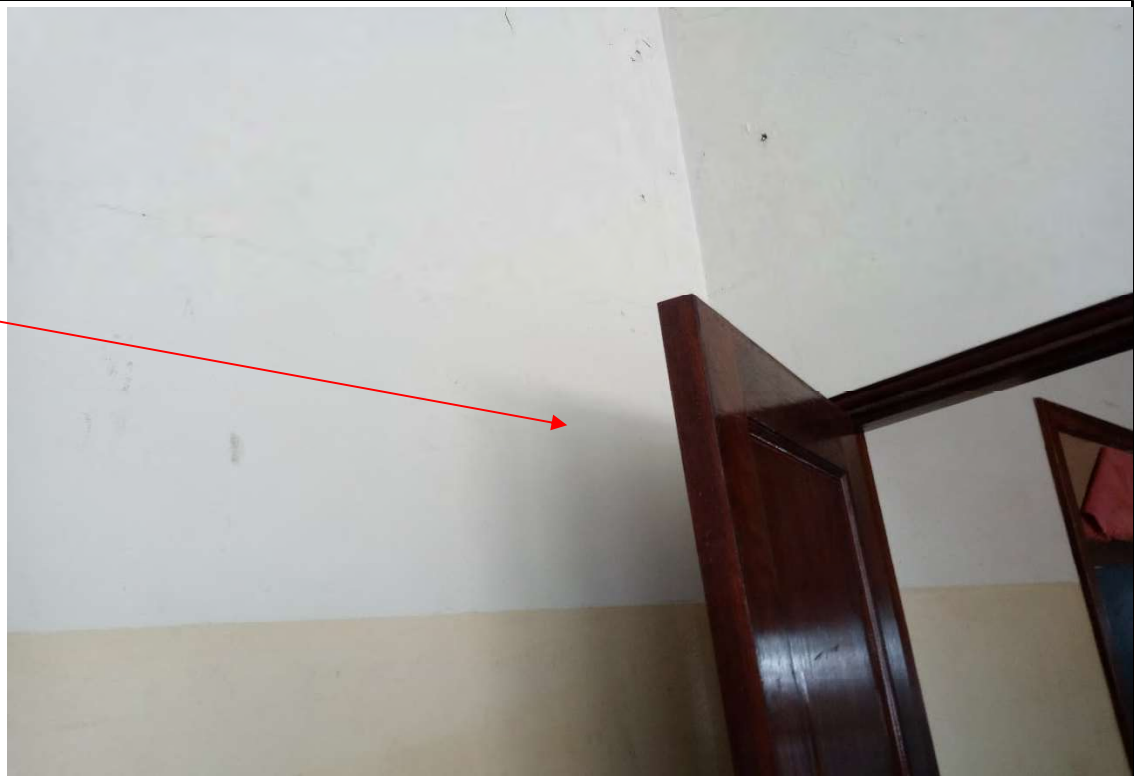
White Plaster Wall

**Tested Positive for
Lead-Based Paint**

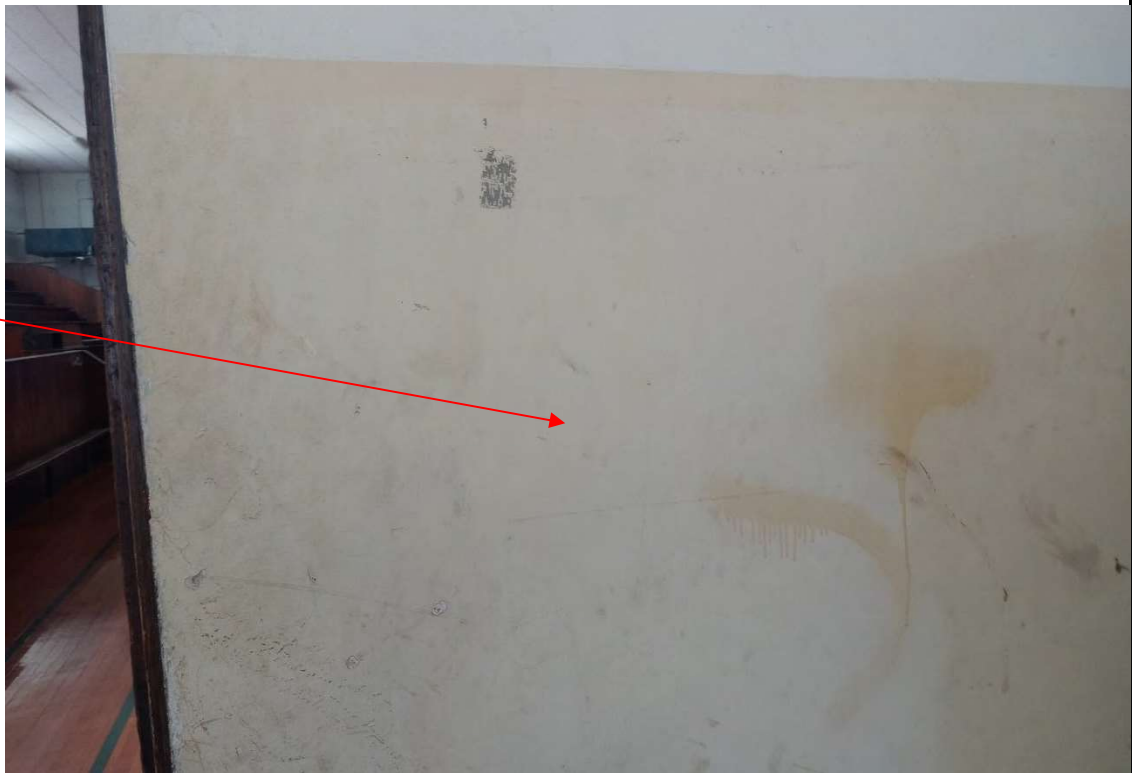
Yellow Plaster Wall

**Tested Positive for
Lead-Based Paint**

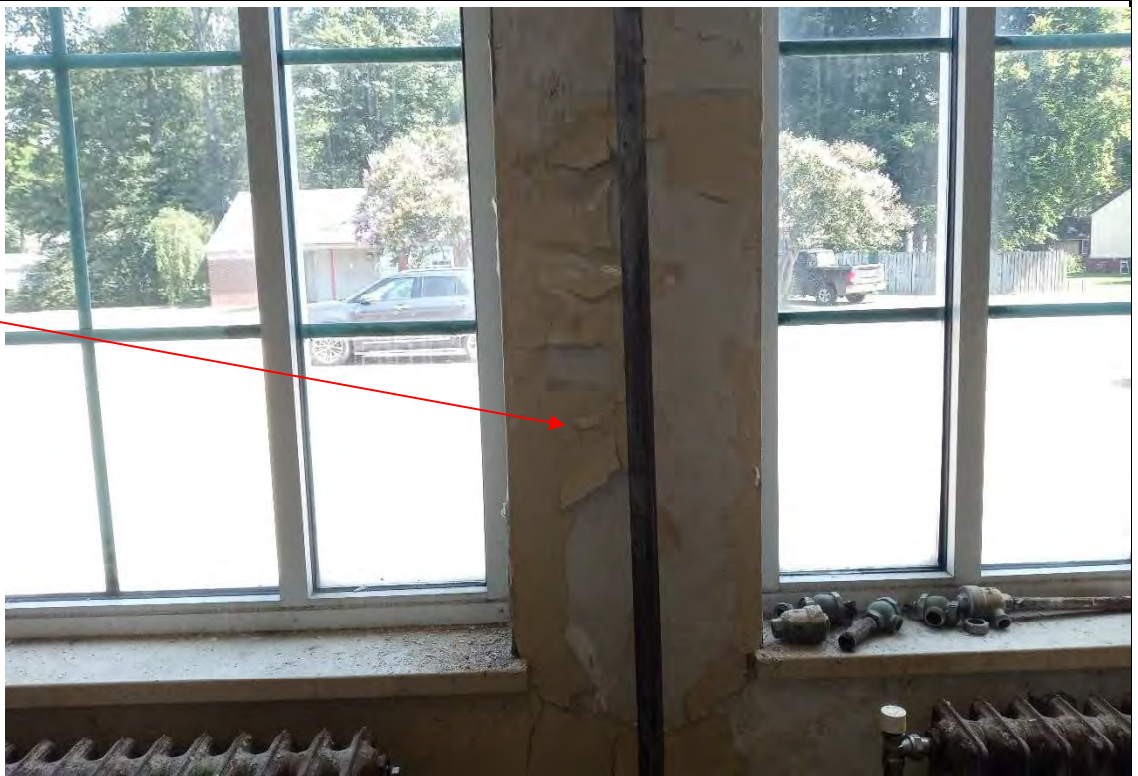
White Plaster Wall

**Tested Positive for
Lead-Based Paint**

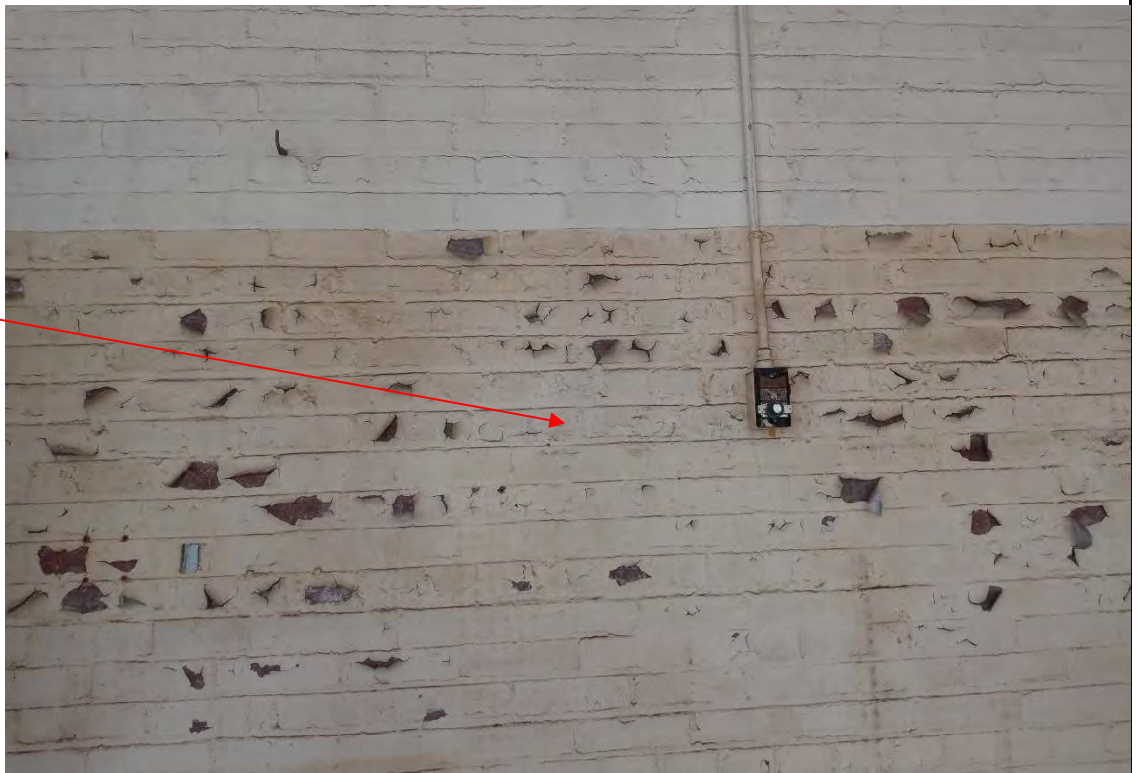
Yellow Brick Wall

**Tested Positive for
Lead-Based Paint**

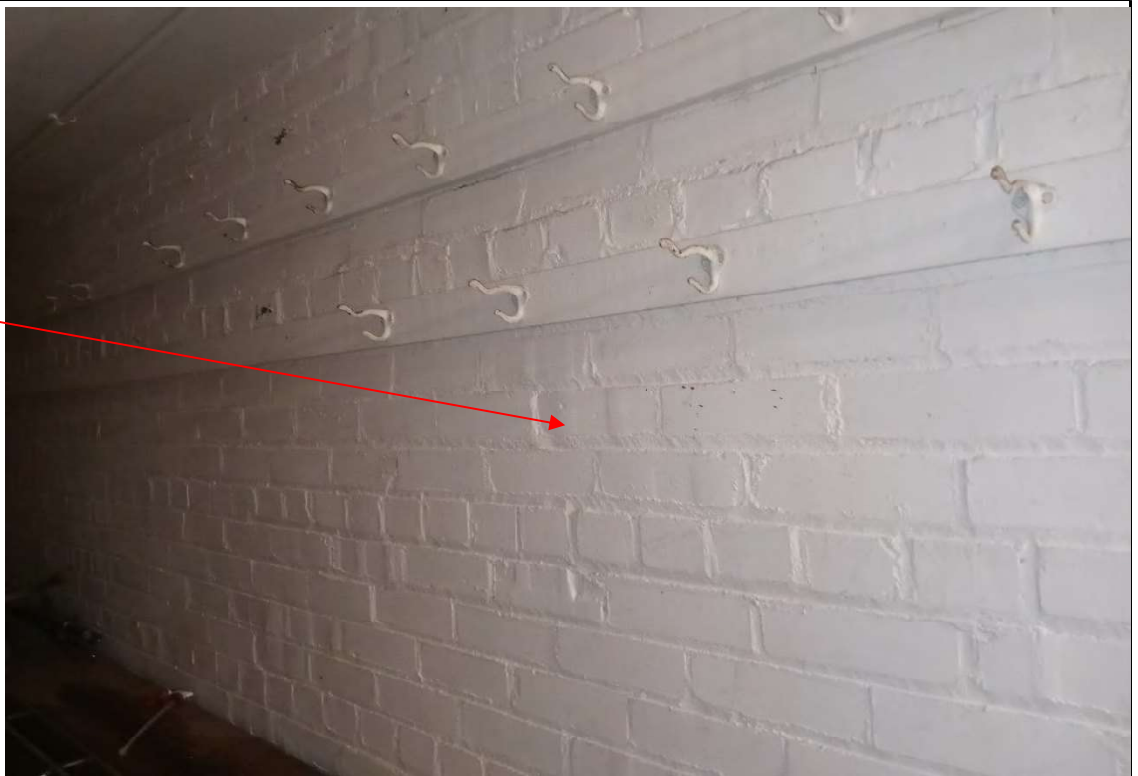
White Brick Wall

**Tested Positive for
Lead-Based Paint**

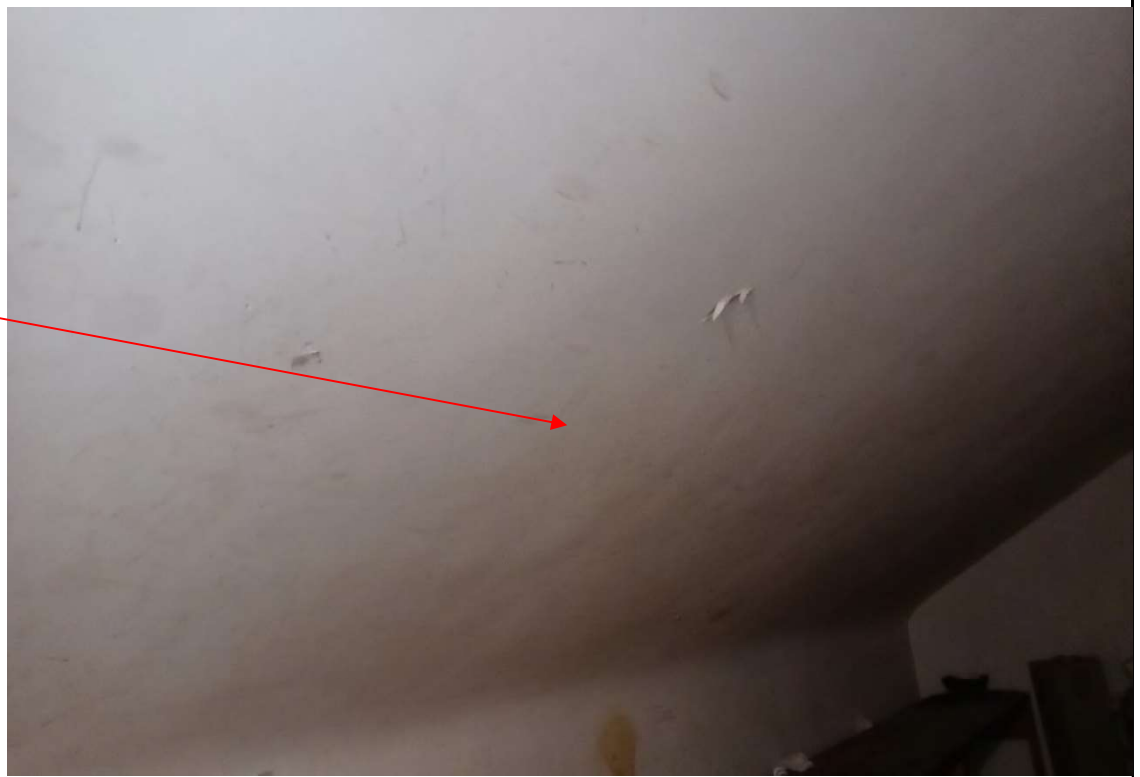
White Plaster Ceiling

**Tested Positive for
Lead-Based Paint**

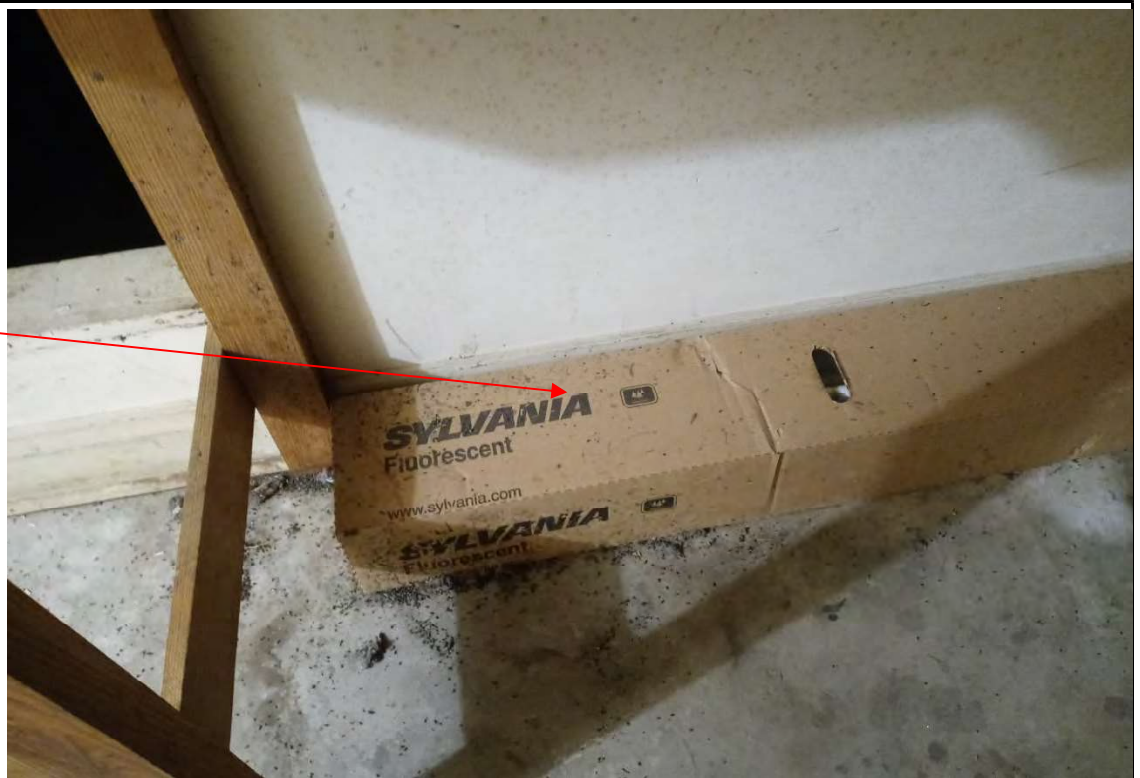
Hazardous Materials:

Mercury-containing
Fluorescent Bulb
Example

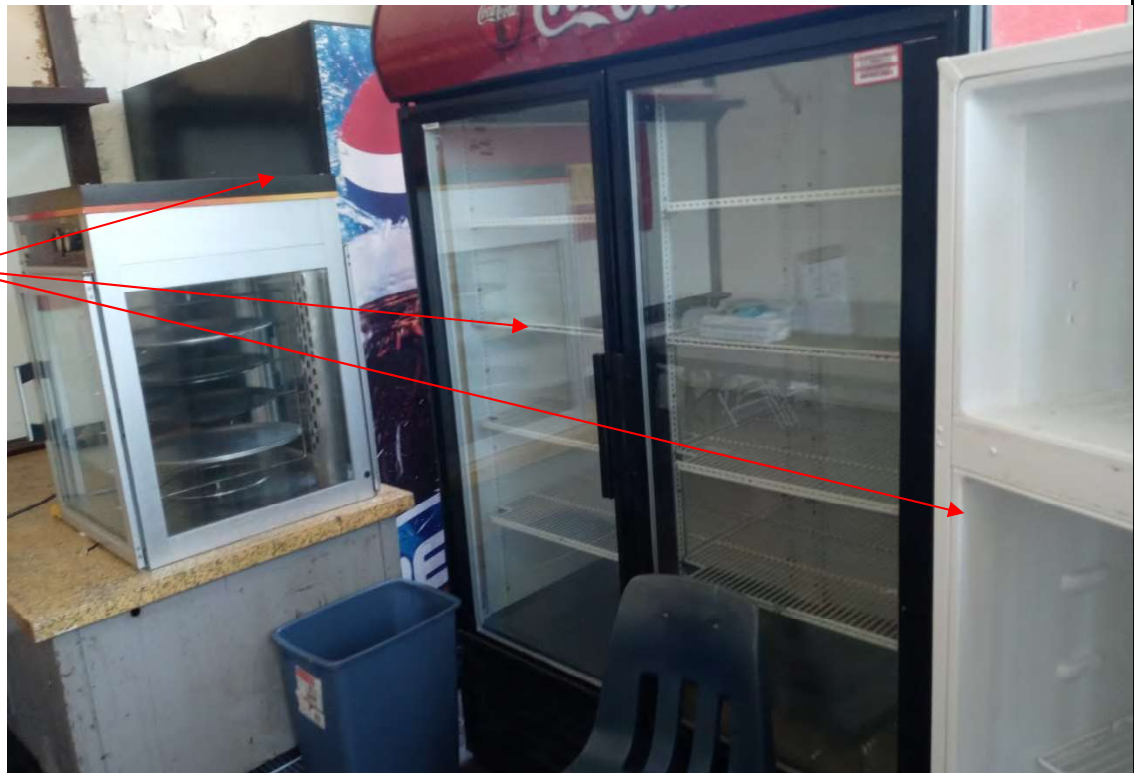
Hazardous Materials:

Refrigerants in
Appliances Example

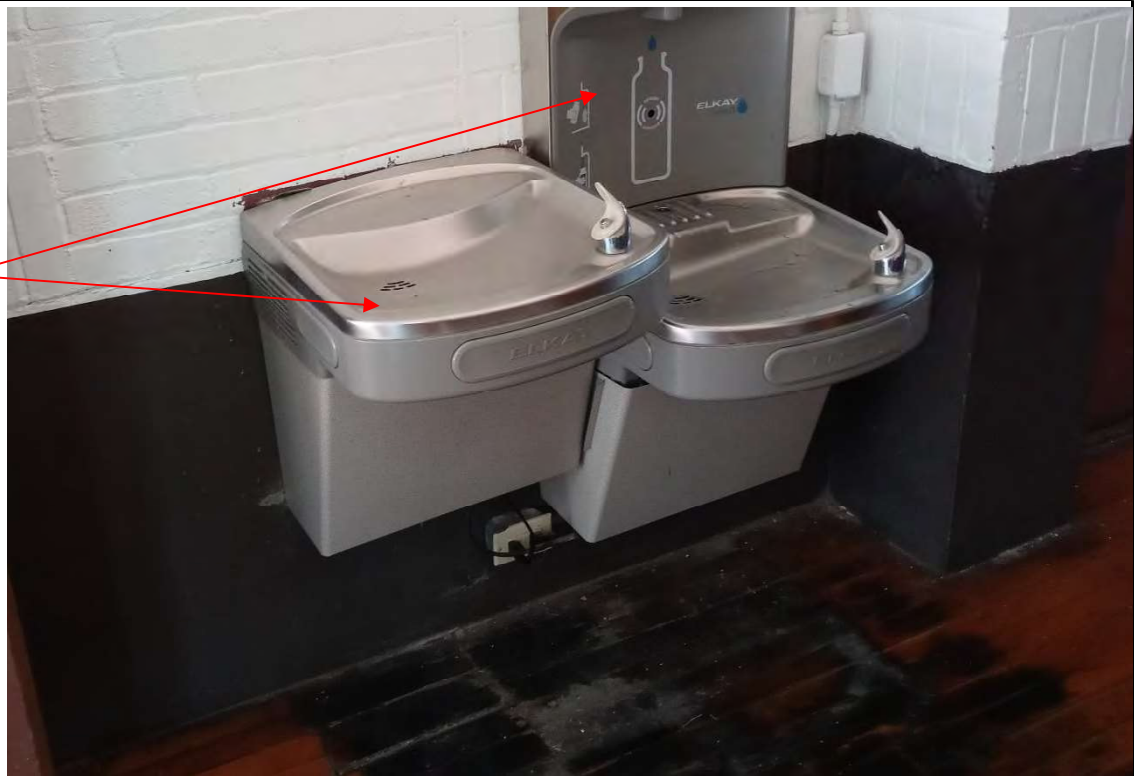
Hazardous Materials:

Refrigerants in
Appliances Example

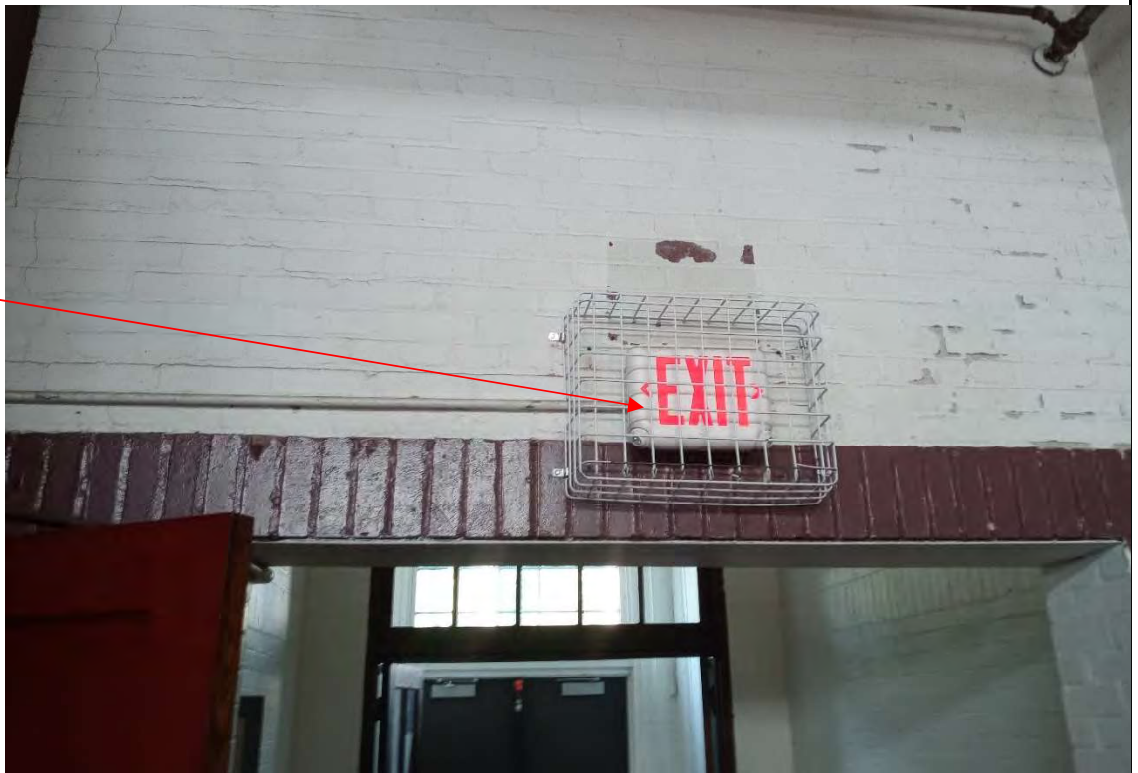
Hazardous Materials:

Exit Sign with Batteries
Example

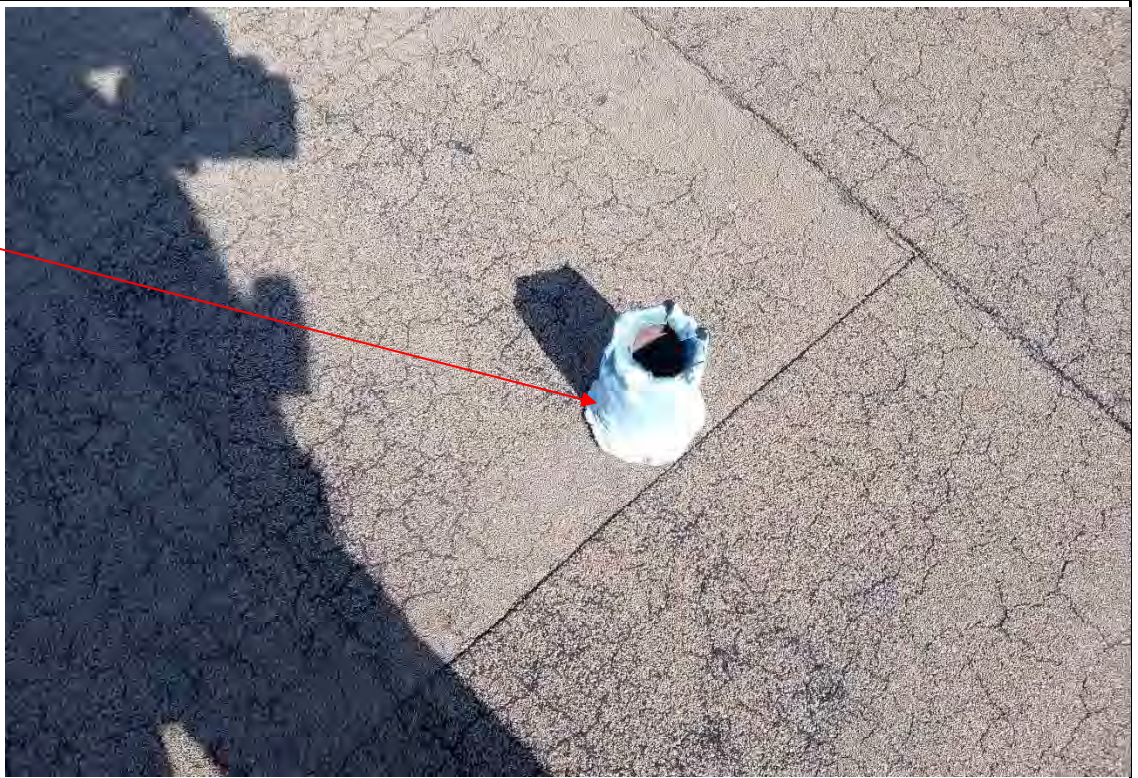
Hazardous Materials:

Lead Flashing Example

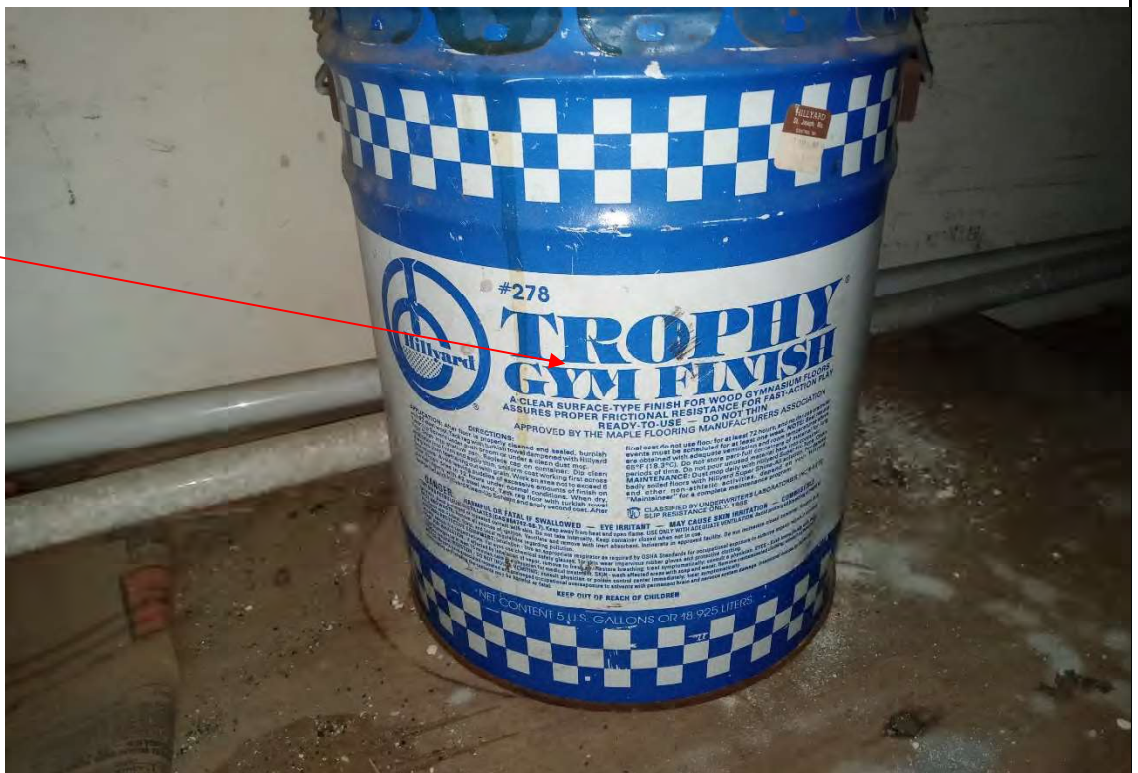
Hazardous Materials:

Chemicals Example

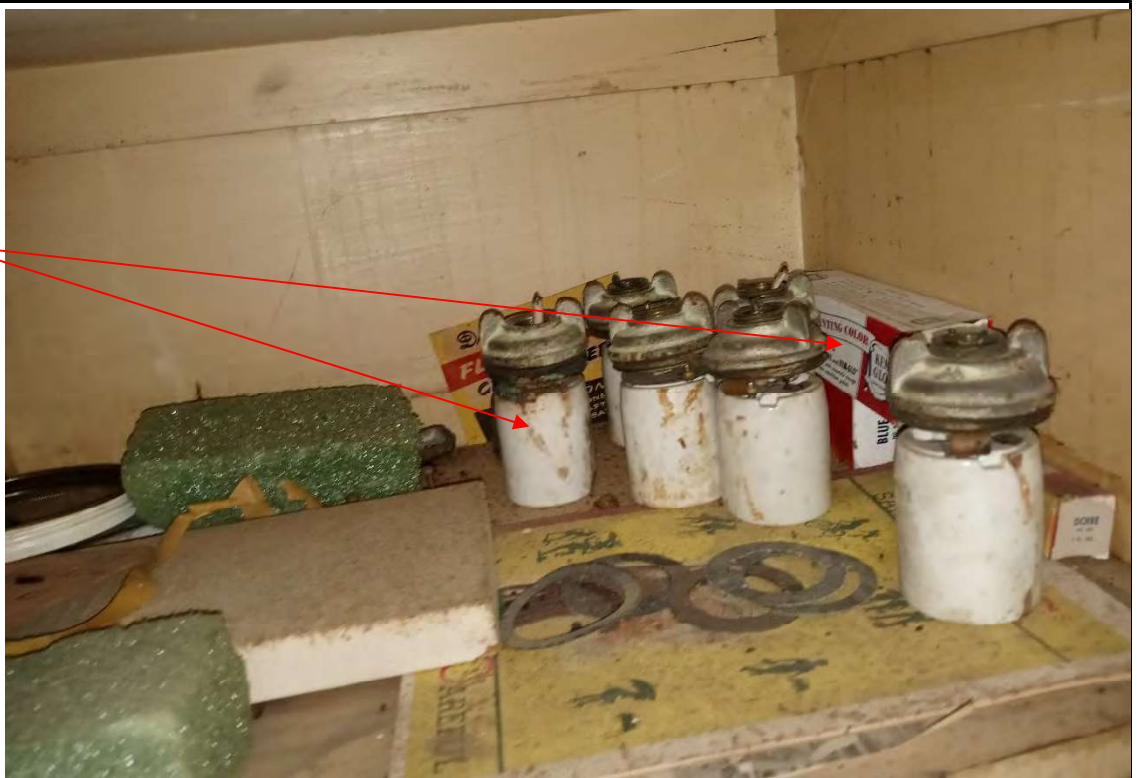
Hazardous Materials:

Chemicals Example

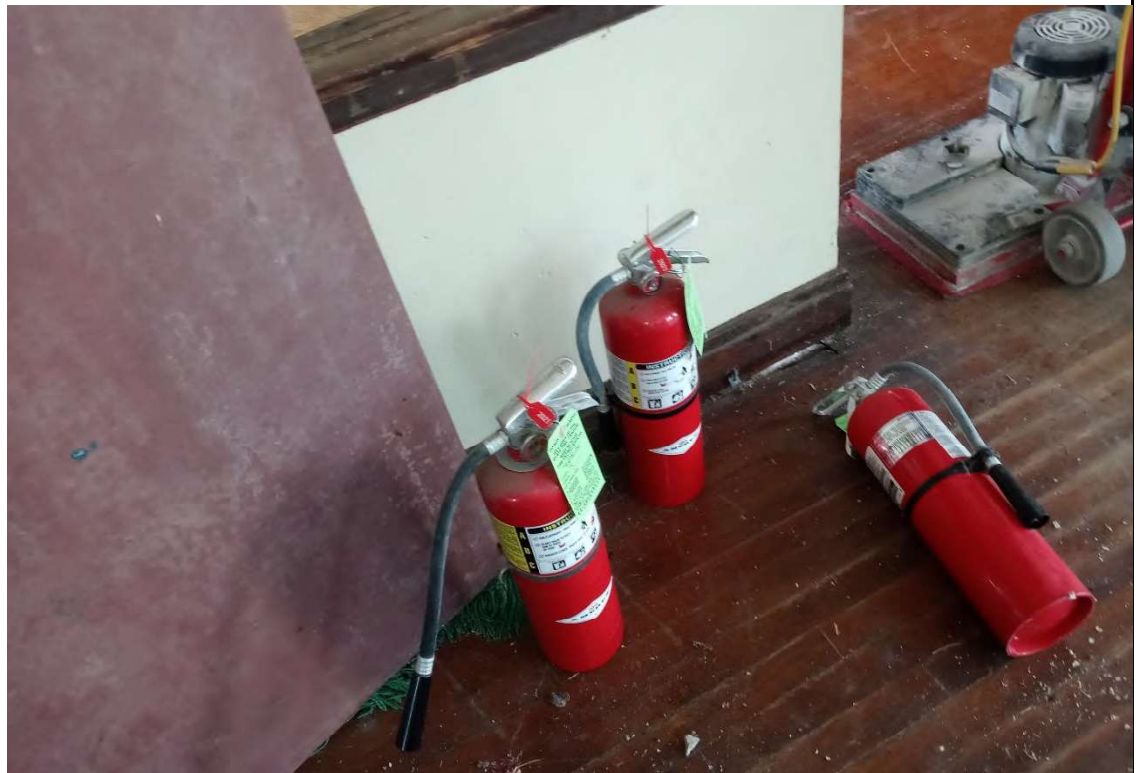
Hazardous Materials:

Fire Extinguisher
Example

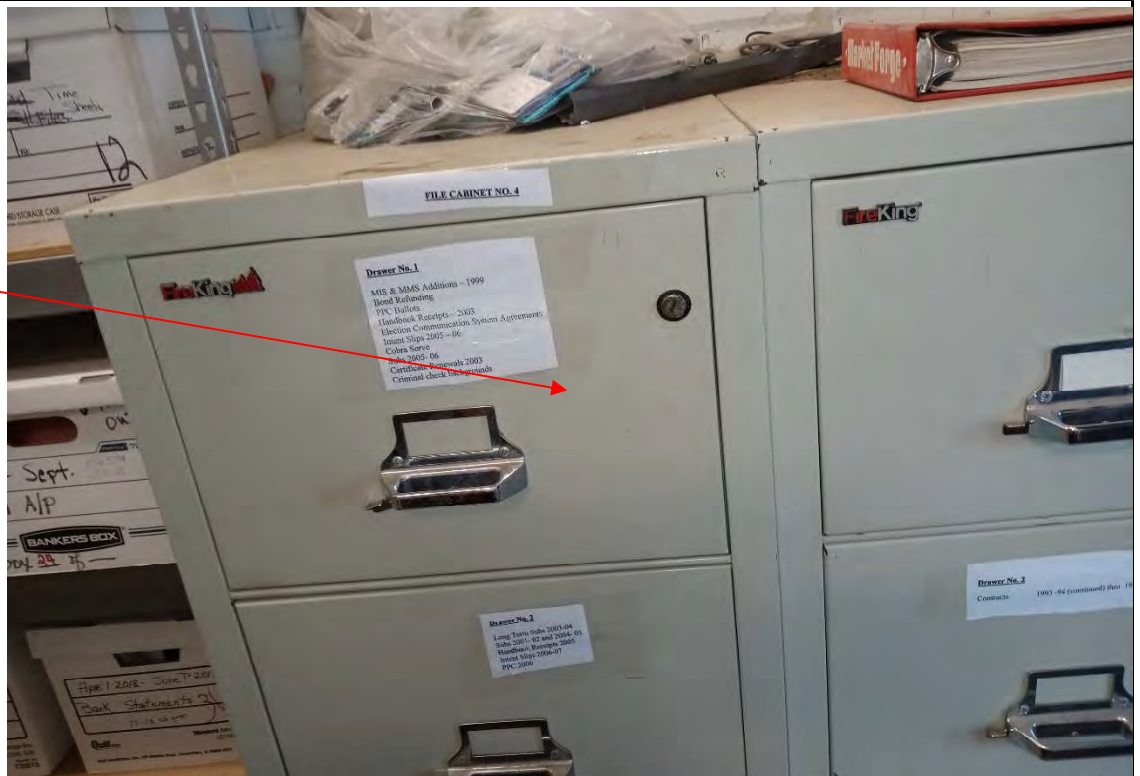
Hazardous Materials:

Fire Resistant File
Cabinet Example
