Springdale Water Utilities

AR0022063, AFIN#72-00003

Leaks in Equalization Basins

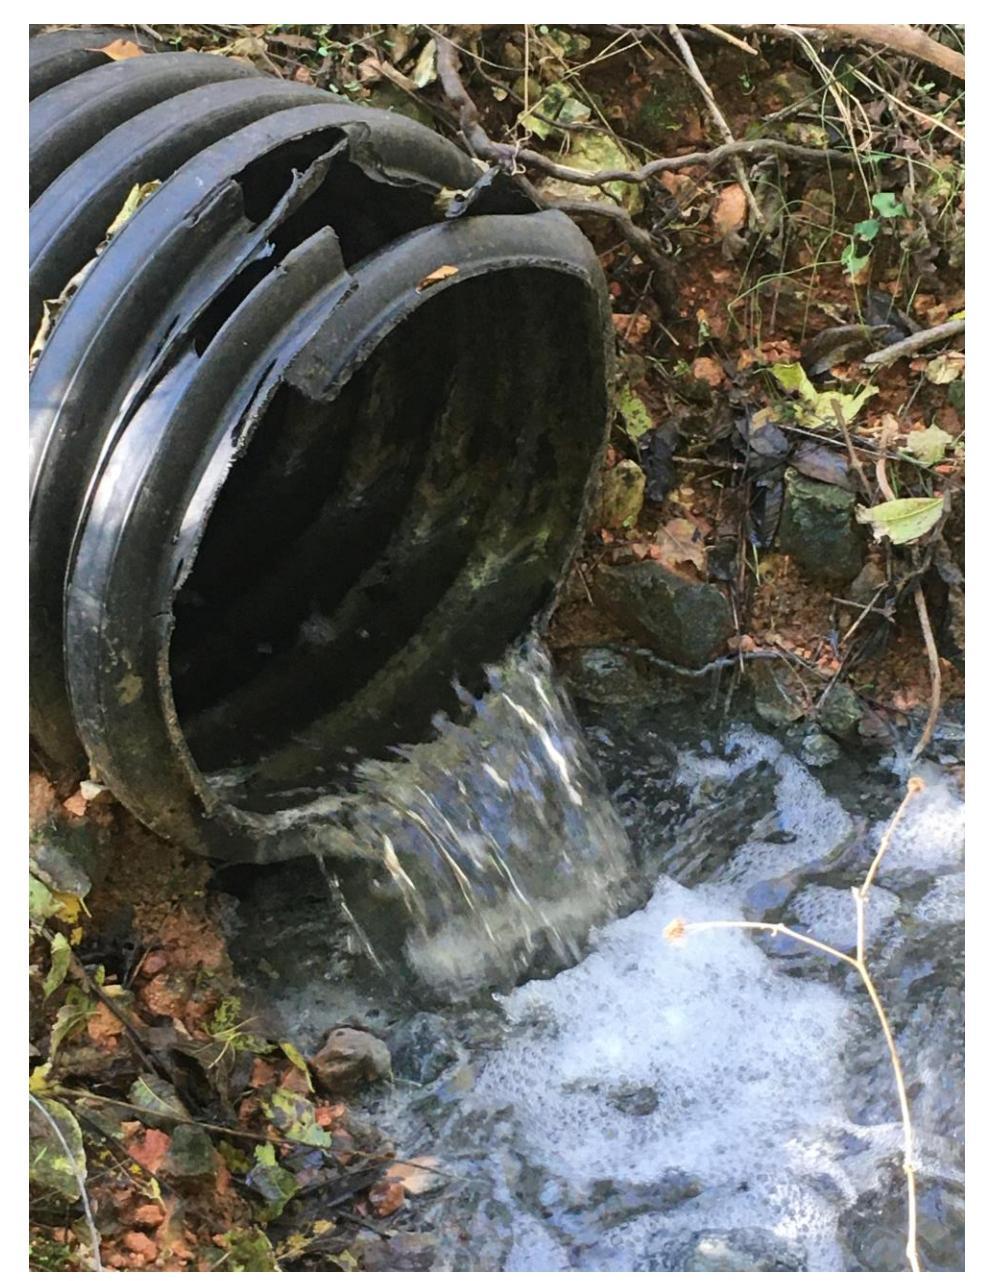
On October 30, 2019, staff observed small amounts of particulate matter in the south EQ basin flowing slowly toward a couple of expansion joints just under the water surface. This movement was indicative of water seeping through the joint in some unknown amount. The south basin, constructed in around 1991, has an underdrain structure below it that discharges groundwater from a pipe that emerges on the east side of the basin and keeps the basin from floating when it is empty. This drain is outside the WWTF fence but on SWU property. Typically, a trickle of groundwater is discharged through the pipe all of the time with a large amount being discharged when it is rainy. The water from the pipe flows downhill for a short distance and disappears underground on the property. Some discoloration and the odor of sewage were observed in the water flowing from the underdrain on this date.

Continued rainfall required the EQ basins to remain in full or partial service until November 17, 2019. Observations through that time showed some odor and discoloration of the water being discharged. When the south basin was completely emptied and cleaned, the water being discharged cleared up, substantiating the suspicion of leakage. There is no real way to estimate the amount of water lost from the cracks as it commingled with groundwater from under the basin before going back underground. From the flow rate in the underdrain pipe, a maximum of 260,000 gallons was discharged over 18 days, and then went back underground.

Attached with this report you will find a photo of groundwater and wastewater commingling in the underdrain pipe from the south basin and an aerial photo of the WWTF with tabs marking the location of that underdrain and the path of the leak from the northwest basin to Spring Creek to provide a visual perspective to this report. Any questions or requests for further information can be directed to Jennifer Enos, Wastewater Facilities Director, 479-756-3657 or jenos@springdalewater.com.

No known adverse environmental impact was observed from the leaks. Considerable time and money had been spent in the past to repair cracks and expansion joints in structures at the WWTF as problems have arisen. The EQ basin cracks and joints have been or are in the process of being repaired in-house as quickly as weather conditions allow, as they must cure in above freezing temperatures and remain dry for the curing process. The northwest basin has been repaired, both the substantial crack and any minor cracking seen. The northeast basin was repaired by an outside contractor last year, and does not appear to have any leaks at this time. Repairs on the newest (south) basin are over halfway complete and should be closer to 75% complete by the end of the week, with the focus being placed on the cracks and joints that look the worst. In addition to normal daily observation, a thorough visual inspection of all basins has been added as an annual preventive maintenance item in our Maintenance Management System. Any problems observed during that inspection or any other time will be repaired as soon as possible.
