-						
			WATER	<b>DIVISION IN</b>	NSP	ECTIC	)N	REPORT
		ERMIT #: <b>ARR000</b>				ATE: 2/6/2017		
_	R K A N S A S	СС	DUNTY: 70 Union		PDS #	#: 095668		MEDIA: WN
Dep	R K A N S A S partment of Environmental Quality	GF	S LAT: 33.15961	4 LONG: -92.4438	849 L	OCATION	: Ent	trance
	FACILITY INFORMAT	ION		INS	SPEC	TION INFC	RM	ATION
	thony Forest Products Compan			FACILITY TYPE: 2 - Industrial		<sup>TOR ID#:</sup>	te	
	36 Urbana Road			FACILITY EVALUATION RATING <b>1 - Unsatisfacto</b>	ry	Inc	ECTION	rial Stormwater

On February 6, 2017, I performed an inspection at Anthony Forest Products Company – Urbana Sawmill. The inspection was completed with Randy Evans, EHS Manager, and Amanda Gallagher, Environmental Engineer with GBMc. GBMc is contracted to perform inspections, sampling, and SWPPP updates. Training is completed by Mr. Evans. The SWPPP and site map was up to date and all Stormwater Annual Reports (SWARs) were completed with associated sampling COCs, laboratory bench sheets, and information. Outfalls 003 and 008 have had some benchmark parameters exceeded in the past three years, but corrective action reports were included with the exceedances. Outfalls 002-012 are indicated as S

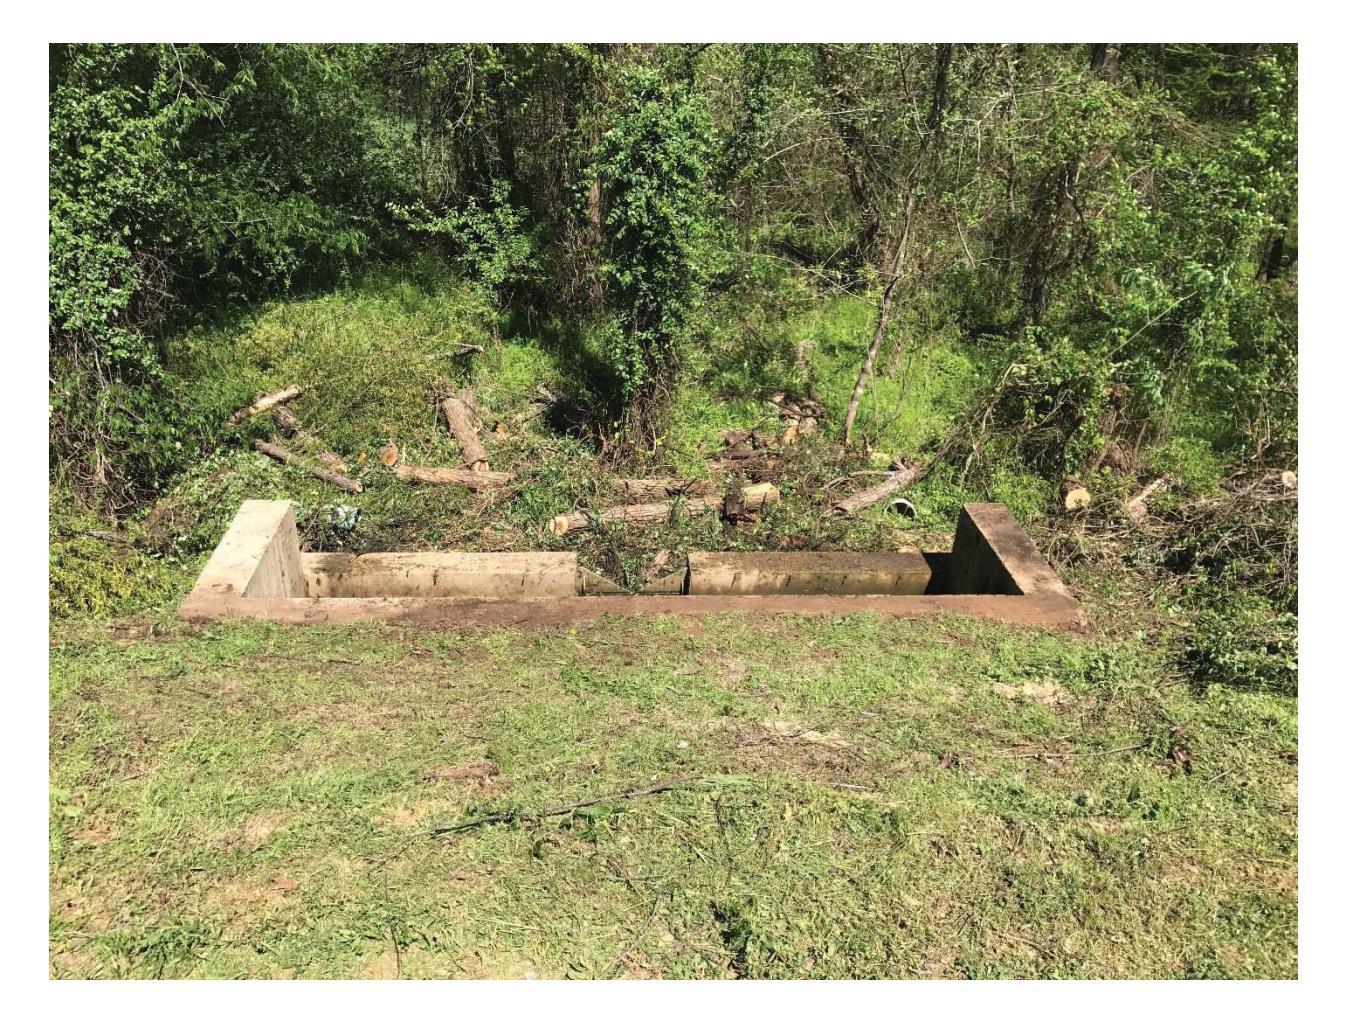
# Attachment 1 Outfall 001 Photo

The flow device at Outfall 001 is not maintained to provide adequate volume of monitored discharges. Materials were observed in the weir box and roots growing up and through the V-notch weir.

Photograph of Outfall 001 weir.

Vines, roots, and debris have been removed from the weir and weir box. Pictures showing the above described corrective actions can be found in Attachment 1.

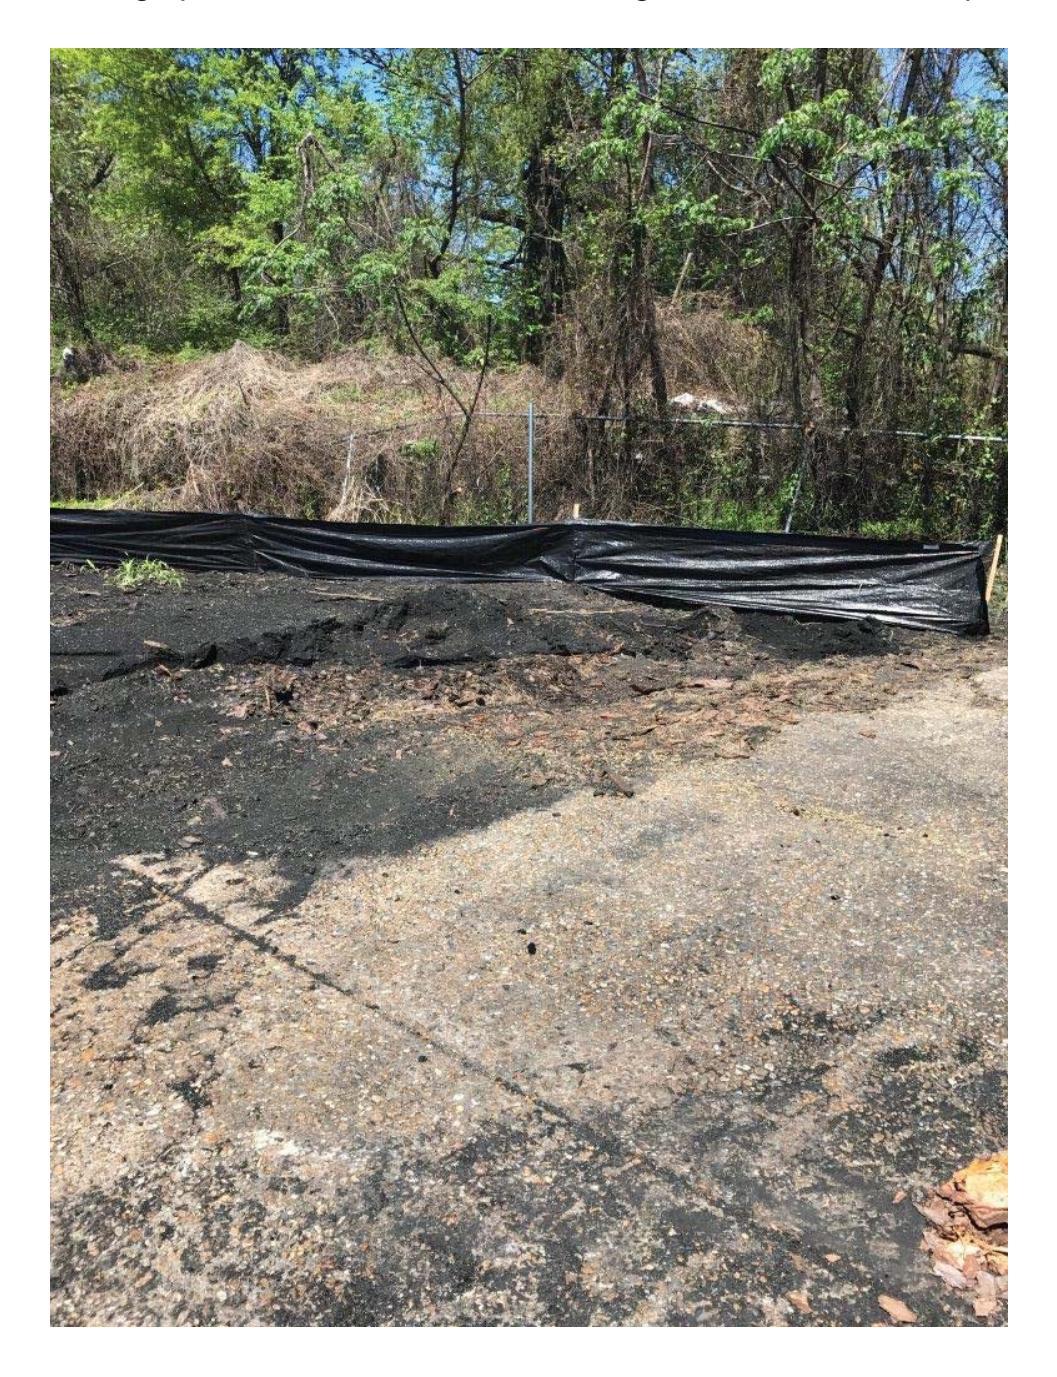
# Attachment 2 Outfall 011 Photos

Photograph 1 of silt fence installed down gradient of the kiln ash pile.

Silt fence has been added to the downstream side of the kiln ash pile as a temporary control measure. Pictures showing the above described corrective action can be found in Attachment 2.

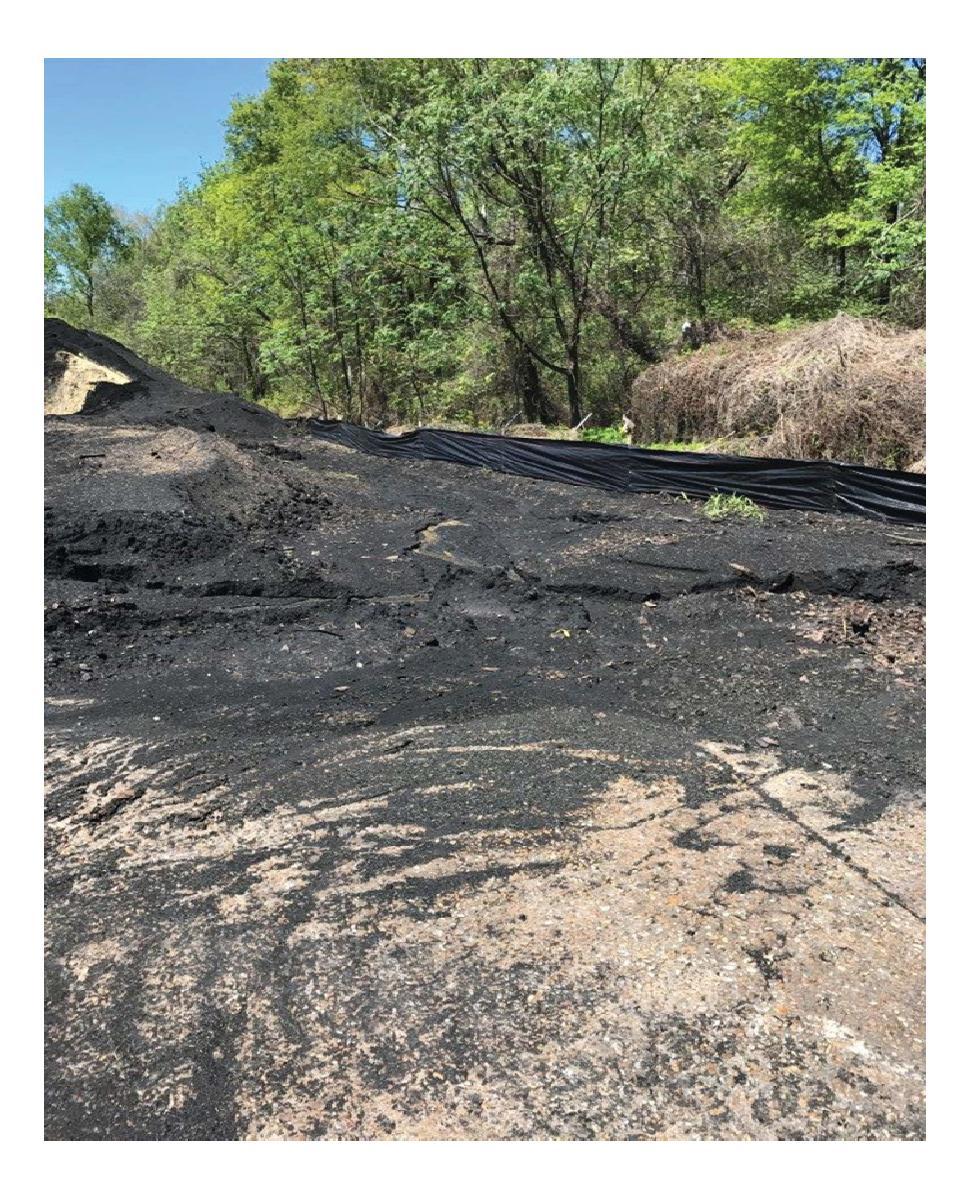
Photograph 2 of silt fence installed down gradient of the kiln ash pile.

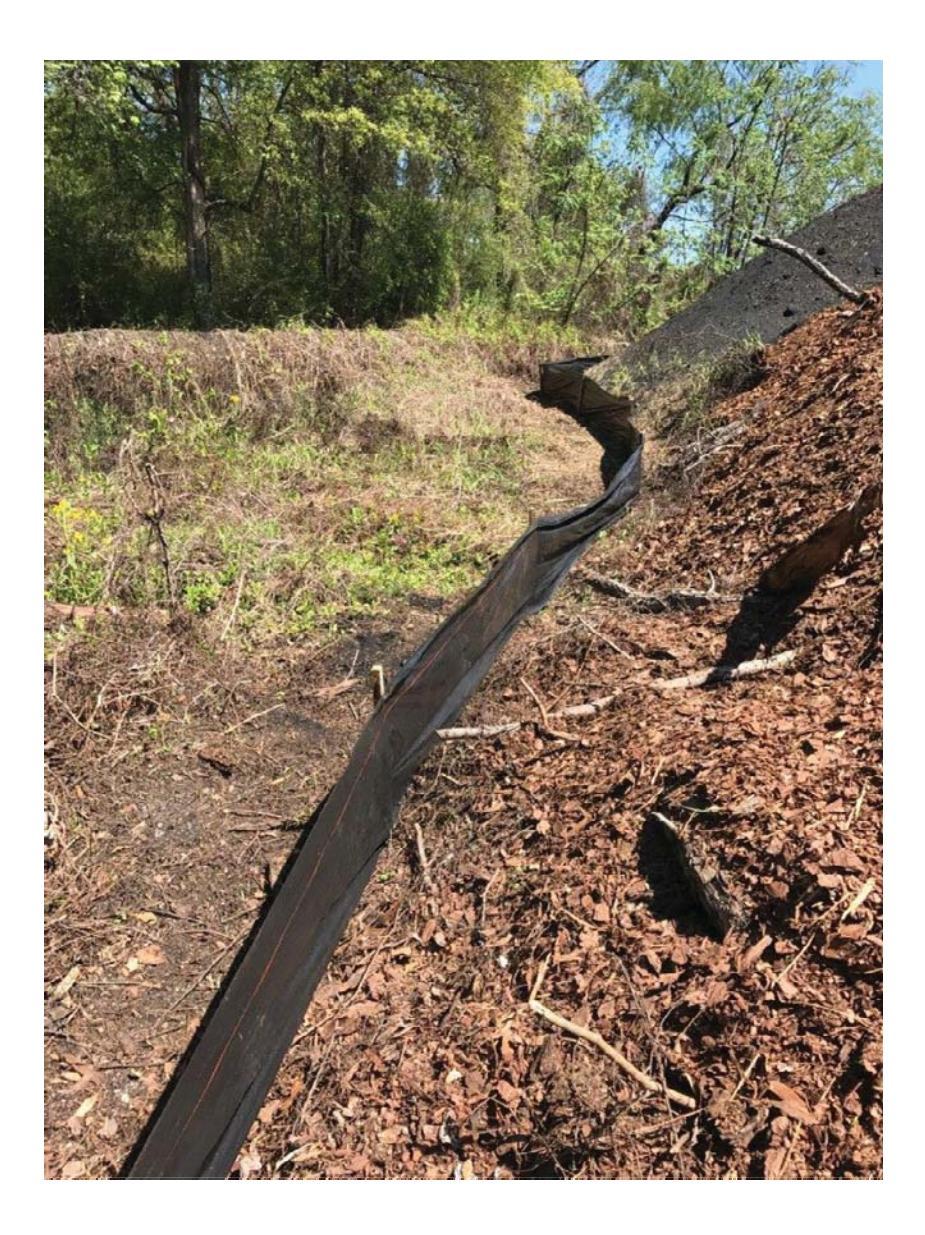
Photograph 3 of silt fence installed down gradient of the kiln ash pile.

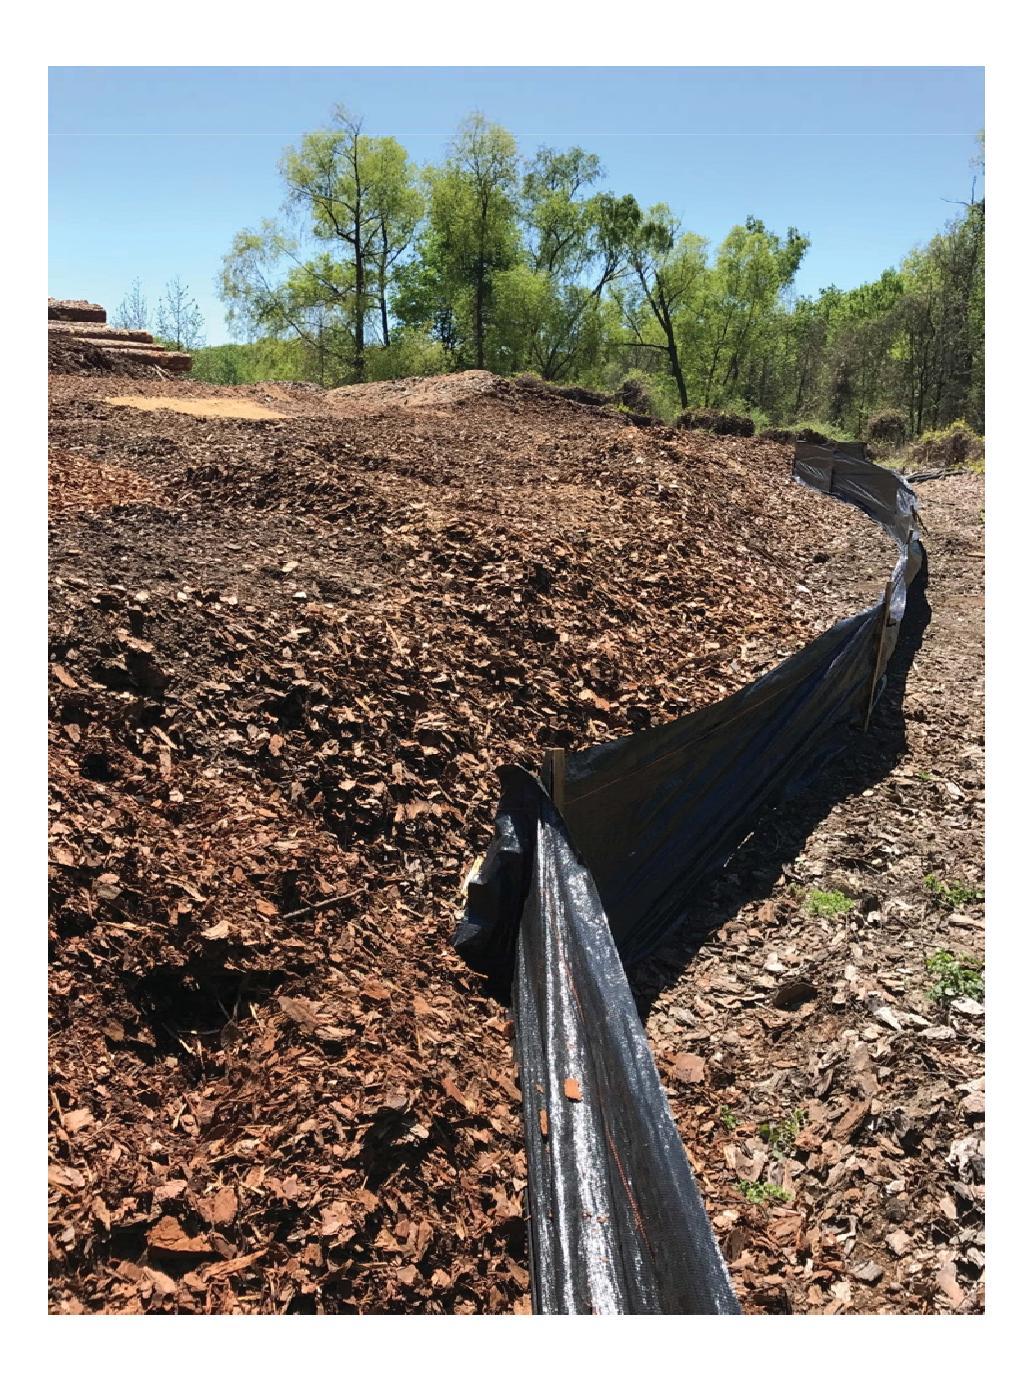
Photograph 4 of silt fence installed down gradient of the kiln ash pile.

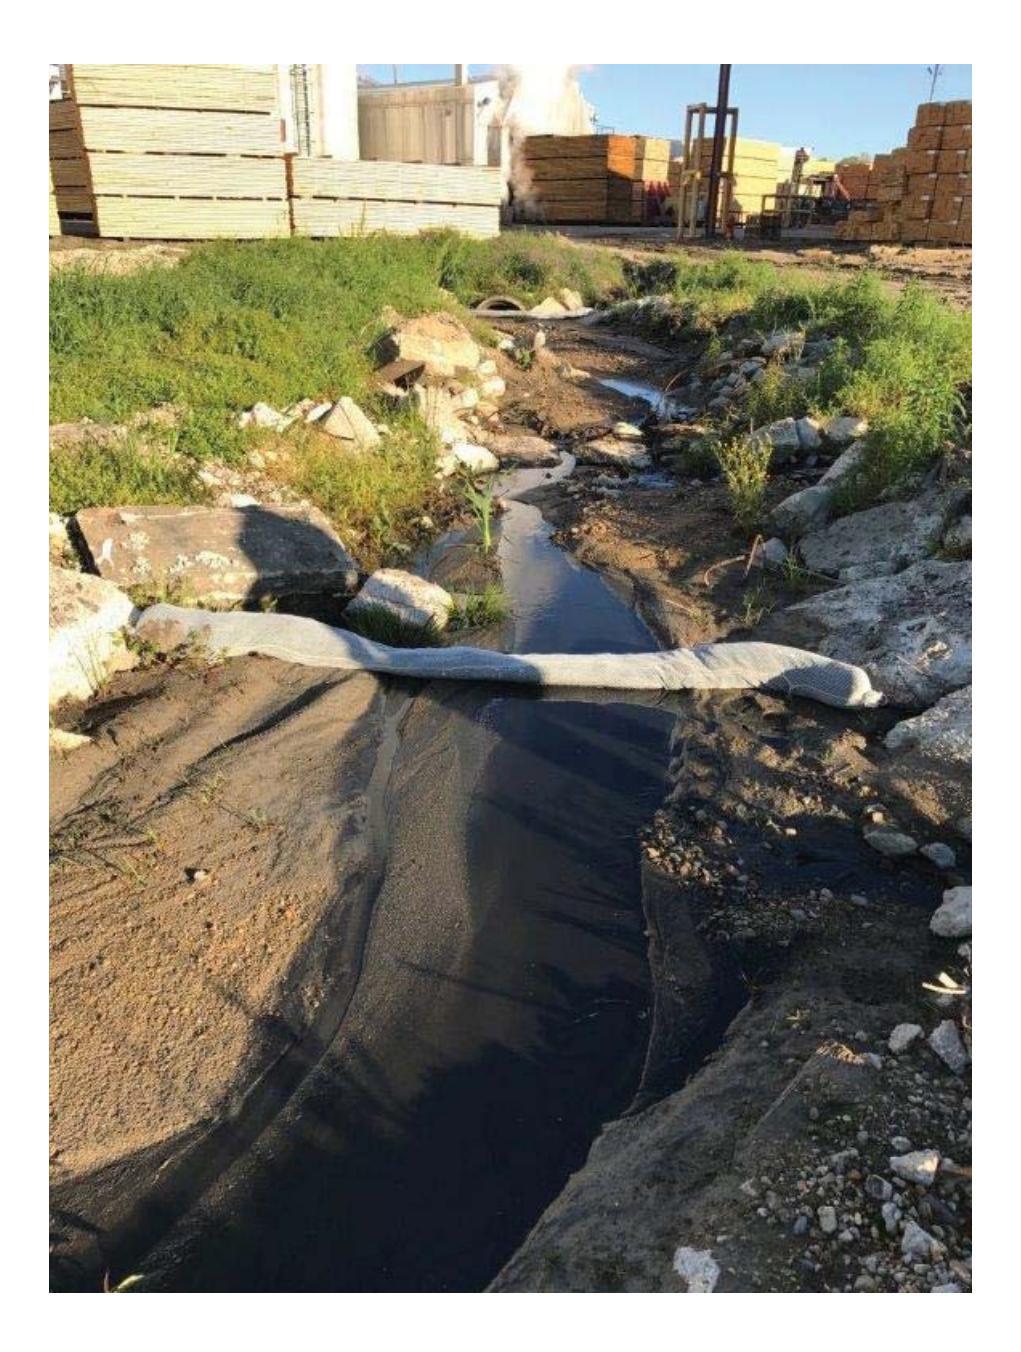
# Attachment 3 Outfall 003 Photos

Photograph showing oils booms that were placed in the drainage ditch leading to Outfall 003.

Oil booms have been placed in the drainage ditch leading to Outfall 003, as can be seen in the picture found in Attachment 3. The kiln area and drainage ditch leading to Outfall 003 will be monitored weekly by the EHS manager to ensure good housekeeping practices are being maintained and the oil booms are properly maintained.

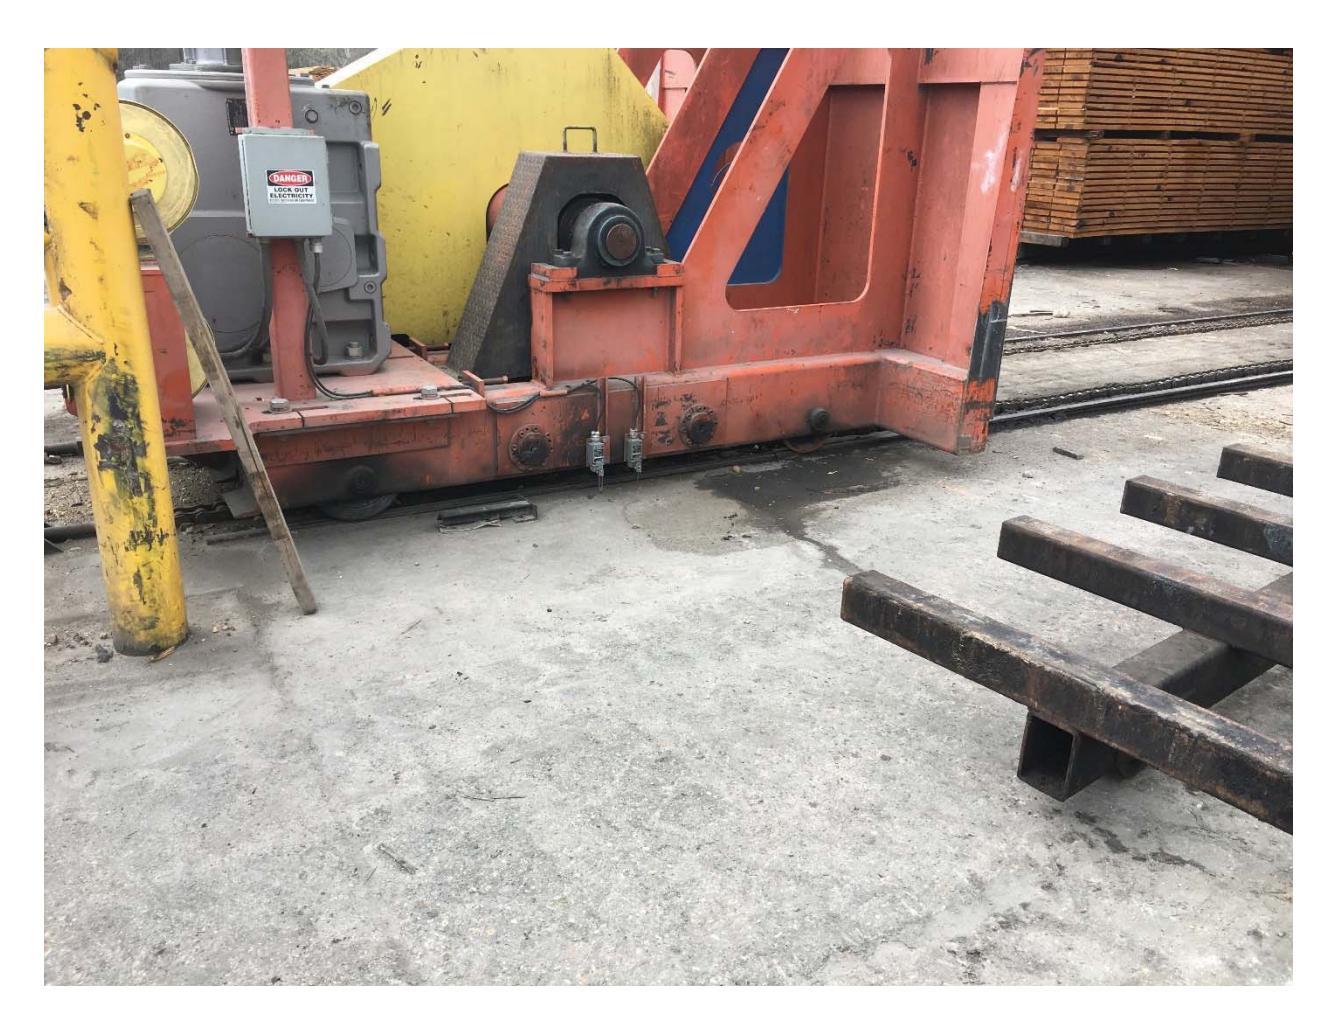
Please note that the exact location of the oil and grease noted on the ground that was noted in Photo No. 12 of the ADEQ inspection could not be determined. Attachment 3 contains pictures of the area taken during the quarterly inspection of the general area of the kilns.

Photograph showing area in the vicinity of the kilns where excess grease has been observed.

Equipment associated with the kilns were found to be a potential source for the oil sheen. Kiln equipment (motor, chain, lumber carts, etc) requires significant amount of lubrication due to repetitive use and the hot kiln environment. In future, employees will be trained to only use the amount of grease necessary on equipment associated with the kiln. Any spills will be immediately cleaned up and reported to the EHS manager.

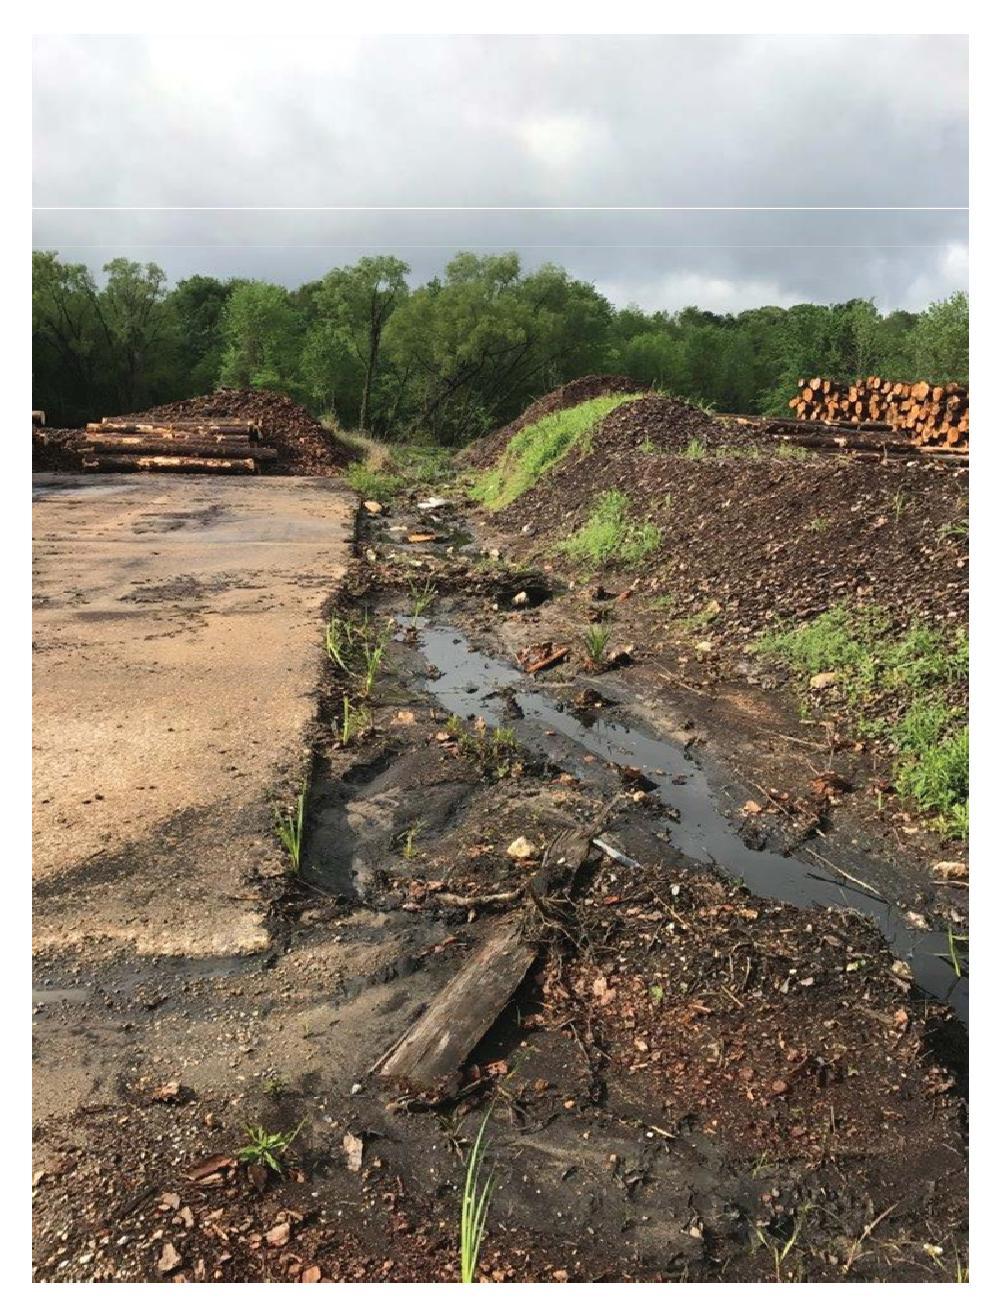
# **Outfall 008 BMP Photos**

Photograph showing the upper part of the ditch leading to Outfall 008. Vegetation has been established in the lower part of the ditch and starting to grow in the upper portion.

This ditch is normally vegetated. However, the ditch as clean out as part a major facility cleanup. Natural vegetation is currently being re-established. Rip-rap will be placed in areas where vegetation cannot be established. Pictures showing the above described corrective action can be found in Attachment 4.

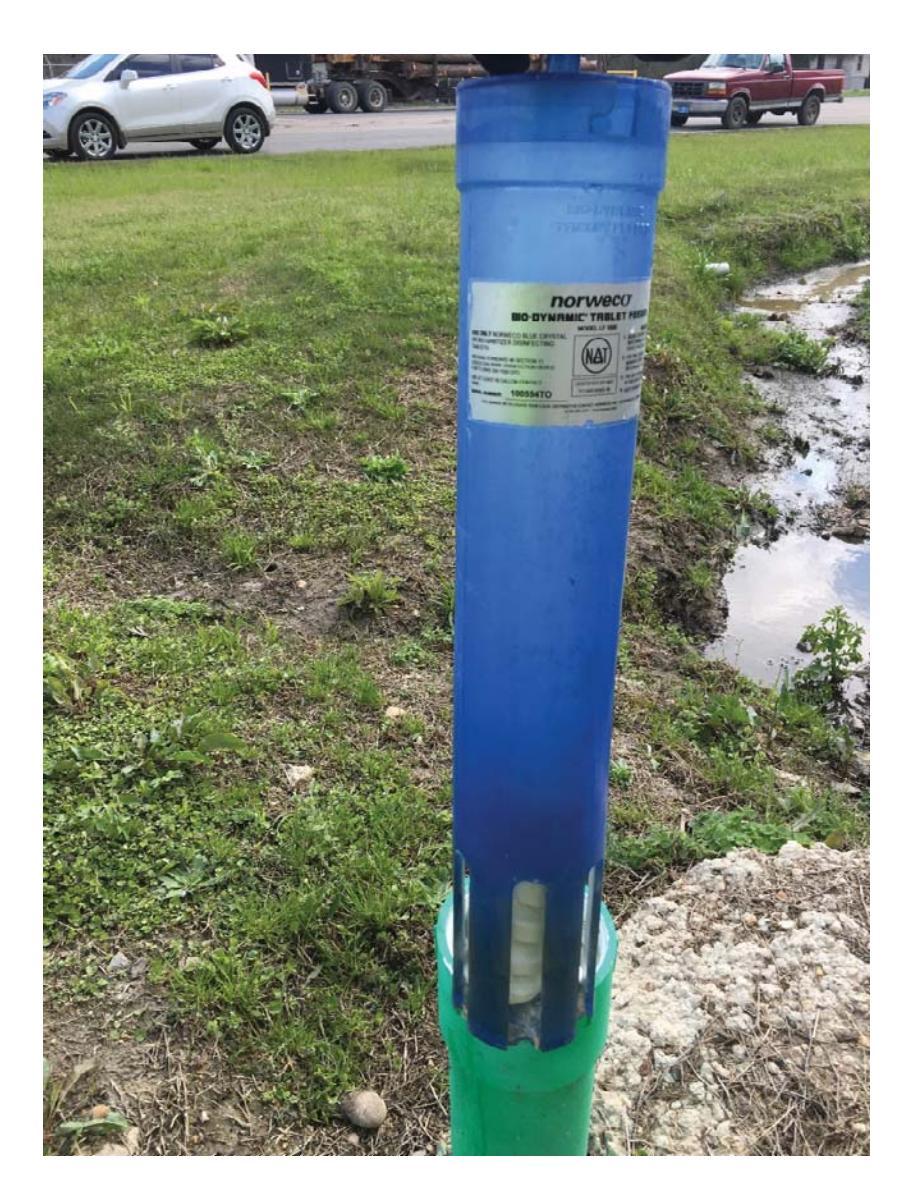
# Attachment 5 ARG55 Photos

The following photograph shows chlorine tablets that were added to the ARG55 treatment system.

Chlorine tablets have been added to the system. This was verified during a site visit on March 15, 2017. A picture showing the above described actions can be found in Attachment 5.
