DIVISION OF ENVIRONMENTAL QUALITY

RE: City of Eureka Springs Inspection – PDS# 128366 (Carroll Co.) AFIN: 08-00036 Permit No.: AR0021865

111 - 111 11 - 111 12		OFFICE OF WATER QUALITY INSPECTION REPORT							
		AF	IN: 08-00036 PI	ERMIT #: AR0021	865		DATE: '	11/9/2023	
\$0,7	AND ENVIRONM	CC	UNTY: 08 Carro	II	PDS ;	#: 128366		MEDIA: WN	
		GF	S LAT: 36.42092	0 LONG: -93.735)82 ∟	OCATION:	Entrance	9	
	FACILITY INFORMAT			INS	SPEC	TION INFO	RMATIO	N	
NAME				FACILITY TYPE:	INSPEC	TOR ID#:		•	
Cit	y of Eureka Springs			1 - Municipal	1422	257 S - Stat	e		
				FACILITY EVALUATION RATING		INSPEC	CTION TYPE:		
CITY:	J AR-25			***		Cor	npliance	Evaluation	
Но	liday Island			DATE(S): ENT	RY TIME:			FECTIVE DATE:	
	RESPONSIBLE OFFIC		-			10140	PERMIT EX	2019 KPIRATION DATE:	
NAME	E / TITLE						1/31/2	2024	
HO	norable Butch Berry / Mayor								
Cit	v of Eureka Springs			FATETTEVILLE SHALE RELATED. N					
MAILI	NG ADDRESS:			FAYETTEVILLE SHALE VIOLATIONS: N					
317	74 East Van Buren								
	STATE, ZIP:			Terry Long, Plant Manager, Class IV. (479) 738-7035.

RE: NPDES Permit AR0021865; AFIN 08-00036

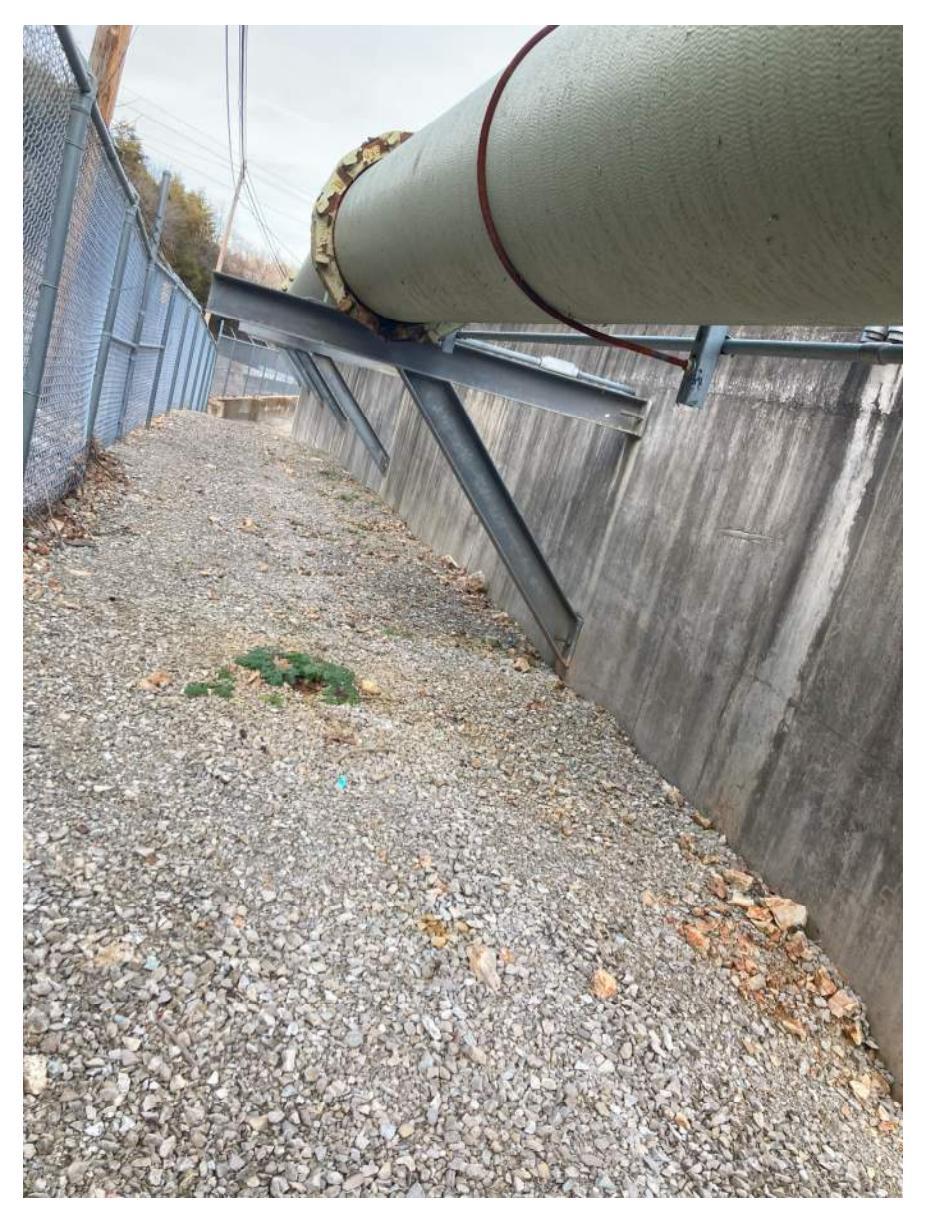
It is requested that the facility identify all possible areas of concern that have contributed to or have potential to contribute to the presence of sludge in Leatherwood Creek downstream of Outfall 001 in accordance with Part III, B.5 of the permit. A SSO report dated September 12, 2023, by Mr. Terry Long indicates pump failure has caused a recent undesired discharge.

Figure 1: West side of SBR system where initial overflow occurred indicating there have been no recent overflows

Firstly, it has been reiterated multiple times by plant staff that preventing discharge of sludge into the adjacent Leatherwood Creek is their number one concern along with maintaining full compliance with all permit requirements. See Figure 1 for a picture of the area of unintentional discharge on November 9, 2023. This area has been cleaned and no further discharges have occurred.

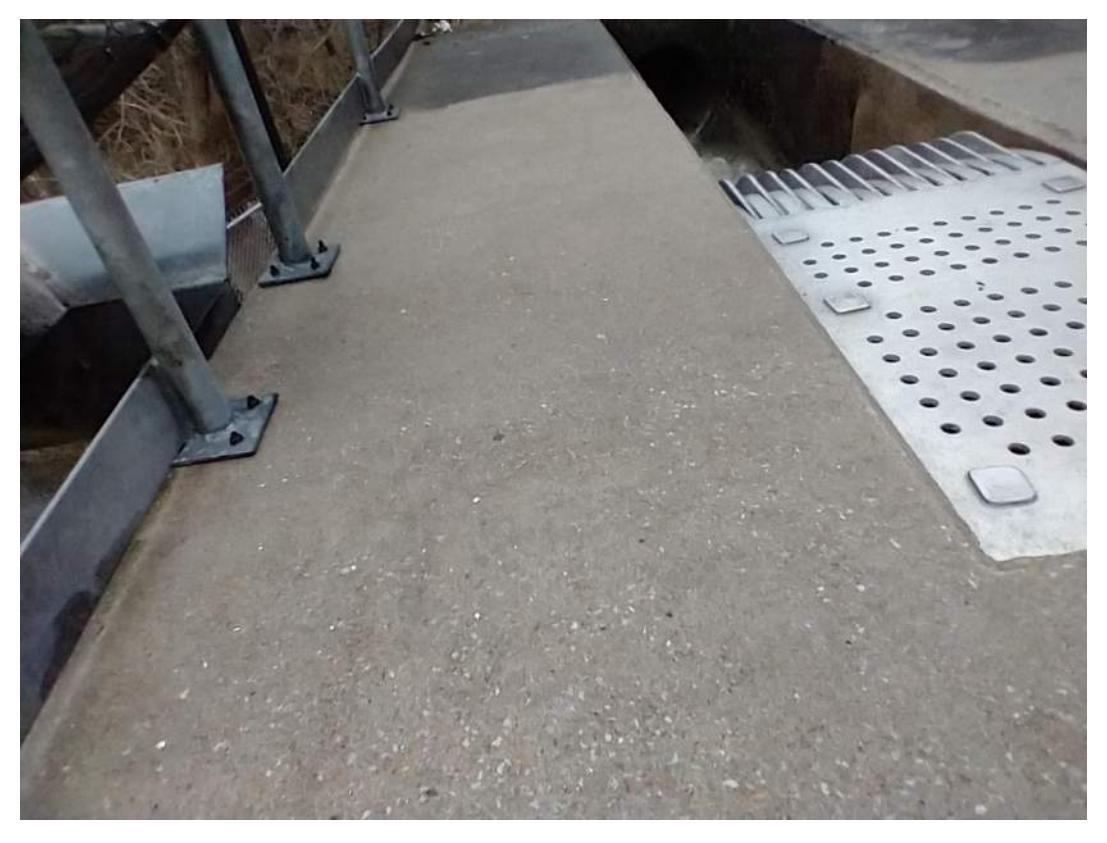
2. There is evidence of exposed solids on the concrete slab adjacent to the influent bar screen. Furthermore, the collection container (55-gallon barrel) does not have additional measures to prevent a discharge in the event of a spill. The solids accumulation next to the bar screen is in violation of Part III, B.6.A of the permit.

Figure 2: Concrete slab adjacent to slab after cleaning

At the influent manual bar screen the spilled waste solids referenced above have been removed from the concrete slab, see Figure 2. Following the solids removal, the area has been washed down with a garden hose and bleach. The disinfectant was allowed to sit for approximately five (5) minutes and then washed into the influent flow channel with site NPW.

New standard operating procedure moving forward shall be that the operators will not ever leave any solids on the concrete during, or after, cleaning the manual influent bar screen. If solids do fall off the shovel during cleaning they will be immediately picked up and placed in the waste barrel for disposal and the concrete area flushed with water directed back to the influent channel and the entire area cleaned with bleach as need.

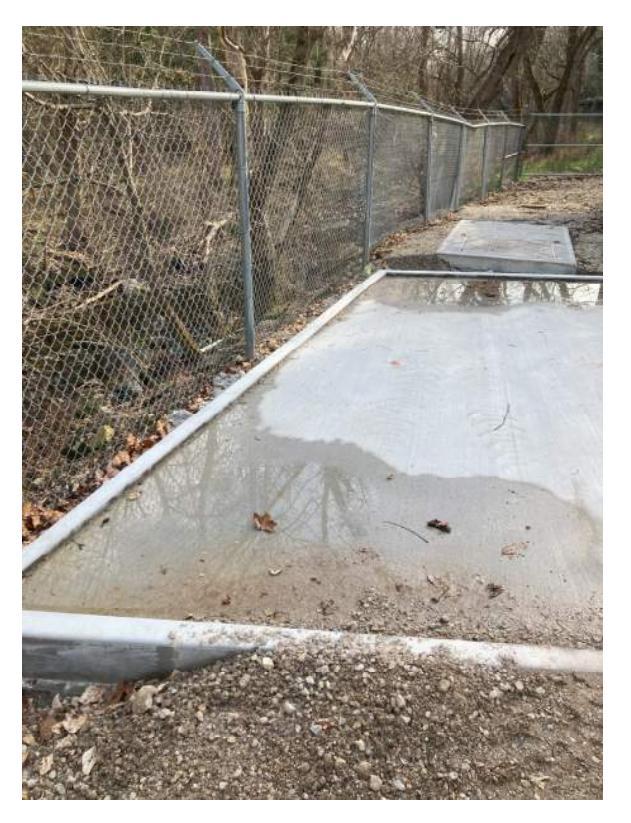
Figure 3: East side of newly constructed concrete slab adjacent to screening and grit removal equipment.

The area adjacent to the manual bar screenings collection 55-gallon barrel drum will be paved with a concrete pad with a perimeter containment curb/lip like the new slab adjacent to the mechanical screen and grit removal unit. The existing 55-gallon barrel with drain to this secondary containment area in case of a spill, see Figure 3 and Figure 4 for pictures of the new containment slab at the mechanical equipment area.

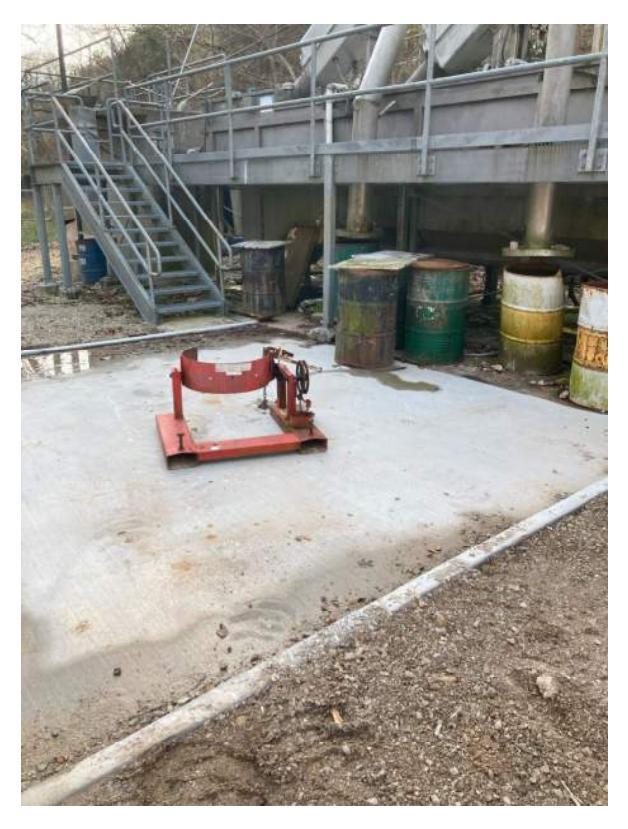
Figure 4: West side of newly constructed concrete slab adjacent to screening and grit removal equipment.

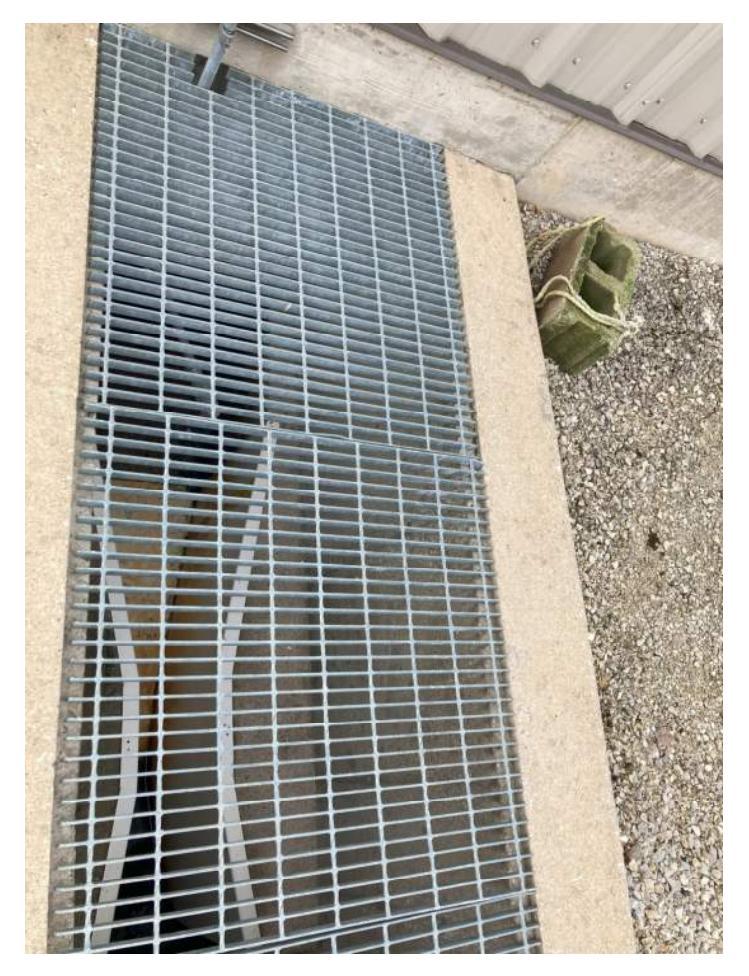
3. A cinder block is currently used for manual flow measurements, which is not consistent with accepted scientific practices and does not ensure reliable data. It is required that a staff gauge and/or ruler of adequate length be implemented for manual flow measurements at the Parshall flume before Outfall 001. This is in violation of Part III, C.2 of the permit.

Effluent flow measurement from the wastewater treatment system is performed at the existing Parshall flume. A concrete cinder block has been used as a temporary offset for manual flow depth measurements. This temporary item has been removed from the area of the Parshall flume. A stainless-steel measurement ruler has been ordered to be used for the periodic verification of effluent flow measurement for calibration/verification of the automatic flow meter.

Figure 5: Photo indicating that the cinder block and attached rope have been removed from the Parshall flume

The existing Parshall flume measurement gauge affixed to the wall of the flume is also used for flow measurement/verification. The existing automatic effluent flow meter is calibrated annually, as required by the permit, by a third party. See Figure 5 for a view of the top of the Parshall flume box, covered in protective grating.

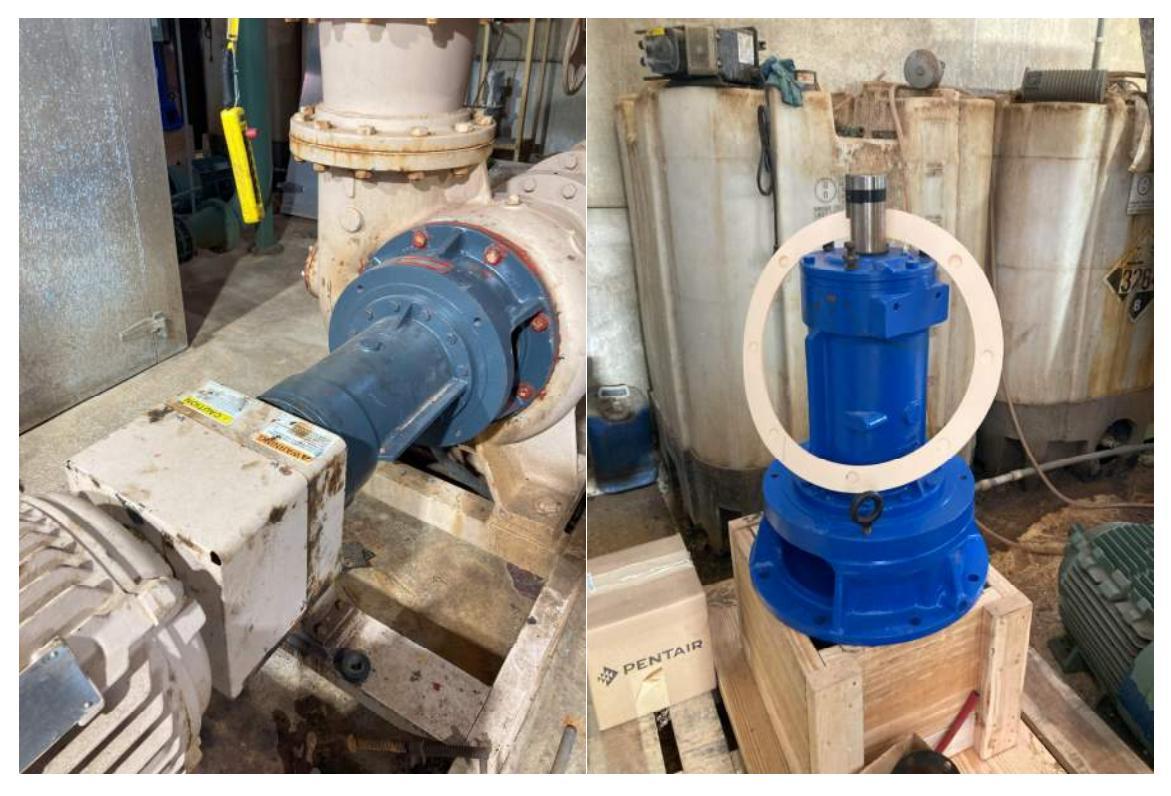
Motive pump for SBR#1 failed due to a bent drive shaft. The enclosed drive shaft coupling/bearing housing has been replaced and the pump has been rebuilt and placed back into service.

Figure 6: Rebuilt motive pump for SBR#1 in service (left); new backup pump (right)

Additionally, a spare enclosed drive shaft coupling/bearing assembly has been purchased to have on hand as an immediate repair if this issue occurs again. See Figure 6 for photos of the repaired pump system and spare parts.

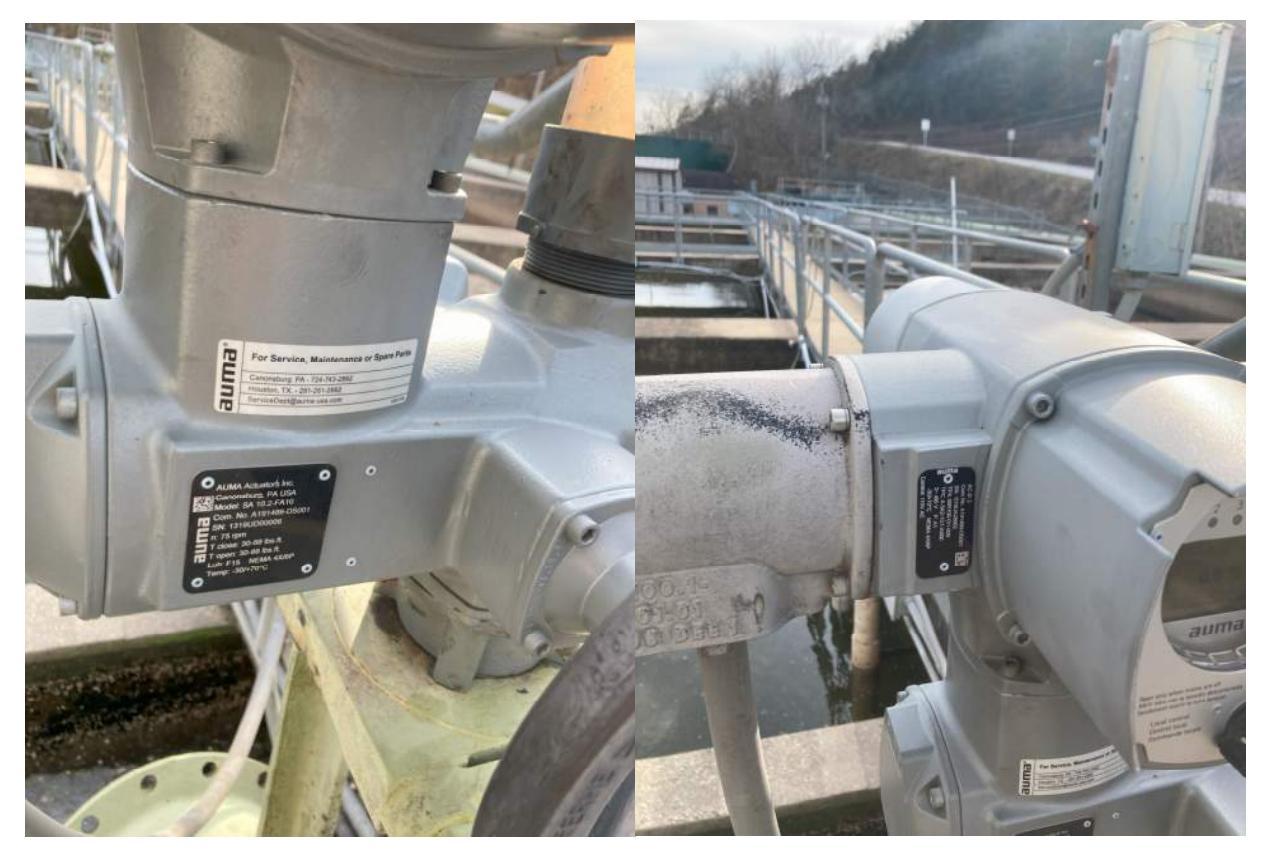
Influent valve for SBR#1 failed due to a broken actuator. The broken actuator was replaced, and reverse internal acme threads were added to the brass drive nut to provide more reliable service. See Figure 7 for pictures of the replaced valve actuator.

Figure 7: Influent valve for SBR#1 in operation

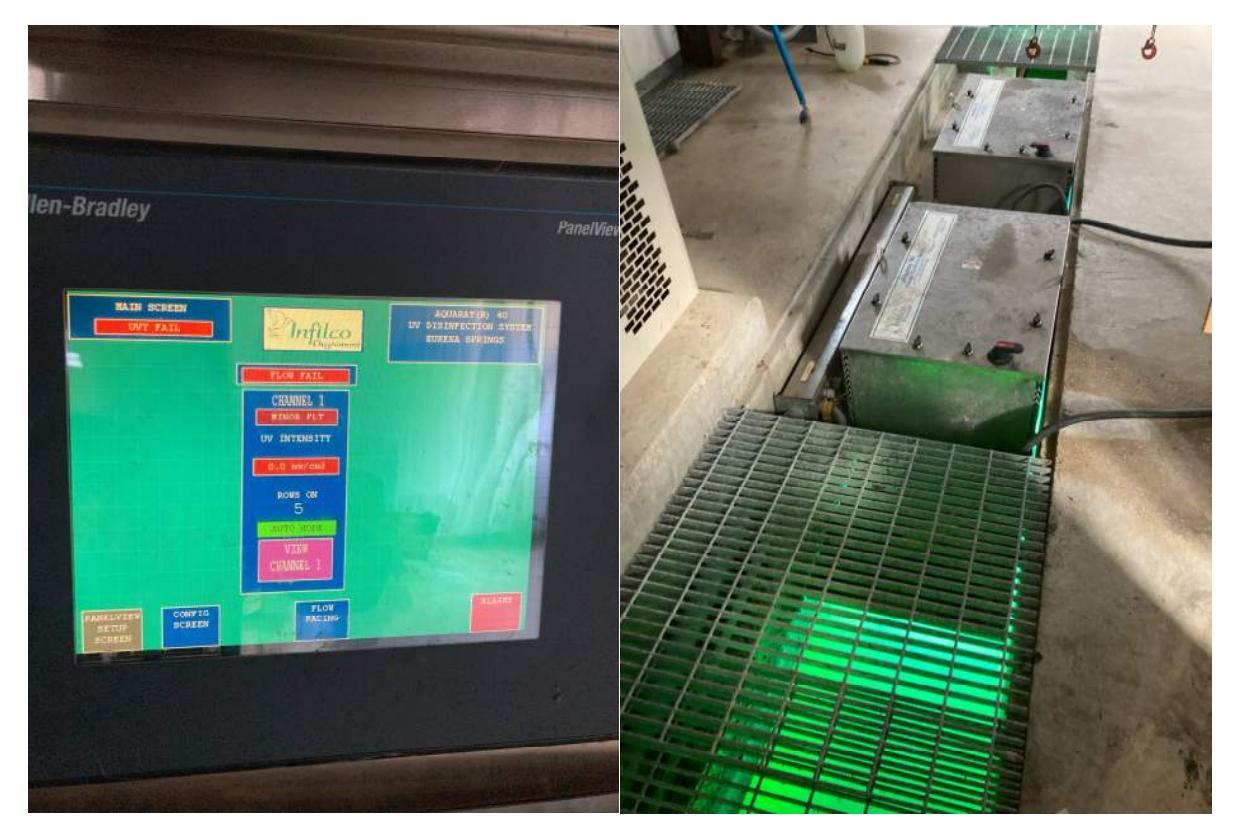
The exiting UV Disinfection unit failed due to multiple components reaching the end of their useful life. The system has been repaired with new quartz sleeves, new UV bulbs, a new DCA assembly, and new liquid tight strain relief fittings.

Currently both UV treatment modules are operational. However, the system is still experiencing communications/controls issues between the UV system control panel and UV modules.

Figure 8: Ongoing issue with communication (left); both UV modules in operation (right)

Plant staff continues to coordinate with a manufacturer's field service technician to resolve these issues. See Figure 8 for pictures of the rebuilt UV system.

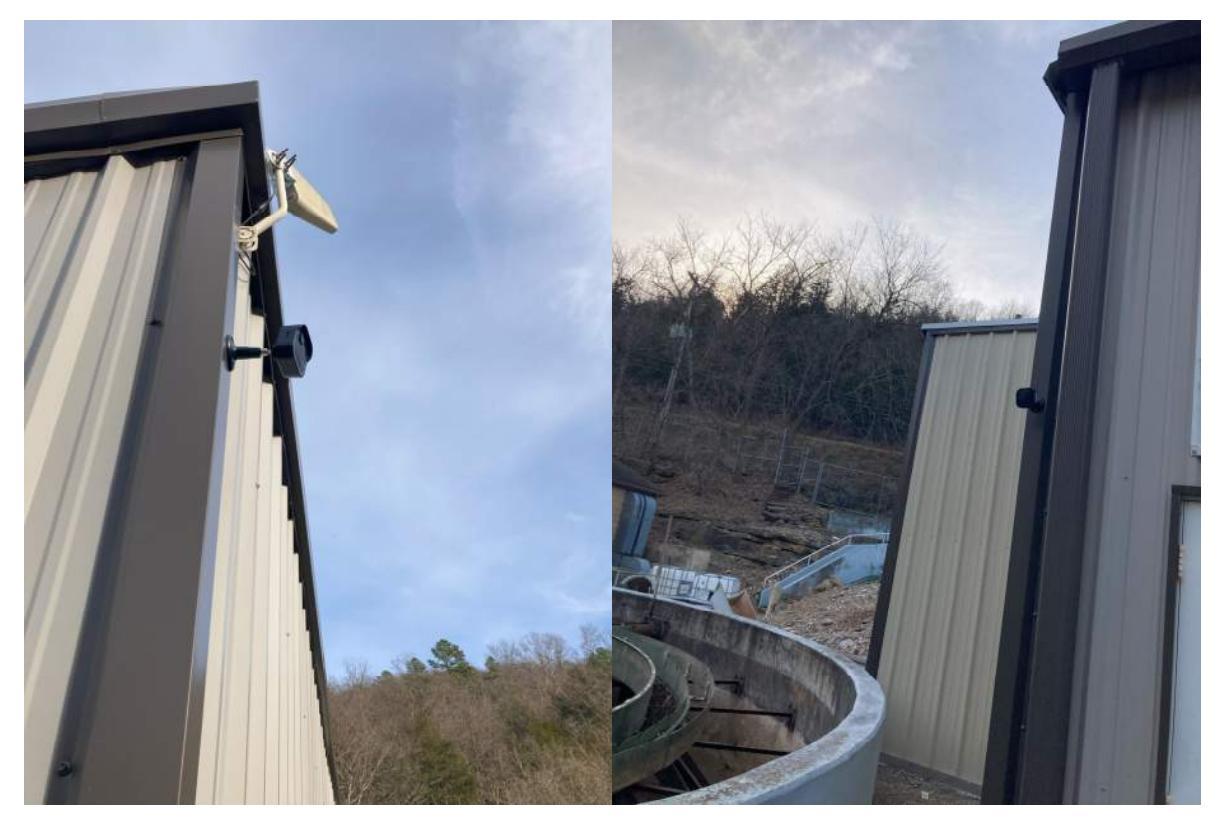
Plant site security has been an ongoing issue. The plant has experienced multiple occurances of members of the public entering the plant while staff is away. Previously no remote monitoring was possible at the plant. Recently, new wireless security cameras have been installed and are operational. To fully active this new security/monitoring system a new wifi signal booster will be installed at the plant to provide the required service at remote corners. See Figure 9 for pictures of the new security cameras.

Figure 9: Camera used to monitor SBR basins (left); camera to monitor fence gap and sludge storage (right)

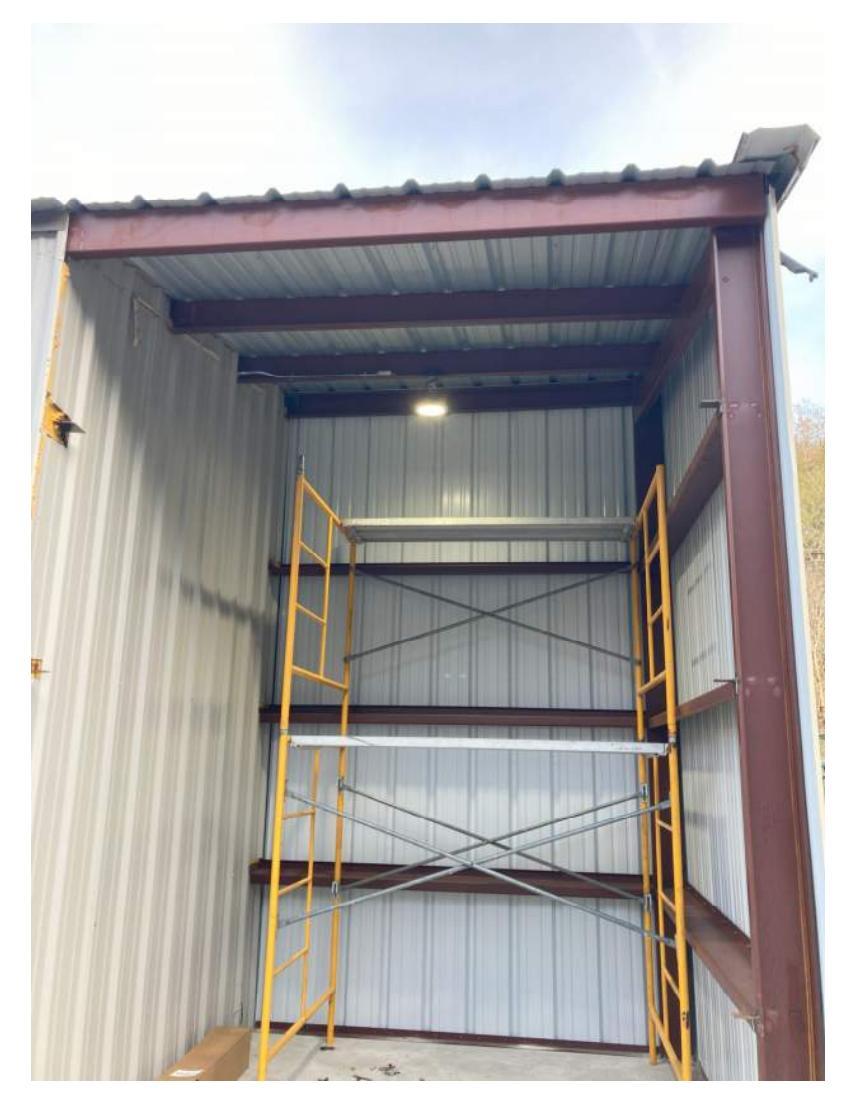
Onsite bulk chemical storage has been expanded with new construction at the existing belt filter press building. A new chemical storage bay has been added to the south side of the existing building. See Figure 10 for pictures of the new storage area. The new storage areas will provide a temperature-controlled environment for the chemicals.

Figure 10: Building add on for temperature controlled chemical storage
