RE: City of Malvern Inspection – PDS# 130057 AFIN: 30-00040 Permit No.: AR0034126

DIFA	OFFICE OF WATER QUALITY INSPECTION REPORT						
( and the second	ENVIRONMENTAL							
V - ENERO'		AF	AFIN: 30-00040 PERMIT #: AR003412				DATE: 4/10/2024	
		CC	COUNTY: 30 Hot Spring PI		PDS #	#: 130057	MEDIA: WN	
		GF	PS LAT: <b>34.3610</b>	LONG: -92.8248	.8248 LOCATION: General Area			
FACILITY INFORMATION				INSPECTION INFORMATION				
NAME				FACILITY TYPE: INSPECTOR ID#:				
	y of Malvern			1 - Municipal		21 S - State		
3672 Grigsby Ford Rd.				FACILITY EVALUATION RATING: INSPECTION TYPE: 1 - Unsatisfactory Sanitary Sewer Overf			-	
city: Malvern				( )	ITRY TIME:	EXIT TIME: 10:50		
	RESPONSIBLE OFFICIAL				0.00	10100	5/1/2021 PERMIT EXPIRATION DATE:	
	E: / TITLE						4/30/2026	
	enda J. Weldon / Mayor			FAYETTEVILLE SHALE RELATED: N				
	y of Malvern							
MAILING ADDRESS:				FAYETTEVILLE SHALE VIOLATIONS: N				
119 W. 3 <sup>rd</sup> St.				INSPECTION PARTICIPANTS				
city, state, zip: Malvern AR 72104				NAME/TITLE/PHONE/FAX/EMAI	L/ETG.:

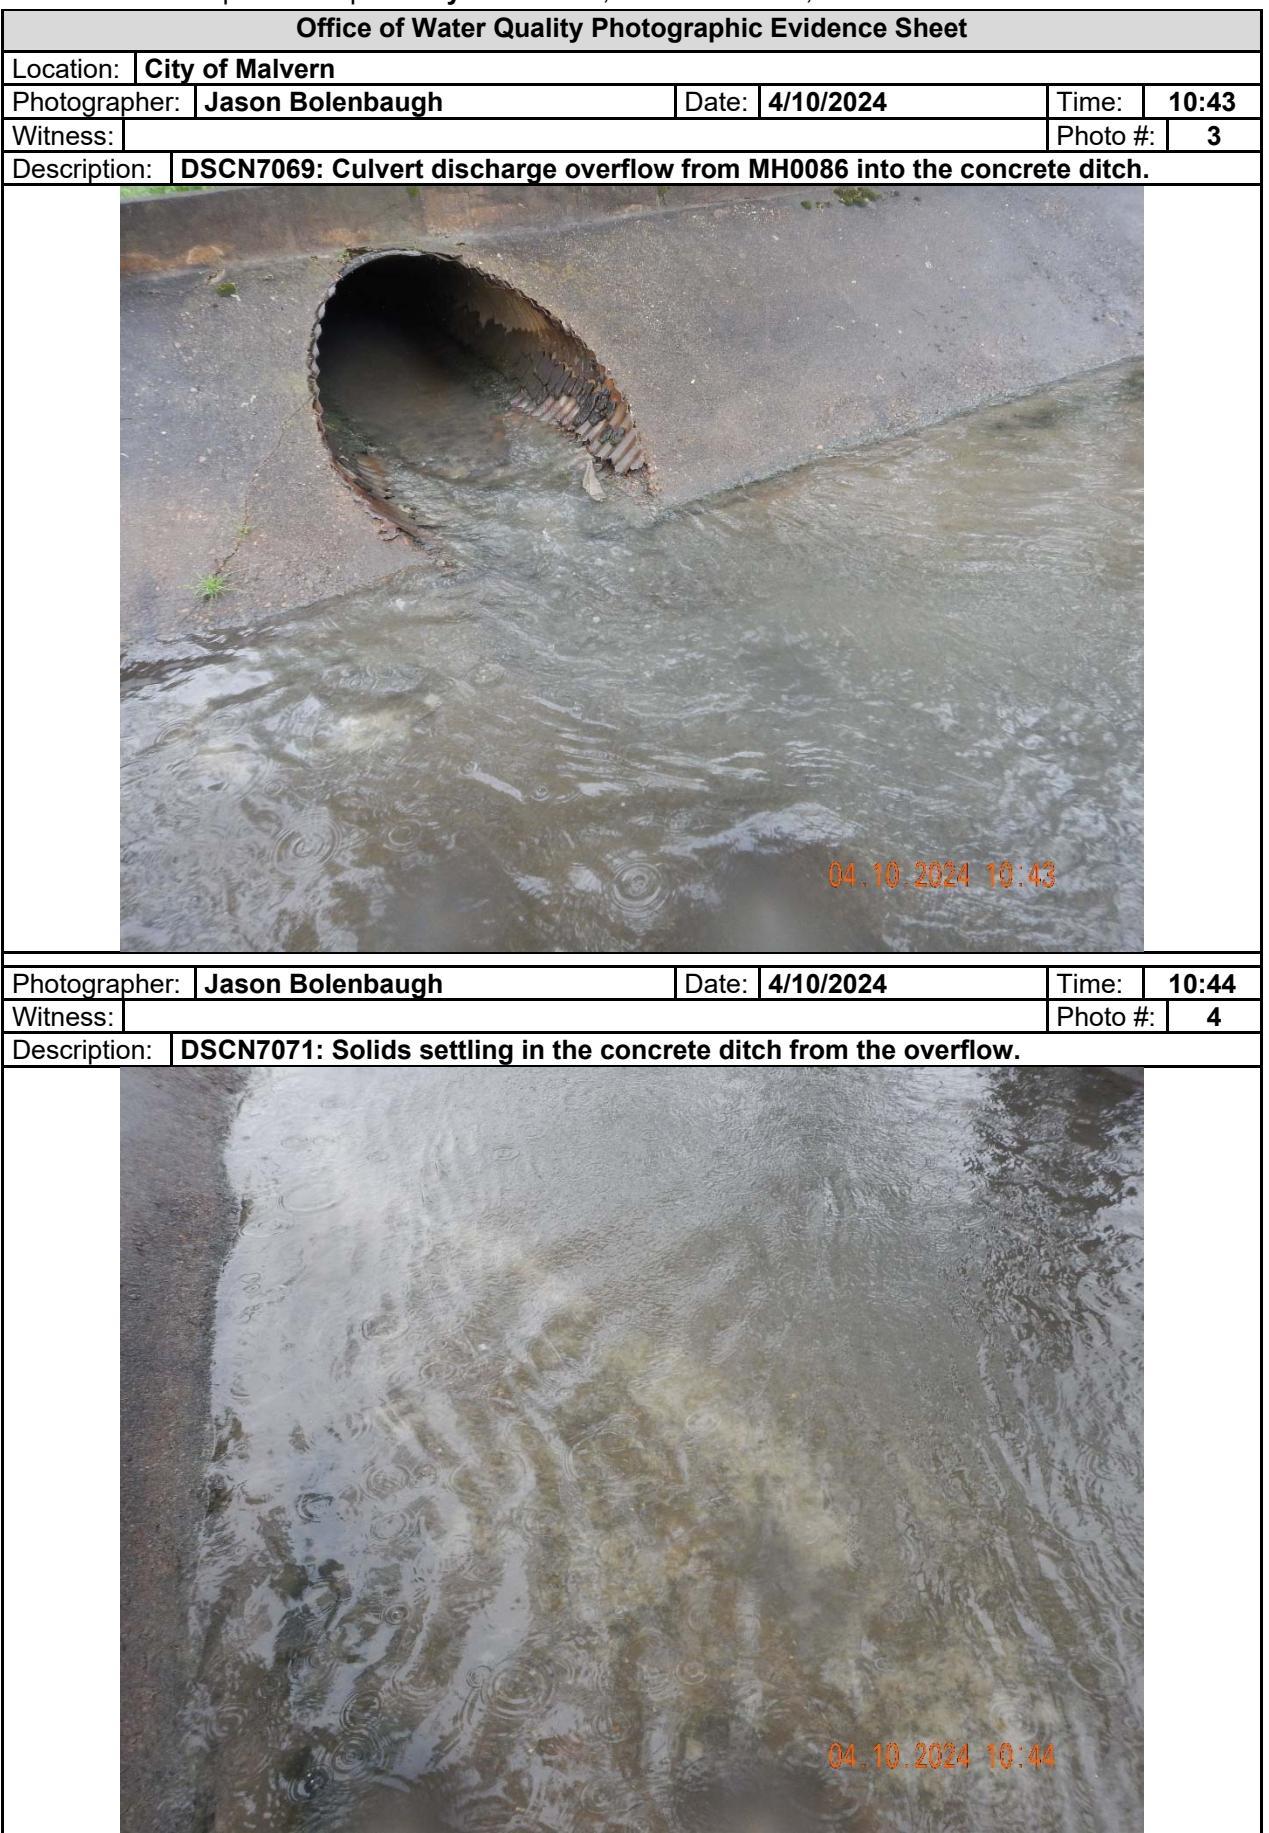
At the time of the inspection the manhole (MH0086) was overflowing and discharging into waters of the State in violation of A.C.A. § 8-4-217(a)(2). In accordance with Part II, Condition 5 of the permit, the permittee reported the Sanitary Sewer Overflow (SSO) to the Office of Water Quality Enforcement Branch. According to the permittee, MH0086 began to overflow on April 9, 2024, and stopped on April 14, 2024. The reported cause of the overflow was Inflow & Infiltration due to rainfall. The permittee estimated approximately 1,750,000 gallons was released from the SSO. The permittee reported they continue to work with an engineer to resolve the SSO. All reported SSO's are being monitored by the Office of Water Quality Enforcement Branch. Additionally, Consent Administrative Order (CAO) LIS# 24-045 was executed and is addressing SSO's within the City of Malvern. A copy of the CAO can be viewed using the following link:

MH0086 has a single overflow pipe set above the normal influent and effluent lines that carry wastewater from area residences to the nearby pump station. The overflow pipe was constructed to discharge into a weir box in the event the manhole experiences high flows similar to those that were occurring on April 10, 2024. The weir box then discharges into a storm drain that leads to the concrete ditch that drains to an unnamed tributary of Town Creek, thence to Town Creek.

Office of Water Quality Photographic Evidence Sheet							
Location: Cit	ty of Malvern						
Photographer:	: Jason Bolenbaugh	Date: 4/10/2024	Time: 10:32				
Witness:	DOCNIZOCO: MURORC et compositives	aulting in diacharge to the severe	Photo #: 1				
Description:	Description: DSCN7062: MH0086 at capacity resulting in discharge to the concrete ditch.						
Photographer	Jason Bolenbaugh	Date: 4/10/2024	Time: 10:32				
Witness:		fuere MU0000	Photo #: 2				
Description:	DSCN7063: Overflowing weir box
