COMPLAINT REPORT

COMPLAINT# 024195 AFIN# 04-02528 DATE RECEIVED 8/2/2018

COMPLAINT AGAINST	ADDRESS	PHONE
BTS Equipment, LLC, dba Brown's Tree Service or Brown's Tree Care	Trafalgar Road, Belle Vista, AR	(479) 273-0202

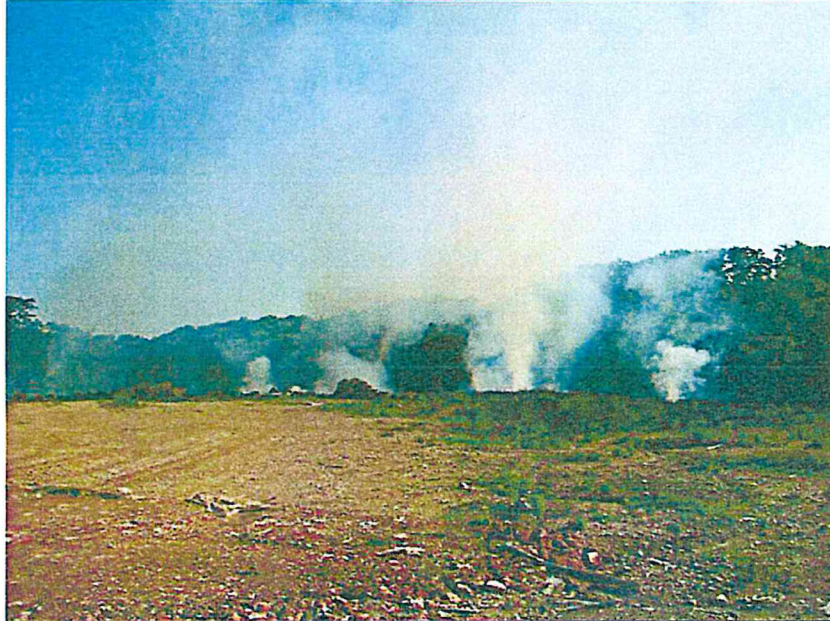
Again referencing the photos, smoke can clearly be seen rising just beyond the northern edge of the platform, along the eastern edge of the platform, along the north-western edge of the platform, and also to the south of the northern edge. (Refer to Photos #1 - #6.) The rising smoke and/or the contents within it, is construed to create a public nuisance as evidenced by the original complaint being made to the ADEQ, possibly a public health hazard due to unknown materials burning from within the waste mass, and is the cause of air pollution. This is a violation of A.C.A. § 8-6-205(a)(5) which states it shall be illegal for any person to sort, collect, transport, process, or dispose of solid waste contrary to the rules, regulations, or orders of the Department or in such a manner or place as to create or be likely to create a public nuisance or a public health hazard or to cause or be likely to cause water or air pollution within the meaning of the Arkansas Water and Air Pollution Control Act, § 8-4-101 et seq.

Location	BTS Equipment, LLC, Trafalgar Road, Bella Vista, Arkansas			Complaint #	024195	County	Benton
Photographer	Jay Ellis, Air Inspector			Witness	N/A		
Photo #	1	Of	27	Date	08/02/2018	Time	a.m.
Description	Bella Vista stump dump fire, looking north.

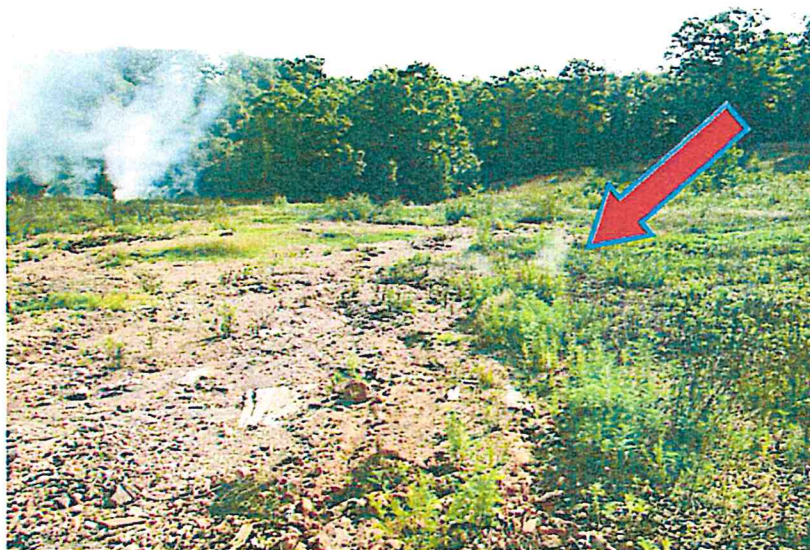
Location	BTS Equipment, LLC, Trafalgar Road, Bella Vista, Arkansas			Complaint #	024195	County	Benton
Photographer	Jay Ellis, Air Inspector			Witness	N/A		
Photo #	2	Of	27	Date	08/02/2018	Time	a.m.
Description	Bella Vista stump dump fire looking northeast – smoke visible south of north edge.

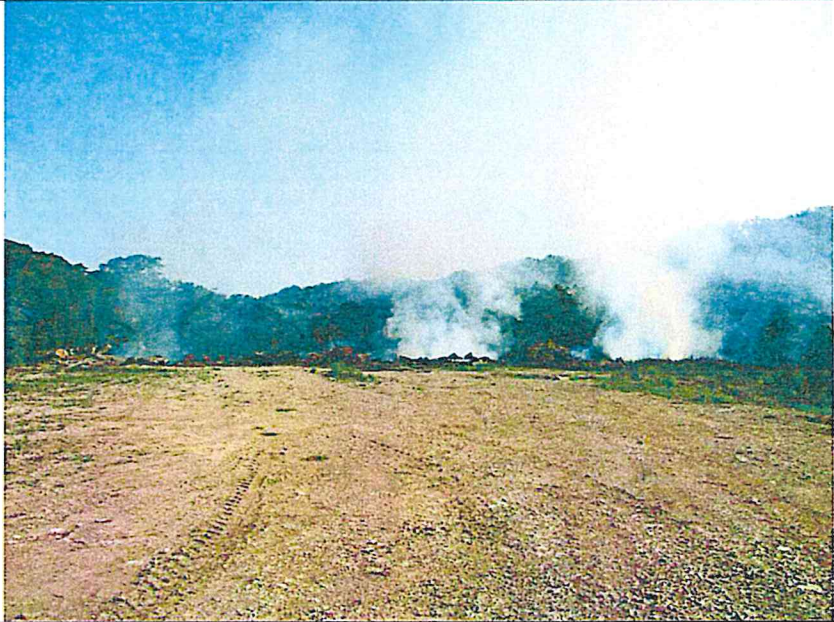
Location	BTS Equipment, LLC, Trafalgar Road, Bella Vista, Arkansas			Complaint #	024195	County	Benton
Photographer	Jay Ellis, Air Inspector			Witness	N/A		
Photo #	3	Of	27	Date	08/02/2018	Time	a.m.
Description	Bella Vista stump dump fire, looking north.

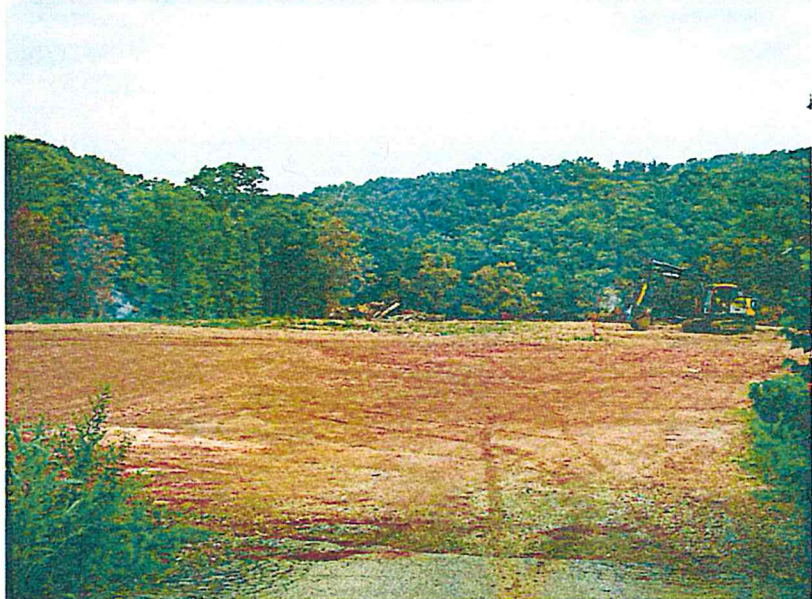
Location	BTS Equipment, LLC, Trafalgar Road, Bella Vista, Arkansas			Complaint #	024195	County	Benton
Photographer	Jay Ellis, Air Inspector			Witness	N/A		
Photo #	4	Of	27	Date	08/08/2018	Time	a.m.
Description	Wide view of Bella Vista stump dump fire, looking north.

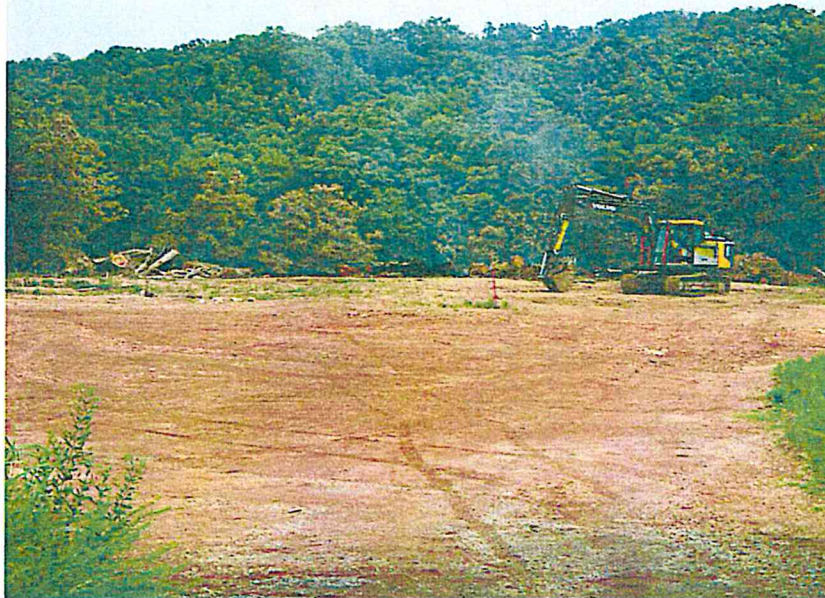
Location	BTS Equipment, LLC, Trafalgar Road, Bella Vista, Arkansas			Complaint #	024195	County	Benton
Photographer	Jay Ellis, Air Inspector			Witness	N/A		
Photo #	5	Of	27	Date	08/08/2018	Time	a.m.
Description	Closer/tighter view from same place Photo #4 was taken, looking north.

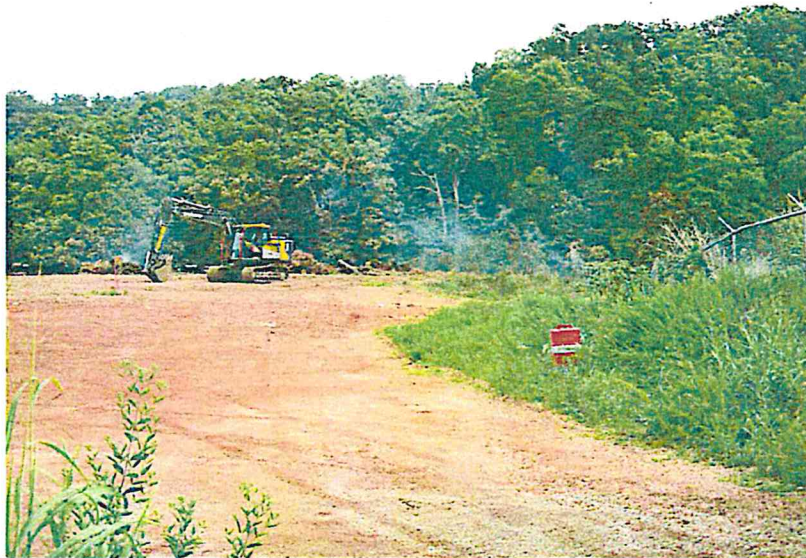
Location	BTS Equipment, LLC, Trafalgar Road, Bella Vista, Arkansas			Complaint #	024195	County	Benton
Photographer	Jay Ellis, Air Inspector			Witness	N/A		
Photo #	6	Of	27	Date	08/08/2018	Time	a.m.
Description	Bella Vista stump dump fire, looking a little more northeast from Photo #5.

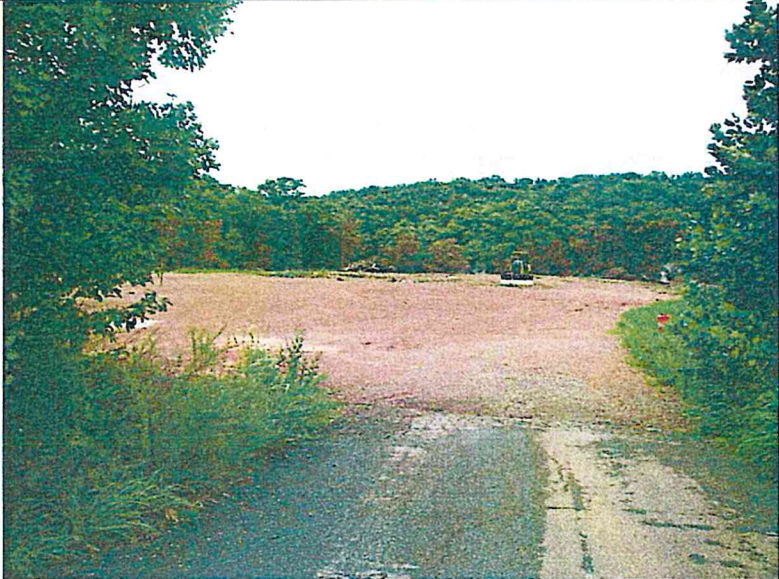
Location	BTS Equipment, LLC, Trafalgar Road, Bella Vista, Arkansas			Complaint #	024195	County	Benton
Photographer	Chris Krou, Compliance Branch Manager		<i>gk</i>	Witness	N/A		
Photo #	7	Of	27	Date	08/15/2018	Time	1050
Description	Overall view of the site from the entrance road.

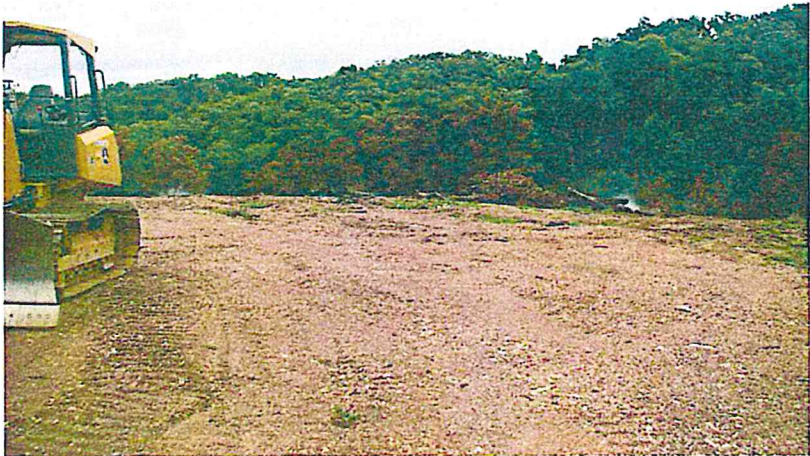
Location	BTS Equipment, LLC, Trafalgar Road, Bella Vista, Arkansas			Complaint #	024195	County	Benton
Photographer	Chris Krou, Compliance Branch Manager		<i>gk</i>	Witness	N/A		
Photo #	8	Of	27	Date	08/15/2018	Time	1054
Description	Overall view looking toward the northern edge.

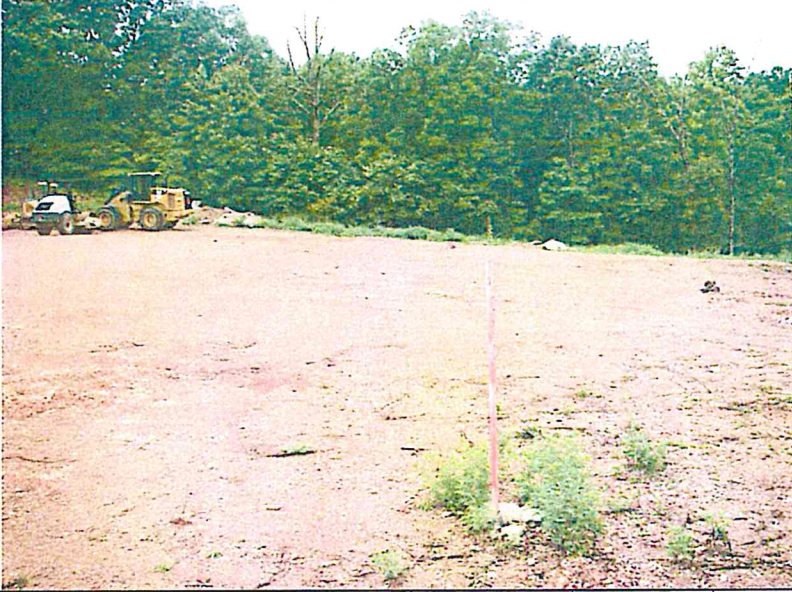
Location	BTS Equipment, LLC, Trafalgar Road, Bella Vista, Arkansas			Complaint #	024195	County	Benton
Photographer	Chris Krou, Compliance Branch Manager		<i>CK</i>	Witness	N/A		
Photo #	9	Of	27	Date	08/15/2018	Time	1056
Description	Looking directly west down the city parcel's northern property line.

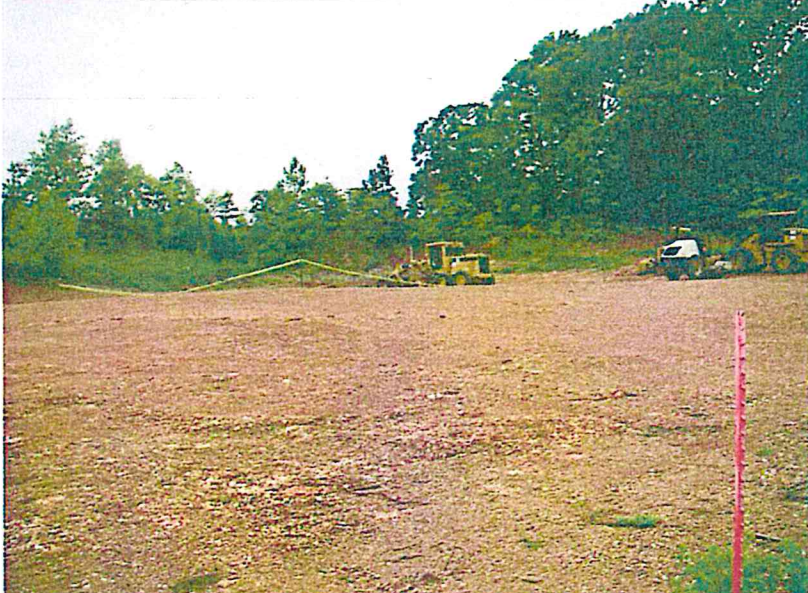
Location	BTS Equipment, LLC, Trafalgar Road, Bella Vista, Arkansas			Complaint #	024195	County	Benton
Photographer	Chris Krou, Compliance Branch Manager		<i>CK</i>	Witness	N/A		
Photo #	10	Of	27	Date	08/15/2018	Time	1056
Description	Looking southwest at the city's pad and equipment from their parcel's northeast corner.

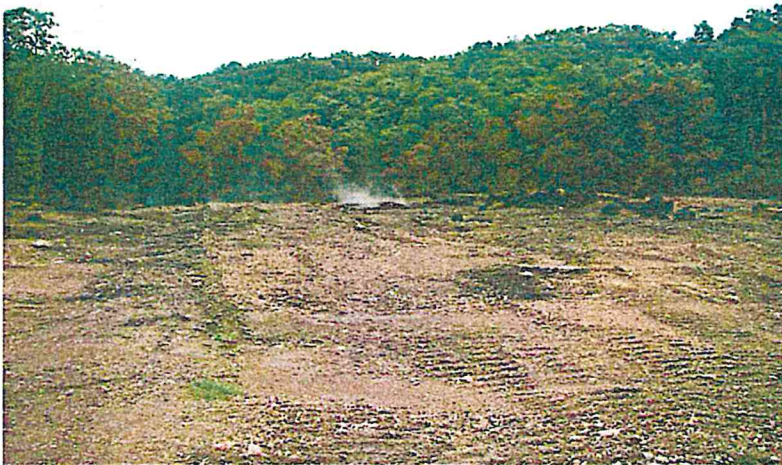
Witness	N/A		
Photo #	11	Of	27	Date	08/15/2018	Time	1058
Description	Overall view looking toward the northern edge.

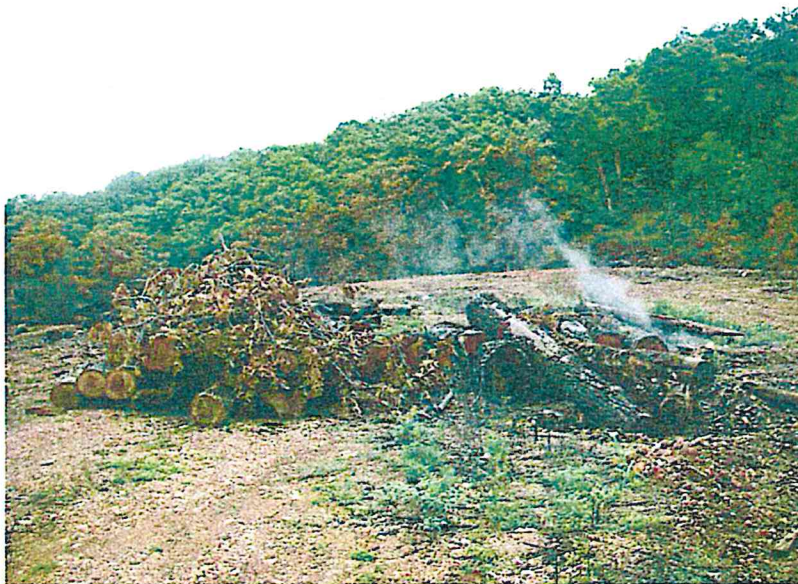
Witness	N/A		
Photo #	12	Of	27	Date	08/15/2018	Time	1059
Description	Overall view of the most easterly of three (3) solid waste piles, looking north.

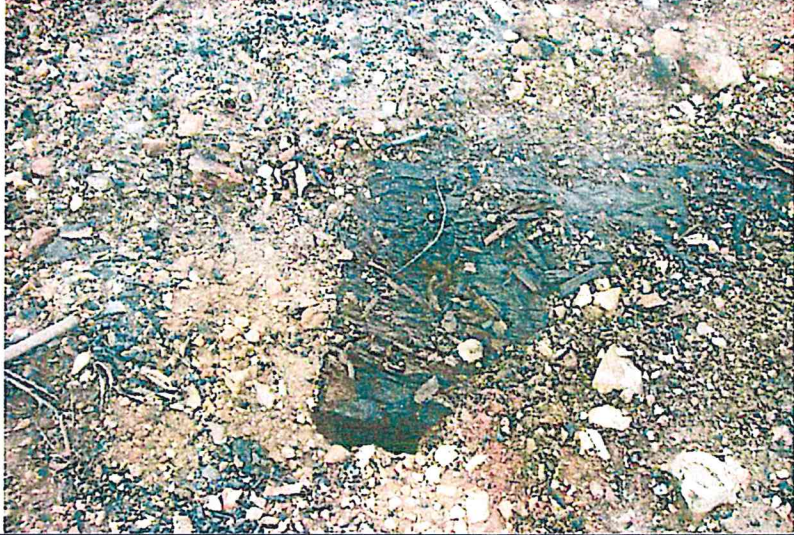
Location	BTS Equipment, LLC, Trafalgar Road, Bella Vista, Arkansas			Complaint #	024195	County	Benton
Photographer	Chris Krou, Compliance Branch Manager		<i>CK</i>	Witness	N/A		
Photo #	13	Of	27	Date	08/15/2018	Time	1101
Description	View of a vent coming up through the pad from the waste below.

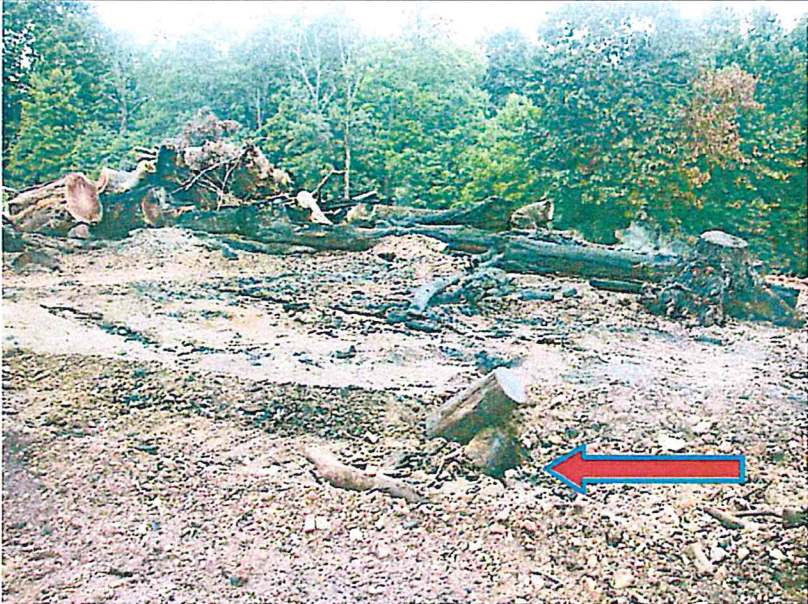
Location	BTS Equipment, LLC, Trafalgar Road, Bella Vista, Arkansas			Complaint #	024195	County	Benton
Photographer	Chris Krou, Compliance Branch Manager		<i>CK</i>	Witness	N/A		
Photo #	14	Of	27	Date	08/15/2018	Time	1104
Description	Overall view of the most westerly of three (3) solid waste piles on the platform, looking west. Another vent from waste below is located below the logs in the foreground (red arrow).

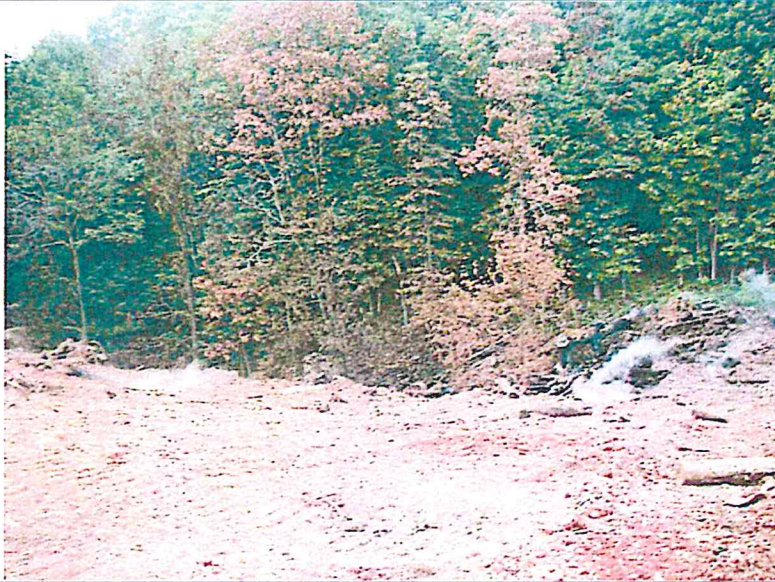
Witness	N/A		
Photo #	15	Of	27	Date	08/15/2018	Time	1107
Description	View of the western edge, looking west, south-west.

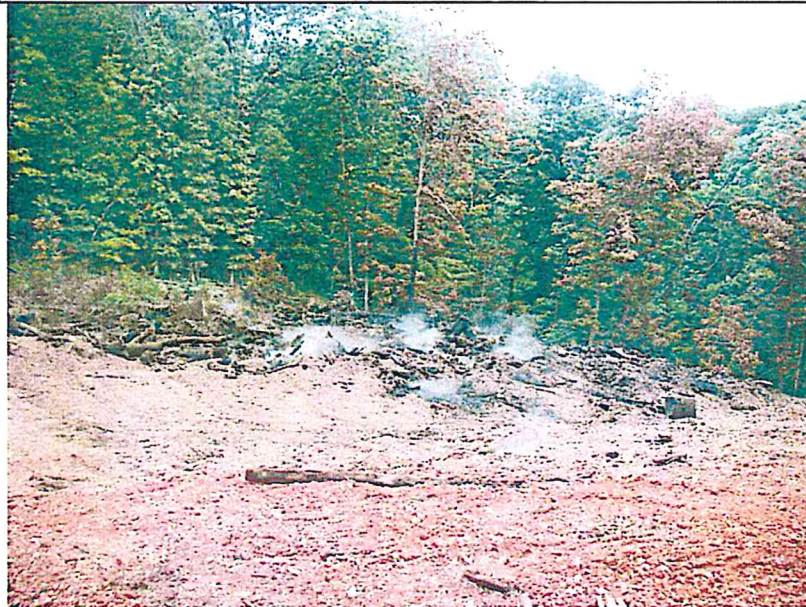
Witness	N/A		
Photo #	16	Of	27	Date	08/15/2018	Time	1109
Description	View of the western edge, looking more north, north-west from Photo #15.

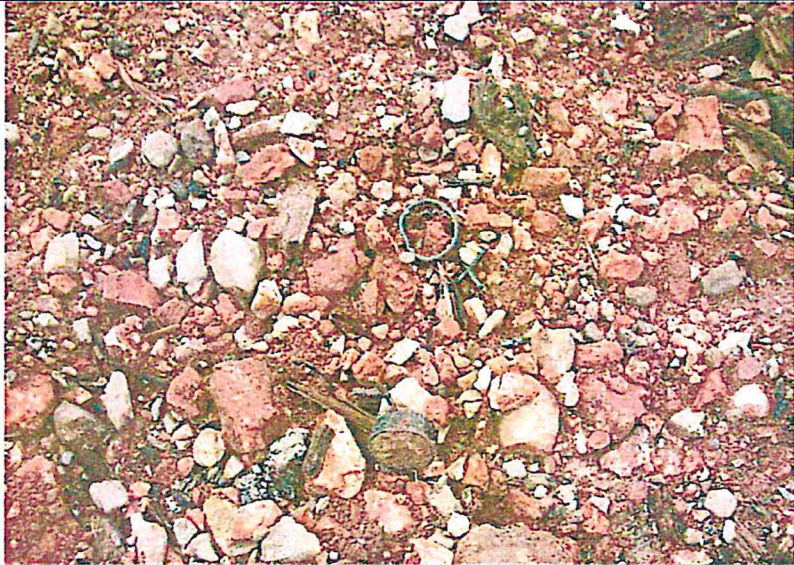
Location	BTS Equipment, LLC, Trafalgar Road, Bella Vista, Arkansas			Complaint #	024195	County	Benton
Photographer	Chris Krou, Compliance Branch Manager		<i>gk</i>	Witness	N/A		
Photo #	17	Of	27	Date	08/15/2018	Time	1111
Description	Examples of the hundreds of black plastic pieces of solid waste observed scattered on the ground.

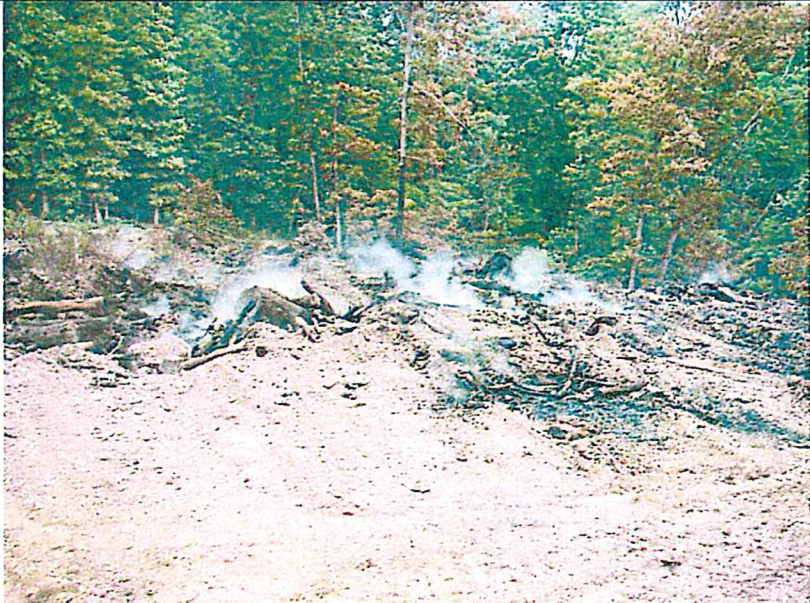
Location	BTS Equipment, LLC, Trafalgar Road, Bella Vista, Arkansas			Complaint #	024195	County	Benton
Photographer	Chris Krou, Compliance Branch Manager		<i>gk</i>	Witness	N/A		
Photo #	18	Of	27	Date	08/15/2018	Time	1113
Description	Overall view along the north-west corner/edge.

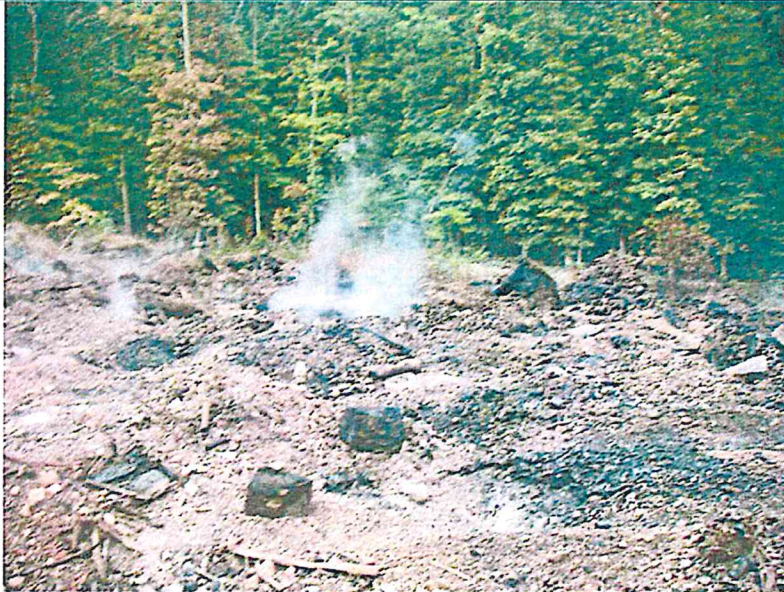
Witness	N/A		
Photo #	19	Of	27	Date	08/15/2018	Time	1114
Description	Overall view just before the northern edge, looking west.

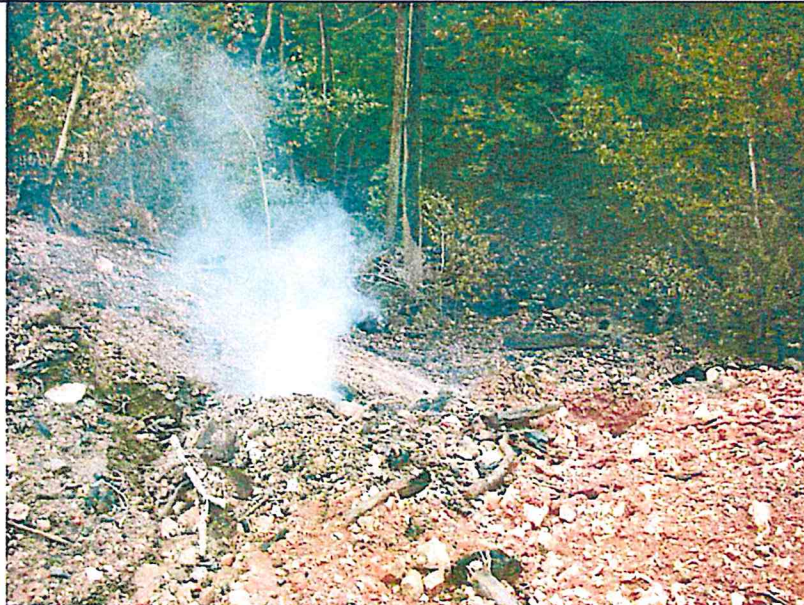
Witness	N/A		
Photo #	20	Of	27	Date	08/15/2018	Time	1114
Description	Overall view from the lip on the northern edge, looking north/down at the valley floor below.

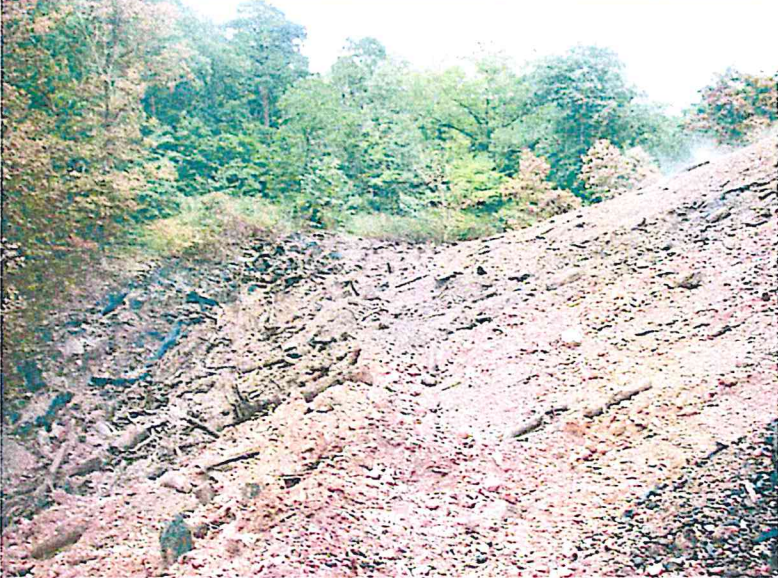
Location	BTS Equipment, LLC, Trafalgar Road, Bella Vista, Arkansas			Complaint #	024195	County	Benton
Photographer	Chris Krou, Compliance Branch Manager		<i>CK</i>	Witness	N/A		
Photo #	21	Of	27	Date	08/15/2018	Time	1116
Description	Overall view from just below the lip on the northern edge, looking east/south-east.

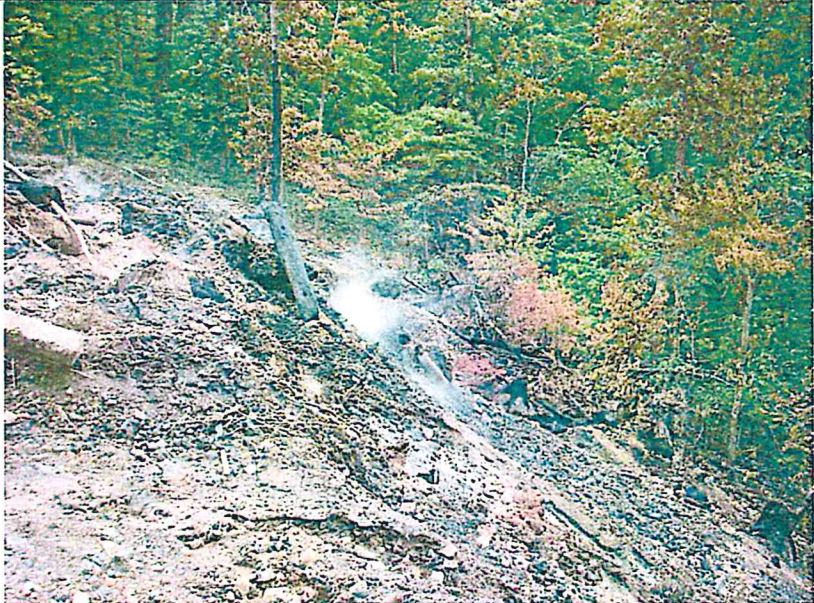
Location	BTS Equipment, LLC, Trafalgar Road, Bella Vista, Arkansas			Complaint #	024195	County	Benton
Photographer	Chris Krou, Compliance Branch Manager		<i>CK</i>	Witness	N/A		
Photo #	22	Of	27	Date	08/15/2018	Time	1116
Description	Overall view from just below the lip on the northern edge, looking west.

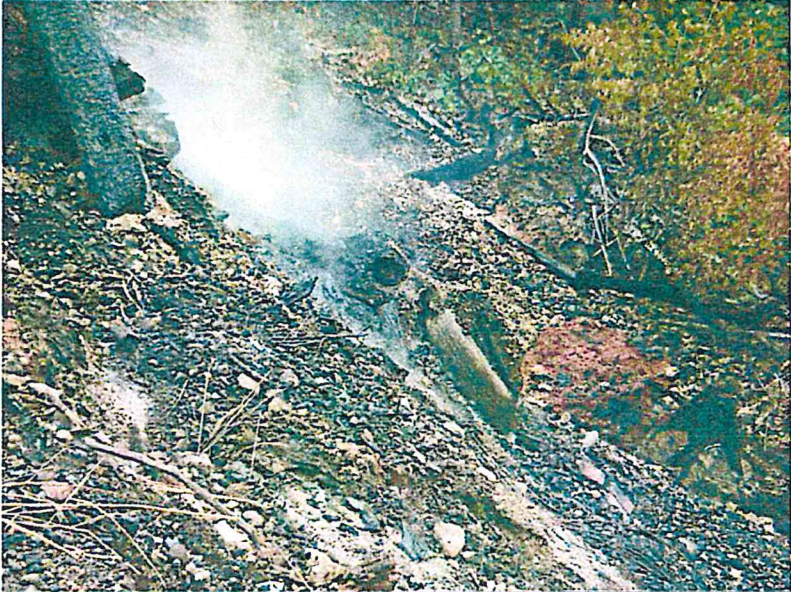
Witness	N/A		
Photo #	23	Of	27	Date	08/15/2018	Time	1116
Description	Closer view of solid wastes observed in Photo #22.

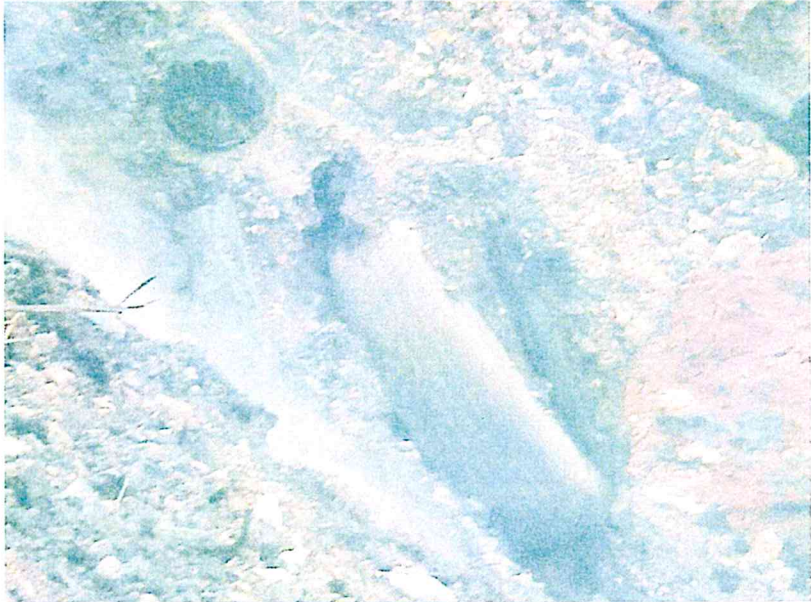
Witness	N/A		
Photo #	24	Of	27	Date	08/15/2018	Time	1116
Description	Closer view of solid wastes observed in Photo #23.

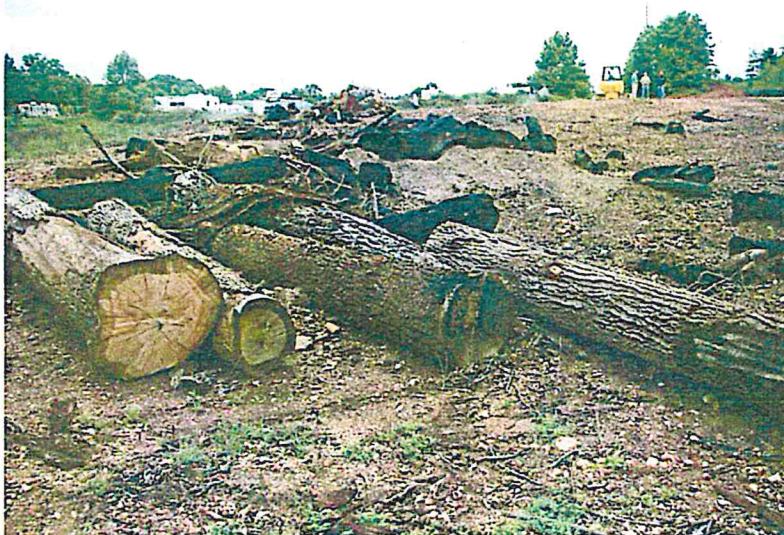
Location	BTS Equipment, LLC, Trafalgar Road, Bella Vista, Arkansas			Complaint #	024195	County	Benton
Photographer	Chris Krou, Compliance Branch Manager		<i>CK</i>	Witness	N/A		
Photo #	25	Of	27	Date	08/15/2018	Time	1121
Description	Overall view of the northern most of three (3) solid waste piles observe don the platform, looking toward the south/south-east.

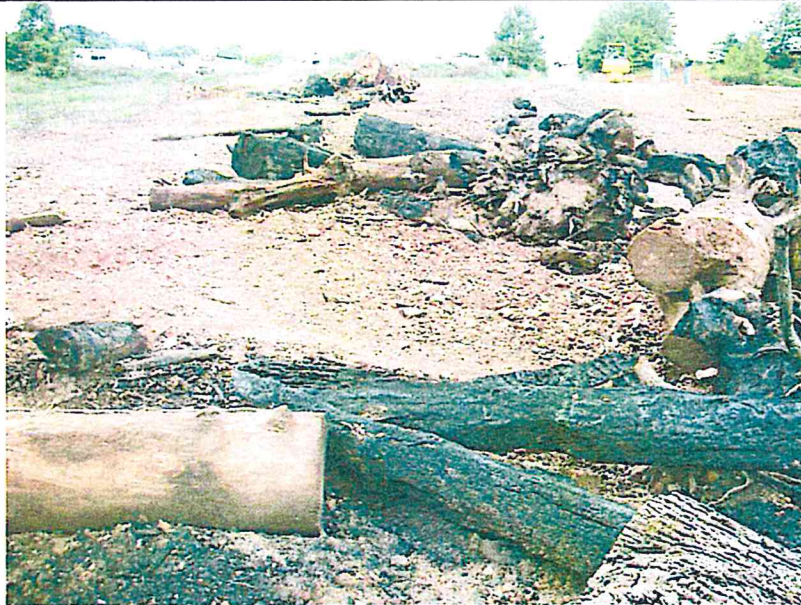
Location	BTS Equipment, LLC, Trafalgar Road, Bella Vista, Arkansas			Complaint #	024195	County	Benton
Photographer	Chris Krou, Compliance Branch Manager		<i>CK</i>	Witness	N/A		
Photo #	26	Of	27	Date	08/15/2018	Time	1122
Description	Close-up view of the solid waste pile contents shown in Photo #25.
