COMPLAINT REPORT

COMPLAINT# 024312 AFIN# 04-00000 DATE RECEIVED 8/30/2018

COMPLAINT AGAINST	ADDRESS	PHONE
Blue Mountain Storage LLC (dba Bedrock Boat & RV Storage)	Trafalgar Rd., Bella Vista, AR	(479) 855-4637

COMPLAINT DESCRIPTION Alleged part of unpermitted landfill site below the RV storage lot.

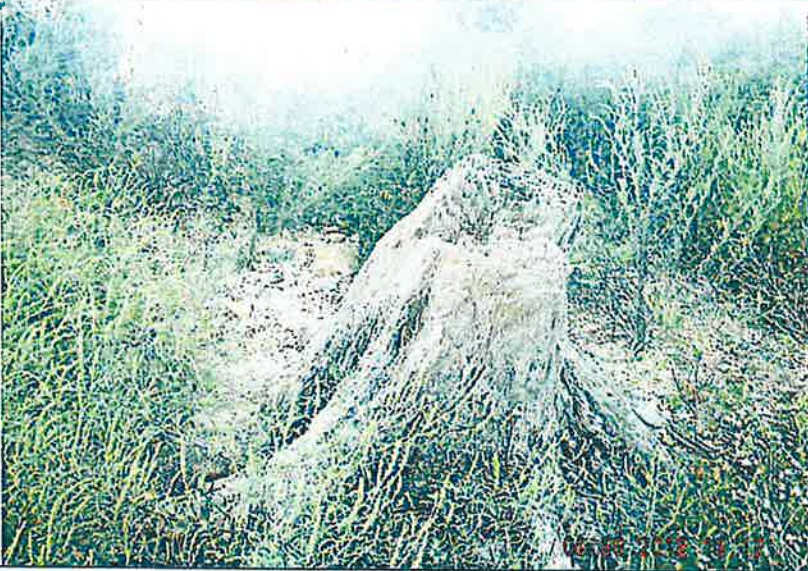
Upon referencing the photos, solid waste (specifically two (2) tree stumps) were observed partially buried along the northern berm of the RV storage lot. This is a violation of A.C.A. § 8-6-205(a)(3) which states it shall be illegal for any person to dispose of solid wastes at any disposal site or facility other than a disposal site or facility for which a permit has been issued by the Department.

Witness	N/A		
Photo #	1	Of	15	Date	8/30/2018	Time	1317
Description	View of a stump on berm adjacent to Blue Mountain Storage.

Letter will be sent to owner.

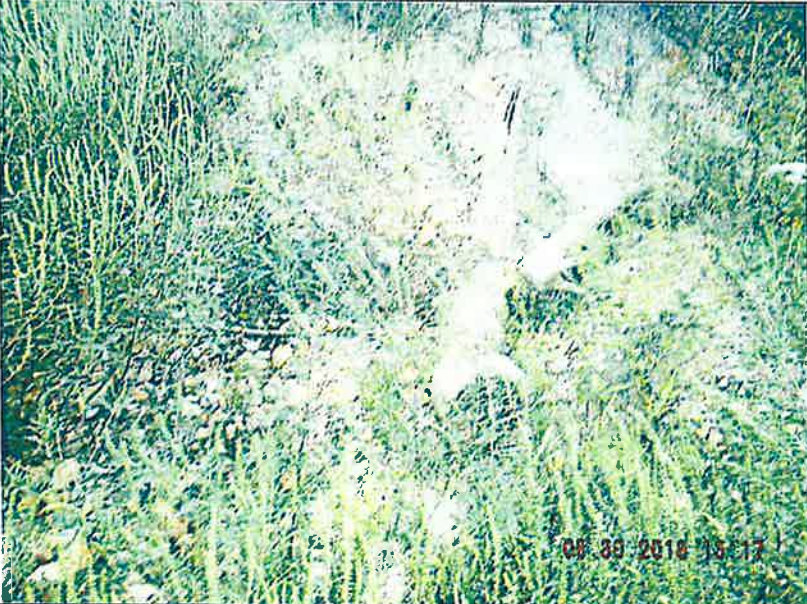
Witness	N/A		
Photo #	2	Of	15	Date	8/30/2018	Time	1317
Description	Additional stump, same as Photo #1. No other stumps or logs were observed around gravel pad.

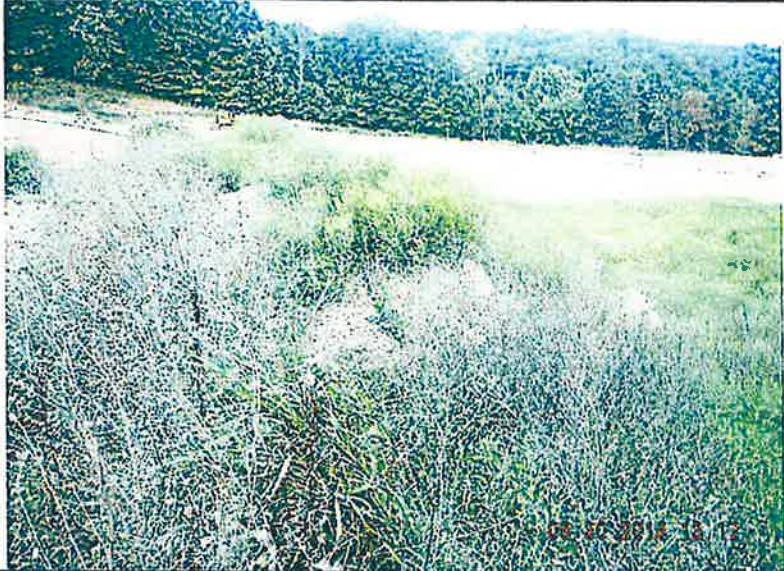
Witness	N/A		
Photo #	3	Of	15	Date	8/30/2018	Time	1317
Description	Top of berm from Photos #1 & #2. Looking west along the northern berm of the RV lot.

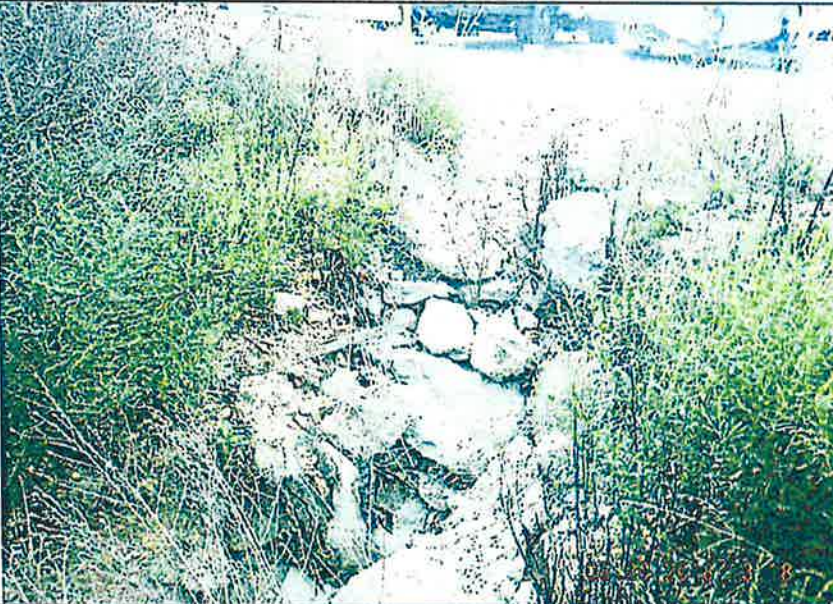
Witness	N/A		
Photo #	4	Of	15	Date	8/30/2018	Time	1318
Description	Stormwater outfall on the northern berm of the RV lot.

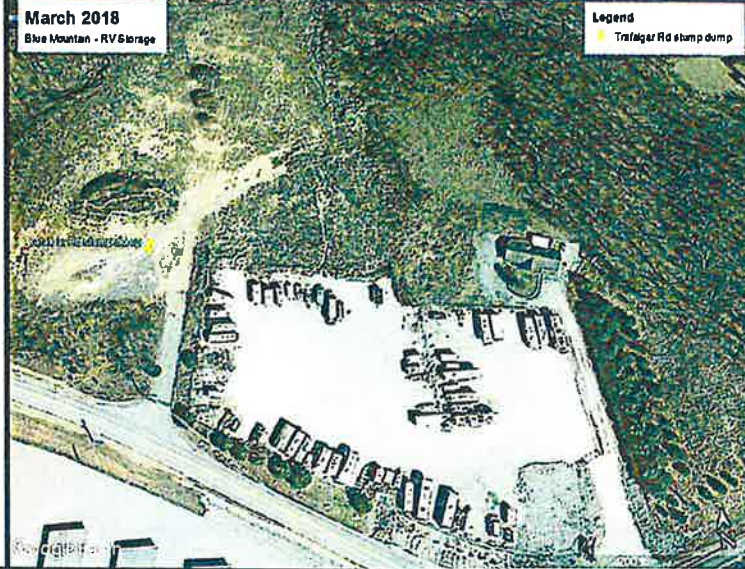
The property on Trafalgar Road meets the definition of a disposal site. Satellite imagery shows the RV storage lot is located above the southern portion of this disposal site which was filled with solid wastes over the years, and therefore, must have a permit from the ADEQ. Upon review of current records, Blue Mountain does not currently, or in the past, possess a valid permit for this disposal site of solid wastes from the ADEQ. This is a violation of APC&EC Regulation 22.1502(a) and A.C.A. § 8-6-205(a)(2) which states, in part, it is unlawful to construct, install, alter, modify, use or operate, any solid waste disposal or processing facility or site without a permit from the Department.

Location	Trafalgar Rd., Bella Vista, AR			Complaint #	024312	County	Benton
Photographer	Chris Krou, Compliance Branch Manager		<i>CK</i>	Witness	N/A		
Photo #	5	Of	15	Date	8/30/2018	Time	NA
Description	Google Earth satellite image of the Trafalgar Road stump dump/Blue Mountain –RV Storage lot.

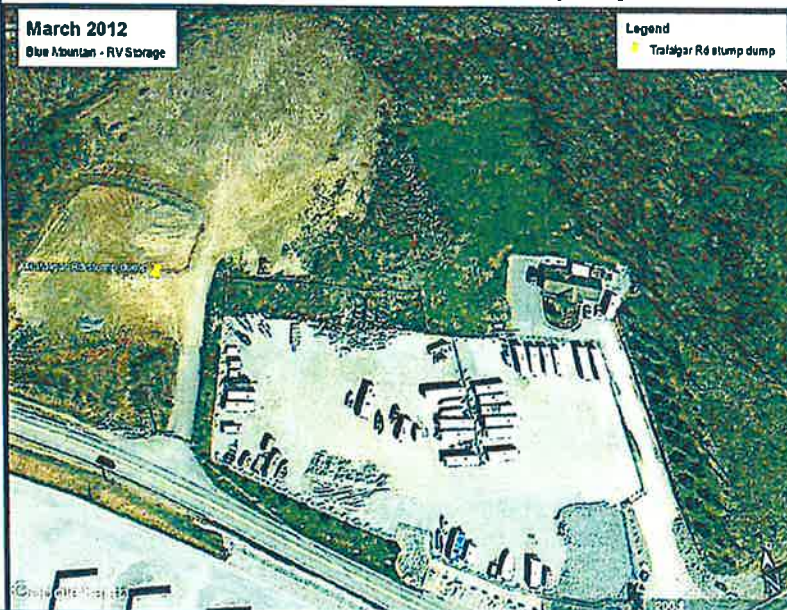
Location	Trafalgar Rd., Bella Vista, AR			Complaint #	024312	County	Benton
Photographer	Chris Krou, Compliance Branch Manager		<i>CK</i>	Witness	N/A		
Photo #	6	Of	15	Date	8/30/2018	Time	NA
Description	Google Earth satellite image of the Trafalgar Road stump dump/Blue Mountain –RV Storage lot.

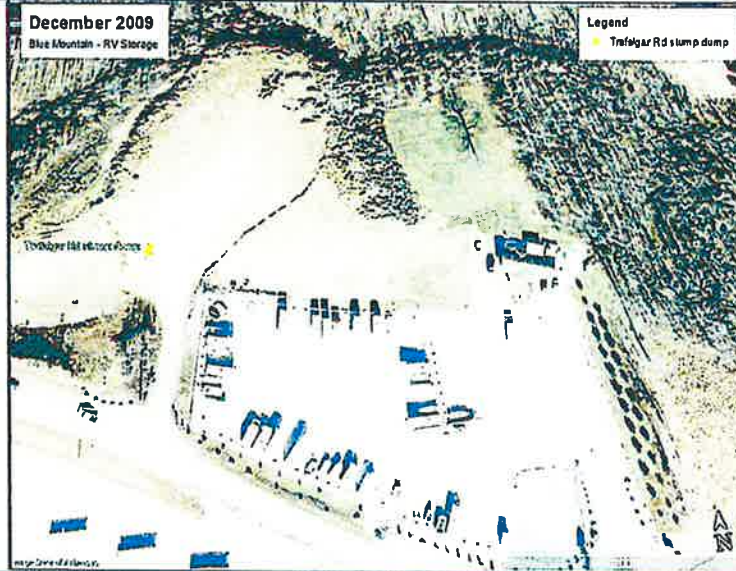
Location	Trafalgar Rd., Bella Vista, AR			Complaint #	024312	County	Benton
Photographer	Chris Krou, Compliance Branch Manager		<i>CK</i>	Witness	N/A		
Photo #	7	Of	15	Date	8/30/2018	Time	NA
Description	Google Earth satellite image of the Trafalgar Road stump dump/Blue Mountain –RV Storage lot.

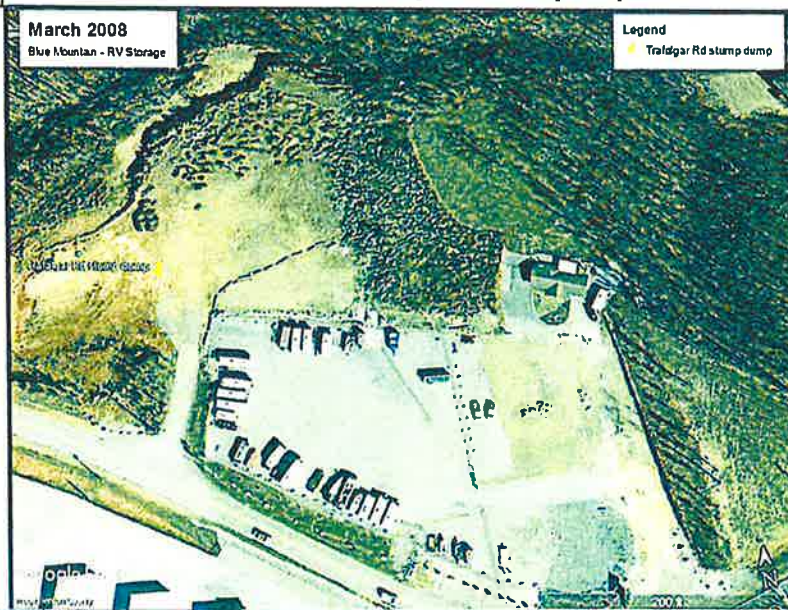
Location	Trafalgar Rd., Bella Vista, AR			Complaint #	024312	County	Benton
Photographer	Chris Krou, Compliance Branch Manager		<i>CK</i>	Witness	N/A		
Photo #	8	Of	15	Date	8/30/2018	Time	NA
Description	Google Earth satellite image of the Trafalgar Road stump dump/Blue Mountain –RV Storage lot.

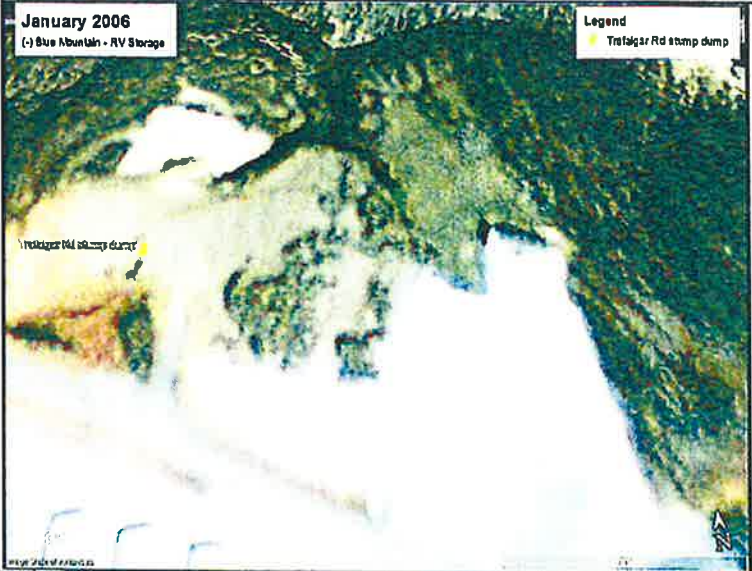
Witness	N/A		
Photo #	9	Of	15	Date	8/30/2018	Time	NA
Description	Google Earth satellite image of the Trafalgar Road stump dump/Blue Mountain –RV Storage lot.

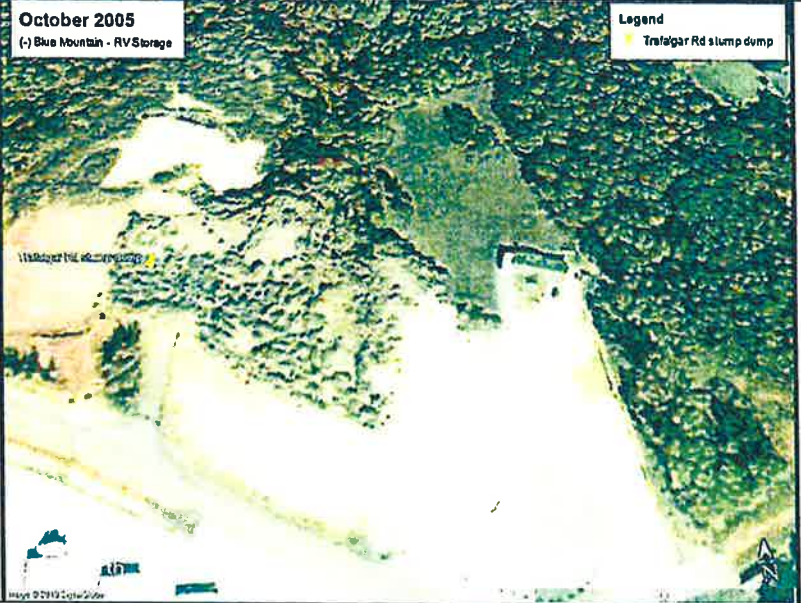
Witness	N/A		
Photo #	10	Of	15	Date	8/30/2018	Time	NA
Description	Google Earth satellite image of the Trafalgar Road stump dump/Blue Mountain –RV Storage lot.

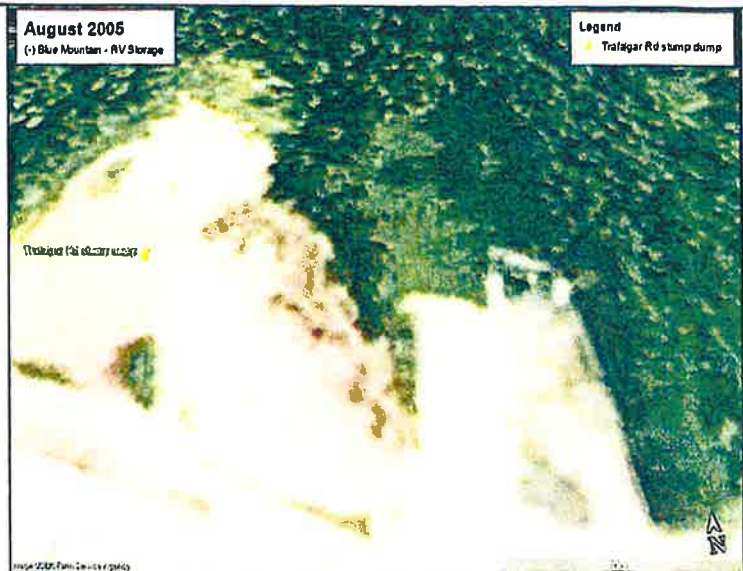
Location	Trafalgar Rd., Bella Vista, AR			Complaint #	024312	County	Benton
Photographer	Chris Krou, Compliance Branch Manager		<i>CK</i>	Witness	N/A		
Photo #	11	Of	15	Date	8/30/2018	Time	NA
Description	Google Earth satellite image of the Trafalgar Road stump dump/Blue Mountain –RV Storage lot.

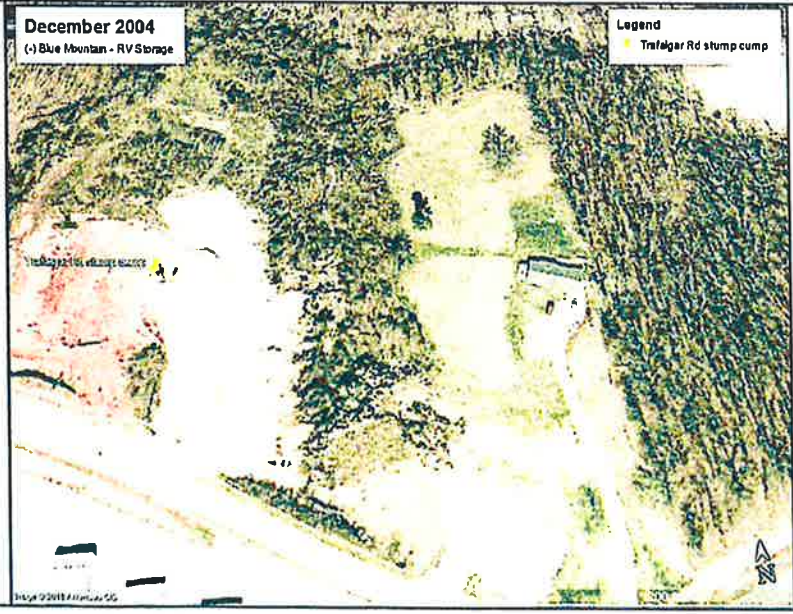
Location	Trafalgar Rd., Bella Vista, AR			Complaint #	024312	County	Benton
Photographer	Chris Krou, Compliance Branch Manager		<i>CK</i>	Witness	N/A		
Photo #	12	Of	15	Date	8/30/2018	Time	NA
Description	Google Earth satellite image of the Trafalgar Road stump dump/Blue Mountain –RV Storage lot.

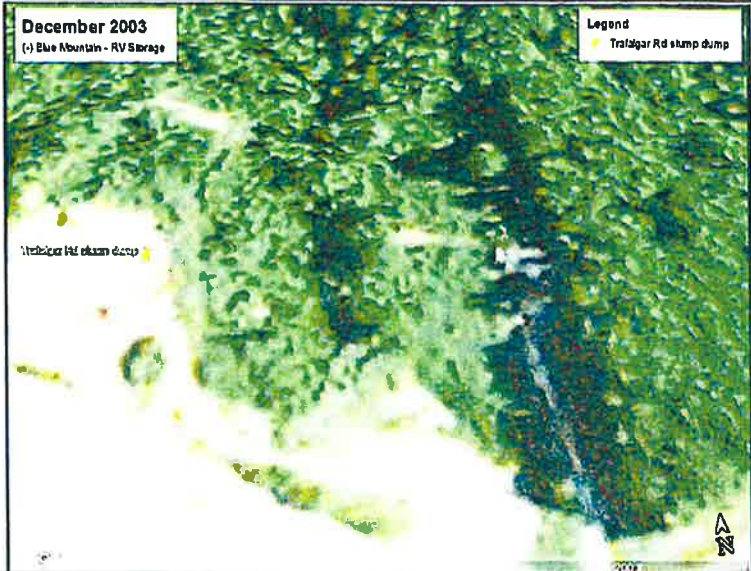
Location	Trafalgar Rd., Bella Vista, AR			Complaint #	024312	County	Benton
Photographer	Chris Krou, Compliance Branch Manager	<i>CJK</i>		Witness	N/A		
Photo #	13	Of	15	Date	8/30/2018	Time	NA
Description	Google Earth satellite image of the Trafalgar Road stump dump/Blue Mountain –RV Storage lot.

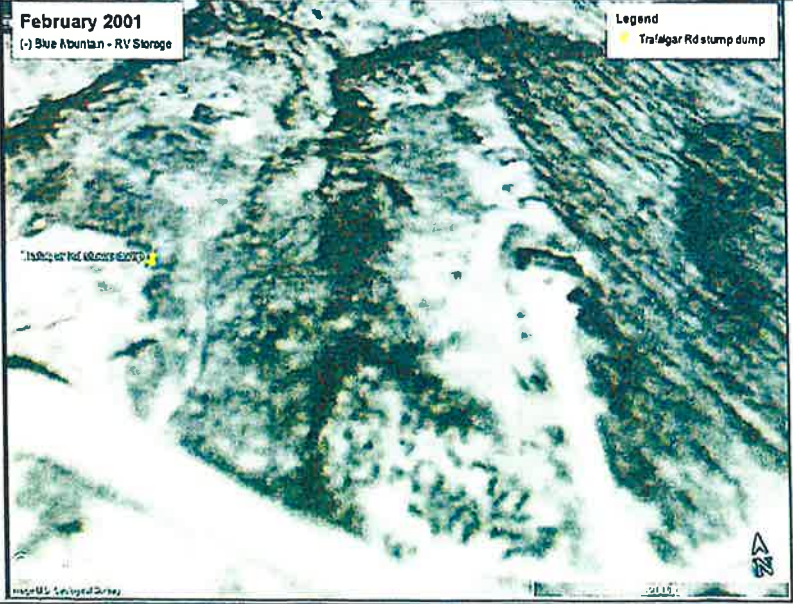
Location	Trafalgar Rd., Bella Vista, AR			Complaint #	024312	County	Benton
Photographer	Chris Krou, Compliance Branch Manager	<i>CJK</i>		Witness	N/A		
Photo #	14	Of	15	Date	8/30/2018	Time	NA
Description	Google Earth satellite image of the Trafalgar Road stump dump/Blue Mountain –RV Storage lot.
