RE: Complaint Investigation conducted on August 2, 8 and 15, 2018
Complaint #024195
ERC #18-0372
AFIN 04-02528

COMPLAINT REPORT

COMPLAINT# 024195 AFIN# 04-02528 DATE RECEIVED 8/2/2018

COMPLAINT AGAINST	ADDRESS	PHONE
BTS Equipment, LLC, dba Brown's Tree Service or Brown's Tree Care	Trafalgar Road, Belle Vista, AR	(479) 273-0202

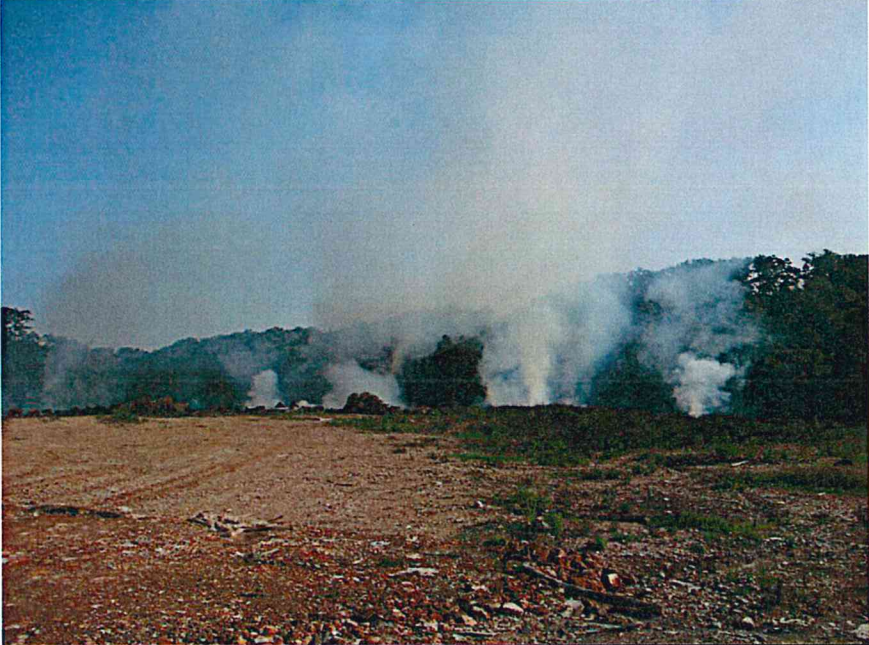
Location	BTS Equipment, LLC, Trafalgar Road, Bella Vista, Arkansas			Complaint #	024195	County	Benton
Photographer	Jay Ellis, Air Inspector			Witness	N/A		
Photo #	1	Of	27	Date	08/02/2018	Time	a.m.
Description	Bella Vista stump dump fire, looking north.

Again referencing the photos, smoke can clearly be seen rising just beyond the northern edge of the platform, along the eastern edge of the platform, along the north-western edge of the platform, and also to the south of the northern edge. (Refer to Photos #1 - #6.) The rising smoke and/or the contents within it, is construed to create a public nuisance as evidenced by the original complaint being made to the ADEQ, possibly a public health hazard due to unknown materials burning from within the waste mass, and is the cause of air pollution. This is a violation of A.C.A. § 8-6-205(a)(5) which states it shall be illegal for any person to sort, collect, transport, process, or dispose of solid waste contrary to the rules, regulations, or orders of the Department or in such a manner or place as to create or be likely to create a public nuisance or a public health hazard or to cause or be likely to cause water or air pollution within the meaning of the Arkansas Water and Air Pollution Control Act, § 8-4-101 et seq.

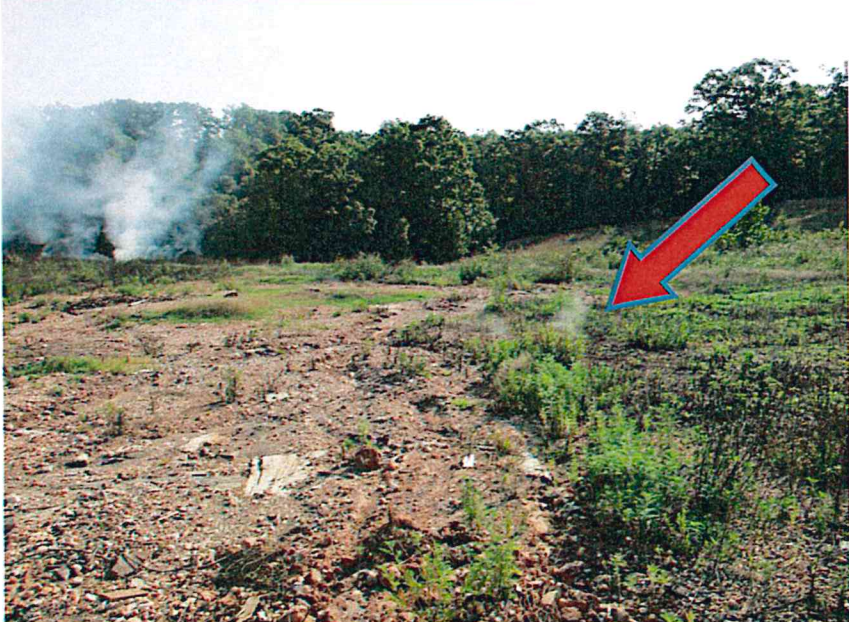
Location	BTS Equipment, LLC, Trafalgar Road, Bella Vista, Arkansas			Complaint #	024195	County	Benton
Photographer	Jay Ellis, Air Inspector			Witness	N/A		
Photo #	2	Of	27	Date	08/02/2018	Time	a.m.
Description	Bella Vista stump dump fire looking northeast – smoke visible south of north edge.

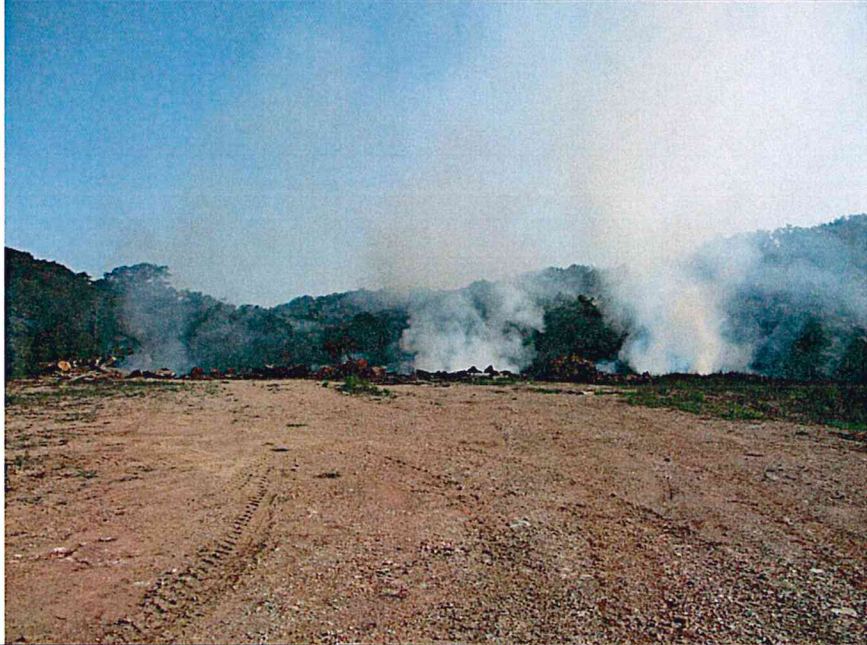
Location	BTS Equipment, LLC, Trafalgar Road, Bella Vista, Arkansas			Complaint #	024195	County	Benton
Photographer	Jay Ellis, Air Inspector			Witness	N/A		
Photo #	3	Of	27	Date	08/02/2018	Time	a.m.
Description	Bella Vista stump dump fire, looking north.

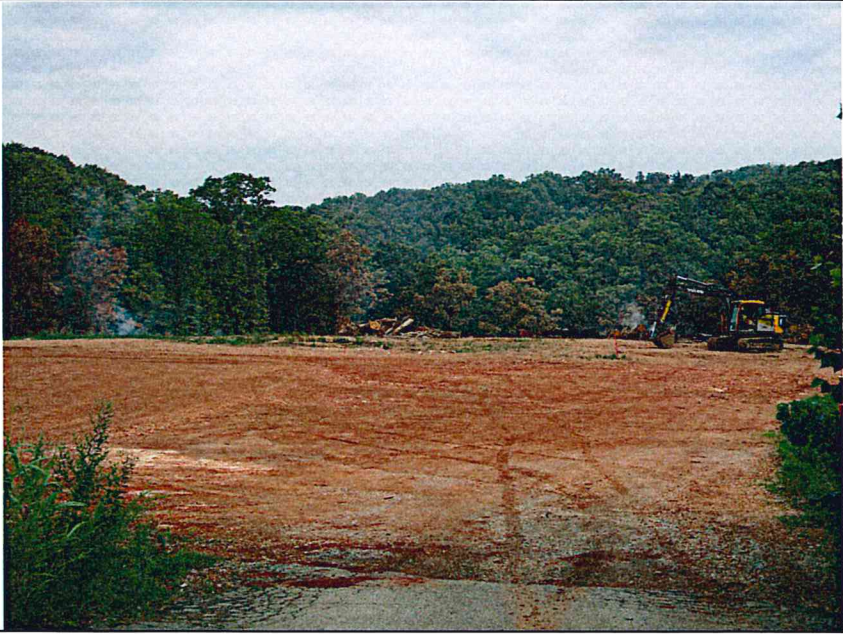
Location	BTS Equipment, LLC, Trafalgar Road, Bella Vista, Arkansas			Complaint #	024195	County	Benton
Photographer	Jay Ellis, Air Inspector			Witness	N/A		
Photo #	4	Of	27	Date	08/08/2018	Time	a.m.
Description	Wide view of Bella Vista stump dump fire, looking north.

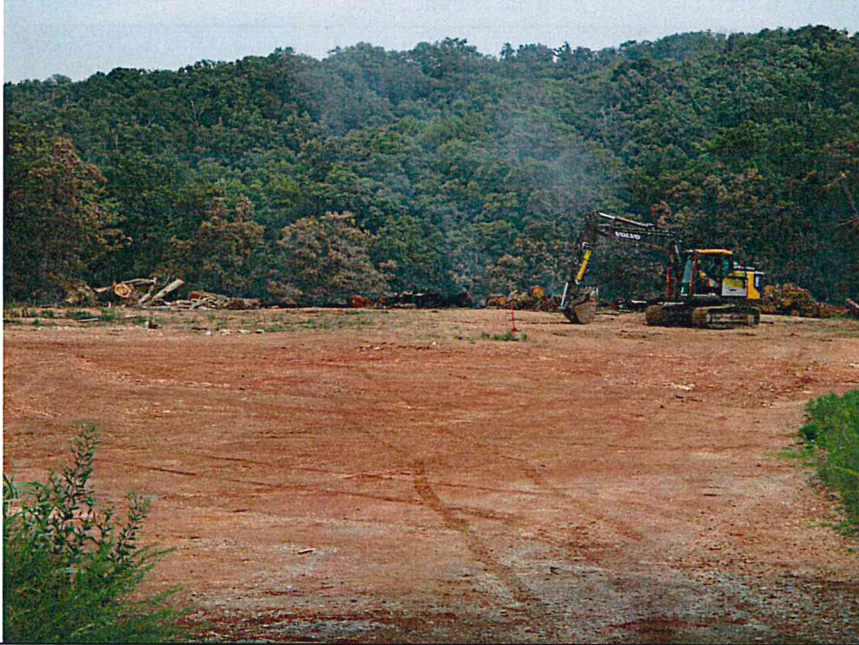
Location	BTS Equipment, LLC, Trafalgar Road, Bella Vista, Arkansas			Complaint #	024195	County	Benton
Photographer	Jay Ellis, Air Inspector			Witness	N/A		
Photo #	5	Of	27	Date	08/08/2018	Time	a.m.
Description	Closer/tighter view from same place Photo #4 was taken, looking north.

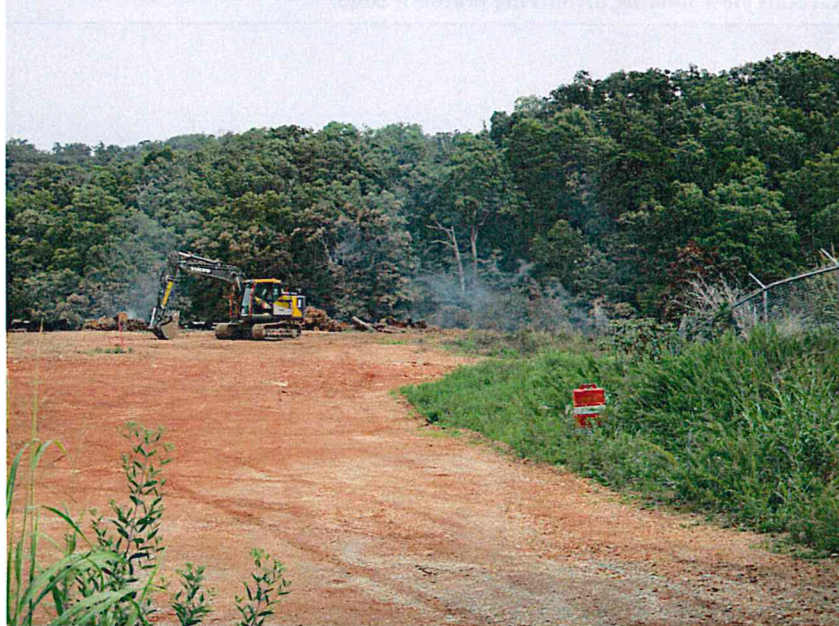
Location	BTS Equipment, LLC, Trafalgar Road, Bella Vista, Arkansas			Complaint #	024195	County	Benton
Photographer	Jay Ellis, Air Inspector			Witness	N/A		
Photo #	6	Of	27	Date	08/08/2018	Time	a.m.
Description	Bella Vista stump dump fire, looking a little more northeast from Photo #5.

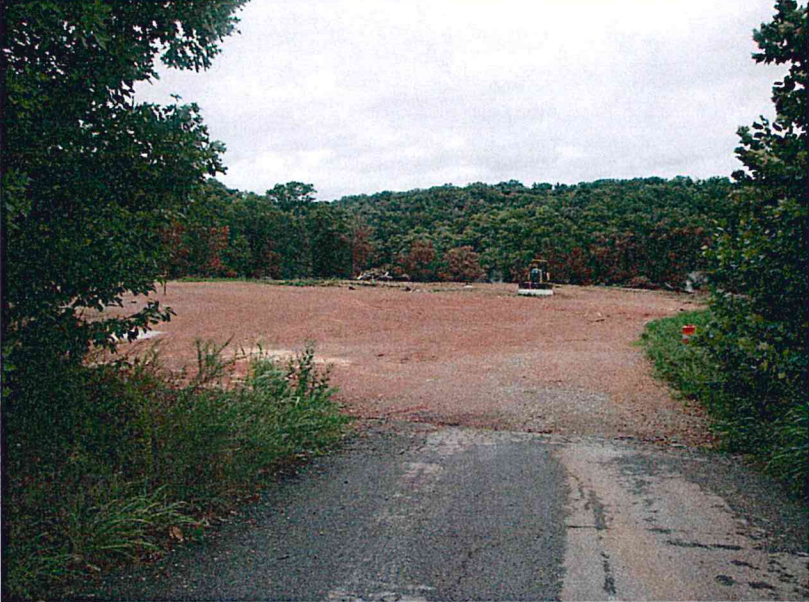
Witness	N/A		
Photo #	7	Of	27	Date	08/15/2018	Time	1050
Description	Overall view of the site from the entrance road.

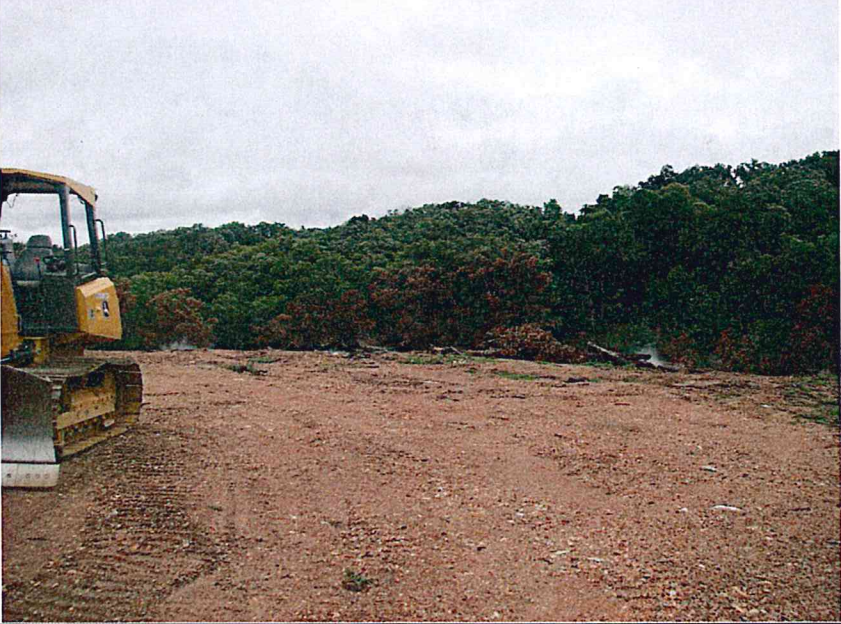
Witness	N/A		
Photo #	8	Of	27	Date	08/15/2018	Time	1054
Description	Overall view looking toward the northern edge.

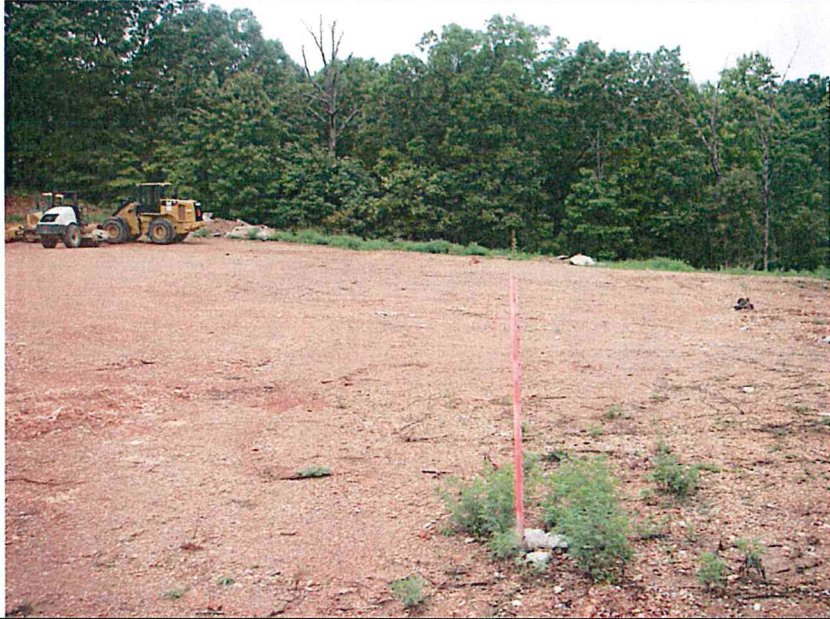
Location	BTS Equipment, LLC, Trafalgar Road, Bella Vista, Arkansas			Complaint #	024195	County	Benton
Photographer	Chris Krou, Compliance Branch Manager		<i>CK</i>	Witness	N/A		
Photo #	9	Of	27	Date	08/15/2018	Time	1056
Description	Looking directly west down the city parcel's northern property line.

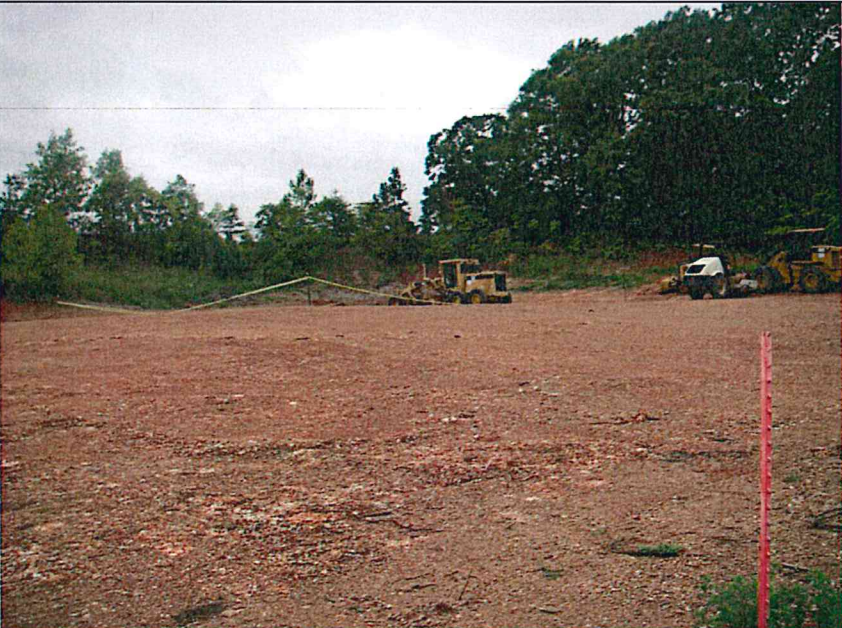
Location	BTS Equipment, LLC, Trafalgar Road, Bella Vista, Arkansas			Complaint #	024195	County	Benton
Photographer	Chris Krou, Compliance Branch Manager		<i>CK</i>	Witness	N/A		
Photo #	10	Of	27	Date	08/15/2018	Time	1056
Description	Looking southwest at the city's pad and equipment from their parcel's northeast corner.

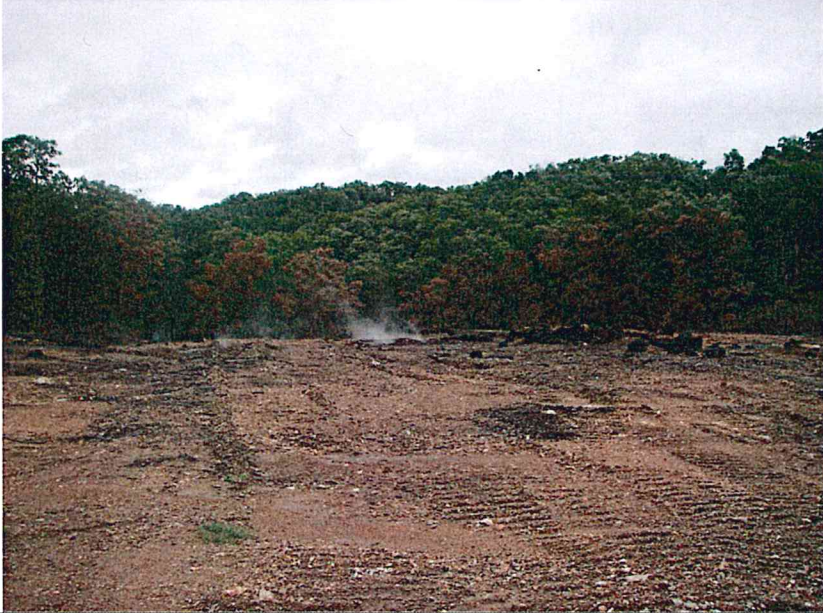
Location	BTS Equipment, LLC, Trafalgar Road, Bella Vista, Arkansas			Complaint #	024195	County	Benton
Photographer	Chris Krou, Compliance Branch Manager		<i>gk</i>	Witness	N/A		
Photo #	11	Of	27	Date	08/15/2018	Time	1058
Description	Overall view looking toward the northern edge.

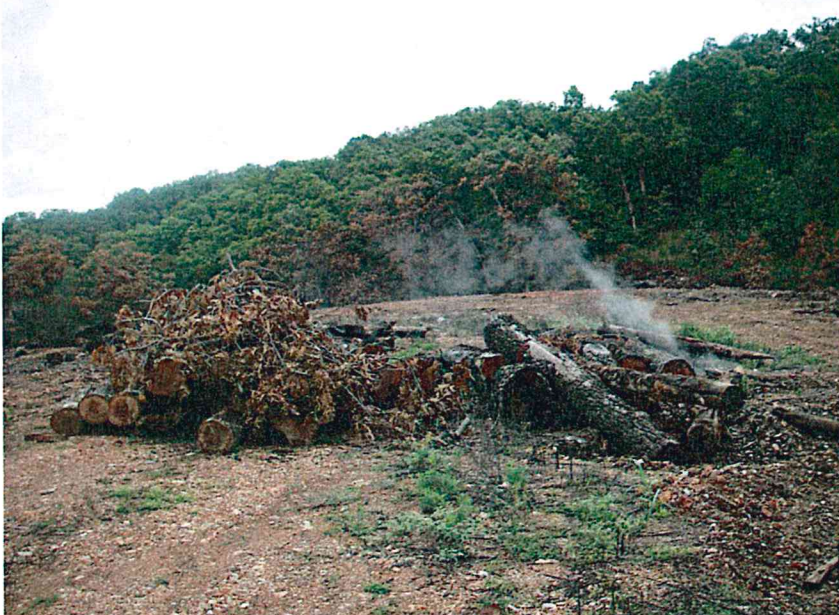
Location	BTS Equipment, LLC, Trafalgar Road, Bella Vista, Arkansas			Complaint #	024195	County	Benton
Photographer	Chris Krou, Compliance Branch Manager		<i>gk</i>	Witness	N/A		
Photo #	12	Of	27	Date	08/15/2018	Time	1059
Description	Overall view of the most easterly of three (3) solid waste piles, looking north.

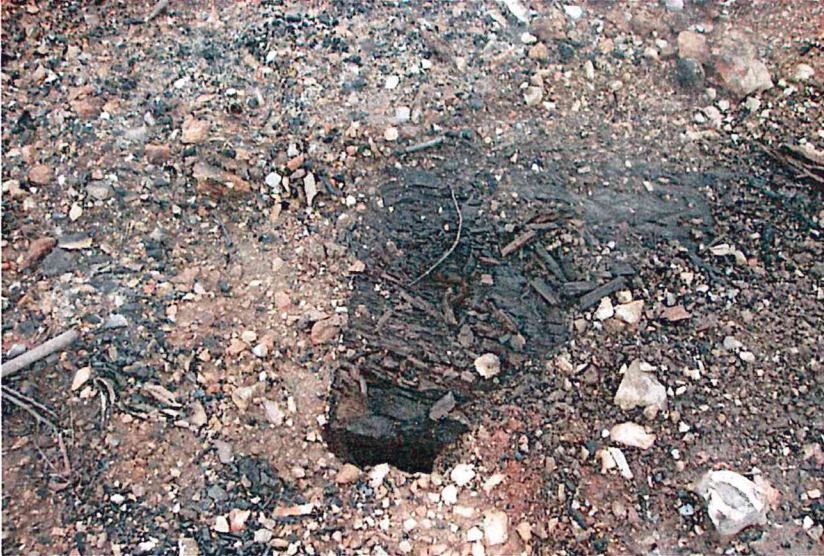
Location	BTS Equipment, LLC, Trafalgar Road, Bella Vista, Arkansas			Complaint #	024195	County	Benton
Photographer	Chris Krou, Compliance Branch Manager		<i>CK</i>	Witness	N/A		
Photo #	13	Of	27	Date	08/15/2018	Time	1101
Description	View of a vent coming up through the pad from the waste below.

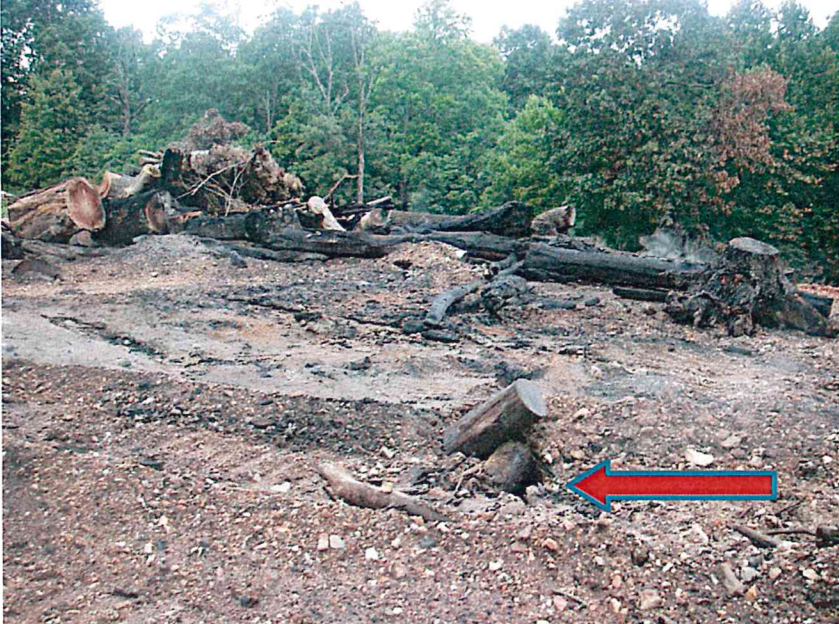
Location	BTS Equipment, LLC, Trafalgar Road, Bella Vista, Arkansas			Complaint #	024195	County	Benton
Photographer	Chris Krou, Compliance Branch Manager		<i>CK</i>	Witness	N/A		
Photo #	14	Of	27	Date	08/15/2018	Time	1104
Description	Overall view of the most westerly of three (3) solid waste piles on the platform, looking west. Another vent from waste below is located below the logs in the foreground (red arrow).

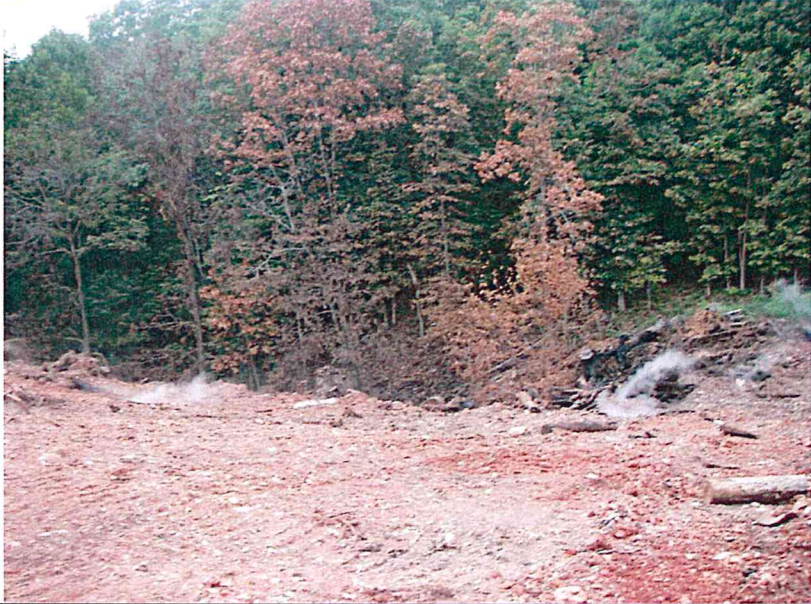
Witness	N/A		
Photo #	15	Of	27	Date	08/15/2018	Time	1107
Description	View of the western edge, looking west, south-west.

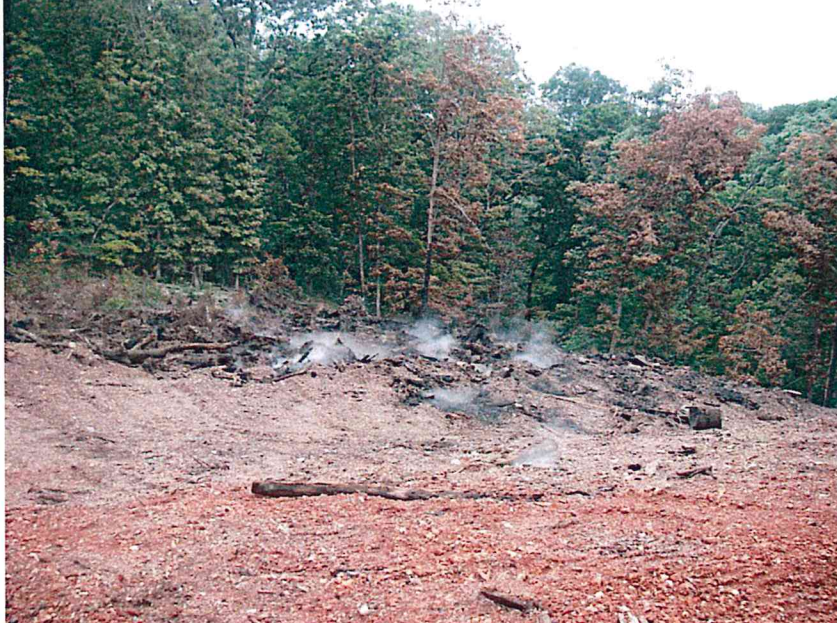
Witness	N/A		
Photo #	16	Of	27	Date	08/15/2018	Time	1109
Description	View of the western edge, looking more north, north-west from Photo #15.

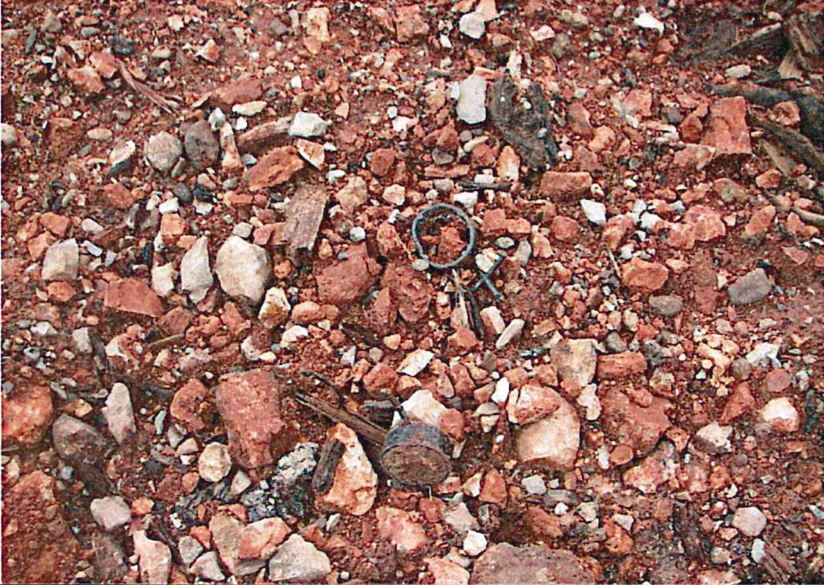
Location	BTS Equipment, LLC, Trafalgar Road, Bella Vista, Arkansas			Complaint #	024195	County	Benton
Photographer	Chris Krou, Compliance Branch Manager		<i>CK</i>	Witness	N/A		
Photo #	17	Of	27	Date	08/15/2018	Time	1111
Description	Examples of the hundreds of black plastic pieces of solid waste observed scattered on the ground.

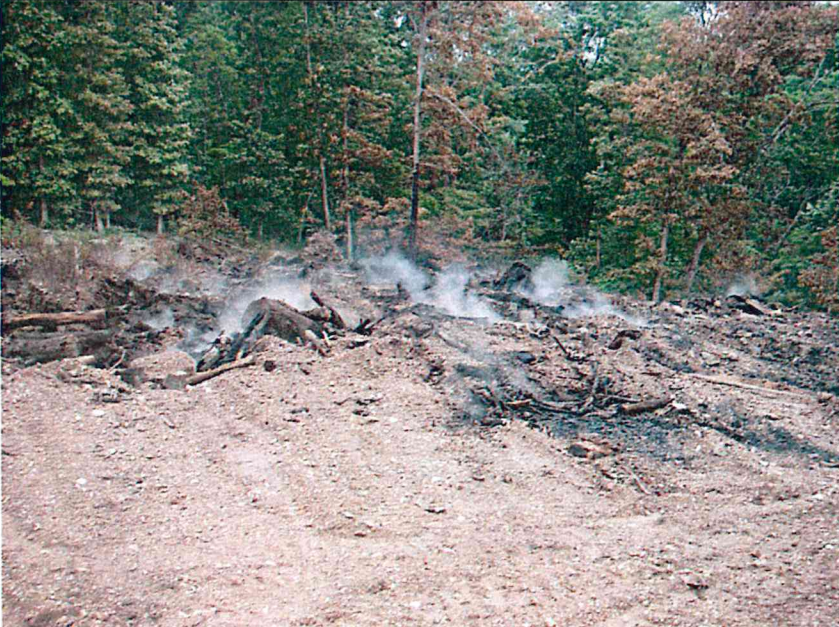
Location	BTS Equipment, LLC, Trafalgar Road, Bella Vista, Arkansas			Complaint #	024195	County	Benton
Photographer	Chris Krou, Compliance Branch Manager		<i>CK</i>	Witness	N/A		
Photo #	18	Of	27	Date	08/15/2018	Time	1113
Description	Overall view along the north-west corner/edge.

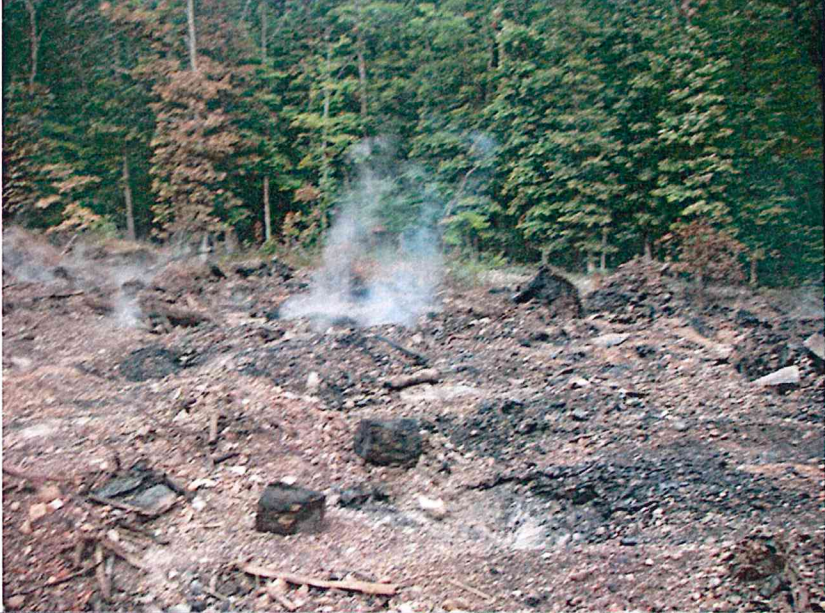
Witness	N/A		
Photo #	19	Of	27	Date	08/15/2018	Time	1114
Description	Overall view just before the northern edge, looking west.

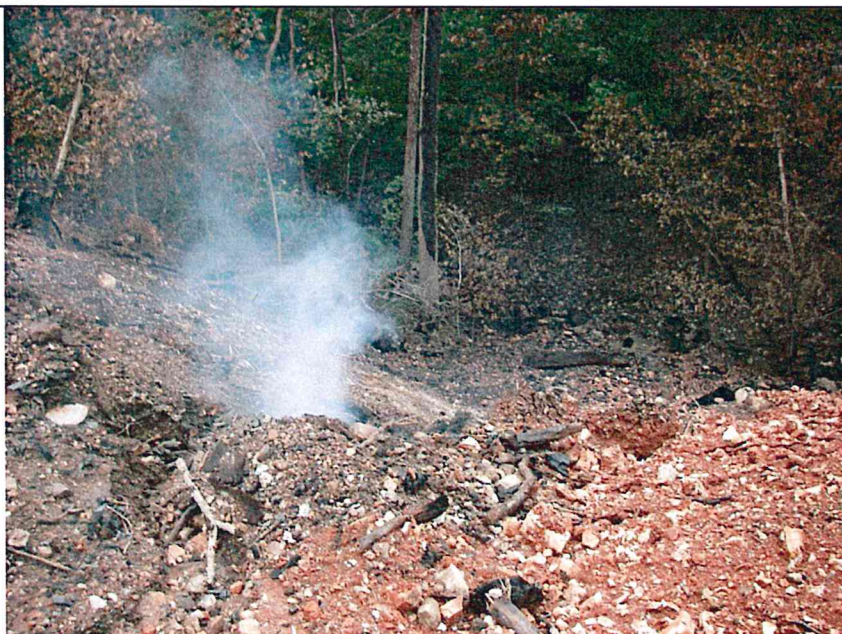
Witness	N/A		
Photo #	20	Of	27	Date	08/15/2018	Time	1114
Description	Overall view from the lip on the northern edge, looking north/down at the valley floor below.

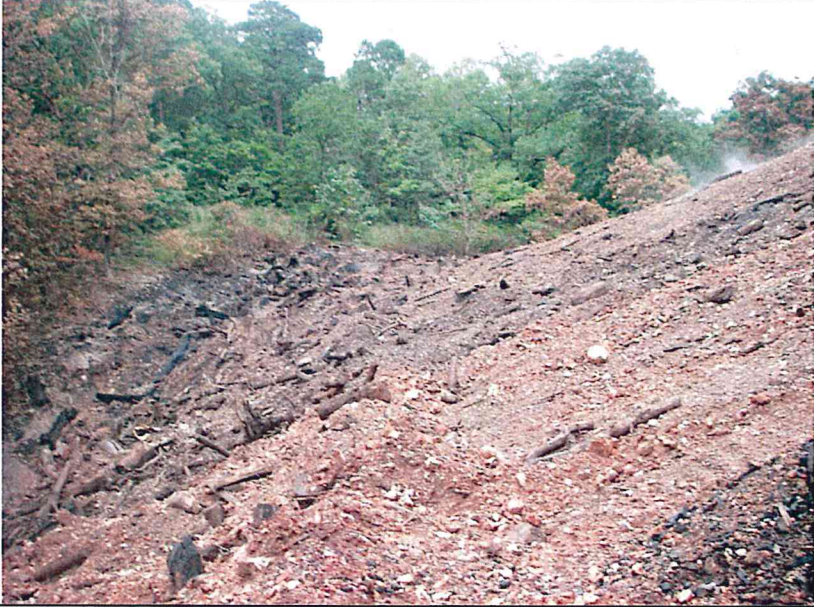
Location	BTS Equipment, LLC, Trafalgar Road, Bella Vista, Arkansas			Complaint #	024195	County	Benton
Photographer	Chris Krou, Compliance Branch Manager		<i>gk</i>	Witness	N/A		
Photo #	21	Of	27	Date	08/15/2018	Time	1116
Description	Overall view from just below the lip on the northern edge, looking east/south-east.

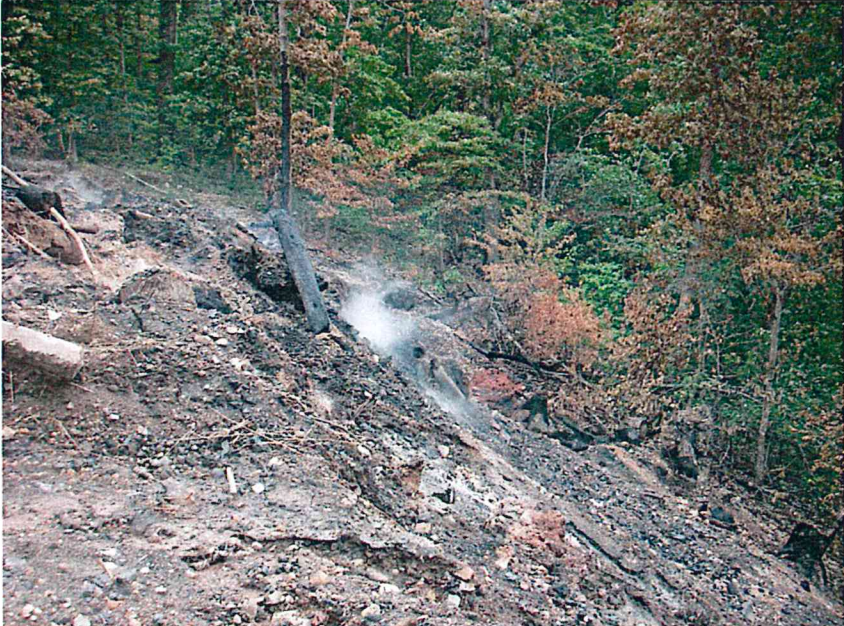
Location	BTS Equipment, LLC, Trafalgar Road, Bella Vista, Arkansas			Complaint #	024195	County	Benton
Photographer	Chris Krou, Compliance Branch Manager		<i>gk</i>	Witness	N/A		
Photo #	22	Of	27	Date	08/15/2018	Time	1116
Description	Overall view from just below the lip on the northern edge, looking west.

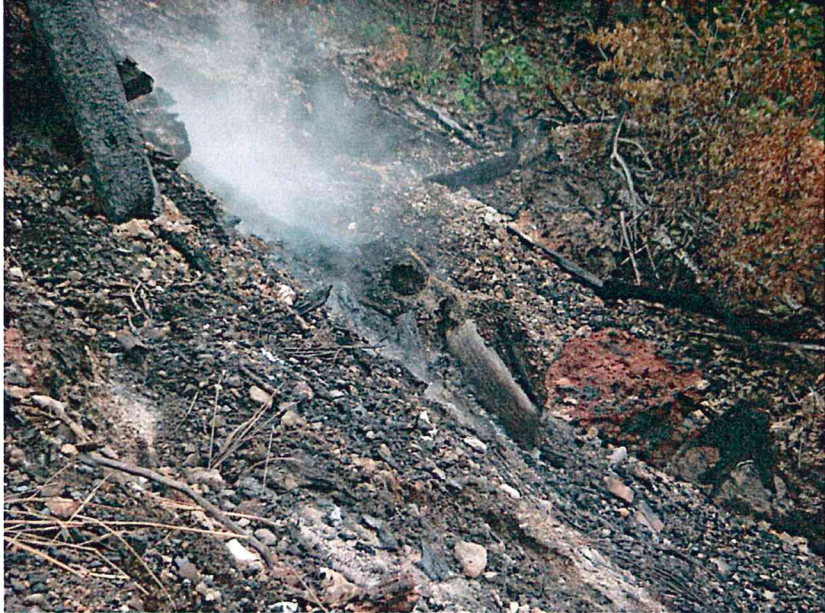
Witness	N/A		
Photo #	23	Of	27	Date	08/15/2018	Time	1116
Description	Closer view of solid wastes observed in Photo #22.

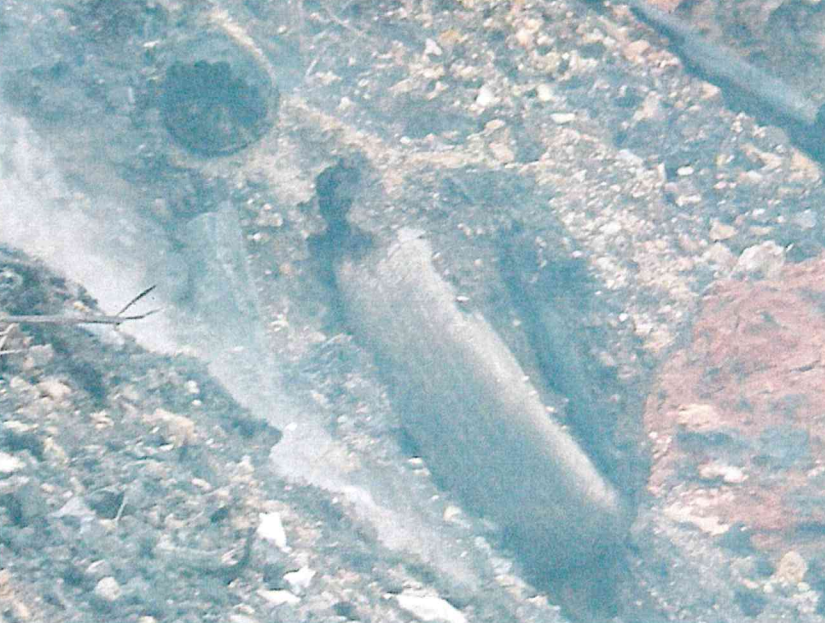
Witness	N/A		
Photo #	24	Of	27	Date	08/15/2018	Time	1116
Description	Closer view of solid wastes observed in Photo #23.
