**RE: Complaint Investigation of August 30, 2018
Complaint #024312**

COMPLAINT REPORT

COMPLAINT DESCRIPTION Alleged part of unpermitted landfill site below the RV storage lot.

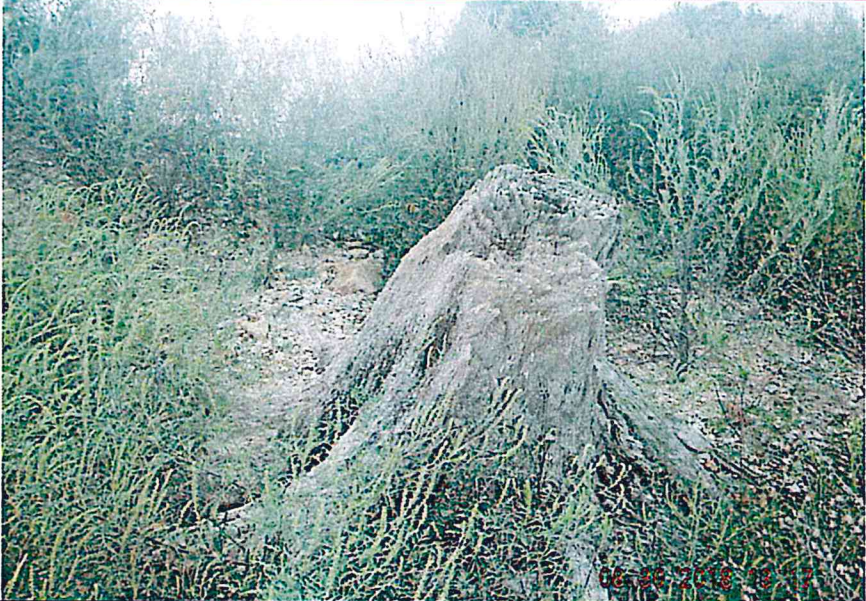
Upon referencing the photos, solid waste (specifically two (2) tree stumps) were observed partially buried along the northern berm of the RV storage lot. This is a violation of A.C.A. § 8-6-205(a)(3) which states it shall be illegal for any person to dispose of solid wastes at any disposal site or facility other than a disposal site or facility for which a permit has been issued by the Department.

Witness	N/A		
Photo #	1	Of	15	Date	8/30/2018	Time	1317
Description	View of a stump on berm adjacent to Blue Mountain Storage.

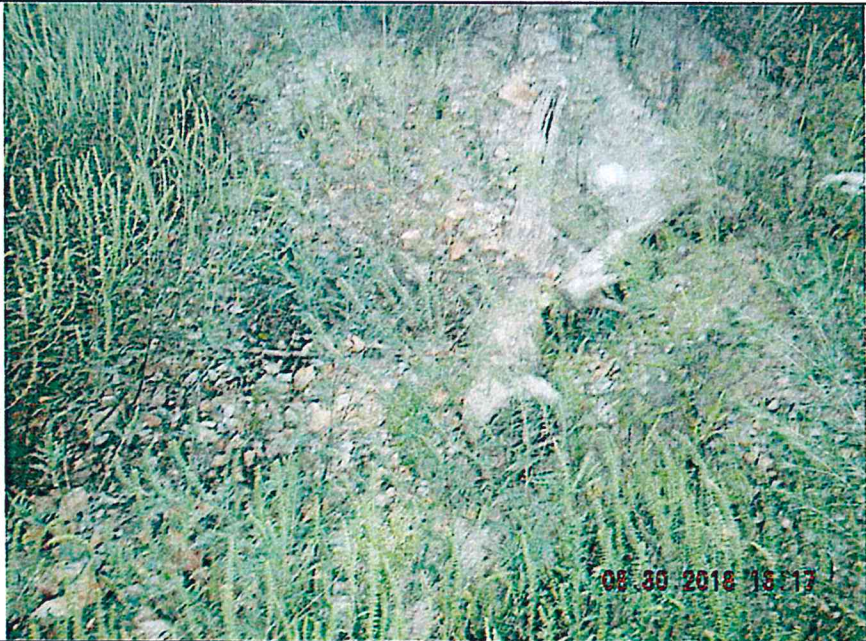
Witness	N/A		
Photo #	2	Of	15	Date	8/30/2018	Time	1317
Description	Additional stump, same as Photo #1. No other stumps or logs were observed around gravel pad.

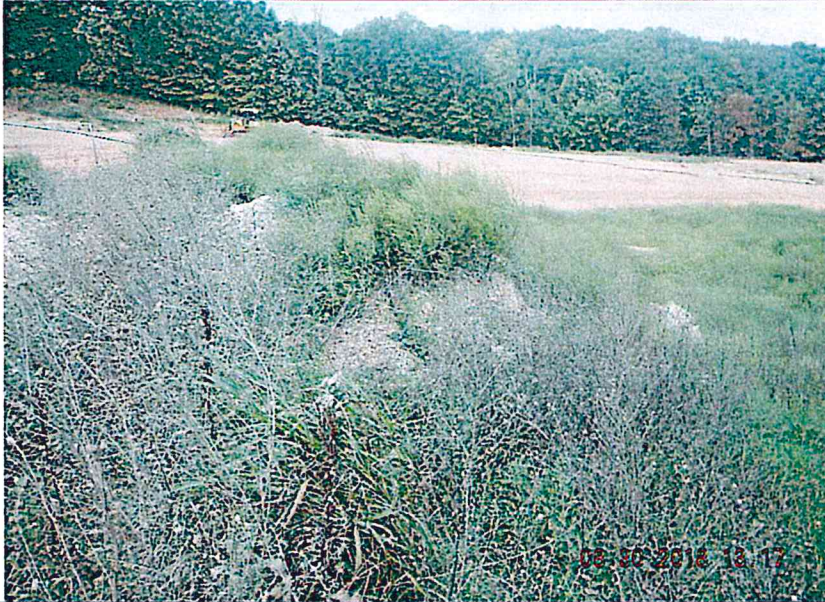
Witness	N/A		
Photo #	3	Of	15	Date	8/30/2018	Time	1317
Description	Top of berm from Photos #1 & #2. Looking west along the northern berm of the RV lot.

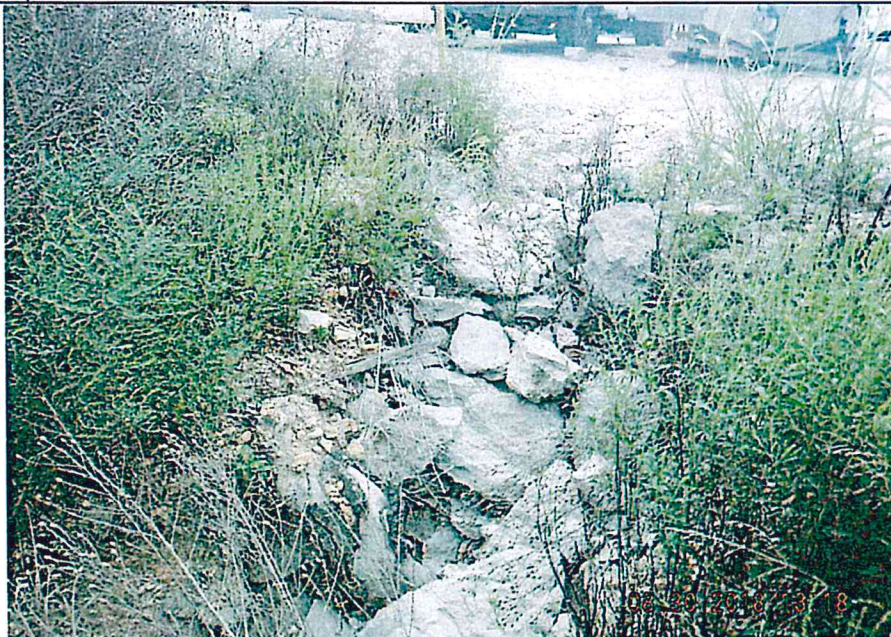
Witness	N/A		
Photo #	4	Of	15	Date	8/30/2018	Time	1318
Description	Stormwater outfall on the northern berm of the RV lot.

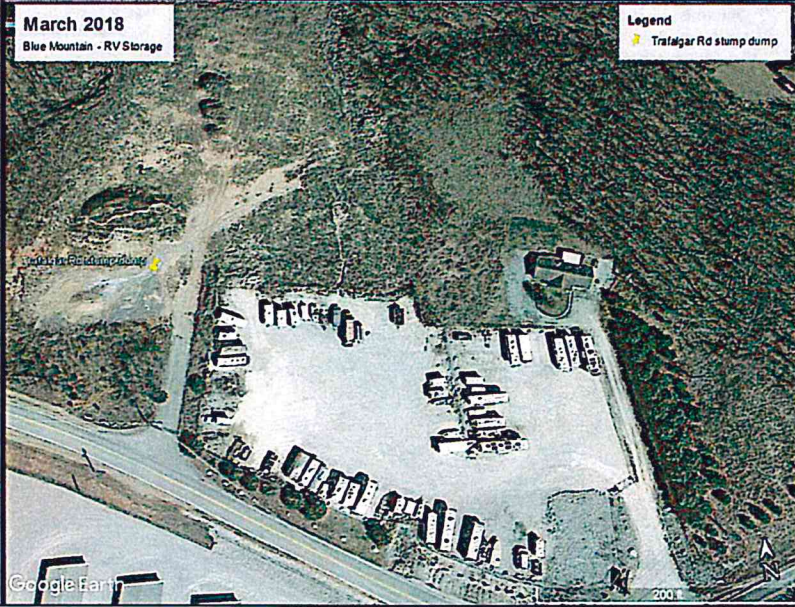
The property on Trafalgar Road meets the definition of a disposal site. Satellite imagery shows the RV storage lot is located above the southern portion of this disposal site which was filled with solid wastes over the years, and therefore, must have a permit from the ADEQ. Upon review of current records, Blue Mountain does not currently, or in the past, possess a valid permit for this disposal site of solid wastes from the ADEQ. This is a violation of APC&EC Regulation 22.1502(a) and A.C.A. § 8-6-205(a)(2) which states, in part, it is unlawful to construct, install, alter, modify, use or operate, any solid waste disposal or processing facility or site without a permit from the Department.

Location	Trafalgar Rd., Bella Vista, AR			Complaint #	024312	County	Benton
Photographer	Chris Krou, Compliance Branch Manager		<i>CK</i>	Witness	N/A		
Photo #	5	Of	15	Date	8/30/2018	Time	NA
Description	Google Earth satellite image of the Trafalgar Road stump dump/Blue Mountain –RV Storage lot.

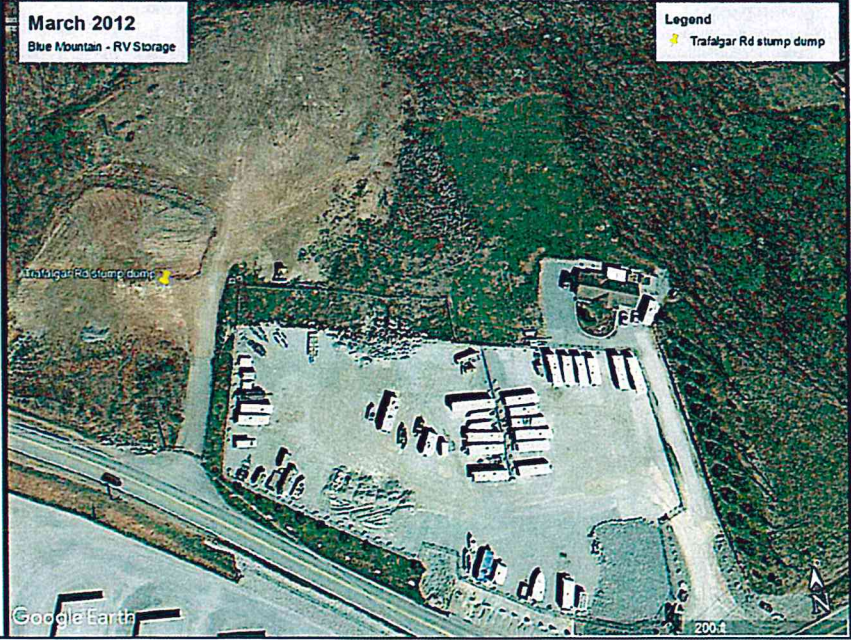
Location	Trafalgar Rd., Bella Vista, AR			Complaint #	024312	County	Benton
Photographer	Chris Krou, Compliance Branch Manager		<i>CK</i>	Witness	N/A		
Photo #	6	Of	15	Date	8/30/2018	Time	NA
Description	Google Earth satellite image of the Trafalgar Road stump dump/Blue Mountain –RV Storage lot.

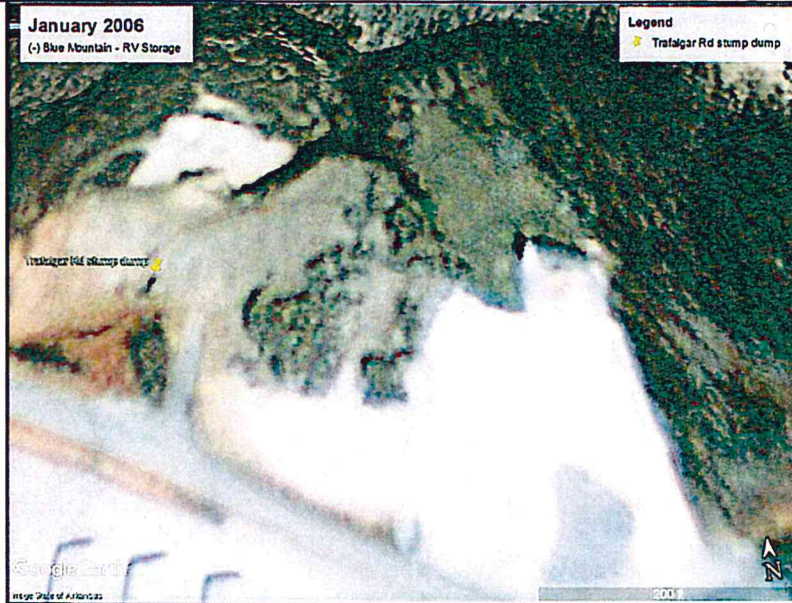
Location	Trafalgar Rd., Bella Vista, AR			Complaint #	024312	County	Benton
Photographer	Chris Krou, Compliance Branch Manager		<i>CK</i>	Witness	N/A		
Photo #	9	Of	15	Date	8/30/2018	Time	NA
Description	Google Earth satellite image of the Trafalgar Road stump dump/Blue Mountain –RV Storage lot.

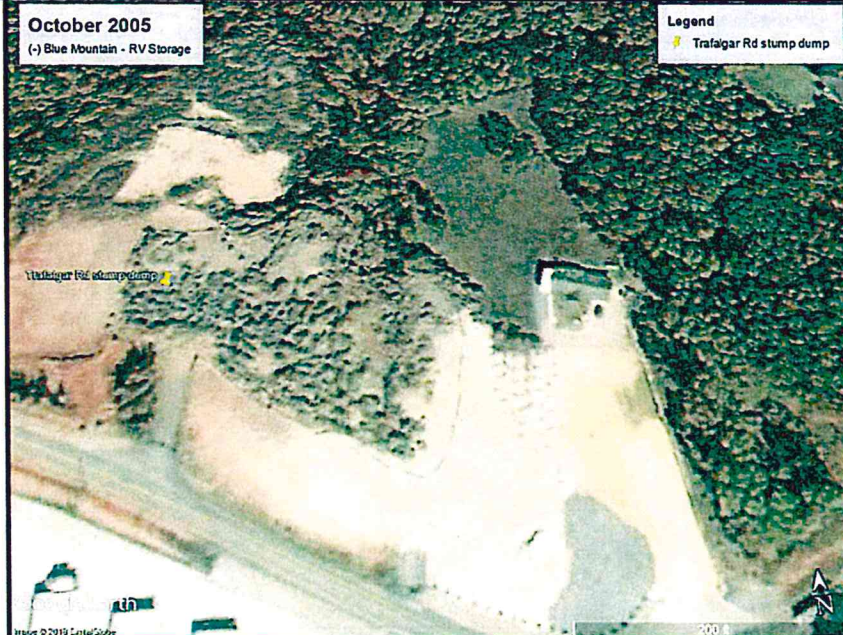
Location	Trafalgar Rd., Bella Vista, AR			Complaint #	024312	County	Benton
Photographer	Chris Krou, Compliance Branch Manager		<i>CK</i>	Witness	N/A		
Photo #	10	Of	15	Date	8/30/2018	Time	NA
Description	Google Earth satellite image of the Trafalgar Road stump dump/Blue Mountain –RV Storage lot.
