A R K A N S A S
Department of Environmental Quality

WATER DIVISION COMPLAINT REPORT

COMPLAINANT NAME: Carol Bitting	COMPLAINT AGAINST: C&H Hog Farm
RESPONSE REQUESTED BY COMPLAINANT: No	SITE ADDRESS:
MAILING ADDRESS:	MAILING HC 72 Box 10 ADDRESS:
CITY, STATE, ZIP:	CITY, STATE, ZIP: Mt. Judea AR 72655
PHONE & EXT: _____ FAX: _____	PHONE & EXT: _____ FAX: _____
EMAIL:	EMAIL:

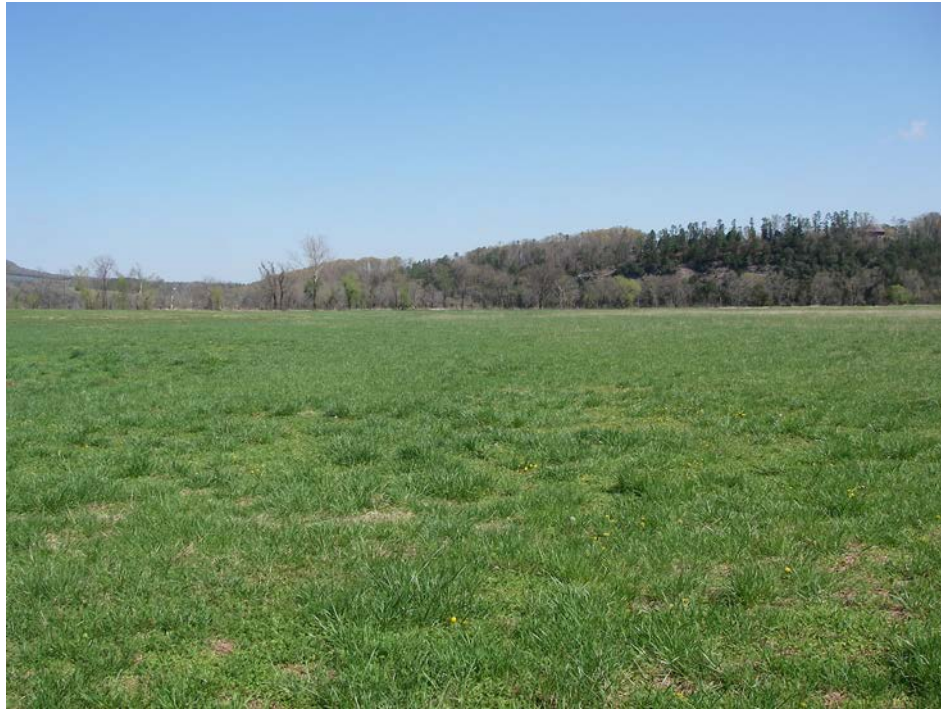
An investigation was conducted of Field 7 to determine if land application of wastewater from the above referenced had taken place using a vac tanker prior to obtaining approval. The review of Field 7 did not indicate any vac tanker had been on the field. There were no tire tracks in the field and the facility's application records through April 1, 2014 indicate no application has taken place on Field 7.

Location:	C&H Hog Farm;		
Photographer:	Jason Bolenbaugh	Date:	4/15/2014
Witness:	Carl Wills (EPA), Chris Lister (EPA), and Mr. Jason Henson (C&H)	Time:	~1100
Description:	Field 7	Photo #:	1

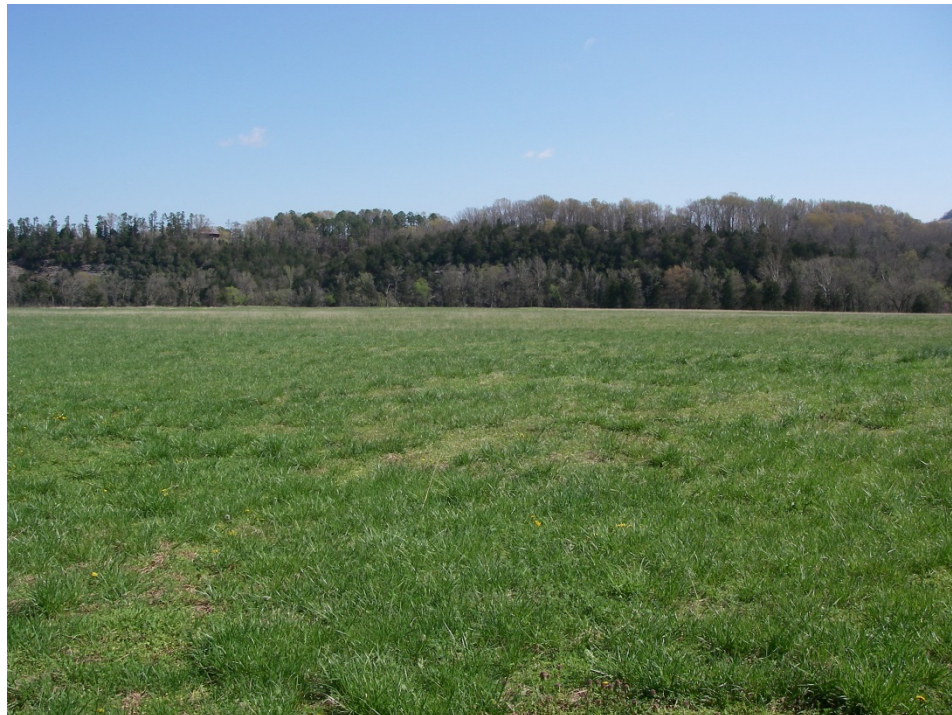
Photographer:	Jason Bolenbaugh	Date:	4/15/2014
Witness:	Carl Wills (EPA), Chris Lister (EPA), and Mr. Jason Henson (C&H)	Time:	~1100
Description:	Field 7	Photo #:	2

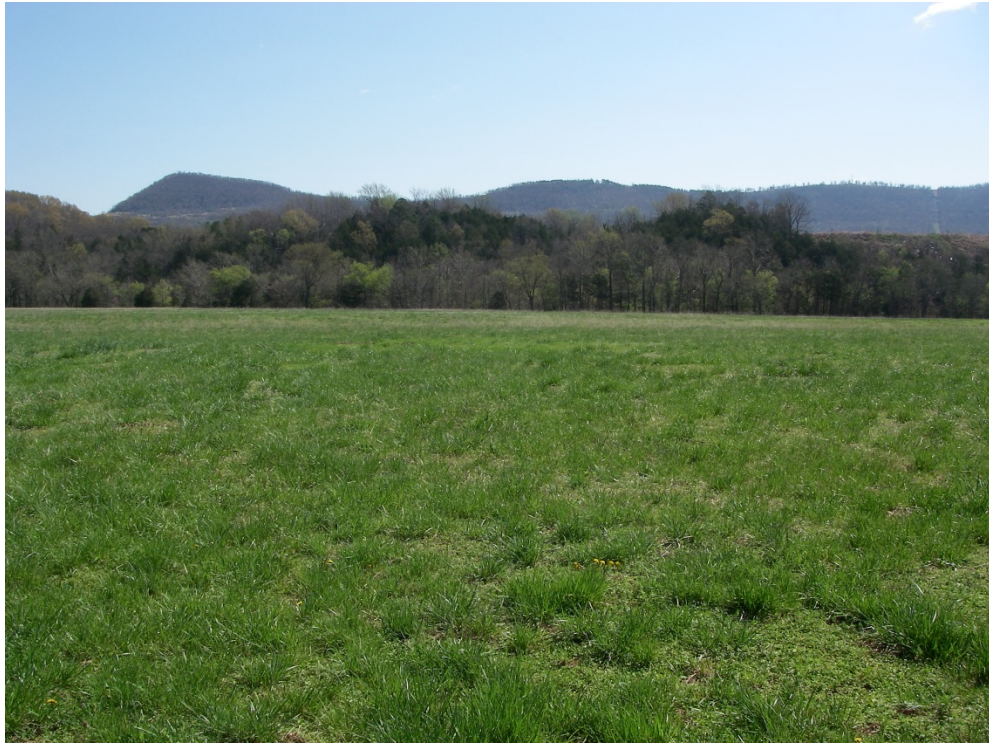
Location:	C&H Hog Farm;		
Photographer:	Jason Bolenbaugh	Date:	4/15/2014
Time:	~1100	Witness:	Carl Wills (EPA), Chris Lister (EPA), and Mr. Jason Henson (C&H)
Photo #:	3	Description:	Carl Wills (EPA), Chris Lister (EPA), and Mr. Jason Henson (C&H)

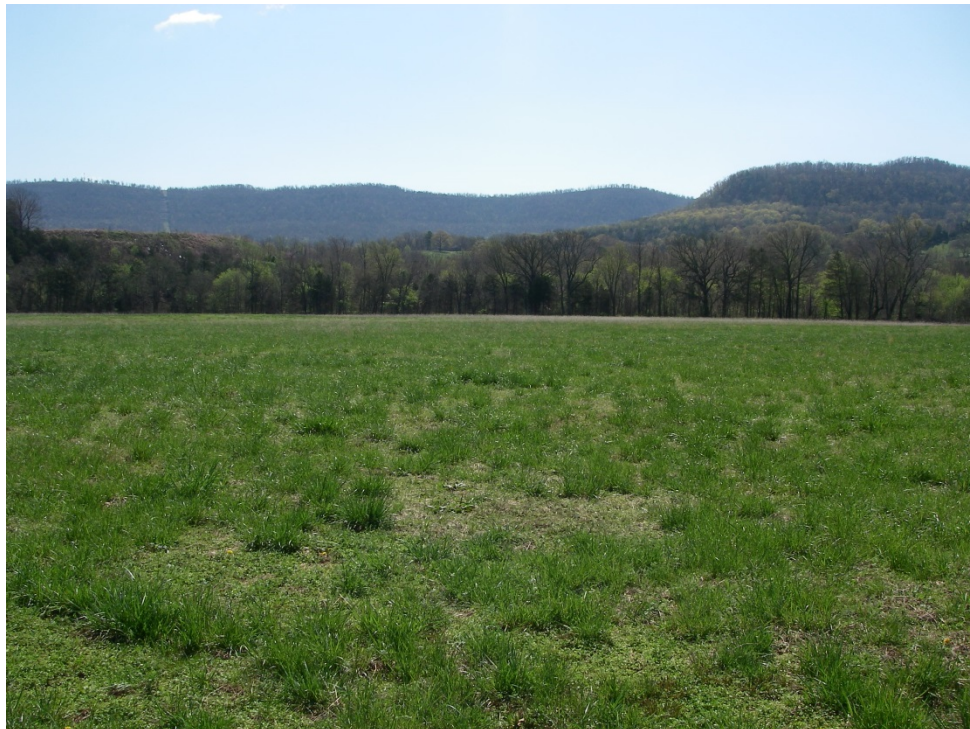
Photographer:	Jason Bolenbaugh	Date:	4/15/2014
Time:	~1100	Witness:	Carl Wills (EPA), Chris Lister (EPA), and Mr. Jason Henson (C&H)
Photo #:	4	Description:	Field 7

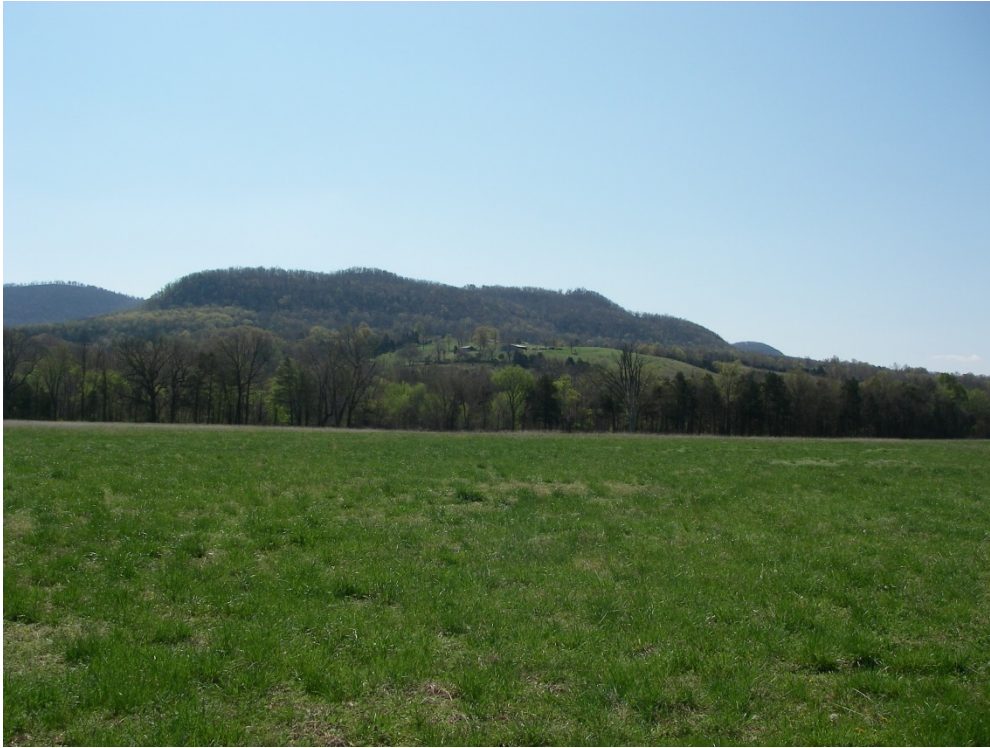
Location:	C&H Hog Farm;				
Photographer:	Jason Bolenbaugh	Date:	4/15/2014	Time:	~1100
Witness:	Carl Wills (EPA), Chris Lister (EPA), and Mr. Jason Henson (C&H)			Photo #:	5
Description:	Field 7

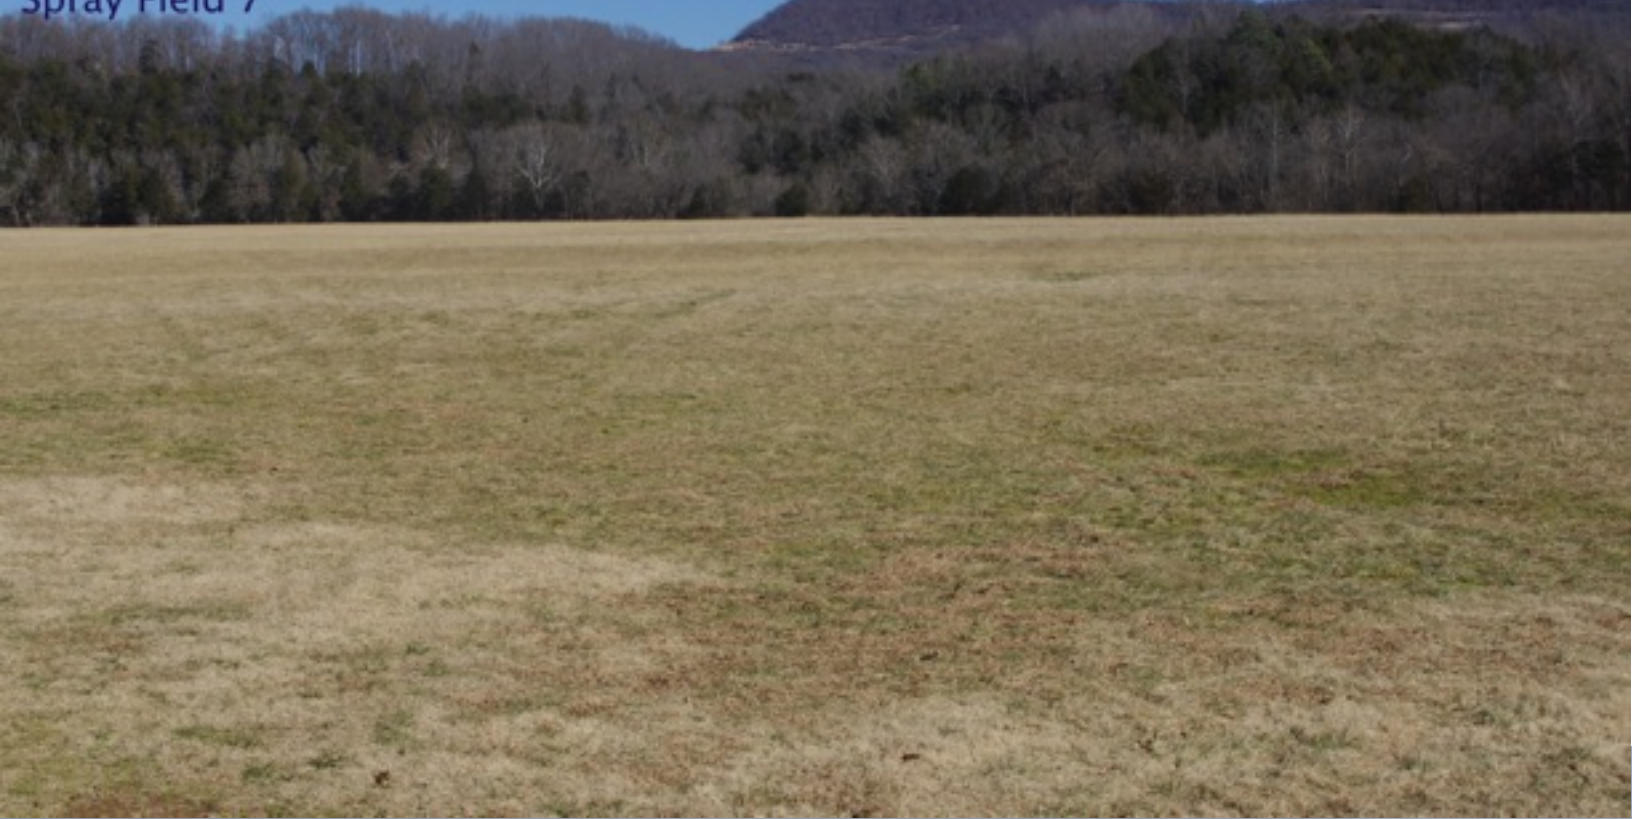
01/16/2014
Spray Field 7

The first photo taken in January shows light travel across Field 7, this is primarily associated with the removal of the hay from the field.

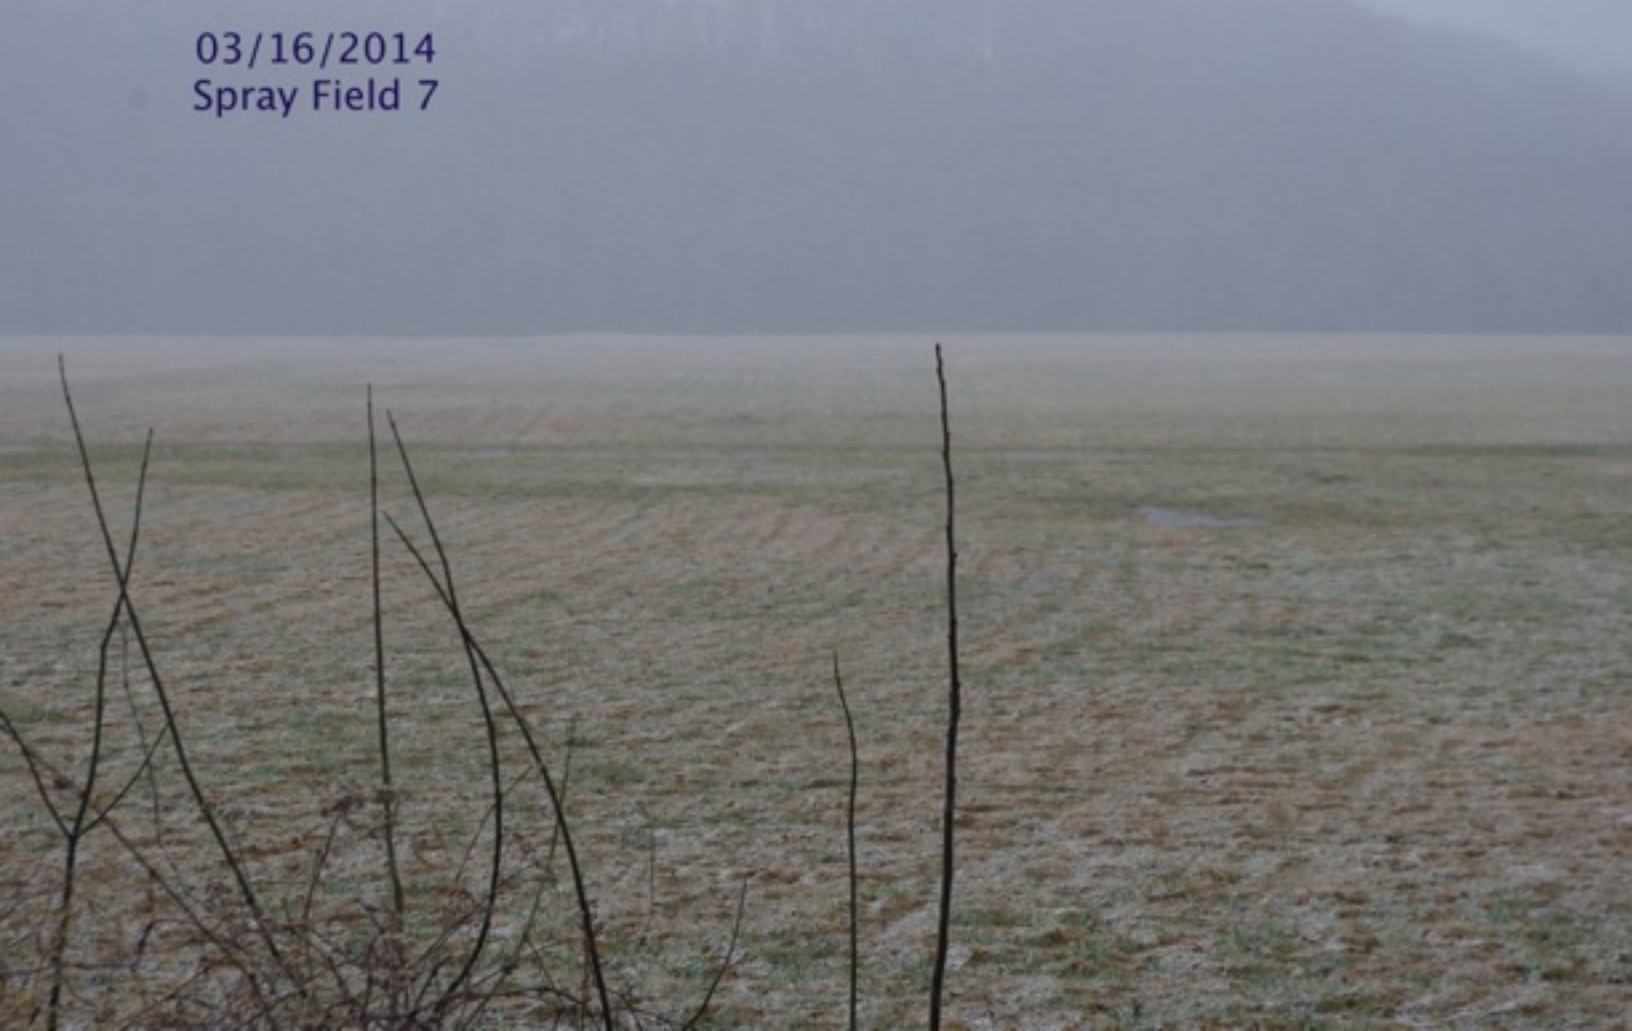
03/16/2014
Spray Field 7

The second two photos taken 2 months later show heavy truck traffic travel over and over again continually covering the same area.

All three photos taken from near the same location as noted by the trees in the background.
