ARKANSAS  
Department of Environmental Quality

## WATER DIVISION COMPLAINT REPORT

**This is not so much a complaint as a request to check the C&H pond levels following this weekend's rain event. If the ponds are overtopped, erosion could cause a failure of the containment berms. If there is a problem, it is better to catch it early on. If you would respond to me on this i'd much appreciate it. Thanks Brian Thompson.**

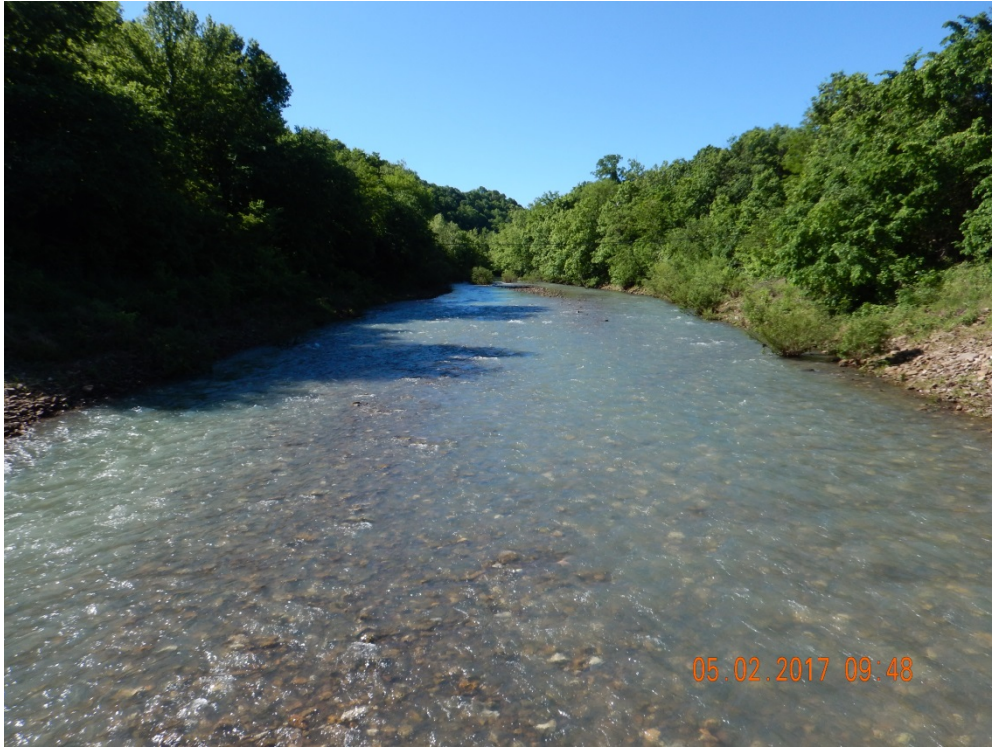
Location:	<b>C&amp;H Hog Farms, Inc.</b>				
Photographer:	<b>Jason Bolenbaugh</b>	Date:	<b>5/2/2017</b>	Time:	<b>09:48</b>
Witness:				Photo #:	<b>1</b>
Description:	<b>Big Creek looking downstream at the C.R. 54 bridge.</b>

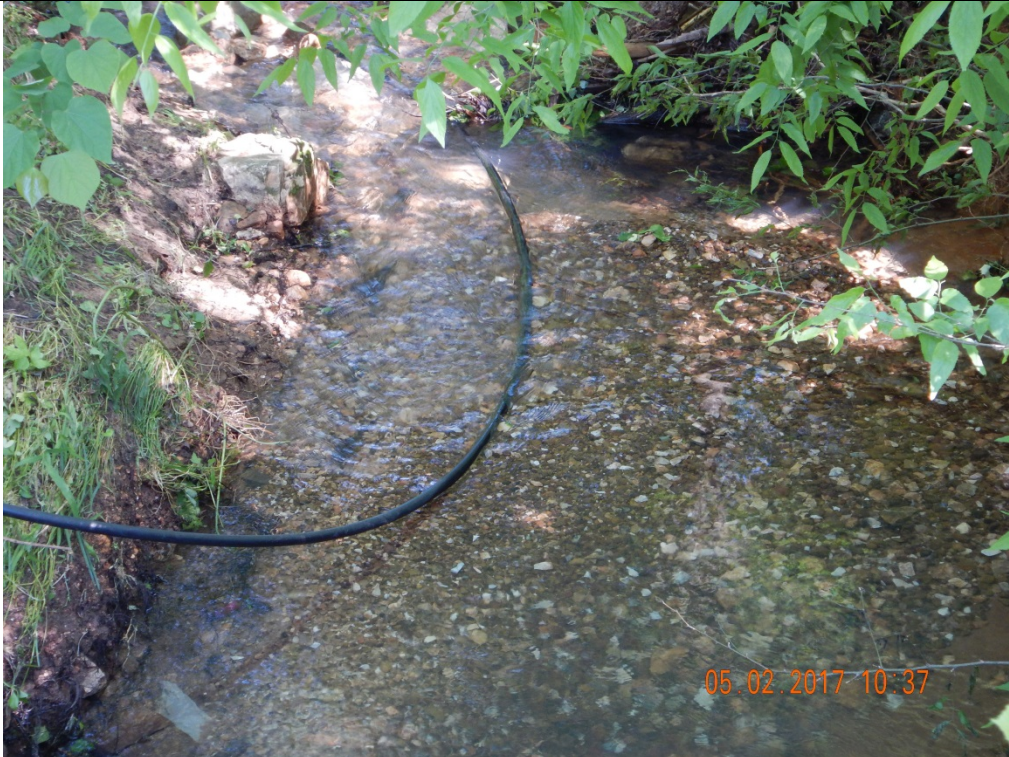
Photographer:	<b>Jason Bolenbaugh</b>	Date:	<b>5/2/2017</b>	Time:	<b>10:37</b>
Witness:				Photo #:	<b>2</b>
Description:	<b>View of the creek across the road from the monitoring station located at 35.923718 and -93.070817. This creek discharges into Big Creek.</b>

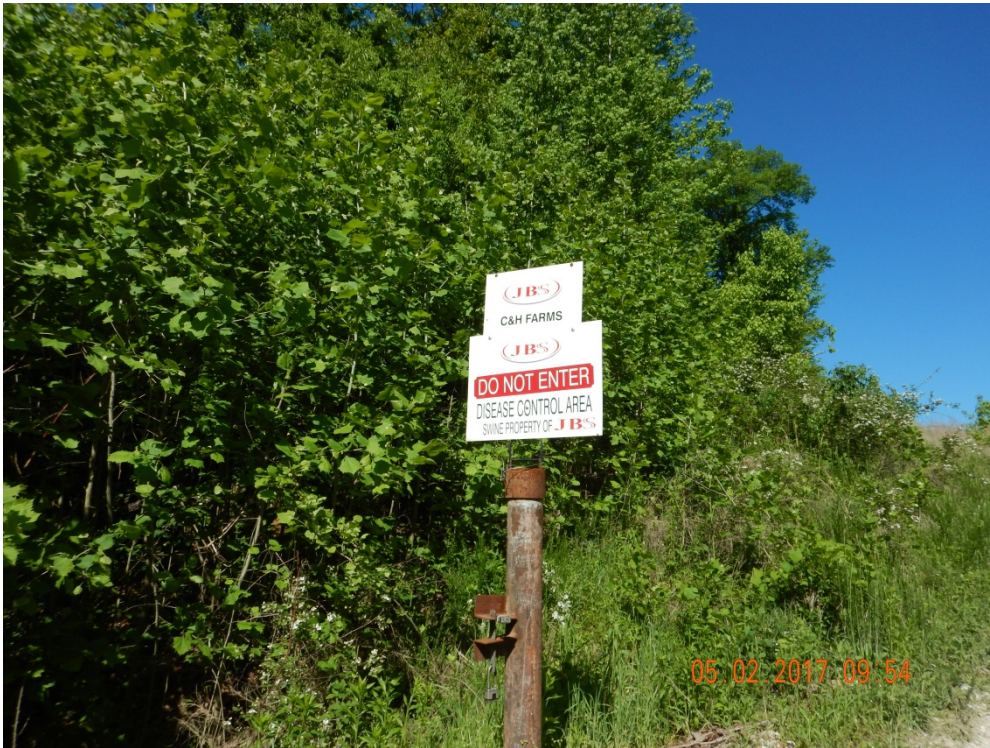
Location:	<b>C&amp;H Hog Farms, Inc.</b>				
Photographer:	<b>Jason Bolenbaugh</b>	Date:	<b>5/2/2017</b>	Time:	<b>09:54</b>
Witness:				Photo #:	<b>3</b>
Description:	<b>Entrance to C&amp;H Hog Farms, Inc.</b>

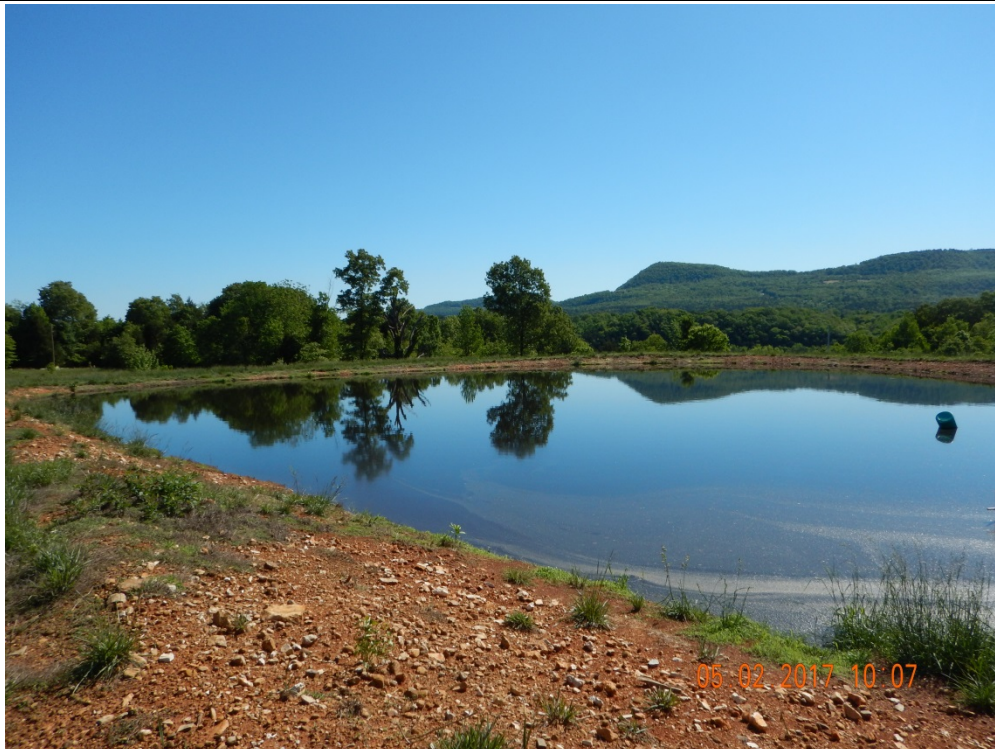
Photographer:	<b>Jason Bolenbaugh</b>	Date:	<b>5/2/2017</b>	Time:	<b>10:07</b>
Witness:				Photo #:	<b>4</b>
Description:	<b>Pond #2 looking northeast.</b>

**On May 2, 2017 I conducted an investigation of C&H Hog Farms, Inc. due to the above referenced complaint. During the investigation water conditions at Big Creek and the unnamed tributary leading to Big Creek were observed. Water conditions were clear and had no evidence of receiving a discharge of wastewater from the facility. I walked around each wastewater pond and directly below to a monitoring station. There was no evidence wastewater had discharged from either pond, or that the ponds were leaking or compromised. Three pump trucks were removing wastewater from Pond 1 and according to Mr. Henson, the trucks were land applying the wastewater onto Field 15. From residue formed on the inside of Pond 1 the pond level had dropped 12-15 inches due to pumping activities. Pond 2 had approximately 2-3 feet of freeboard at the lowest point but was approximately 3-6 inches above the Must Pumpdown Mark. In a telephone conversation with Mr. Henson on May 10, 2017 he indicated Pond 2 is now approximately 12-18 inches below the Must Pumpdown Mark and will submit photodocumentation confirming Pond 2 is below the mark.**

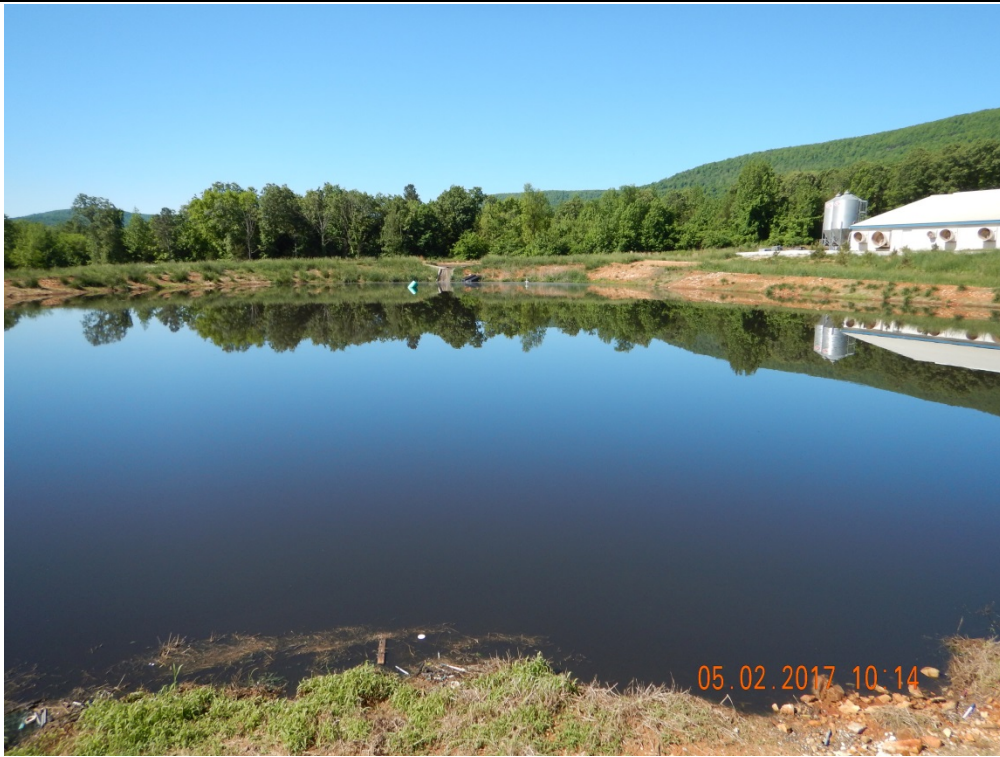
Location:	<b>C&amp;H Hog Farms, Inc.</b>		
Photographer:	<b>Jason Bolenbaugh</b>	Date:	<b>5/2/2017</b>
Witness:		Time:	<b>10:14</b>
Description:	<b>Pond #2 looking southwest.</b>

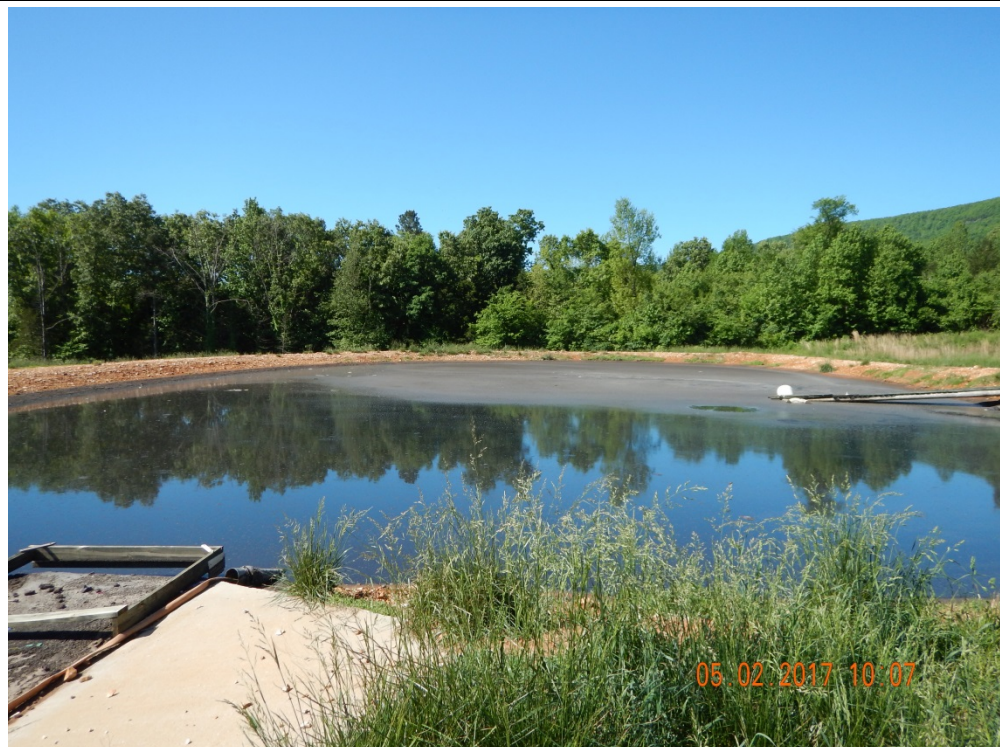
Photographer:	<b>Jason Bolenbaugh</b>	Date:	<b>5/2/2017</b>
Witness:		Time:	<b>10:07</b>
Description:	<b>Pond #1 looking southwest.</b>

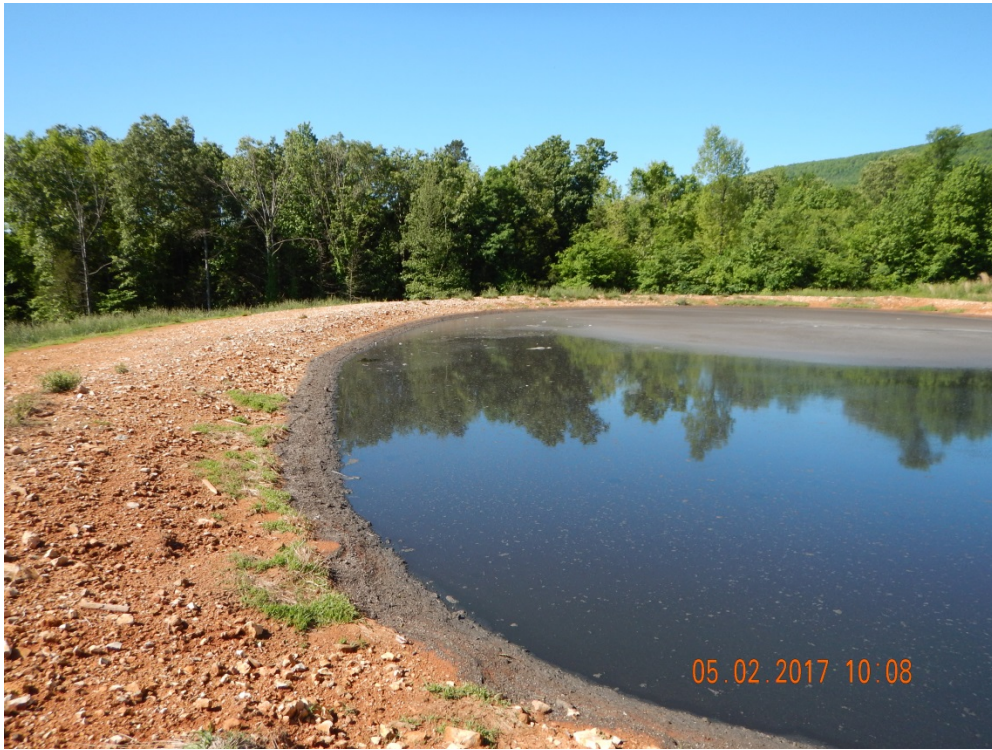
Location:	<b>C&amp;H Hog Farms, Inc.</b>				
Photographer:	<b>Jason Bolenbaugh</b>	Date:	<b>5/2/2017</b>	Time:	<b>10:08</b>
Witness:				Photo #:	<b>7</b>
Description:	<b>Pond #1 showing approximately 12-15 inches of drawdown.</b>

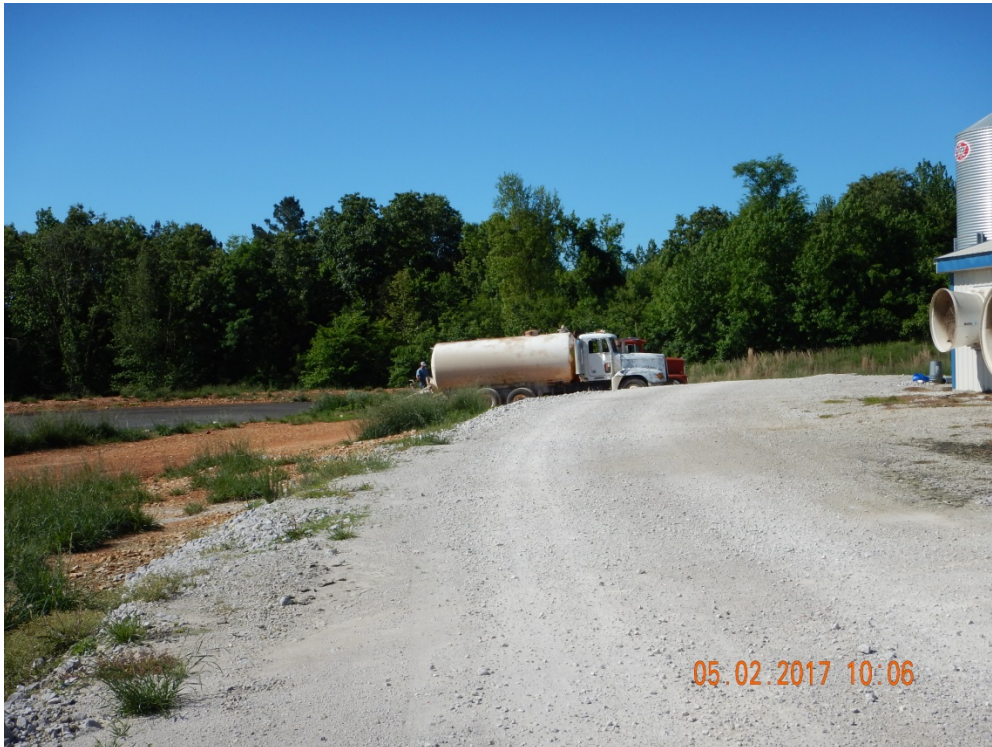
Photographer:	<b>Jason Bolenbaugh</b>	Date:	<b>5/2/2017</b>	Time:	<b>10:06</b>
Witness:				Photo #:	<b>8</b>
Description:	<b>Two of three pump trucks that were operating during the investigation.</b>

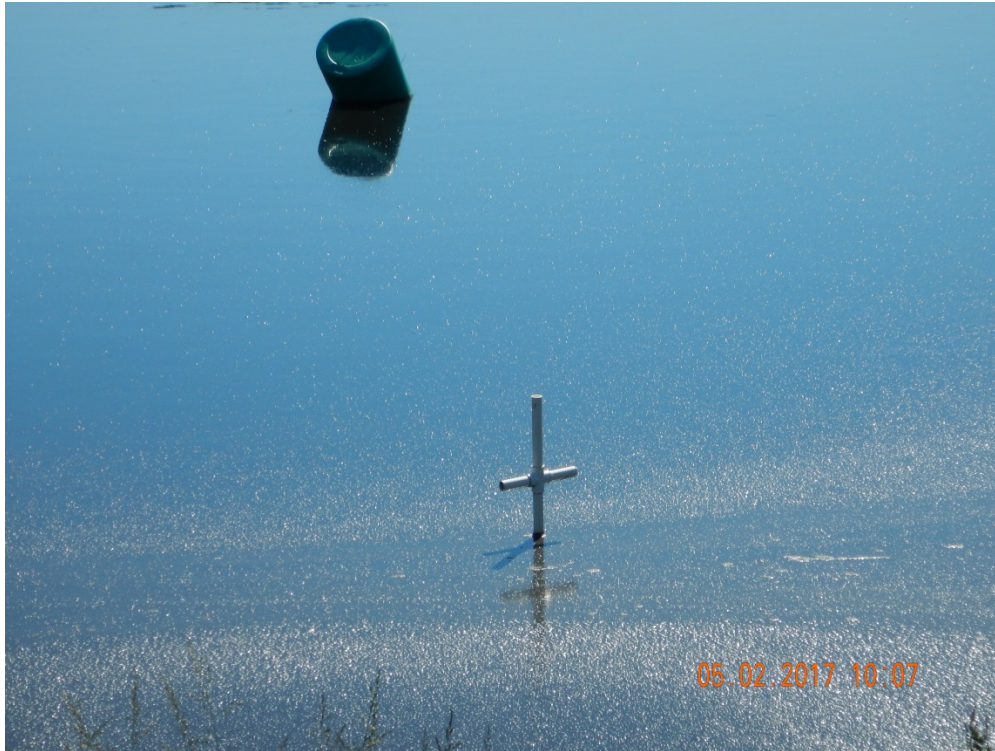
Location:	<b>C&amp;H Hog Farms, Inc.</b>				
Photographer:	<b>Jason Bolenbaugh</b>	Date:	<b>5/2/2017</b>	Time:	<b>10:07</b>
Witness:				Photo #:	<b>9</b>
Description:	<b>Must Pumpdown Level in Pond #2. Approximately 3-6 inches above Must Pumpdown mark.</b>
