UNITED STATES ENVIRONMENTAL PROTECTION AGENCY
Washington, D.C. 20460
NPDES Compliance Inspection Report

| Name and Location of Facility Inspected (For industrial users discharging to POTW, also include POTW name and NPDES permit number) Pleasant Oaks POA Pleasant Oaks Dr. Shannon Hills, AR | Entry Time /Date 1430 on 11/27/06 | Permit Effective Date 02/29/04 |

**Arkansas Department of Environmental Quality (ADEQ)
Official Photograph Sheet**

| Location: | | Pleasant Oaks POA WWTP | | | | | | |

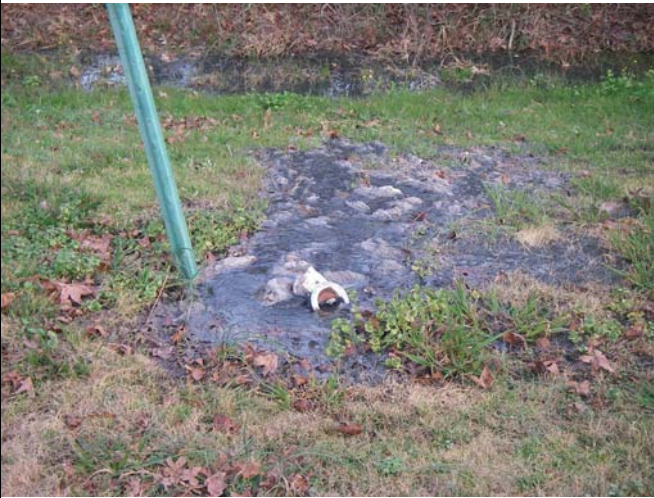
| Photo # | 1 | Of | 8 | Date: | | 11/27/06 | Time: | |

The treatment plant appears to be out of commission with no power to the plant. Two cleanouts on the east side of the plant along the effluent creek were overflowing and discharging untreated influent into the stream. The head works of the plant appeared to be dead and a white film of toilet paper fibers was lining the ground. The aerated basin was completely full of solids and not operational. The facilities clarifier/settling basin was completely full of solids with grass growing on the surface. The facilities sand filters have not been maintained in some time and were not operational. A well at the base of a recently installed pressurized sand filter tower was full of storm water; this sand filter was not operational and appeared to have no power. The facility was not chlorinating their effluent. The plant appeared to not have an operator in some time.

| Description: | | Overflowing cleanout | | | | | | |

The above items require your immediate attention. Please submit a written response to these findings to the NPDES Enforcement Section of this Department. This response should contain documentation describing the course of action taken to correct the items noted. This corrective action should be completed as soon as possible, and the written response is due by December 19, 2006.

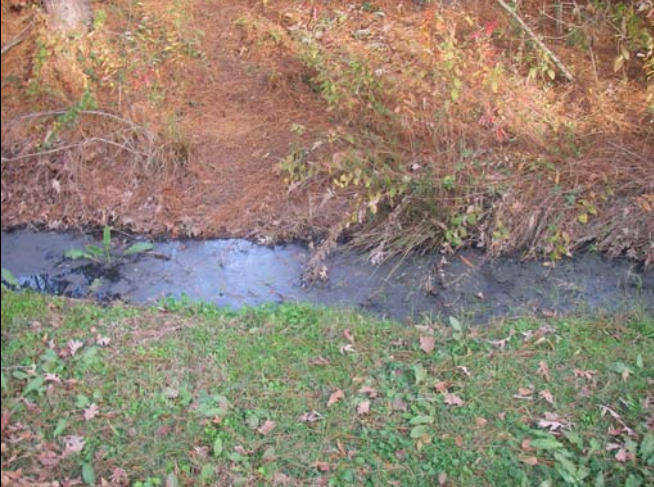
| Photo # | 2 | Of | 8 | Date: | | 11/27/06 | Time: | |

1. The facility was not being maintained and/or operated.
2. The facilities head works were not operational and a layer of domestic solids was found on the ground around the head works of the plant.
3. The facilities aeration basin was full of solids and not operational.
4. The facilities clarifier was full of solids and not operational.
5. The facilities sand filters were full of solids and not operational.
6. The facilities pressurized sand filter was full of storm water and not operational.
7. Raw sewage was being discharged from two cleanouts, on the east side of the plant between the fence and the creek, and entering waters of the state. All domestic solids must be removed from waters of the state.

| Description: | | Sewage in creek | | | | | | |

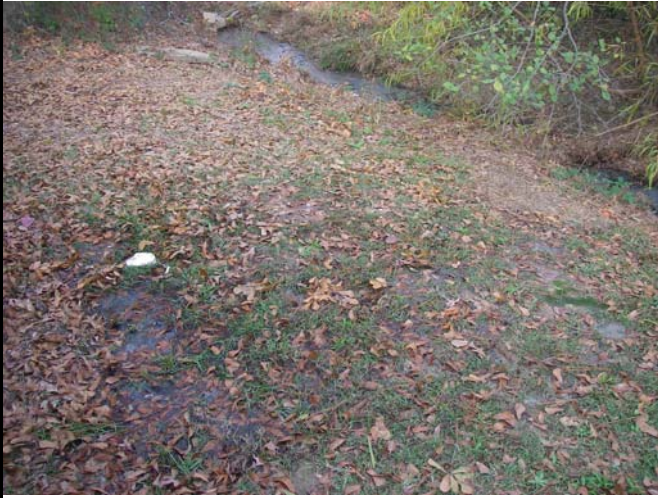
| Photo # | 3 | Of | 8 | | | Date: | 11/27/06 | Time: | |

| Description: | | Overflowing cleanout | | | | | | | |

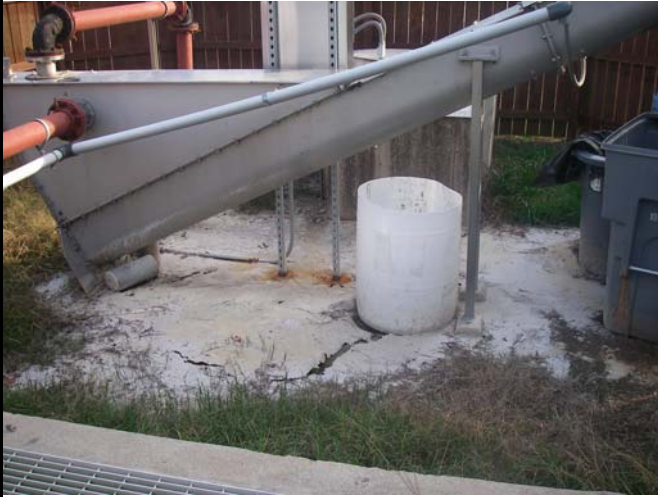
| Photo # | 4 | Of | 8 | | | Date: | 11/27/06 | Time: | |

| Description: | | Solids around head works | | | | | | | |

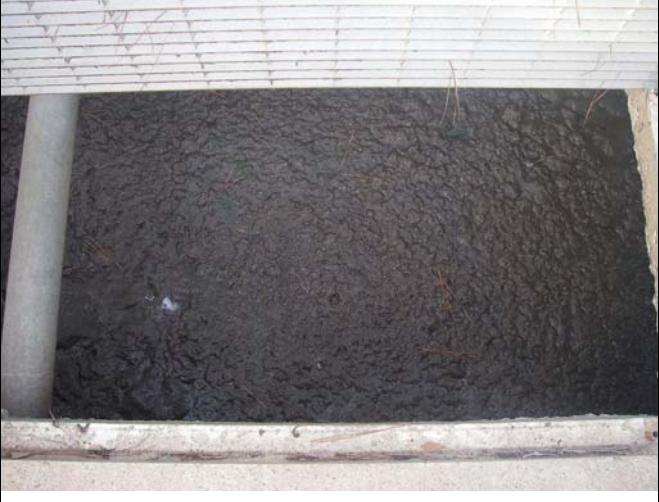
| Photo # | 5 | Of | 8 | | | Date: | 11/27/06 | Time: | |

| Description: | | Sludge built up in aeration basin | | | | | | | |

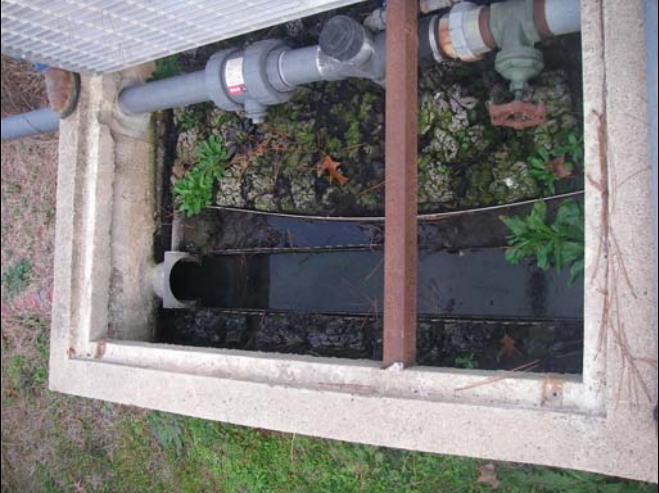
| Photo # | 6 | Of | 8 | | | Date: | 11/27/06 | Time: | |

| Description: | | Sludge and grass in clarifier | | | | | | | |

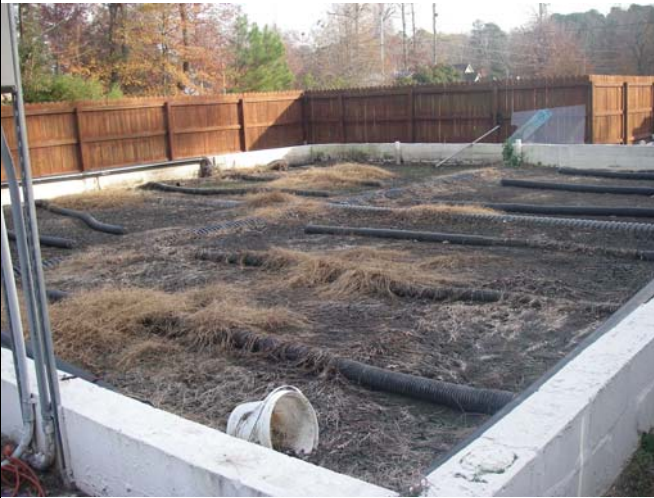
| Photo # | 7 | Of | 8 | | | Date: | 11/27/06 | Time: | |

| Description: | | Grass and solids in sand filter | | | | | | | |

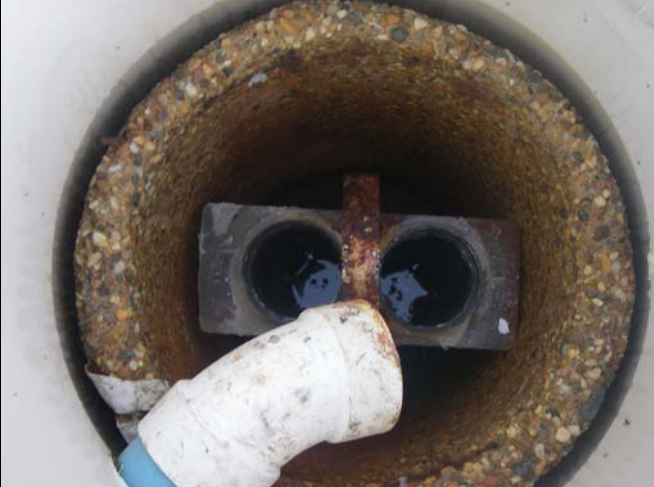
| Photo # | 8 | Of | 8 | | | Date: | 11/27/06 | Time: | |

| Description: | | No chlorine tablets in contact chamber | | | | | | | |
