UNITED STATES ENVIRONMENTAL PROTECTION AGENCY
Washington, D.C. 20460
NPDES Compliance Inspection Report

Name and Location of Facility Inspected (For industrial users discharging to POTW, also include POTW name and NPDES permit number) Cabot Water & Wastewater Commission- 76 Marshall Lane, Cabot, AR 72023	Entry Time /Date 0915 on 10/31/06	Permit Effective Date June 30, 2003
	Exit Time/Date 1145 on 10/31/06	Permit Expiration Date June 30, 2008
Name(s) of On-Site Representative(s)/Title(s)/Phone and Fax Number(s) Tim Joyner P.E./ General Manager/ 501-605-1740/ fax 501-605-1743/ cell 501-743-2154 Tony Reaves/ Wastewater Manager/ 501-843-1226 Jana Coleman/ Lab Tech/ 501-843-1226	Other Facility Data	
Name, Address of Responsible Official/Title/Phone and Fax Number Tim Joyner/ General Manager P.O. Box 1362 Cabot, AR 72023 office 501-605-1740/ fax 501-605-1743/ cell 501-743-2154	Contacted Yes <input checked="" type="checkbox"/> No <input type="checkbox"/>

**Arkansas Department of Environmental Quality (ADEQ)
Official Photograph Sheet**

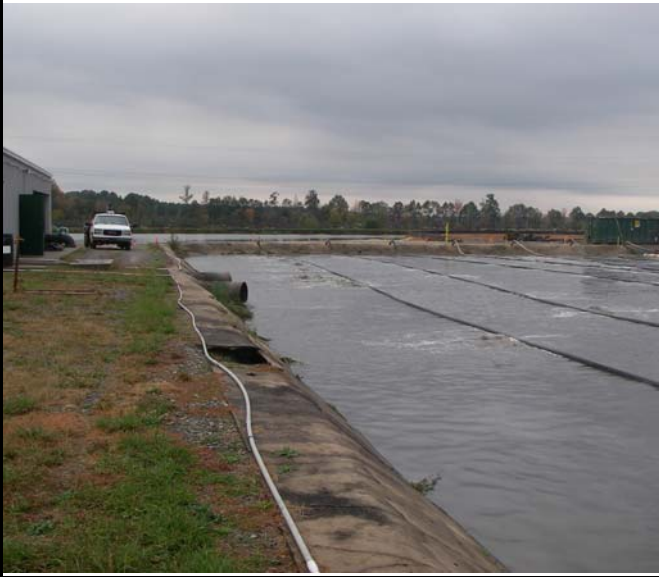
Section C- Solids were observed on the ground between the aeration basin and the equalization pond. The solids were from an aerator that was inoperable at the time of the inspection. Large cracks are present in the aeration basin and the polishing pond. Vegetation is beginning to grow through many of the cracks.

Location:		Cabot Wastewater Facility. 76 Marshall Lane, Cabot, AR 72023							
Photographer:		Lisa Jacobs			Witness:		Tony Reaves		
Photo #	1	Of	5			Date:	10/31/06	Time:	1100
Description:		This picture shows cracks and vegetation in the aeration basin.

1. The facility is not being properly operated and maintained. Solids were placed on the ground from the removal of an inoperable aerator. Large cracks still remain in the aeration basin and the polishing pond. Vegetation is growing through many of the cracks and holes.

1. The aerator that was out of service has been repaired and placed back in service. In the future, Wastewater Personnel will promptly cleanup any solids spilled on the ground at the wastewater treatment plant. As for the cracks and holes in the concrete basins, Cabot WaterWorks is currently building a new treatment facility that will replace the current basins. The current schedule is to have the new facility operational by Jan 1, 2008. The existing facility will be demolished shortly afterwards.

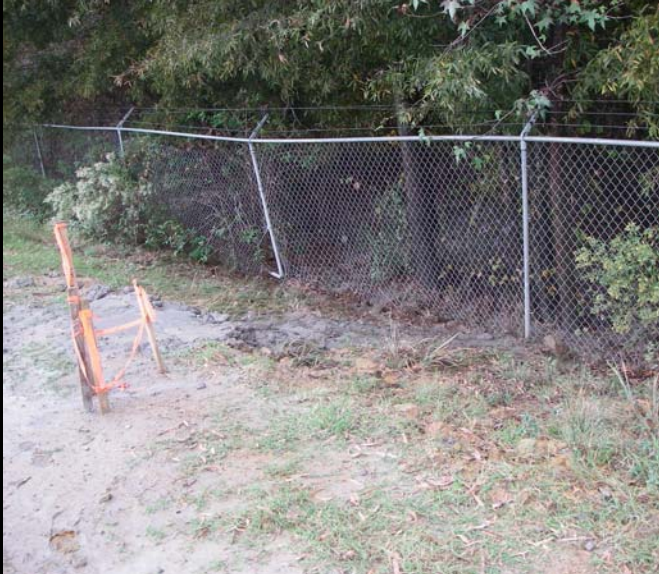
The SWPPP has not yet been completed. Many components are lacking from the plan. During the inspection, an area was noted having donafill washed down the bank into the receiving stream.

Photographer:		Lisa Jacobs			Witness:		Tony Reaves		
Photo #	2	Of	5			Date:	10/31/06	Time:	1118
Description:		Donafill going down the side of the hill into the receiving stream.

5. During the inspection, donafill was observed leaving the construction area of the site and entering Waters of the State.

4. Attached is the SWPPP for the wastewater plant. Please review and notify us if acceptable.
5. The contractor and engineering firm (USI INC.) responsible for construction of the new treatment plant have been notified that all soil materials including donafill are to be contained on the construction site. The contractor has installed silt fencing at the location where donafill was observed leaving the construction site.

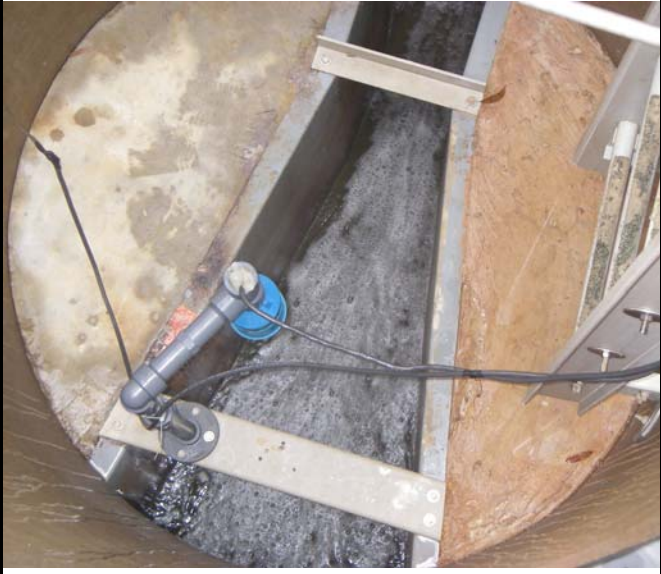
Section G- There was an excessive amount of foam observed in the effluent and the receiving stream.

Receiving Waters Observations: There was an excessive amount of foam discharging into the receiving stream. The foam was noted in the polishing pond, as well as the chlorine contact chamber.

Photographer:		Lisa Jacobs			Witness:		Tony Reaves	
Photo #	4	Of	5		Date:	10/31/06	Time:	1126
Description:		Foam in effluent.

3. Foam in the plant effluent and receiving stream has been removed. The Plant Operator will check and report foam in the effluent and receiving stream daily. The Plant Operator will also monitor daily the dissolved oxygen levels at the aeration basin effluent and the polishing pond effluent. Ammonia will be monitored daily at the plant effluent. Laboratory equipment has been ordered to perform this testing.

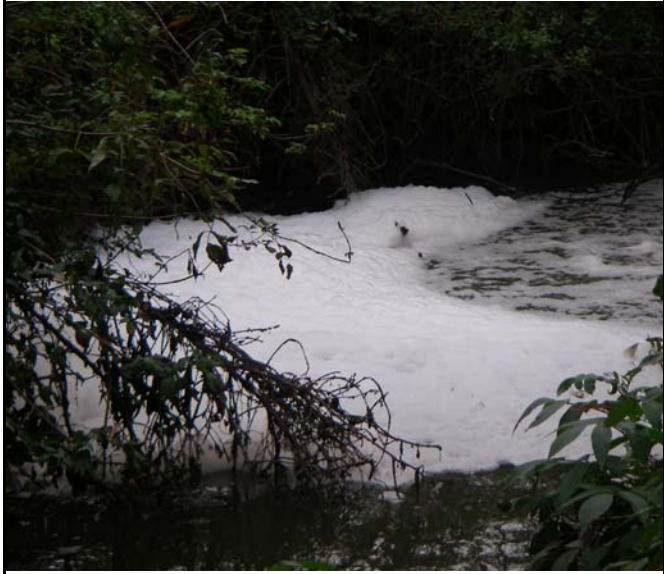
Location:	Cabot Wastewater Facility. 76 Marshall Lane, Cabot, AR 72023						
Photographer:	Lisa Jacobs			Witness:	Tony Reaves		
Photo #	5	Of	5	Date:	10/31/06	Time:	1128
Description:	Foam in the receiving stream.

3. There was an excessive amount of foam in the effluent and in the receiving stream at the time of the inspection.
4. The SWPPP is not yet finished and implemented. Many components of the plan are still missing.
