## NPDES Compliance Inspection Report

Name and Location of Facility Inspected (For industrial users discharging to POTW, also include POTW name and NPDES permit number) <b>City of Osceola WWTP South of Highway #140 West Osceola, AR</b>	Entry Time /Date <b>1300 / May 10, 2007</b>	Permit Effective Date <b>December 1, 2005</b>
	Exit Time/Date <b>1600 / May 10, 2007</b>	Permit Expiration Date <b>November 30, 2010</b>
Name(s) of On-Site Representative(s)/Title(s)/Phone and Fax Number(s) <b>James N. Carlock / Superintendent / 870-622-5068 / 870-563-7460</b>		Other Facility Data 35.679614°N 90.038576°W
Name, Address of Responsible Official/Title/Phone and Fax Number <b>Dickie Kennemore / Mayor / 870-563-5102 P.O. Box 443 Osceola, AR 72370</b>		
<p style="text-align: center;">Contacted</p> Yes <input type="checkbox"/> No <input checked="" type="checkbox"/>

RE: Wastewater Treatment Plant

## Arkansas Department of Environmental Quality (ADEQ) Official Photograph Sheet

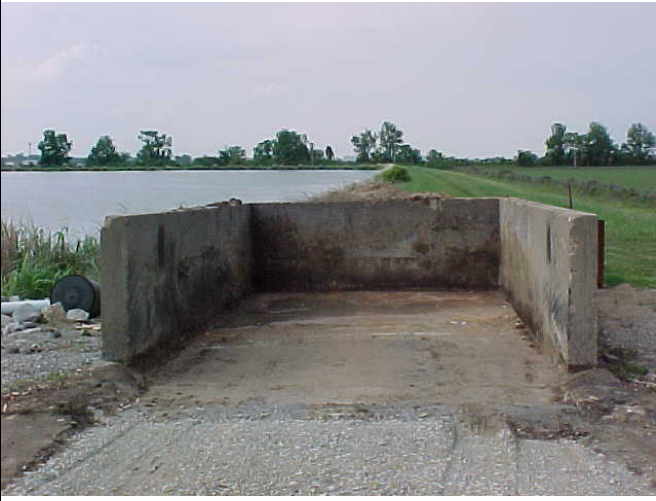
<b>Location:</b>		Osceola WWTP ponds approximately 1/2 mile south of Highway #140 and approximately 1.5 miles West of Osceola, Arkansas (Mississippi County)						
<b>Photographer:</b>		Mike Kennedy			<b>Witness:</b>		James Carlock	
<b>Photo #</b>	1	<b>Of</b>	4		<b>Date:</b>	5-10-07	<b>Time:</b>	1532
<b>Description:</b>								
<p>This picture shows the septic waste dump station at the Osceola treatment ponds. The treatment pond in the background is Cell #1.</p>

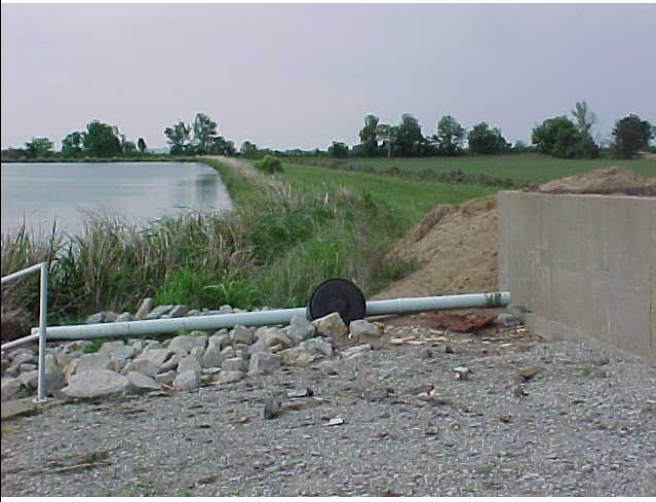
<b>Photographer:</b>		Mike Kennedy			<b>Witness:</b>		James Carlock	
<b>Photo #</b>	2	<b>Of</b>	4		<b>Date:</b>	5-10-07	<b>Time:</b>	1532
<b>Description:</b>								
<p>This picture shows the drain pipe leading from the dump station to the treatment pond known as Cell #1.</p>

The inspector observed plastics in the waste material draining from the dump station into Cell #1 of the treatment ponds. This was brought to the attention of Mr. James Carlock, Superintendent. A recommendation was made to install a filtering system to remove the plastics before the waste drains into Cell #1.

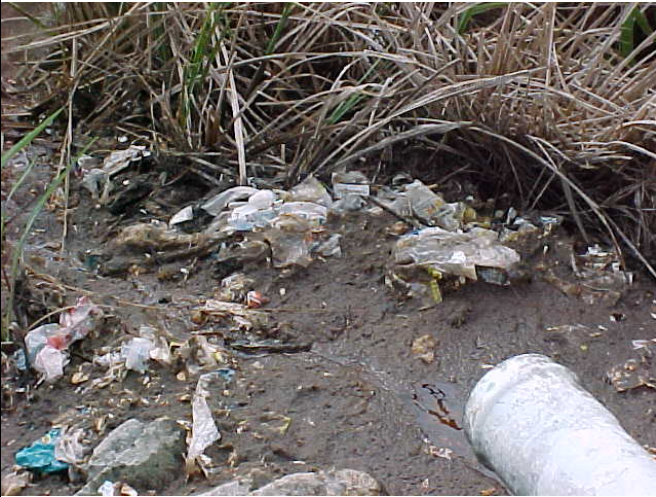
<b>Location:</b>		Osceola WWTP ponds approximately 1/2 mile south of Highway #140 and approximately 1.5 miles West of Osceola, Arkansas (Mississippi County)						
<b>Photographer:</b>		Mike Kennedy			<b>Witness:</b>		James Carlock	
<b>Photo #</b>	3	<b>Of</b>	4		<b>Date:</b>	5-10-07	<b>Time:</b>	1533
<b>Description:</b>								
<p>This picture shows plastics and other solid waste that flows out of the drain pipe onto the ground before the liquid drains into Cell #1.</p>
