ADEQ Water NPDES Inspection	AFIN: 18-00110	Permit #: AR0021971

Water Division NPDES Photographic Evidence Sheet											
Location:	Location: City of Marion WWTP											
Photographer: Brent Walker					Witness:	None						
Photo #	1	Of	4		Date:	12/21/2007	Time:	1242

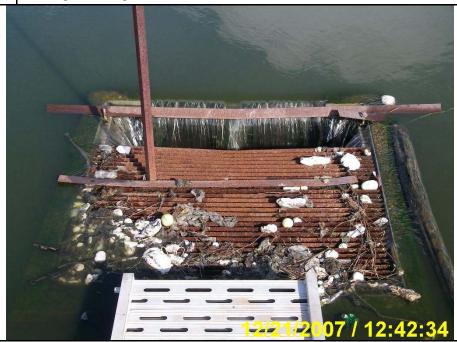
Description: Discharge from Lagoon #1 into the old outfall structure.

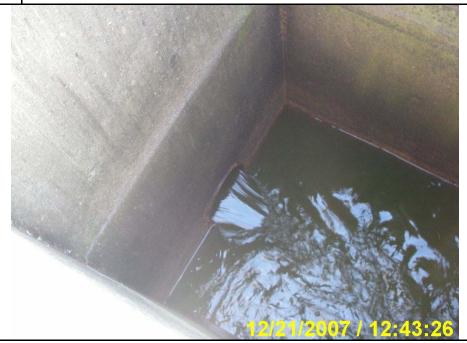
Photograph	ner:	Brent V	Walker	Witness:	None		
Photo #	2	Of	4	Date:	12/21/2007	Time:	1243

is reconnaissance inspection was c rected.	ondu	cted	to det	ermi	ne if	the u	ınper	mitt	ed dis	charg	e note	d duri	ing a	CEI	insp	ecti	on on	n Dec	embe	er 19	, 200	7, ha	d bee	n	
At the time of this inspection the facility was still discharging from the old outfall structure of lagoon #1 into the abandoned chlorine contact chamber thence through the abandoned outfall into the receiving stream.																										
The	The NPDES Enforcement Section of this department was notified immediately via telephone of the observations.																									
No	letter will be sent.																									
Nan	ne(s) and Signature(s) of Inspector(s	5)									ephone		10li4-	Ion-	aka-					Date	e					
Brei	at L. Walker Bred & Walk	n						_				ntal Q (70) 93	-			U				Mai	rch :	24, 20	800			
Signature of Reviewer Agency/Office/Photo										one an	ne and Fax Numbers							Date

Description: Discharge into the abandoned chlorine contact chamber.

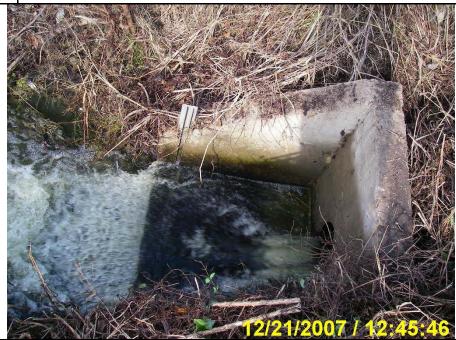
Photograph	ner:	Brent V	Walker	Witness:	None	None						
Photo #	4	Of	4	Date:	12/21/2007	Time:	1245

Description: Solids on bank of receiving stream.
