ADEQ Water NPDES Inspection	AFIN: 18-0010	Permit #: AR0021971

Water Division NPDES Photographic Evidence Sheet											
Location:	Location: City of Marion WWTP											
Photographer: Brent Walker					Witness:	None						
Photo #	1	Of	4		Date:	1/3/2008	Time:	1237

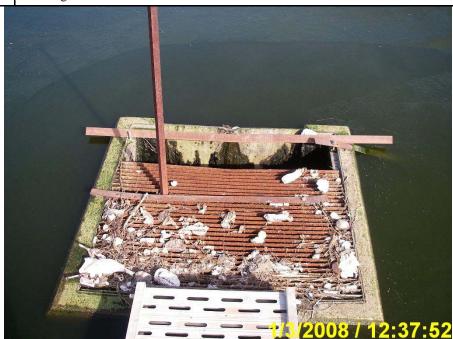
Description: Discharge from cell 1 into old outlet structure.

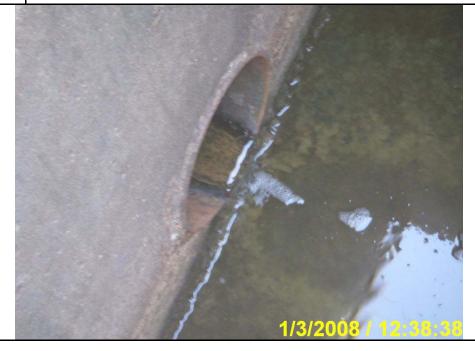
Photographer: Brent Walker						Witness:	None	None				
Photo #	2	Of	4				Date:	1/3/2008	Time:	1238

Description: Discharge from cell one into abandoned chlorine contact chamber.

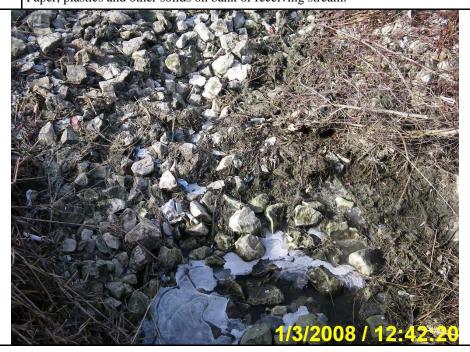
Photograph	ner:	Brent V	Walker	Witness:	None		
Photo #	4	Of	4	Date:	1/3/2008	Time:	1242

Description: Paper, plastics and other solids on bank of receiving stream.
