NPDES Compliance Inspection Report

Name and Location of Facility Inspected (<i>For industrial users discharging to POTW, also include POTW name and NPDES permit number</i>) City of Marion WWTP West of Highway 118 S. of UP Railroad Marion, AR	Entry Time/Date 1420 1/9/2008	Permit Effective Date March 1, 2007
	Exit Time/Date 1440 1/9/2008	Permit Expiration Date February 29, 2012
Name(s) of On-Site Representative(s)/Title(s)/Phone and Fax Number(s) None	Other Facility Data	
Name, Address of Responsible Official/Title/Phone and Fax Number Frank Fogleman/Mayor/870-739-3073 City of Marion P.O. Box 717 Marion, AR 72364	Contacted Yes <input type="checkbox"/> No <input checked="" type="checkbox"/>

This inspection was conducted to verify that the unpermitted discharge observed on 12/19/2007 and 1/3/2008 had been stopped.

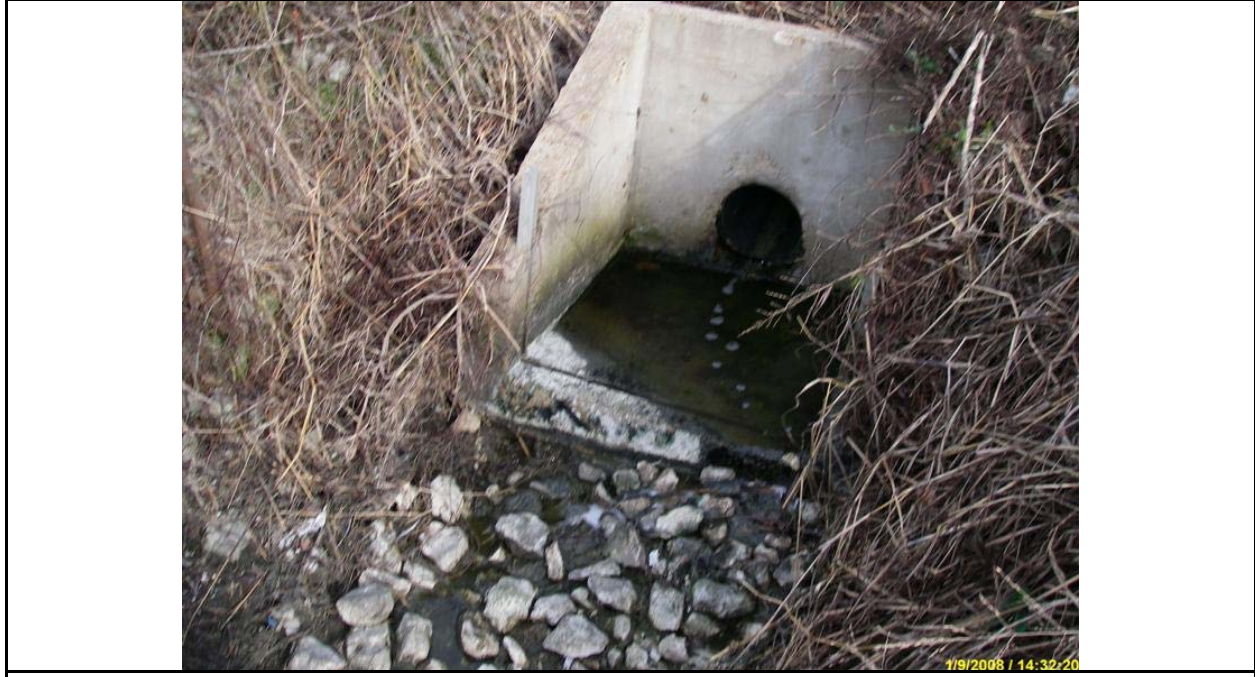
Photo #	1	Of	4	Date:	1/9/2008	Time:	1432
----------------	---	-----------	---	--------------	----------	--------------	------

Facility personnel had recently permanently disabled the conveyance structure from the old outlet from cell 1 to the abandoned chlorine contact chamber. At the time of the inspection there was still an unpermitted discharge from the old outfall structure into the receiving stream due to residual waste water draining from the abandoned chlorine contact chamber.

Description:	Unpermitted discharge from primary lagoon out the old outfall.		
---------------------	--	--	--

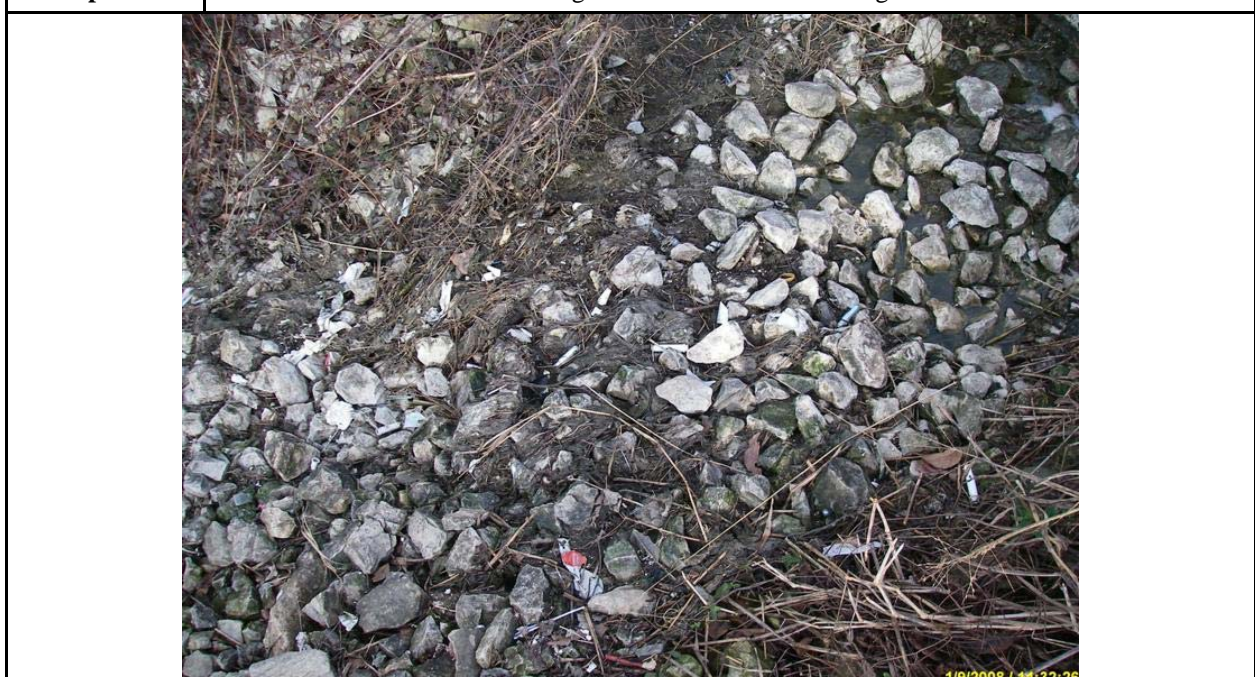
Photo #	2	Of	4	Date:	1/9/2008	Time:	1432
----------------	---	-----------	---	--------------	----------	--------------	------

Description:	Solids on the bank of the receiving stream from above discharge.		
---------------------	--	--	--

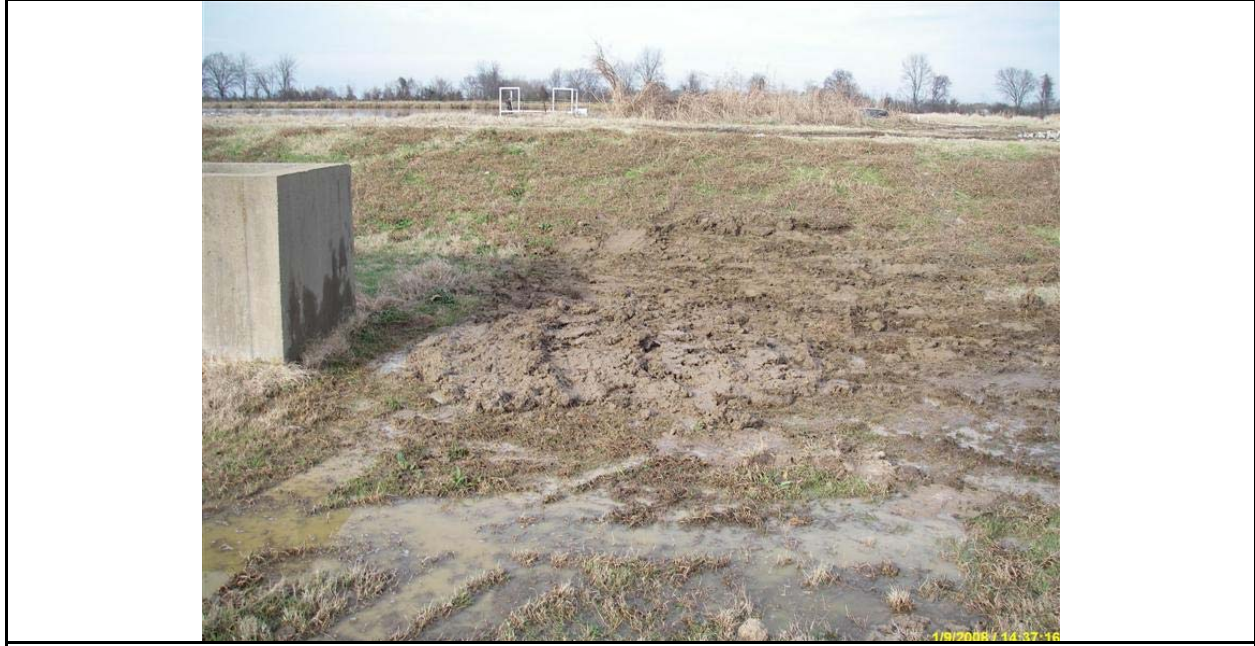
Photo #	3	Of	4	Date:	1/9/2008	Time:	1437
----------------	---	-----------	---	--------------	----------	--------------	------

Description:	Location where old outfall pipe was excavated and permanently obstructed to stop/prevent discharges.
---------------------	--

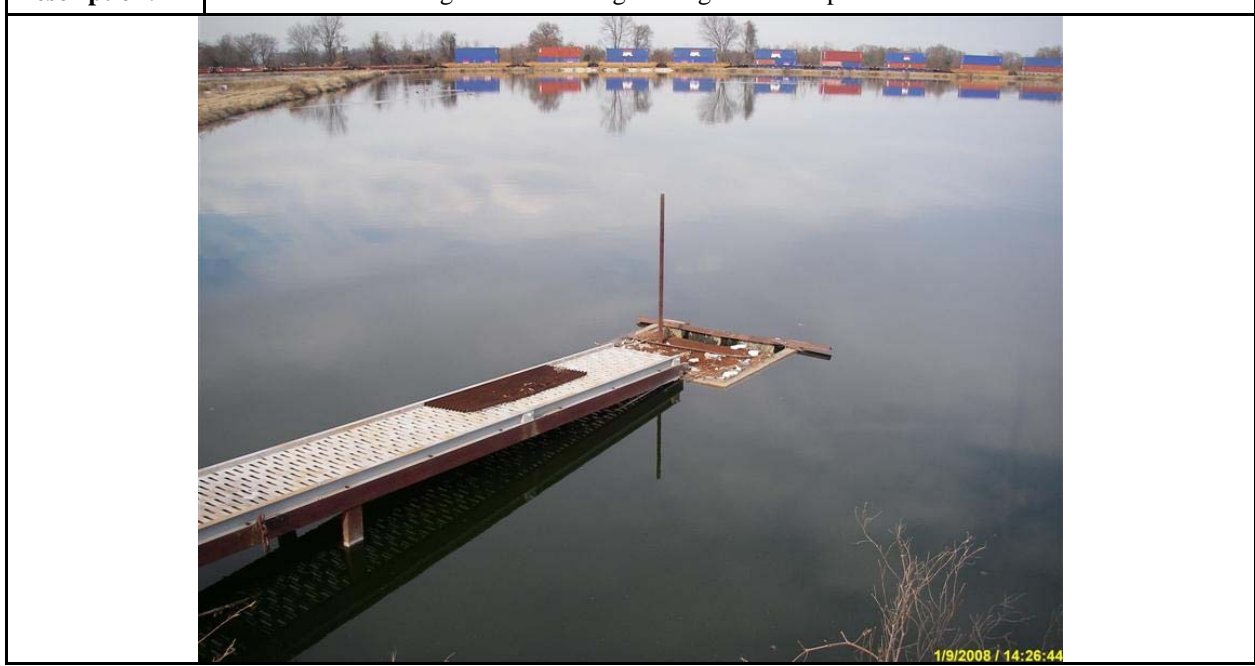
Photo #	4	Of	4	Date:	1/9/2008	Time:	1426
----------------	---	-----------	---	--------------	----------	--------------	------

Additionally the water level in lagoon cell 1 was still near maximum capacity.

Description:	Water level in first lagoon cell still high enough to overtop old outfall structure.
---------------------	--
