RE: City of Sunset Waste Water Collection System

AFIN: 18-00427 NPDES Permit No.: Satellite of AR0021971

On September 11 & 17, and October 1 & 6, 2008, I performed an inspection of the waste water collection system in accordance with the provisions of the Federal Clean Water Act, the Arkansas Water and Air Pollution Control Act, and the regulations promulgated thereunder. These inspections were conducted in response to complaints alleging the system was malfunctioning and revealed the following violations:

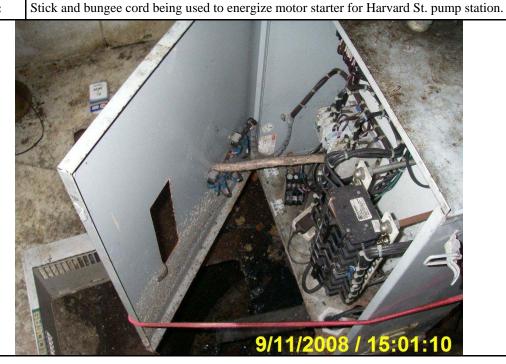
Photo #
 4
 Of
 6
 Date:
 9/11/2008
 Time:
 1608

**Description:** Uncovered wet well with accumulation of excessive solids in the main pump station.

- g. There was an extensive accumulation of solids at both pump stations that appeared to interfering with the flow and pumping of waste water.
- h. There were no alarms or other such notification devices in use at either pump station to indicate malfunctions.

- i. There were no grates or covers over the wet wells at either pump station, thus creating a fall/drowning hazard.
- j. There were no guards around pulleys and belts at either pump station to prevent accidental contact with moving parts.

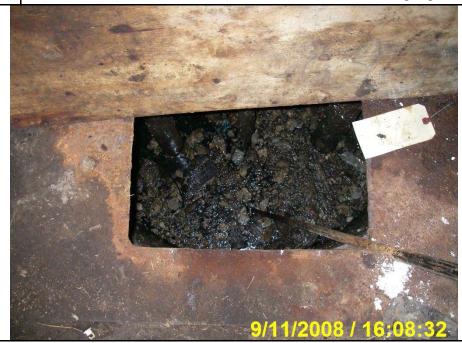
Water Division NPDES Photographic Evidence Sheet										
Location:	Ci	ty of Su	nset							
Photograph	ier:	Brent V	Walker		Witness:	: None				
Photo #	5	Of	6		Date:	9/11/2008	Time:	1608		
Description	:	Slippin	g belt at	main pump station.

- f. The drive belt on the pump at the City Hall pump station was slipping. The drive pulleys were designed for using two belts, however only one was installed.
