NPDES Compliance Inspection Report

Name and Location of Facility Inspected (<i>For industrial users discharging to POTW, also include POTW name and NPDES permit number</i>) PILGRIM'S PRIDE CORPORATION – AFIN 70-00020 1810 South West Ave. El Dorado, AR EL DORADO SOUTH PLANT AR0033723	Entry Time/Date 13:15/02/01/2013	Permit Effective Date 01 October 2008
	Exit Time/Date 14:37/02/01/2013	Permit Expiration Date 30 September 2013
Name(s) of On-Site Representative(s)/Title(s)/Phone and Fax Number(s) Hal Davis, Plant Manager/870-863-1200	Other Facility Data PDS# 070045	
Name, Address of Responsible Official/Title/Phone and Fax Number Troy Peshorn, Western Director of Environmental Engineering/903-767-6182 PILGRIM'S PRIDE CORPORATION 1105 S. Texas Street Pittsburg, TX 75686	Contacted Yes <input type="checkbox"/> No <input checked="" type="checkbox"/>

POTW Pretreatment Program

Water Division NPDES Photographic Evidence Sheet

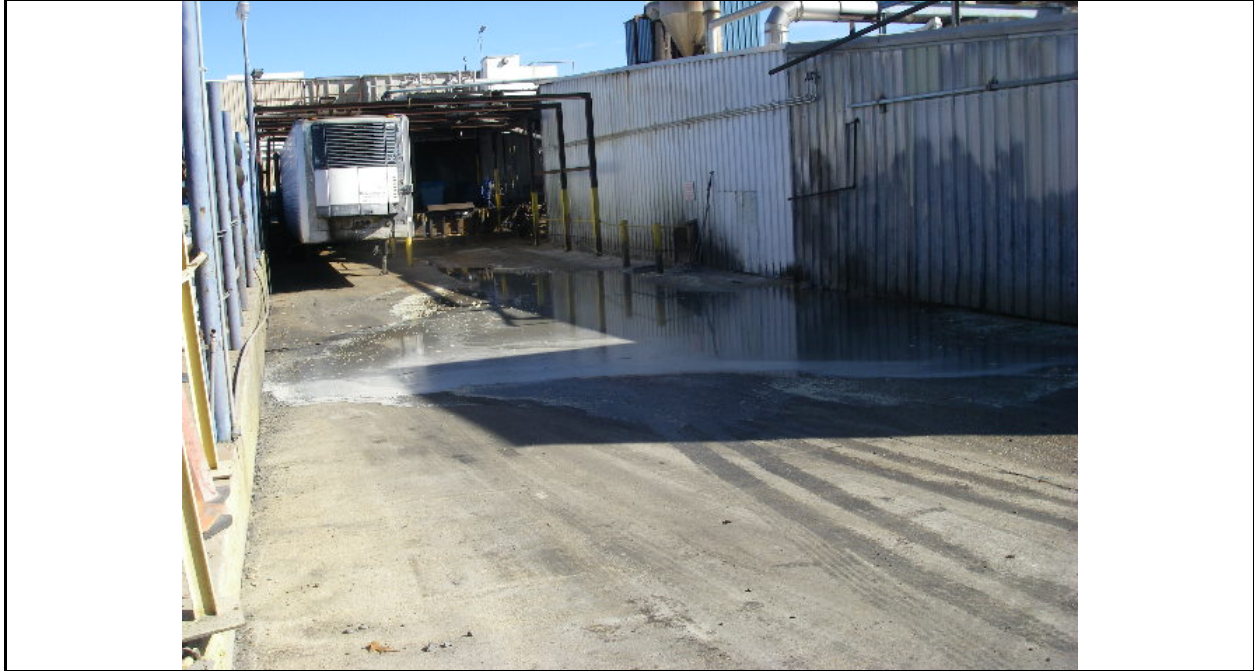
Photo #	1	Of	1	Date:	2/1/2013	Time:	14:09
----------------	---	-----------	---	--------------	----------	--------------	-------

Housekeeping was not being fully implemented at the truck unloading bay which drains to the pretreatment wastewater treatment plant. Specifically, the drain in the bay was stopped up and had chicken fat and water in the bay. See photo 1.

Additional Comments: Housekeeping was not being fully implemented at the truck unloading bay which drains to the pretreatment wastewater treatment plant. Specifically, the drain in the bay was stopped up and had chicken fat and water in the bay. See photo 1.

Description:	Drain at the truck unloading ramp stopped up. This drains to the facility's pretreatment plant and thence to the City of El Dorado						
---------------------	--	--	--	--	--	--	--
