<b>A R K A N S A S</b> Department of Environmental Quality		<b>WATER DIVISION INSPECTION REPORT</b>					
		AFIN: 72-00003		PERMIT #: AR0022063		DATE: 7/28/2014	
		COUNTY: 72 Washington			PDS #: 079207		MEDIA: WN
		GPS LAT: ~N36.2031 LONG: ~W-94.1402 LOCATION: General Area					
<b>FACILITY INFORMATION</b>			<b>INSPECTION INFORMATION</b>				
NAME: <b>City of Springdale</b> LOCATION:  CITY: <b>Springdale</b>			FACILITY TYPE: <b>1 - Municipal</b>		INSPECTOR ID#: <b>14939 S - State</b>		
			FACILITY EVALUATION RATING: <b>***</b>		INSPECTION TYPE: <b>Compliance Assistance</b>		
			DATE(S): <b>7/28/2014</b>	ENTRY TIME: <b>09:30</b>	EXIT TIME: <b>10:45</b>	PERMIT EFFECTIVE DATE: <b>2/9/2004</b>	
						PERMIT EXPIRATION DATE: <b>3/31/2009</b>	
<b>RESPONSIBLE OFFICIAL</b>							
NAME / TITLE: <b>Heath Ward / Executive Director</b> COMPANY: <b>Springdale Water Utilities</b> MAILING ADDRESS: <b>P.O. Box 769</b> CITY, STATE, ZIP: <b>Springdale AR 72765</b> PHONE & EXT. / FAX: <b>479.751.5751 /</b> EMAIL: <b>hward@springdalewater.com</b>			FAYETTEVILLE SHALE RELATED: <b>N</b> FAYETTEVILLE SHALE VIOLATIONS: <b>N</b>

Inspection Report: **City of Springdale**, AFIN: **72-00003**, Permit #: **AR002

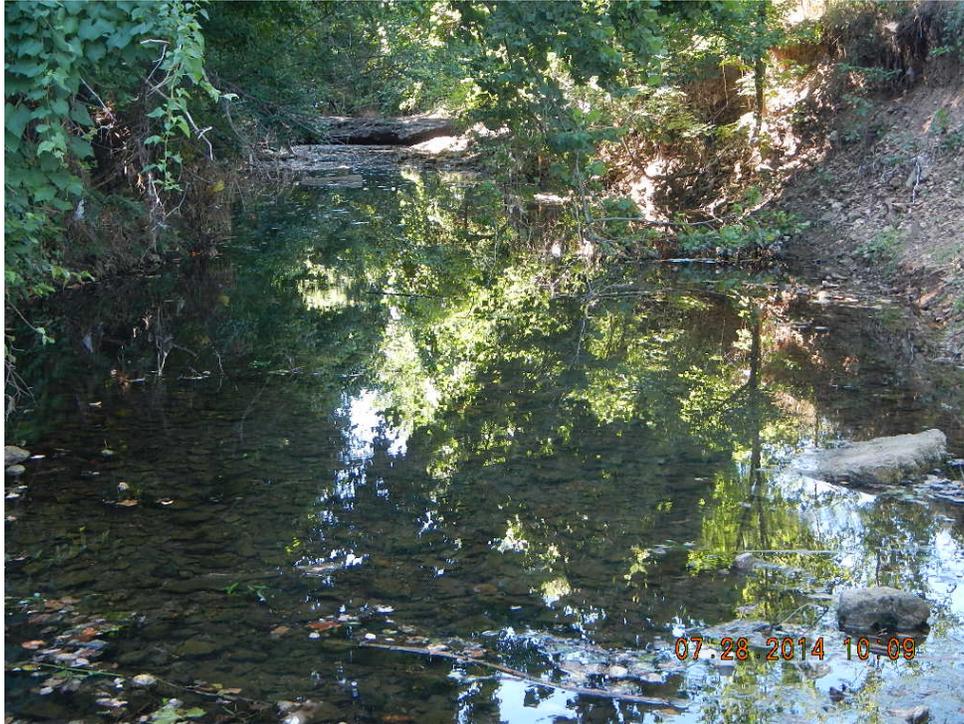
Location:	<b>City of Springdale</b>				
Photographer:	<b>Alison West</b>	Date:	<b>7-28-2014</b>	Time:	<b>10:09</b>
Witness:	<b>Matt Holden</b>	Photo #:	<b>1</b>		
Description:	<b>DSCN2961. Spring Creek upstream of solids.</b>

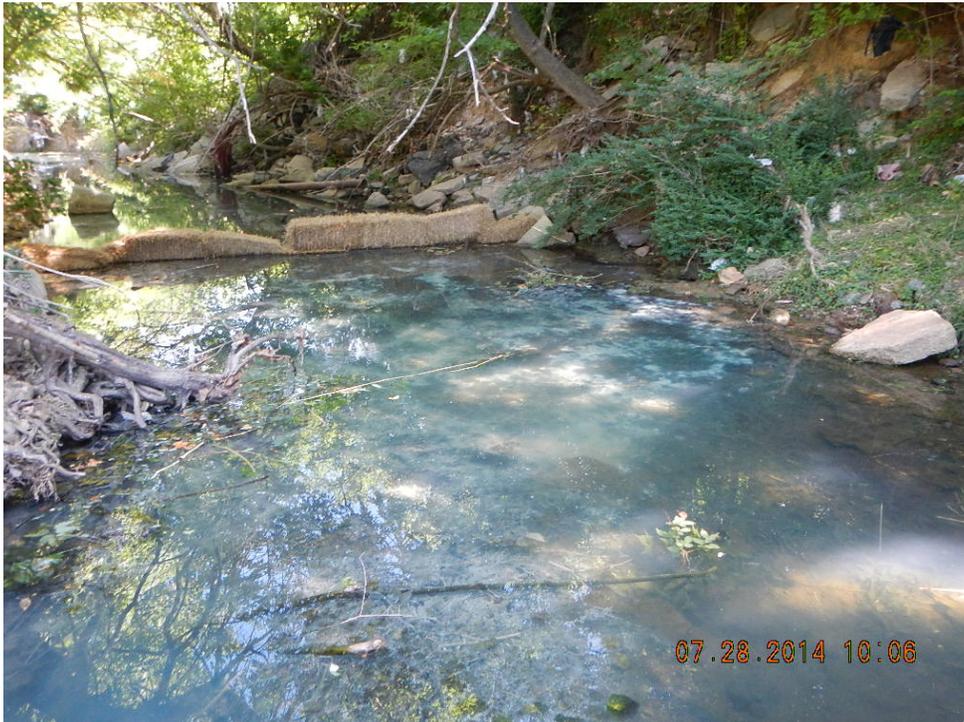
This is a summary of our mystery issue at Spring Creek. We believe that there may be sewage of some type getting into a section of the stream through the karst formations from an unknown location. Thus far massive and lengthy dye testing over the last 10 days from logical areas upstream have yielded no results. The D.O. levels are acceptable and the fish are thriving and so is wild life. However, our organoleptic observations and other tests tell us something is going on and we are not sure of the source. It may be a private line, septic tank, step system or some other extreme distance sewer issue we have not discovered yet. We have found no evidence it is our sanitary sewer, but we are not ruling it out due to the nature of the geology. We have placed hay bales downstream to prevent and to contain the "migration" of any solids that may be there. We do know the following:

Photographer:	<b>Alison West</b>	Date:	<b>7-28-2014</b>	Time:	<b>10:06</b>
Witness:	<b>Matt Holden</b>	Photo #:	<b>2</b>		
Description:	<b>DSCN2959. Solids in Spring Creek.</b>

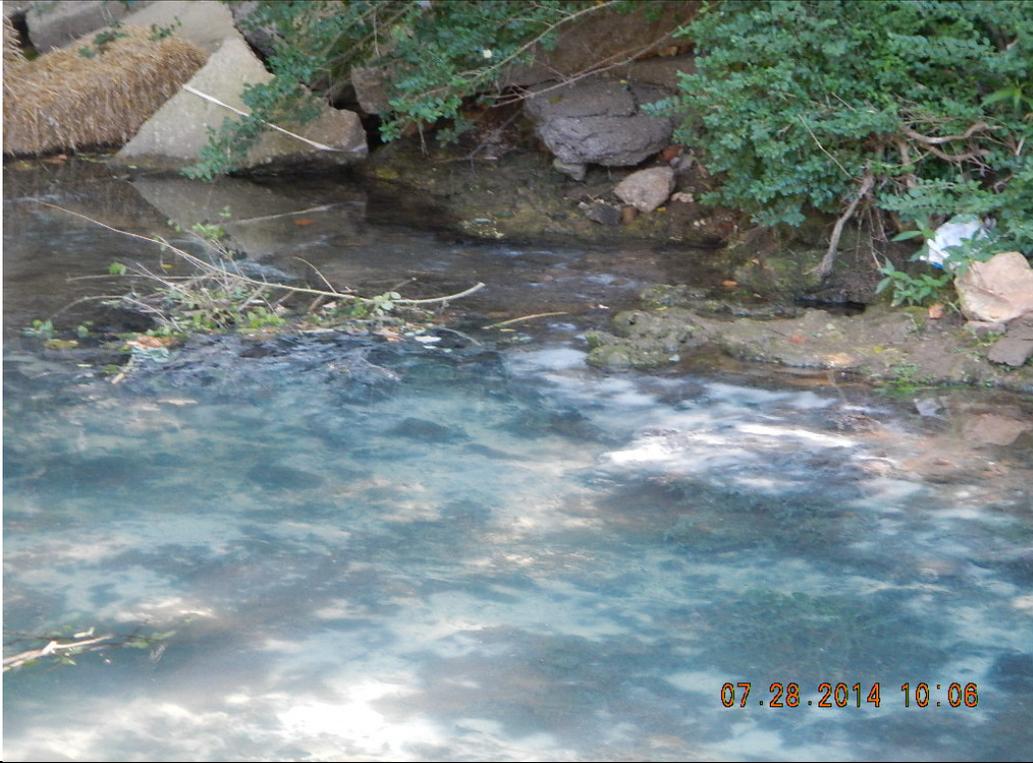
Location:	<b>City of Springdale</b>		
Photographer:	<b>Alison West</b>	Date:	<b>7-28-2014</b>
Witness:	<b>Matt Holden</b>	Time:	
		Photo #:	<b>3</b>
Description:	<b>DSCN2960. Solids in Spring Creek.</b>

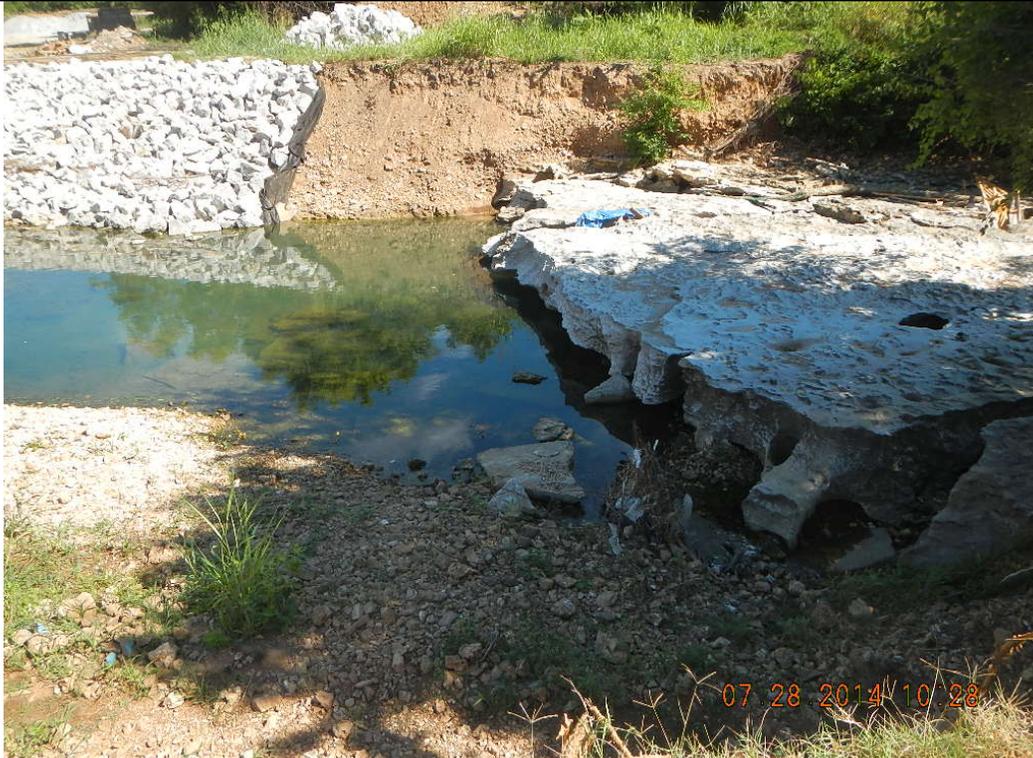
Photographer:	<b>Alison West</b>	Date:	<b>7-28-2014</b>	Time:	<b>10:28</b>
Witness:				Photo #:	<b>4</b>
Description:	<b>DSCN2965. Spring Creek downstream of solids.</b>

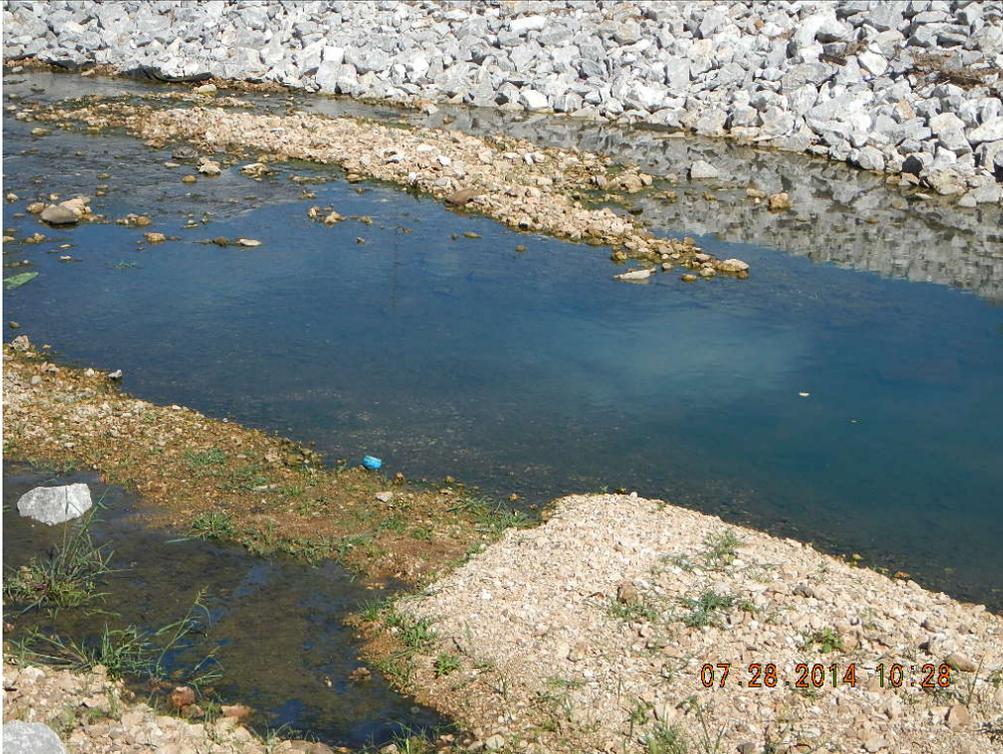
Location:	<b>City of Springdale</b>		
Photographer:	<b>Alison West</b>	Date:	<b>7-28-2014</b>
Witness:	<b>Matt Holden</b>	Time:	<b>10:28</b>
		Photo #:	<b>5</b>
Description:	<b>DSCN2966. Spring Creek downstream of solids.</b>
