inspection Report. Heber Springs Wastewater Treatment Plant, AFIN. 12-00029, Femilit #. AR0022361									
	ADEO		WATER		DIVISION I	NSF	PECT	101	N RE	PORT
	ADLQ	AF	IN: 12-00029	PE	RMIT #: AR0022	2381			DATE: 2	2/17/2016
Α	RKANSAS	CC	UNTY: 12 Cle	our	ne	PDS	#: 0896	63		MEDIA: WN
Dep	partment of Environmental Quality	GF	S LAT:	LO	NG: LOC	CATIO	V: N/A			
FACILITY INFORMATION				IN	SPEC	TION IN	IFOR	MATION	N	
	ः ber Springs Wastewater Treatme। जाठाः	nt P	lant		FACILITY TYPE: 1 - Municipal	8402	TOR ID#: 22 S - S			
	74 Bypass Rd				3 - Satisfactory	-				ion System
Не	ber Springs, AR				(-)	NTRY TIME:	EXIT TII 14:3			FECTIVE DATE:
	RESPONSIBLE OFFIC	CIAL			2/1//2010 0	0.50	14.0	,,	3/1/20 PERMIT EX	013 (PIRATION DATE:
	NAME: / TITLE								2/28/2018	
	Kent Latch / General Manager			-	FAYETTEVILLE SHALE RELATED: N					
	ber Springs Water and Sewer Co	mmi	ssion	-	FAYETTEVILLE SHALE VIOLATIONS: N					
	NG ADDRESS:									<u> </u>

On Wednesday, Feb 17, 2016 an inspection was conducted of the City's collection system with the abovementioned inspection participants. The inspection consisted of a site assessment of six (6) lift stations and a review of the Department's online SSO Report for pe

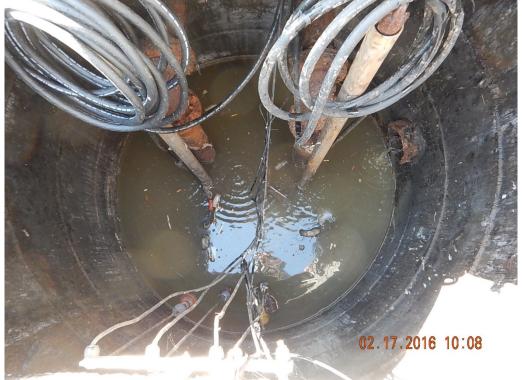
Water Division Photographic Evidence Sheet							
Location:	Location: Heber Springs Wastewater Treatment Plant						
Photograp	Photographer: Cody Wallace Date: Feb 17, 2016 Time: 1008						
Witness:	Kerri	McCabe			Photo #:	5

Description: Brighton Pointe Lift Station wet well; solids low.

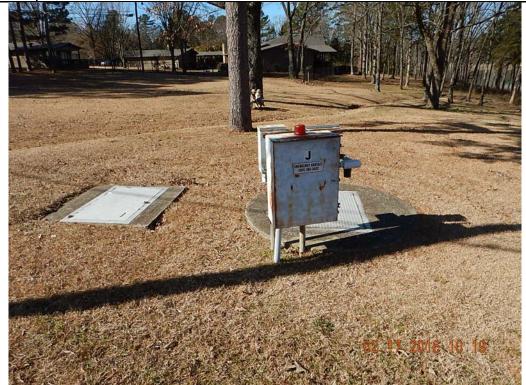
Photographer: Cody Wallace	Date: Feb 17, 2016	Time:	1019
Witness: Kerri McCabe		Photo #:	6

Description: Scenic Lift Station; visual alarm.

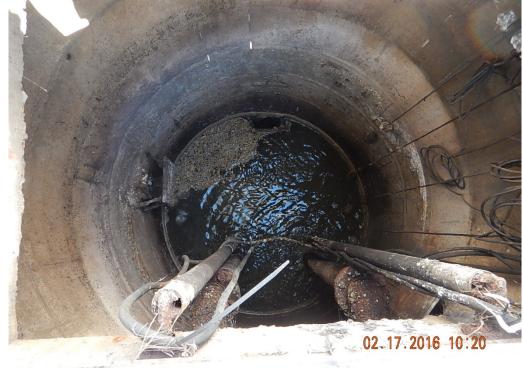
Water Division Photographic Evidence Sheet							
Location: Heber Springs Wastewater Treatment Plant							
Photographer: Cody Wallace		Date:	Feb 17, 2016	Time:	1020		
Witness: Kerri McCabe				Photo #	: 7

Description: Scenic Lift Station wet well; solids low.

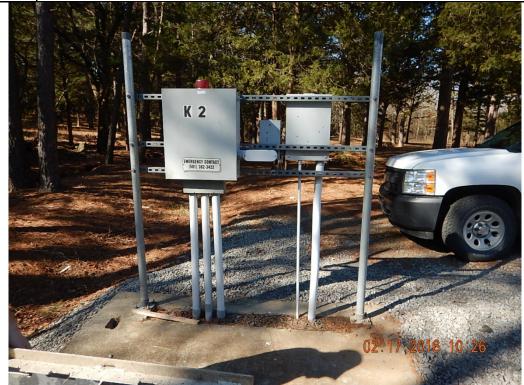
Photographer:	Cody Wallace	Date: Feb 1	17, 2016	Time:	1026
Witness: Kerri McCabe			Photo #:	8

Description: Case Ford Lift Station; visual alarm.

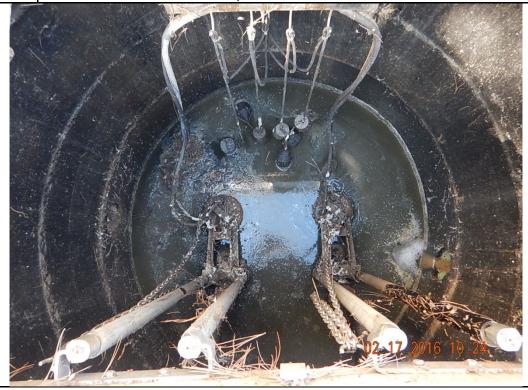
-1	· · · · · · · · · · · · · · · · · · ·		-,, -				
Water Division Photographic Evidence Sheet							
Location: Heber Springs Wastewater Treatment Plant							
Photographe	r: Cody Wallace	Date:	Feb 17, 2016	Time:	1024		
Witness: Kerri McCabe					[‡] : 9		
Description: Case Ford Lift Station wet well; solids moderate.

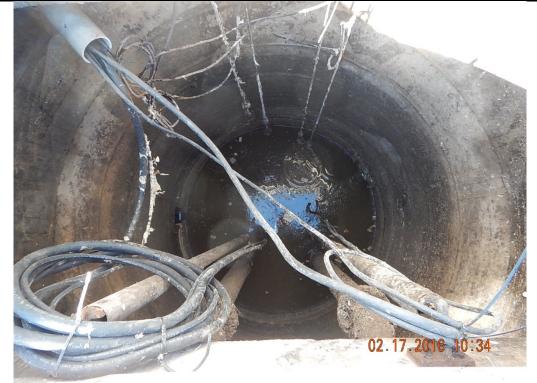
Photographer: Cody Wallace Date: Feb 17, 2016 Time: 1034
Witness: Kerri McCabe Photo #: 12

Description: 25N Lift Station; visual alarm.

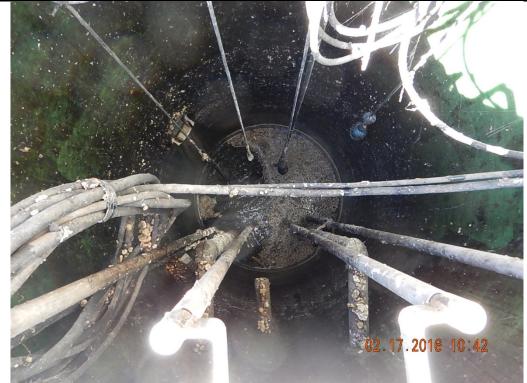
Photographer: Cody Wallace Date: Feb 17, 2016 Time: 1042
Witness: Kerri McCabe Photo #: 14

Description: Barnett Lift Station; audio and visual alarms.

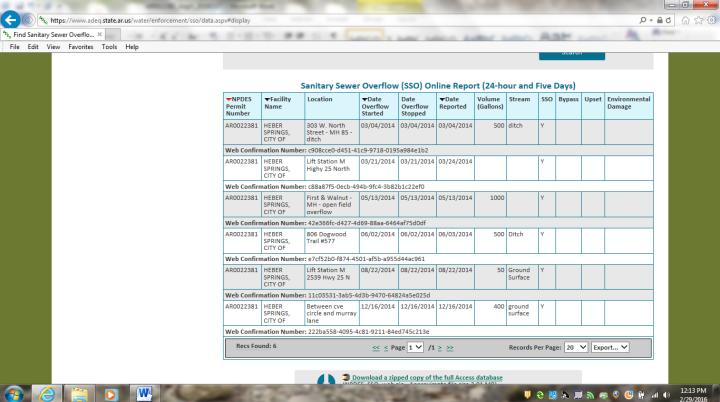
The City reported six (6) SSOs for 2014 and four (4) SSOs for 2015 (see Figures 2 - 3).

Figure 2. City of Heber Springs Sanitary Sewer Overflows (SSOs) reported to ADEQ in 2014.

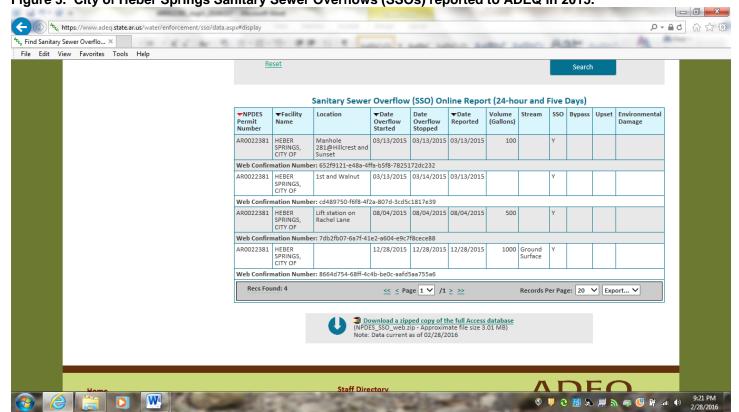
Inspection Report: Heber Springs Wastewater Treatment Plant, AFIN: 12-00029, Permit #: AR0022381 Figure 3. City of Heber Springs Sanitary Sewer Overflows (SSOs) reported to ADEQ in 2015.
