<b>A R K A N S A S</b> Department of Environmental Quality	<b>OFFICE OF WATER INSPECTION REPORT</b>		
	AFIN: <b>66-01652</b>	PERMIT #: <b>AR0021750</b>	DATE: <b>6/7/2017</b>
	COUNTY: <b>66 Sebastian</b>	PDS #: <b>097834</b>	MEDIA: <b>WN</b>
	GPS LAT: <b>35.313206</b> LONG: <b>-94.405142</b> LOCATION: <b>Entrance</b>		
<b>FACILITY INFORMATION</b>		<b>INSPECTION INFORMATION</b>	
NAME: <b>QualServ Corporation</b> LOCATION: <b>7400 South 28<sup>th</sup> Street</b> CITY: <b>Fort Smith</b>		FACILITY TYPE: <b>2 - Industrial</b> INSPECTOR ID#: <b>71330 S - State</b> FACILITY EVALUATION RATING: <b>3 - Satisfactory</b> INSPECTION TYPE: <b>Industrial User</b>	
<b>RESPONSIBLE OFFICIAL</b>		DATE(S): <b>6/7/2017</b> ENTRY TIME: <b>08:30</b> EXIT TIME: <b>09:10</b> PERMIT EFFECTIVE DATE: <b>2/1/2015</b> PERMIT EXPIRATION DATE: <b>1/31/2020</b>	
NAME / TITLE: <b>Carl Geffken / City Administrator</b> COMPANY: <b>Fort Smith, City of</b> MAILING ADDRESS: <b>P.O. Box 1908</b> CITY, STATE, ZIP: <b>Fort Smith AR 72902</b> PHONE & EXT. / FAX: <b>479-494-3908 /</b> EMAIL: <b>Imcavoy@fortsmithar.gov</b>		<b>INSPECTION PARTICIPANTS</b>

**POTW Pretreatment Program**

**Industrial Site Visit**

**Name of Ind

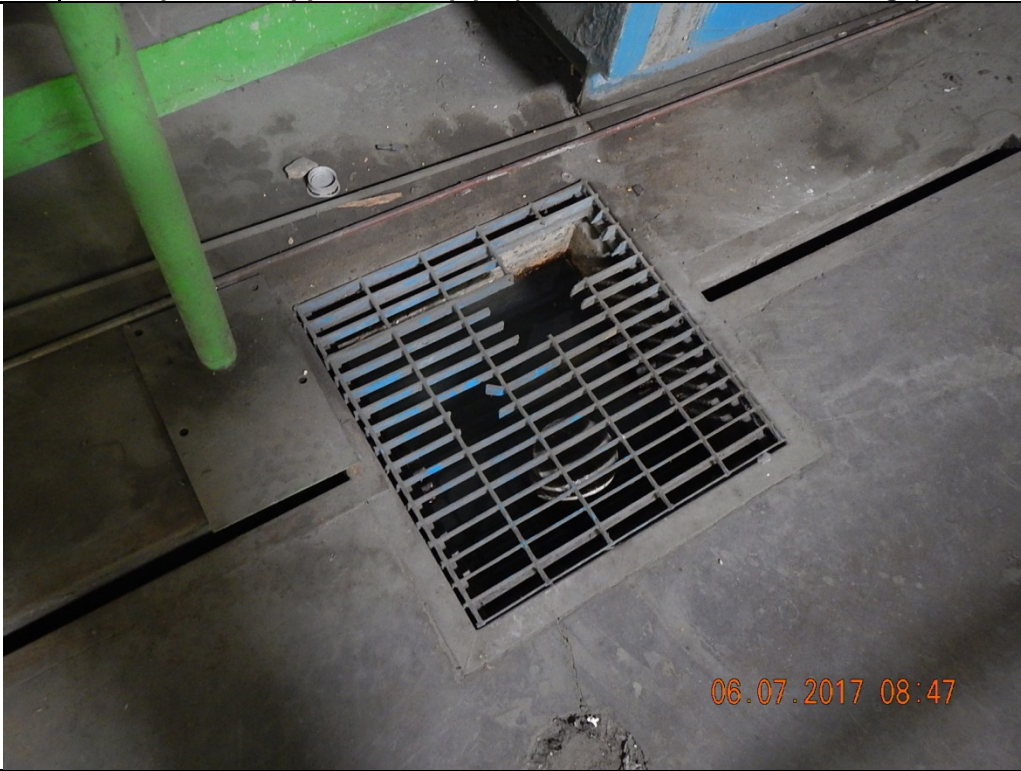
Location:	<b>QualServ Corporation</b>		
Photographer:	<b>Dannielle Gray</b>	Date:	<b>6/7/2017</b>
		Time:	<b>0847</b>
Witness:	<b>Kerri McCabe, John Hancock, Don Clover, Chris Cooper, Bobbie Edgington</b>		Photo #:
			<b>1</b>
Description:	<b>Outfall pit with capped outfall pipe (outfall not in use; no discharge).</b>

I inspected this facility with the above-referenced inspection participants on June 7, 2017. Inspection consisted of a pretreatment component assessment and discussion designed to ascertain the IU's familiarity with the City's pretreatment program. This facility is listed as a Significant Industrial User (SIU) under the City's pretreatment program due to being a categorical industry. However, the facility has designed a process by which they have no discharge; and therefore, sampling and flow measurement are not required. The facility collects all process wastewaters in drums and the drums are disposed of approximately once per year. A contracted waste hauler (Renco) collects the 55-gal drums of process wastewater and disposes of them. Disposal manifests are provided to the facility and are reviewed by City staff during inspections. Disposal had recently occurred and no drums were observed in the storage area during inspection (see Photo 3). The outfall pipe is capped and the City conducts routine inspections to ensure that no discharge is occurring.

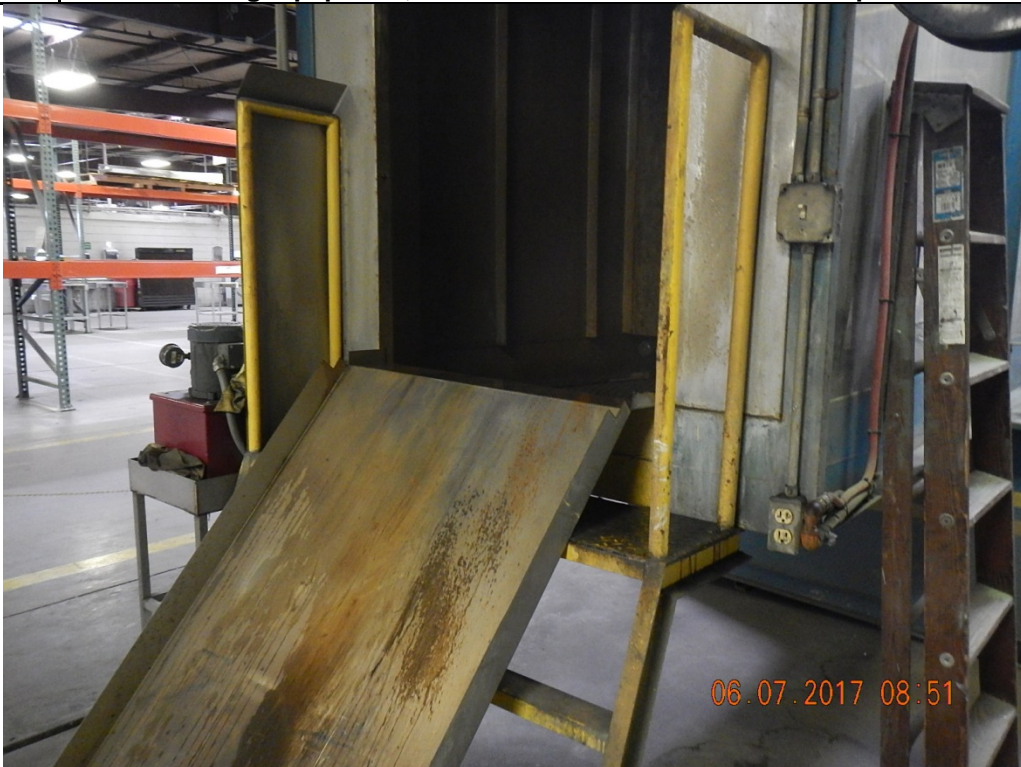
During inspection, I observed water in the outfall pit. The pit was full and the capped outfall pipe was submerged. Upon further investigation, it was revealed that the water in the pit was condensate from nearby metal finishing equipment (see Photo 2). This equipment was staged on a pad and a drainage channel had been installed in the concrete. The drainage channel flowed to the outfall pit. I discussed this with Ms. Edgington and recommended that the pit be routinely pumped out and any water removed be stored with the rest of the process wastewater. Ms. Edgington agreed to draft up a policy to incorporate these recommendations.

Photographer:	<b>Dannielle Gray</b>	Date:	<b>6/7/2017</b>
		Time:	<b>0851</b>
Witness:	<b>Kerri McCabe, John Hancock, Don Clover, Chris Cooper, Bobbie Edgington</b>		Photo #:
			<b>2</b>
Description:	<b>Metal Finishing equipment; condensate runoff flows to outfall pit.</b>

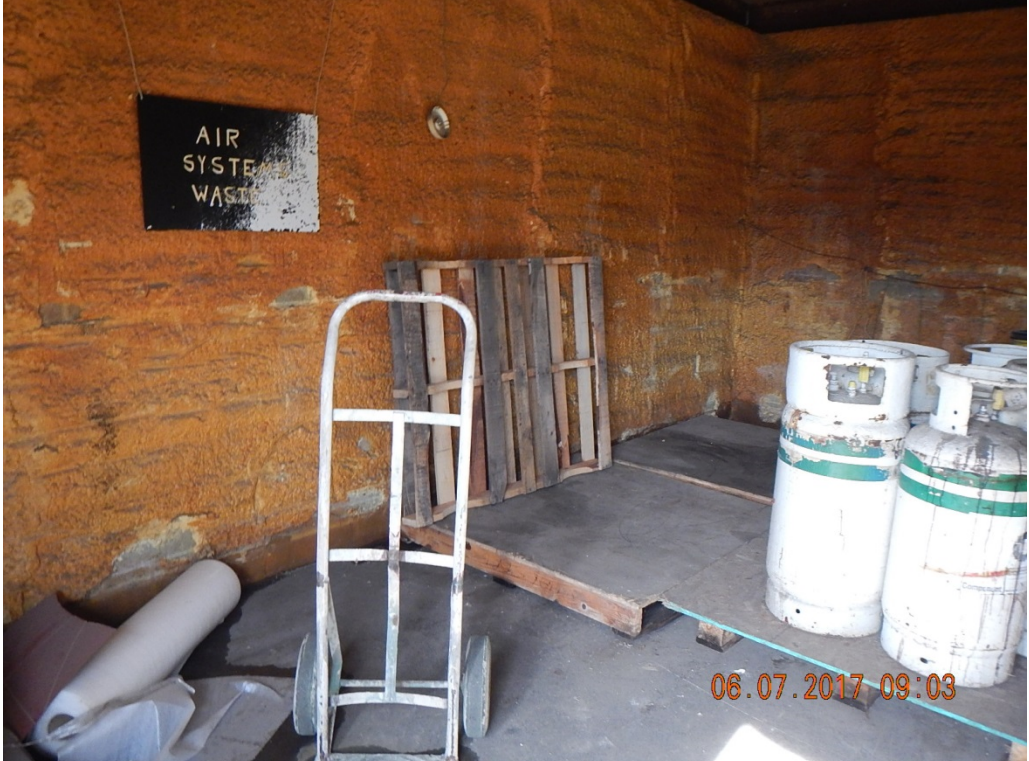
Office of Water Photographic Evidence Sheet			
Location:	<b>QualServ Corporation</b>		
Photographer:	<b>Dannielle Gray</b>	Date:	<b>6/7/2017</b>
Witness:	<b>Kerri McCabe, John Hancock, Don Clover, Chris Cooper, Bobbie Edgington</b>	Time:	<b>0903</b>
		Photo #:	<b>3</b>
Description:	<b>Hazardous waste and process wastewater storage area. Note no process wastewater stored during inspection. Vacant area left of white cylinders is where process wastewater is stored before pickup and disposal.</b>

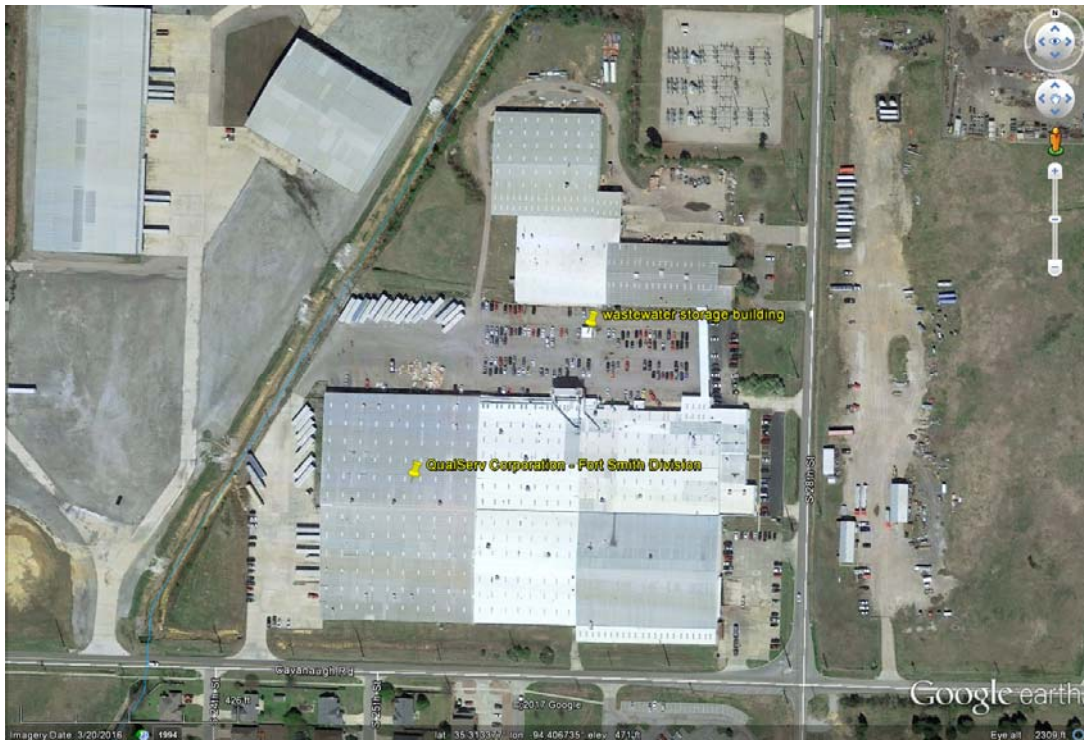
Figure 1. Google Earth image dated March 20, 2016 showing facility overview and wastewater storage location.
