**RE:** Camden Water Utilities Inspections (Ouachita Co)

AFIN: 52-00073 NPDES Permit No.: AR0022365

mopodiion reporti	•			•, . •.				
	V DEO		WATER	<b>DIVISION I</b>	NSF	SEC.	ΓΙΟ	N RE	PORT
	ADLQ	AF	IN: <b>52-00073</b>   F	PERMIT #: AR002	2365			DATE: 2	2/9/2018
Δ	RKANSAS	CC	OUNTY: <b>52 Ouac</b>	hita	PDS	#: 1018	832		MEDIA: WN
Dep	partment of Environmental Quality	GF	PS LAT: <b>33.5634</b> 0	9 LONG: -92.816	980	OCAT	ION: I	Entrance	)
	FACILITY INFORMAT	IN	ISPEC	TION	NFOF	RMATION	١		
	: mden Water Utilities			FACILITY TYPE:  1 - Municipal	101	TOR ID#: 531 S -		-	
	1 Ouachita 197	FACILITY EVALUATION RATIN  4 - Satisfactory	,		Con	TION TYPE: npliance	Evaluation

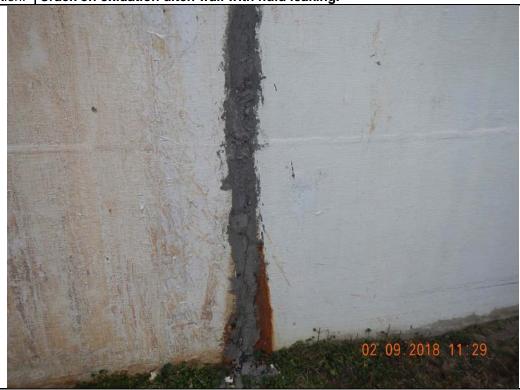
1.) The facility has cracks in the cement wall of the racetrack oxidation ditch that are allowing some fluid to run down the wall. This is a violation of permit condition Part III. (B.) (1.) (A.) of the permit.

During the site inspection, I observed all required treatment devices functioning. The racetrack oxidation ditch had recently been repaired using a cement or epoxy. I observed that the areas of repair had liquid leaking through the repair (see Photos 1-6). Keith Ballard, Plant Superintendent, stated that the epoxy used may have pulled liquid through the crack and they were in the process of completing repairs. All blowers in the oxidation ditch were in operation, and the sludge digester had recently been cleaned of vegetation. The outfall flow is measured prior to chlorine contact (per footnote in Part IA of the permit) and the Prosonic flowmeter was in operation and within the required  $\pm$  10% deviation of flow in the 12" Parshall flume. The water discharged from the outfall was colorless, and the refrigerated composite sampler was in operation with a thermometer reading 4°C. The belt press for the sludge was not in operation at the time of inspection.

# Water Division Photographic Evidence Sheet Location: Camden Water Utilities Photographer: Michael Young Date: 02/09/2018 Time: 11:29 Witness: Photo #: 3 Description: Crack on oxidation ditch wall with fluid leaking.

As a response to this inspection, please provide photos of the completed repairs to the oxidation ditch.

During Mr. Young's inspection, he noticed cracks in the cement wall of the racetrack oxidation ditch that was allowing some fluid to run down the wall. We have corrected this problem by patching the walls with a cement patch and have painted the cracks. We have in closed pictures of the racetrack to show the repairs.

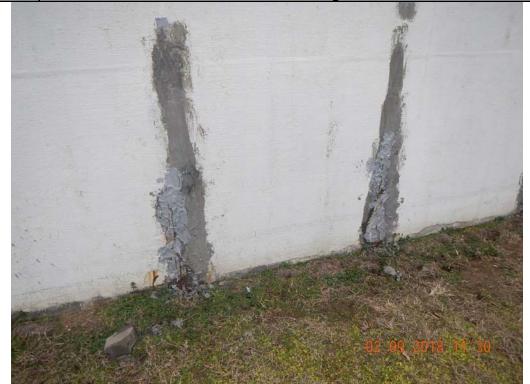
Photographer: Michael Young Date: 02/09/2018 Time: 11:30 Witness: Photo #: 4

Description: Crack on oxidation ditch wall with fluid leaking.

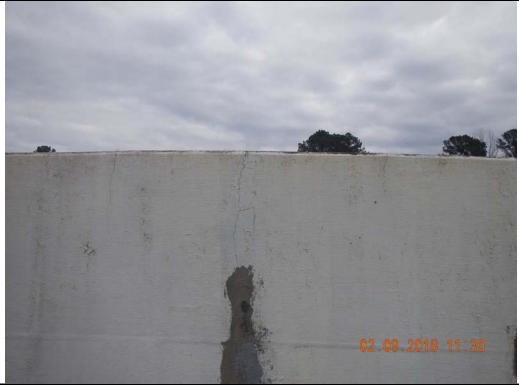
# Water Division Photographic Evidence Sheet Location: Camden Water Utilities Photographer: Michael Young Date: 02/09/2018 Time: 11:30 Witness: Photo #: 5

Description: Crack on oxidation ditch wall with fluid leaking.

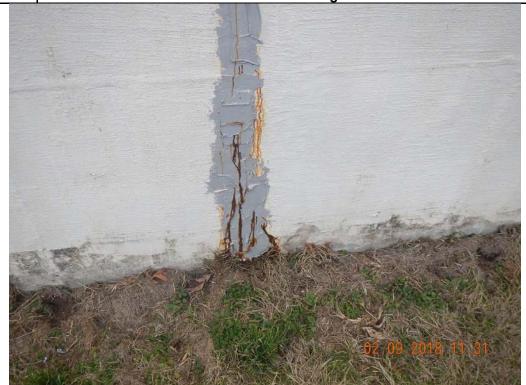
Photographer:	Michael Young	Date:	02/09/2018	Time:	11:31
Witness:				Photo #	6

Description: Crack on oxidation ditch wall with fluid leaking.
