ARKANSAS  
Department of Environmental Quality

**RE: Heber Springs WWTP Inspections (Cleburne Co)**  
**AFIN: 12-00029**                      **NPDES Permit No.: AR0022381**

<b>A R K A N S A S</b> Department of Environmental Quality	<b>WATER DIVISION INSPECTION REPORT</b>				
	AFIN: 12-00029	PERMIT #: AR0022381	DATE: 2/22/2018		
	COUNTY: 12 Cleburne	PDS #: 102125	MEDIA: WN		
	GPS LAT: 35.487928 LONG: -91.999388 LOCATION: General Area				
<b>FACILITY INFORMATION</b>		<b>INSPECTION INFORMATION</b>			
NAME: <b>Heber Springs WWTP</b> LOCATION: <b>1174 Bypass Road</b> CITY: <b>Heber Springs</b>		FACILITY TYPE: <b>1 - Municipal</b> INSPECTOR ID#: <b>117208 S - State</b> FACILITY EVALUATION RATING: <b>2 - Marginal</b> INSPECTION TYPE: <b>Compliance Evaluation</b>			
<b>RESPONSIBLE OFFICIAL</b>		DATE(S):      ENTRY TIME:      EXIT TIME:      PERMIT EFFECTIVE DATE: <b>2/22/2018      09:45      13:55      3/1/2013</b> PERMIT EXPIRATION DATE: <b>2/28/2018</b>			
NAME / TITLE: <b>Kent Latch / General Manager</b> COMPANY: <b>Heber Springs Water and Sewer Utility</b> MAILING ADDRESS: <b>1108 West Front</b> CITY, STATE, ZIP: <b>Heber Springs AR 72543</b> PHONE & EXT. / FAX: <b>501-362-3422 /</b

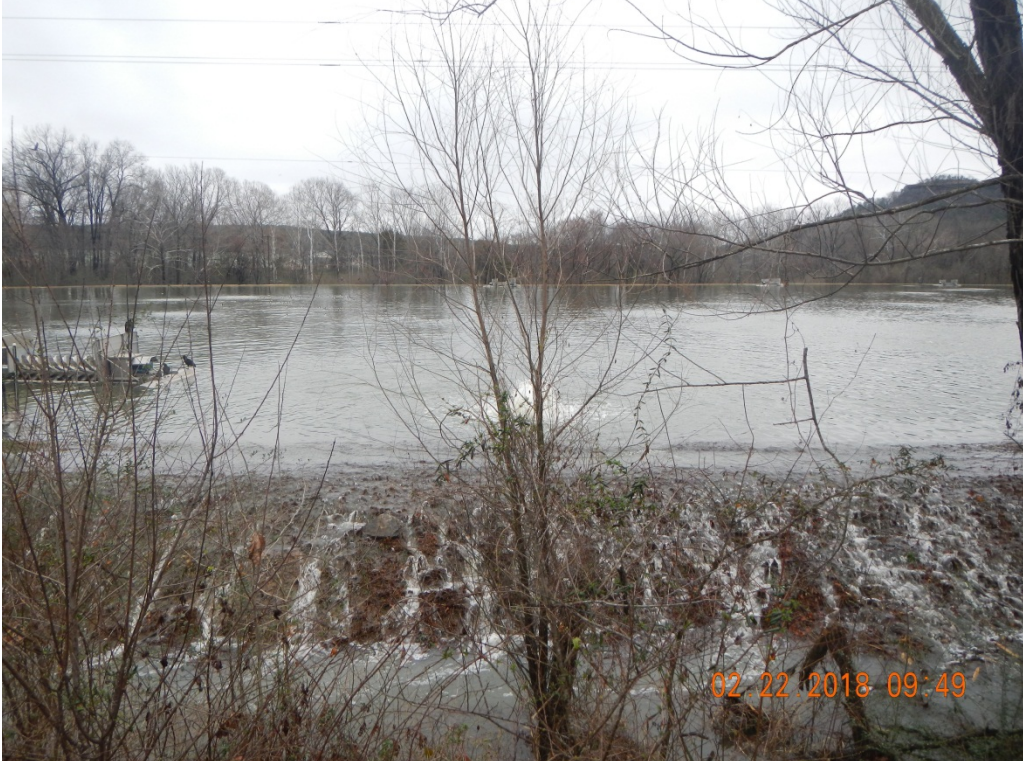
Water Division Photographic Evidence Sheet			
Location:	<b>Heber Springs WWTP</b>		
Photographer:	<b>Skyler Schlick</b>	Date:	<b>2/22/2018</b>
Witness:	<b>Kerri McCabe</b>	Time:	<b>0949</b>
		Photo #:	<b>1</b>
Description:	<b>Unpermitted discharge occurring from Cell #1 (primary cell); overflow to UT of Sulphur Creek (upstream of permitted outfall).</b>

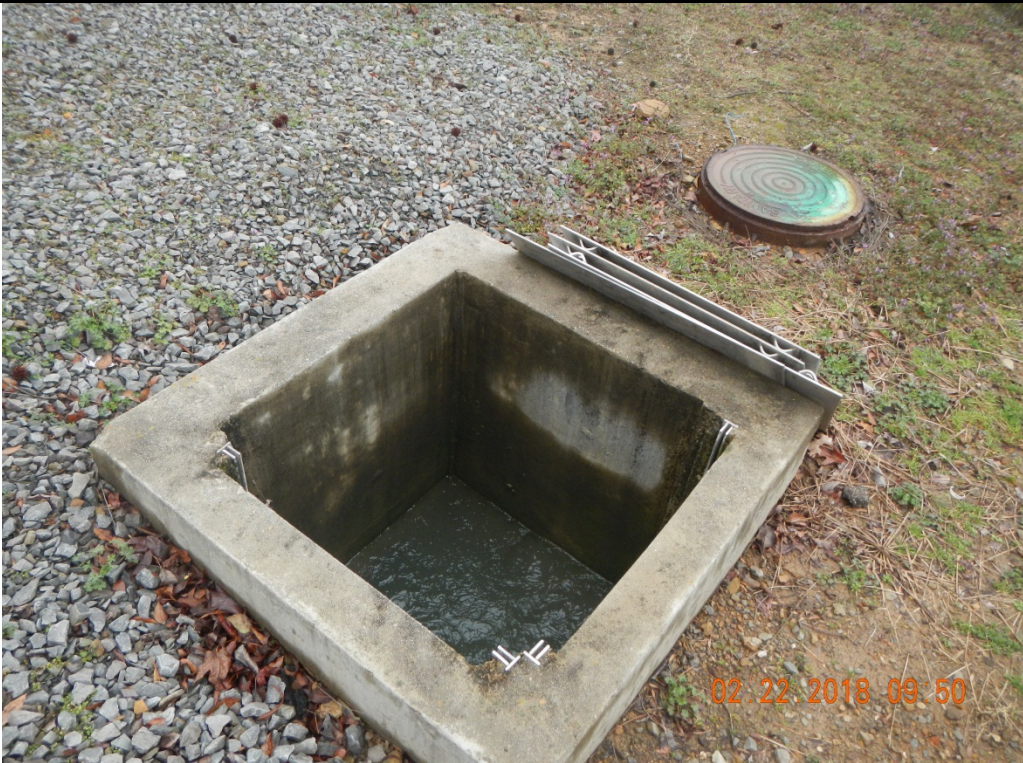
Photographer:	<b>Skyler Schlick</b>	Date:	<b>2/22/2018</b>
Witness:	<b>Kerri McCabe</b>	Time:	<b>0950</b>
		Photo #:	<b>2</b>
Description:	<b>Influent box.</b>

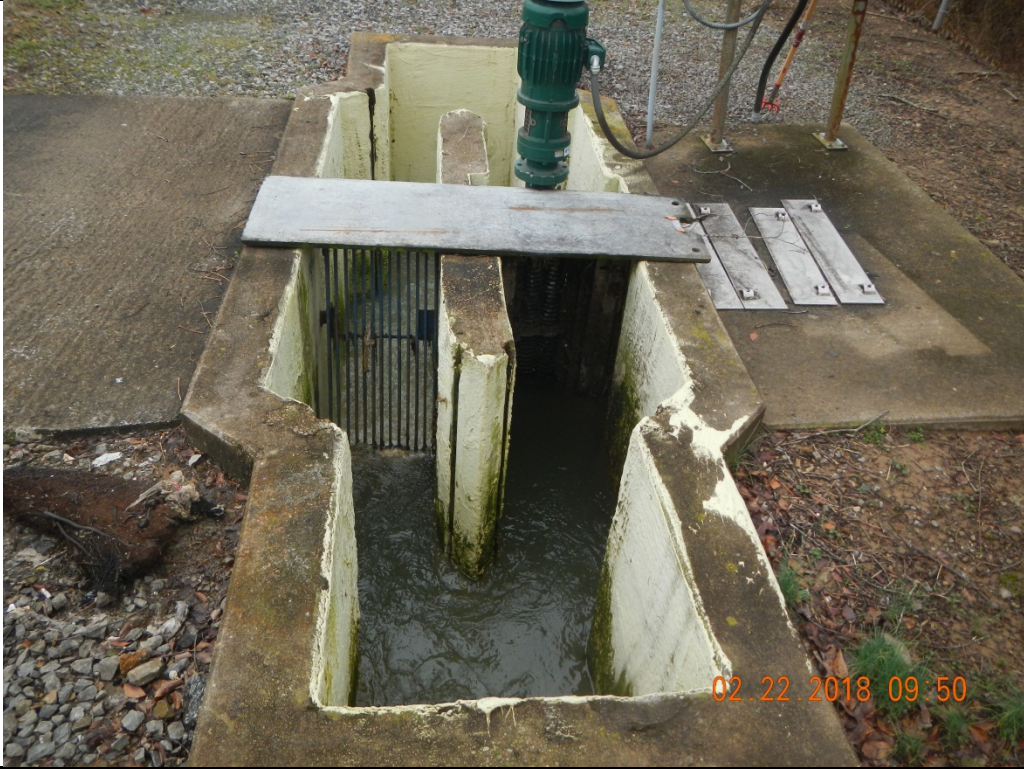
Location:	<b>Heber Springs WWTP</b>		
Photographer:	<b>Skyler Schlick</b>	Date:	<b>2/22/2018</b>
Witness:	<b>Kerri McCabe</b>	Time:	<b>0950</b>
Description:		Photo #:	<b>3</b>
<b>Comminutor and bar screen for preliminary.</b>

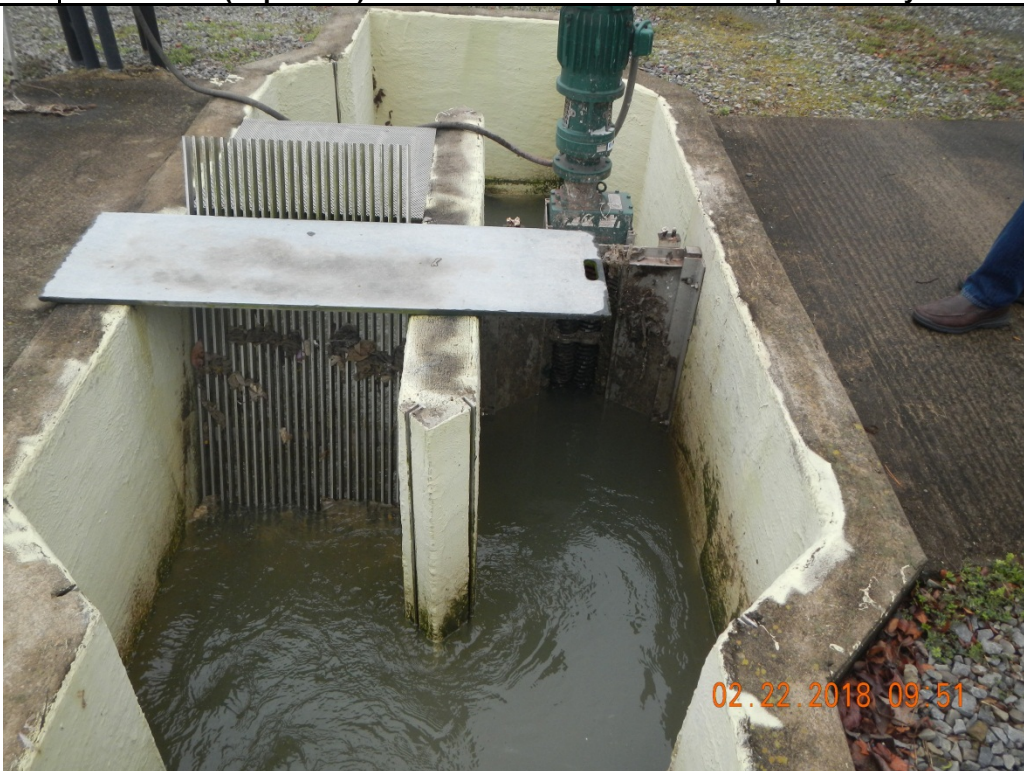
Photographer:	<b>Skyler Schlick</b>	Date:	<b>2/22/2018</b>
Witness:	<b>Kerri McCabe</b>	Time:	<b>0951</b>
Description:		Photo #:	<b>4</b>
<b>The second (in parallel) comminutor and bar screen for preliminary.</b>

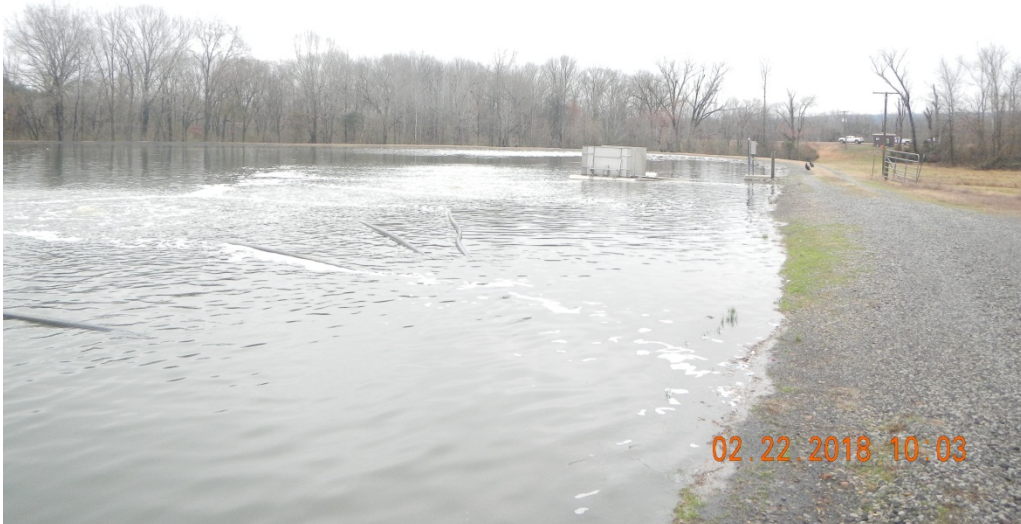
Location:	<b>Heber Springs WWTP</b>				
Photographer:	<b>Skyler Schlick</b>	Date:	<b>2/22/2018</b>	Time:	<b>1003</b>
Witness:	<b>Kerri McCabe</b>	Photo #:	<b>5</b>		
Description:	<b>Overview of Cell #3 of the lagoon.</b>

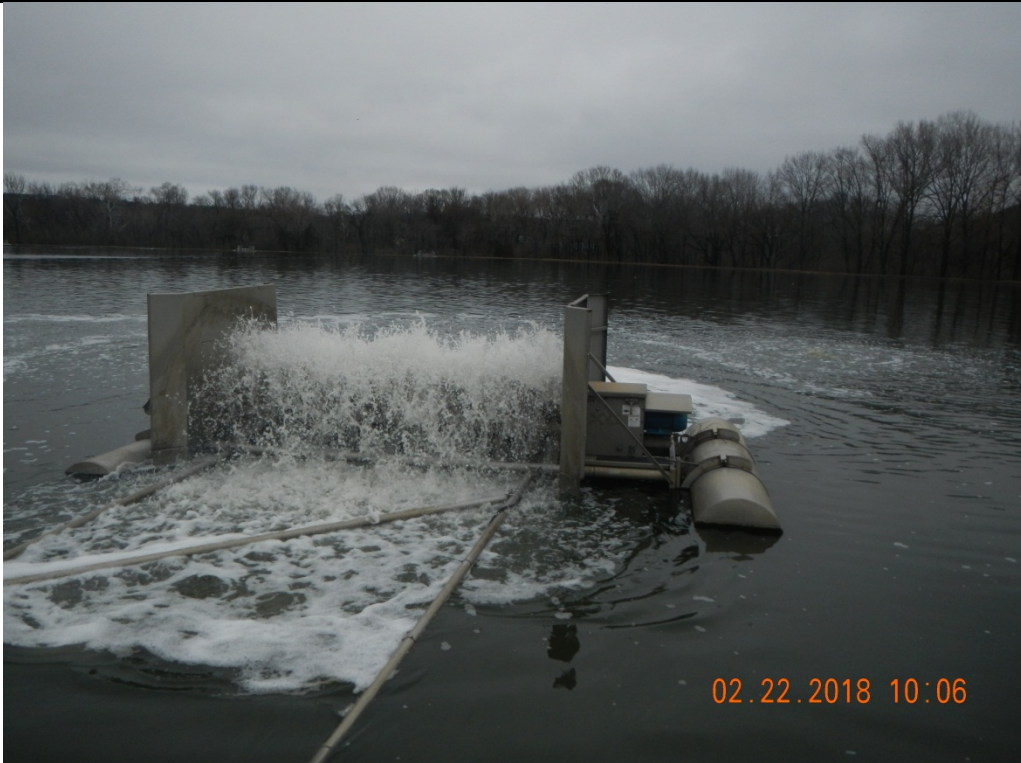
Photographer:	<b>Skyler Schlick</b>	Date:	<b>2/22/2018</b>	Time:	<b>1006</b>
Witness:	<b>Kerri McCabe</b>	Photo #:	<b>6</b>		
Description:	<b>Surface Agitator in Cell #3.</b>

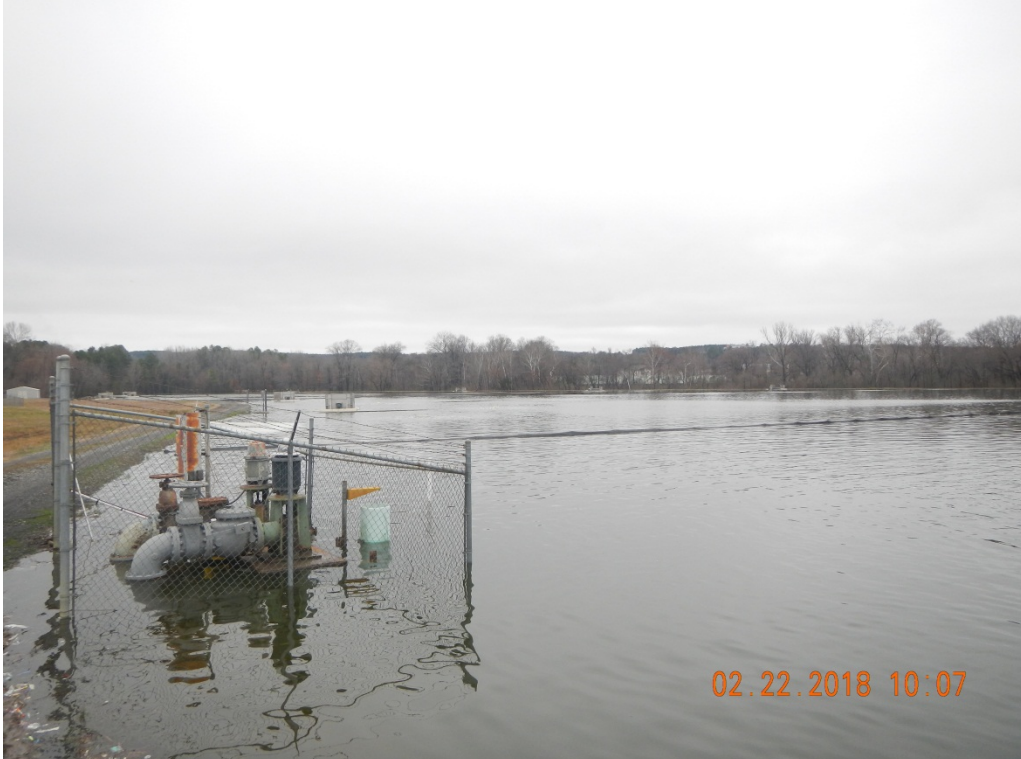
Location:	<b>Heber Springs WWTP</b>		
Photographer:	<b>Skyler Schlick</b>	Date:	<b>2/22/2018</b>
Witness:	<b>Kerri McCabe</b>	Time:	<b>1007</b>
		Photo #:	<b>7</b>
Description:	<b>Overview of the lagoon from Cell #3 and intake structure.</b>

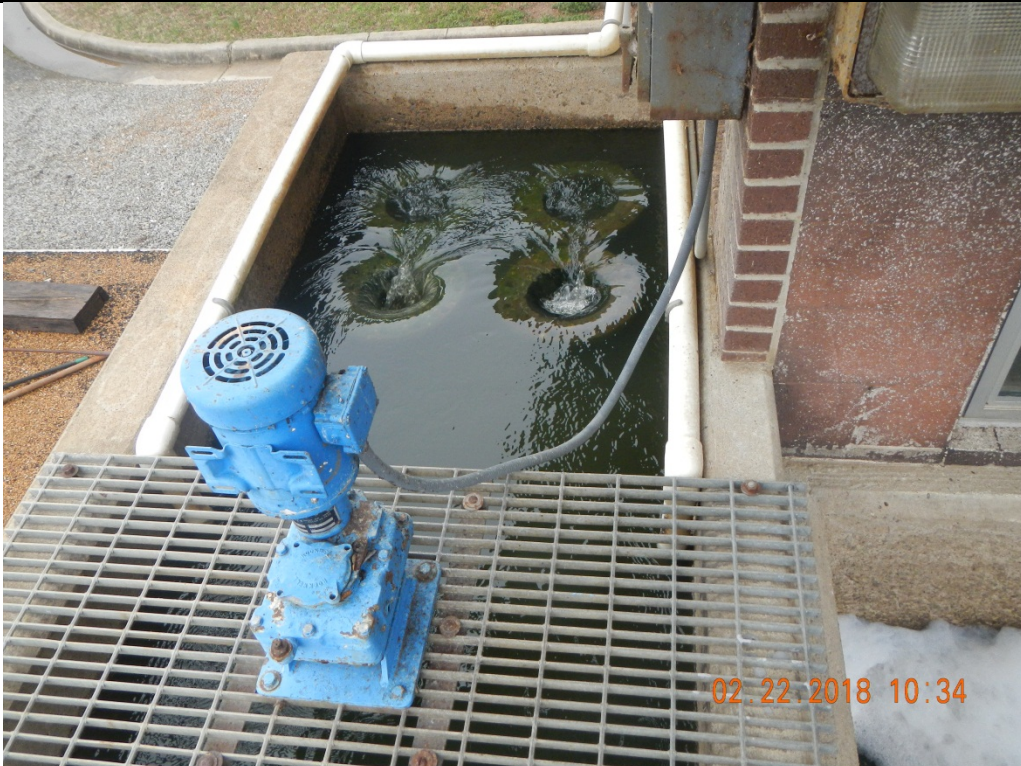
Photographer:	<b>Skyler Schlick</b>	Date:	<b>2/22/2018</b>
Witness:	<b>Kerri McCabe</b>	Time:	<b>1034</b>
		Photo #:	<b>8</b>
Description:	<b>Rapid sand filter</b>

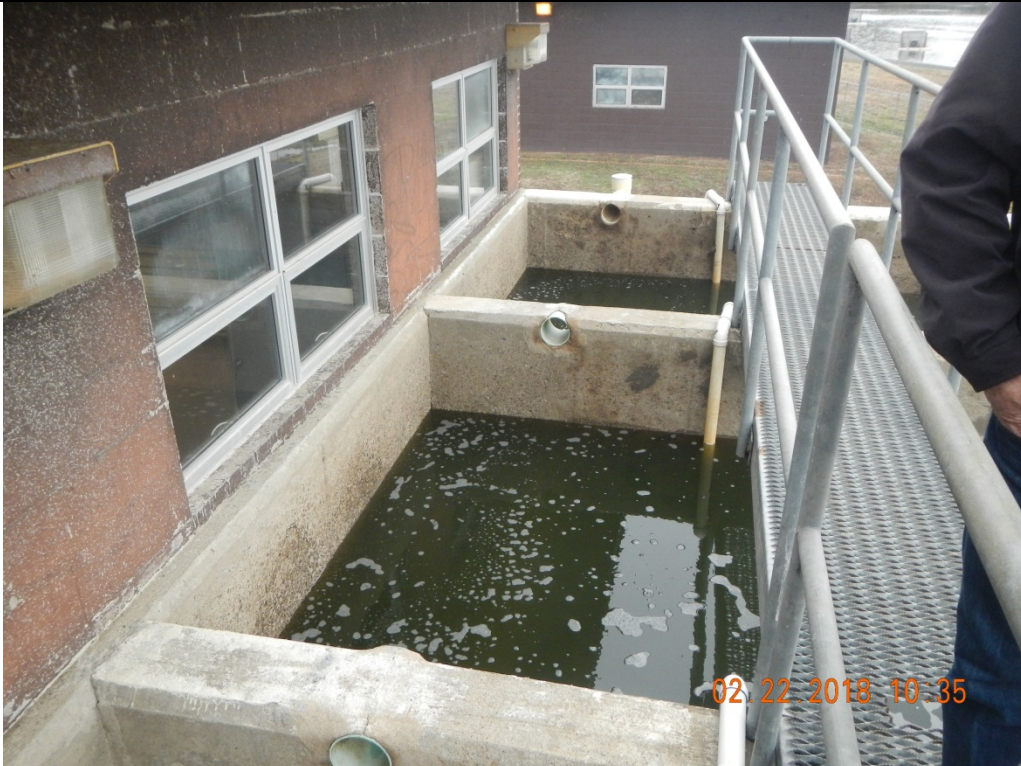
Location:	<b>Heber Springs WWTP</b>		
Photographer:	<b>Skyler Schlick</b>	Date:	<b>2/22/2018</b>
Witness:	<b>Kerri McCabe</b>	Time:	<b>1035</b>
		Photo #:	<b>9</b>
Description:	<b>Rapid sand filter</b>

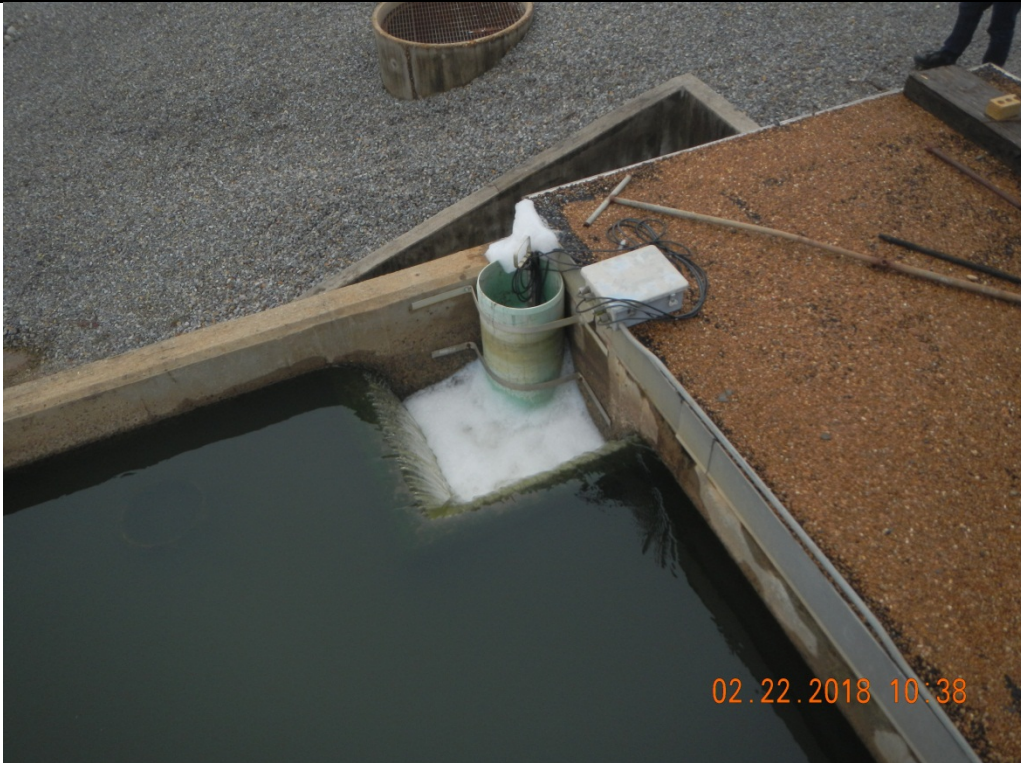
Photographer:	<b>Skyler Schlick</b>	Date:	<b>2/22/2018</b>
Witness:	<b>Kerri McCabe</b>	Time:	<b>1038</b>
		Photo #:	<b>10</b>
Description:	<b>Effluent flowing to UV disinfection.</b>

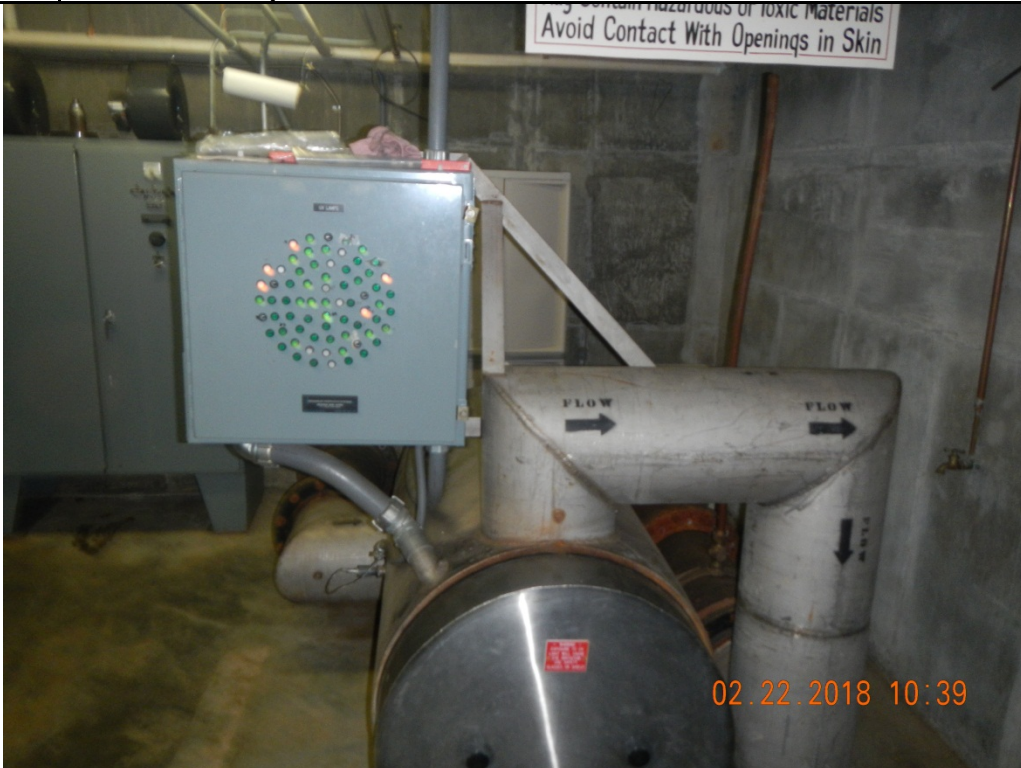
Location:	<b>Heber Springs WWTP</b>		
Photographer:	<b>Skyler Schlick</b>	Date:	<b>2/22/2018</b>
Witness:	<b>Kerri McCabe</b>	Time:	<b>1039</b>
		Photo #:	<b>11</b>
Description:	<b>UV disinfection prior to Outfall 002.</b>

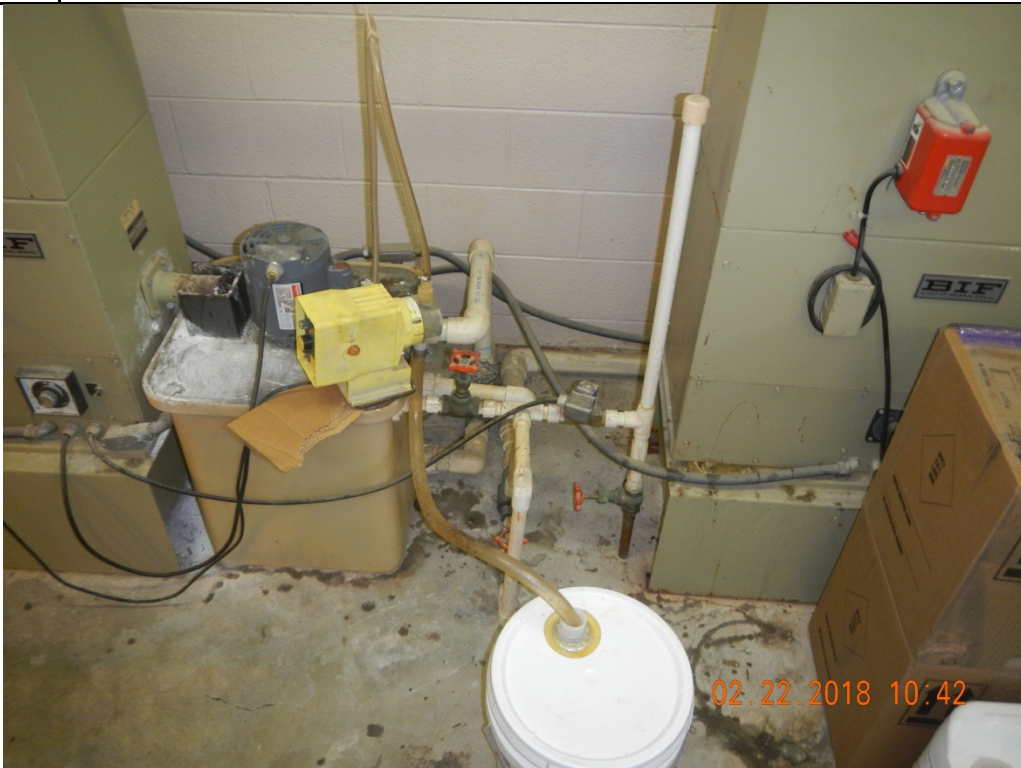
Photographer:	<b>Skyler Schlick</b>	Date:	<b>2/22/2018</b>
Witness:	<b>Kerri McCabe</b>	Time:	<b>1042</b>
		Photo #:	<b>12</b>
Description:	<b>Chemical additive.</b>

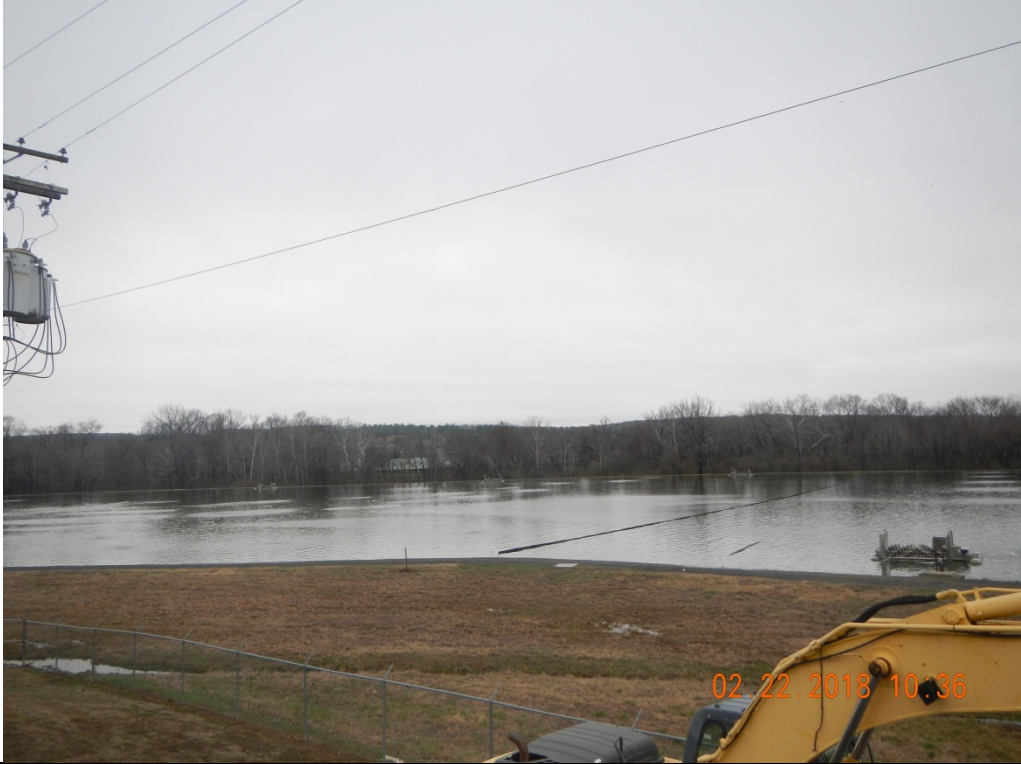
Location:	<b>Heber Springs WWTP</b>		
Photographer:	<b>Skyler Schlick</b>	Date:	<b>2/22/2018</b>
Witness:	<b>Kerri McCabe</b>	Time:	<b>1036</b>
		Photo #:	<b>13</b>
Description:	<b>Overview of the lagoon.</b>

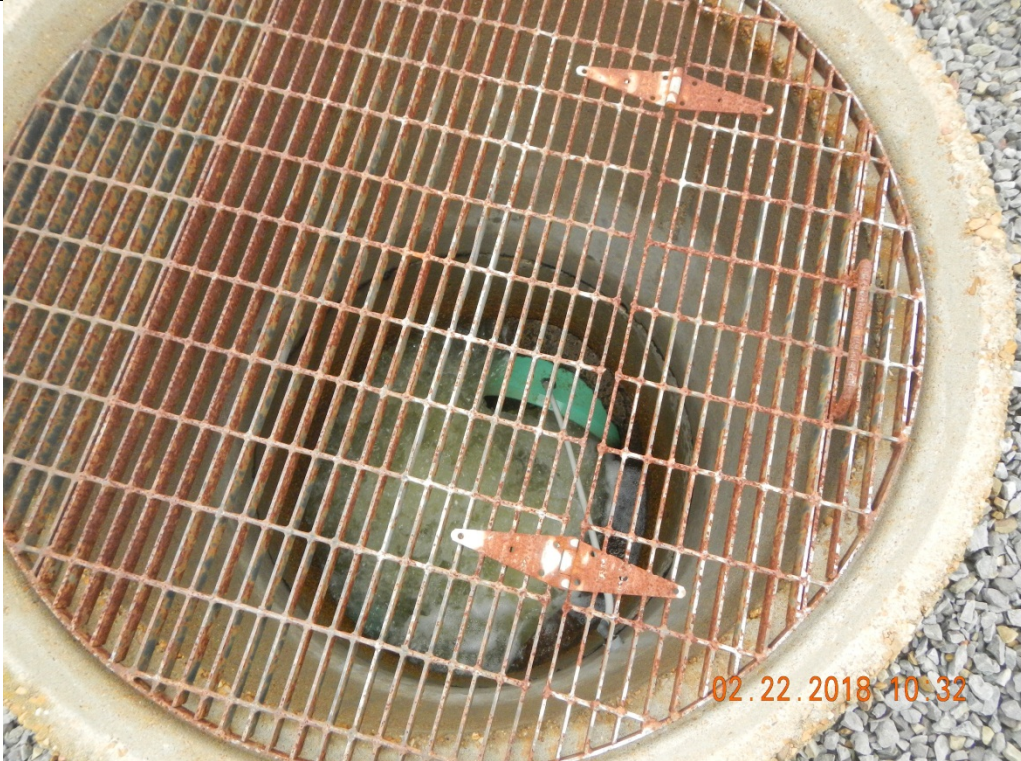
Photographer:	<b>Skyler Schlick</b>	Date:	<b>2/22/2018</b>
Witness:	<b>Kerri McCabe</b>	Time:	<b>1032</b>
		Photo #:	<b>14</b>
Description:	<b>Manhole for sampling prior to Outfall 002.</b>

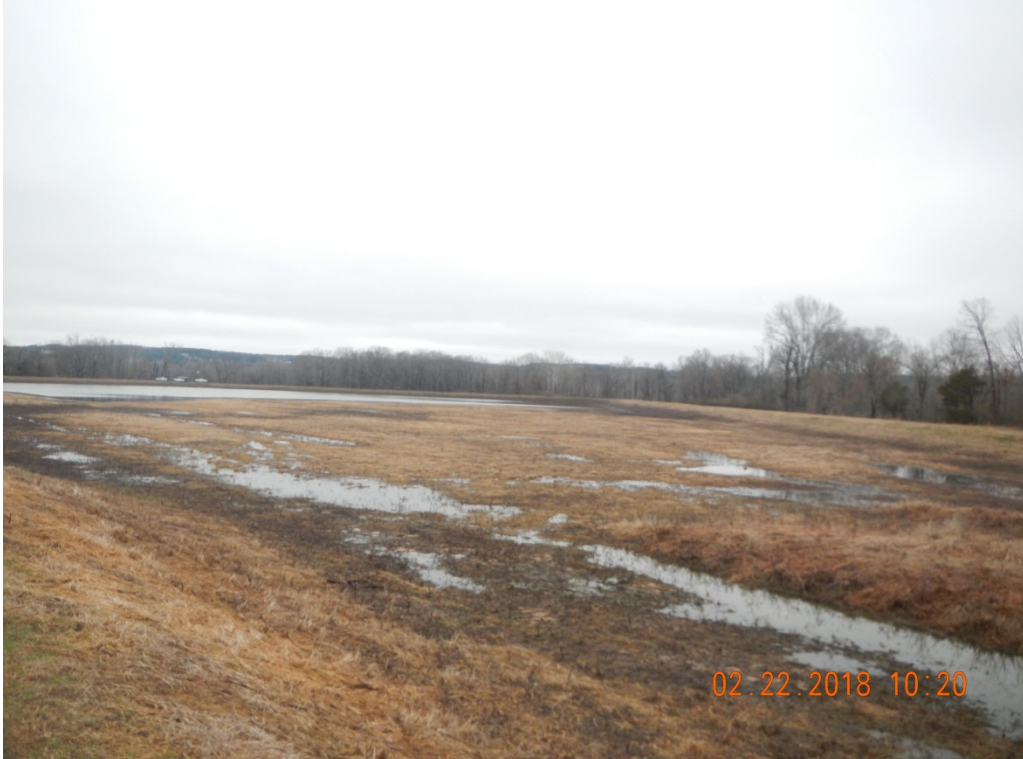
Location:	<b>Heber Springs WWTP</b>		
Photographer:	<b>Skyler Schlick</b>	Date:	<b>2/22/2018</b>
Witness:	<b>Kerri McCabe</b>	Time:	<b>1020</b>
		Photo #:	<b>15</b>
Description:	<b>EQ basin.</b>

1. Sewer routed between the wastewater lagoon and the EQ basin is controlled by valves inside a 20 foot deep concrete vault. The valves are operated by hand using a very long valve wrench that is attached to the concrete wall of the vault with steel brackets. The brackets are to align the valve wrench over the valves when opening or closing the valves. These steel brackets had rusted and broke away from the wall during the attempt to open the valve during a very large rain event. The misaligned valve wrench would not open the valve so personnel had to enter the vault and open the valve from inside the vault. We have contacted a metal fabricator shop to build a new set of brackets made from stainless steel. This should prevent any alignment bracket rust issues in the future.

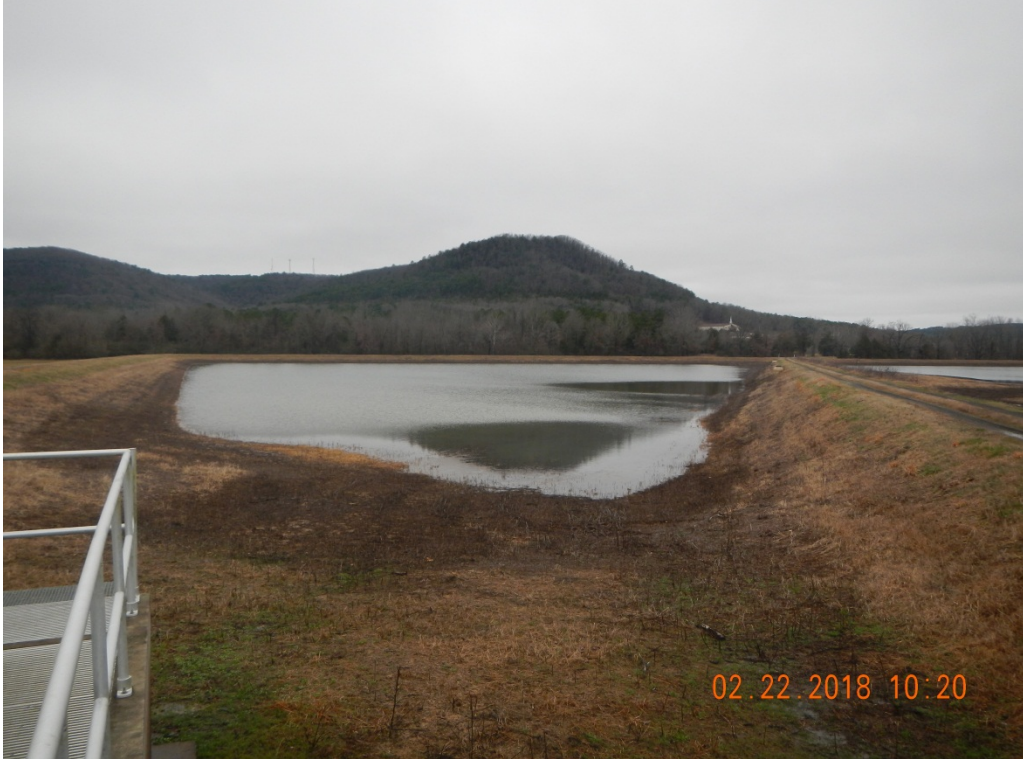
Photographer:	<b>Skyler Schlick</b>	Date:	<b>2/22/2018</b>
Witness:	<b>Kerri McCabe</b>	Time:	<b>1020</b>
		Photo #:	<b>16</b>
Description:	<b>EQ basin.</b>

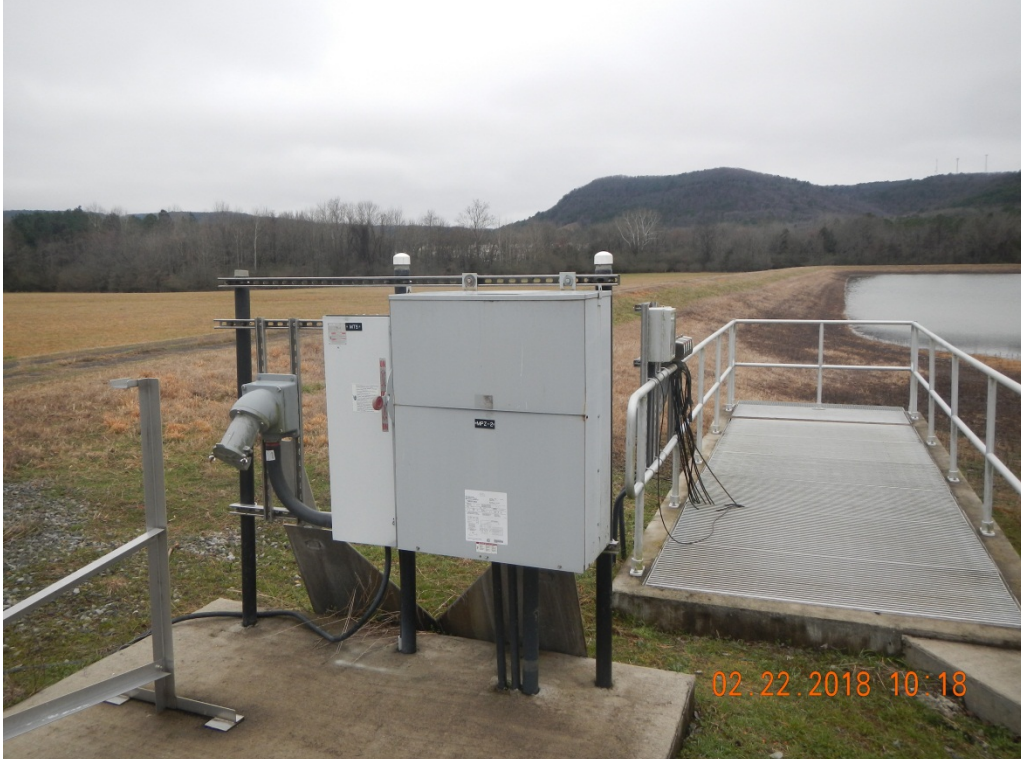
Location:	<b>Heber Springs WWTP</b>		
Photographer:	<b>Skyler Schlick</b>	Date:	<b>2/22/2018</b>
Witness:	<b>Kerri McCabe</b>	Time:	<b>1018</b>
		Photo #:	<b>17</b>
Description:	<b>UV disinfection from EQ basin prior to Outfall 003.</b>

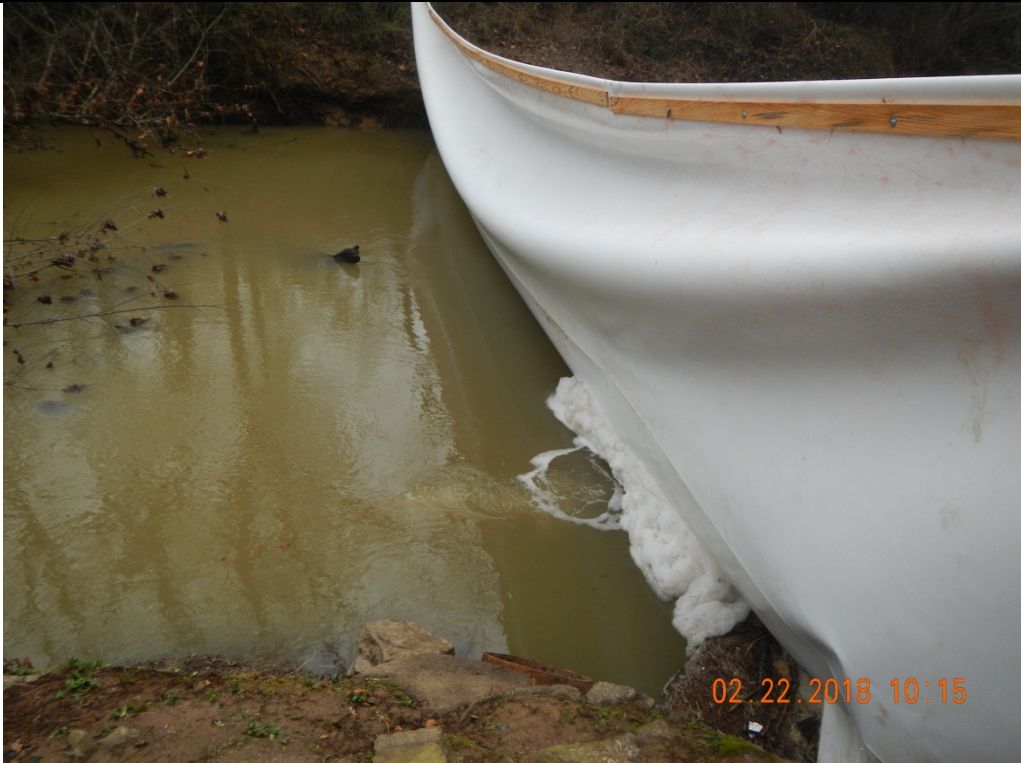
Photographer:	<b>Skyler Schlick</b>	Date:	<b>2/22/2018</b>
Witness:	<b>Kerri McCabe</b>	Time:	<b>1015</b>
		Photo #:	<b>18</b>
Description:	<b>Combined outfalls discharge with curtain for foam control.</b>

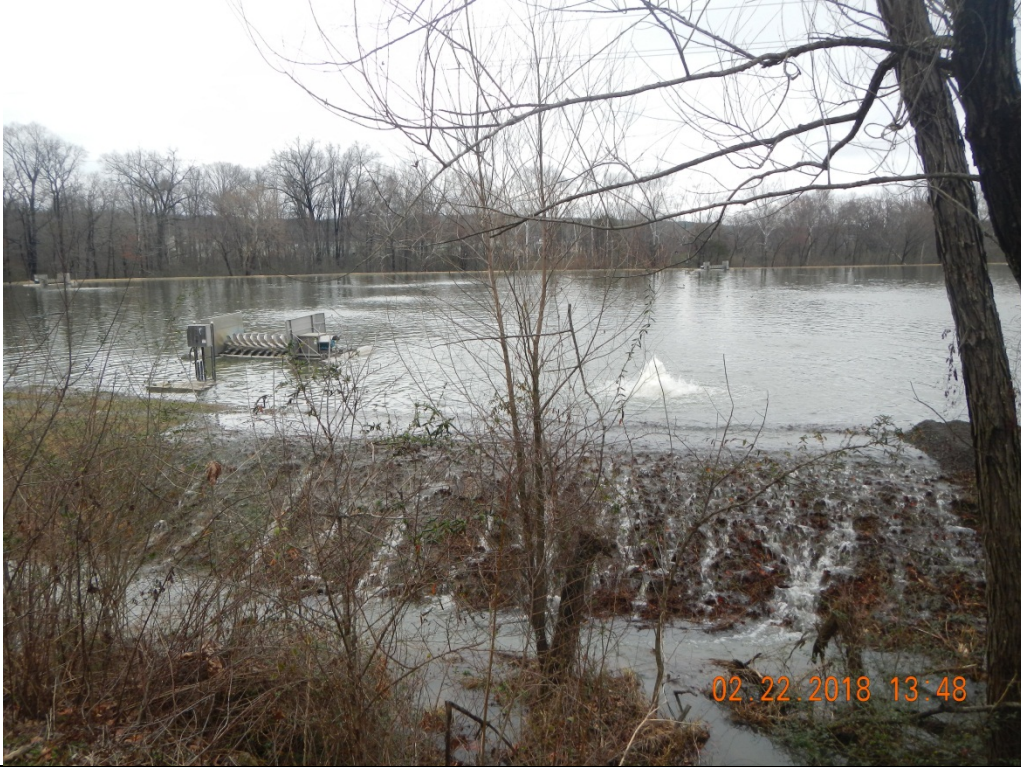
There was an unpermitted discharge occurring from Cell #1 of the lagoon system with the duration lasting from 0949 to 1348. The valve to route wastewater to the EQ basin could not be open and/or was broke, which resulted in an overflow at Cell #1 (primary cell). The valve was repaired and opened during the inspection. It is recommended that procedures for opening the valve to the EQ basin be evaluated periodically to ensure that the EQ can be utilized when needed. The lagoon system was beyond the required freeboard level after several days of excessive rain, and the discharge from Cell #1 was avoidable since the EQ basin was empty at the time of inspection.

4. ALL DISCHARGES ARE PERMITTED: <u>Unpermitted discharge occurring at Cell #1 of lagoon.</u>	<input type="checkbox"/> Y <input checked="" type="checkbox"/> N <input type="checkbox"/> NA <input type="checkbox"/> NE
<b>SECTION B: RECORDKEEPING AND REPORTING EVALUATION</b>	
RECORDS AND REPORTS MAINTAINED AS REQUIRED BY PERMIT	<input checked="" type="checkbox"/> S <input type="checkbox"/> M <input type="checkbox"/> U <input type="checkbox"/> NA <input type="checkbox"/> NE
DETAILS:

Location:	<b>Heber Springs WWTP</b>				
Photographer:	<b>Skyler Schlick</b>	Date:	<b>2/22/2018</b>	Time:	<b>1348</b>
Witness:	<b>Kerri McCabe</b>	Photo #:	<b>19</b>		
Description:	<b>Unpermitted discharge still occurring at Cell #1.</b>

13. HAS CORRECTIVE ACTION BEEN TAKEN TO PREVENT ADDITIONAL BYPASSES/OVERFLOWS: <u>Valve to EQ repaired same day; permittee needs to periodically check valve at EQ and maintain freeboard in lagoon system.</u>	<input checked="" type="checkbox"/> Y <input type="checkbox"/> N <input type="checkbox"/> NA <input type="checkbox"/> NE

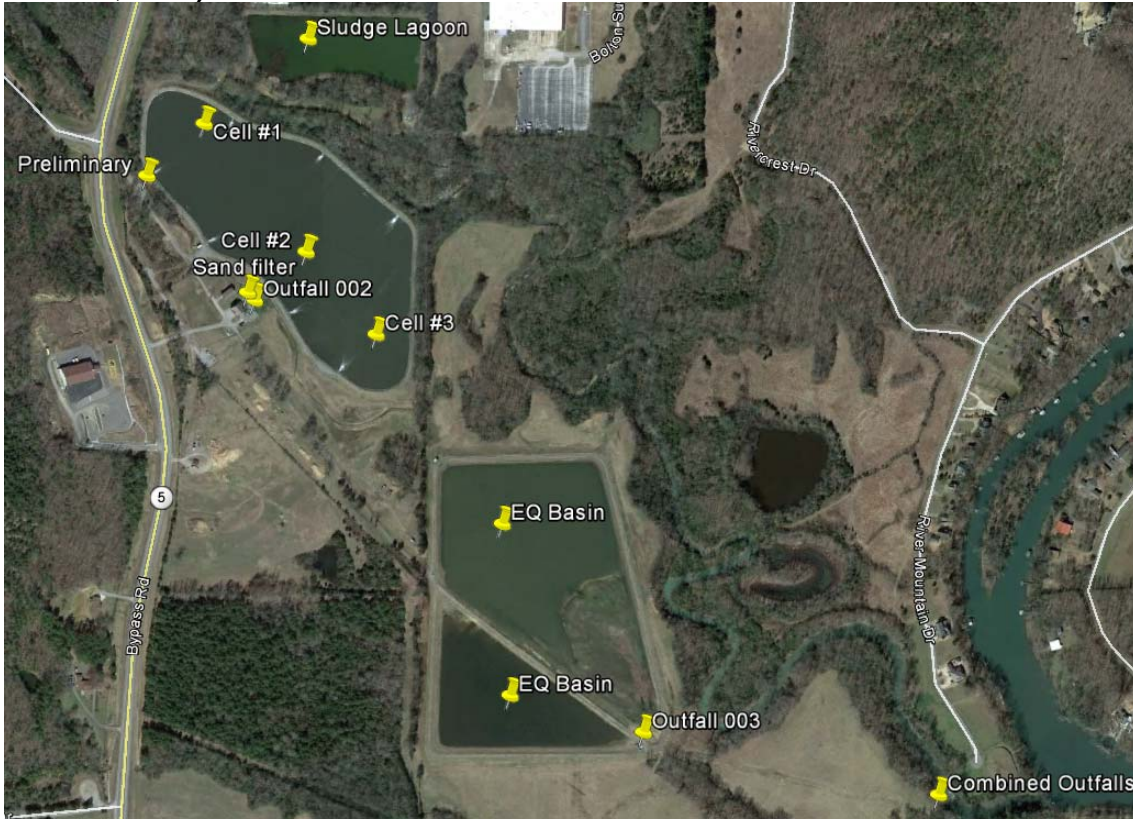
Figure 1. General overview of the site with major components labeled (Google Earth: imagery date March 4, 2016).

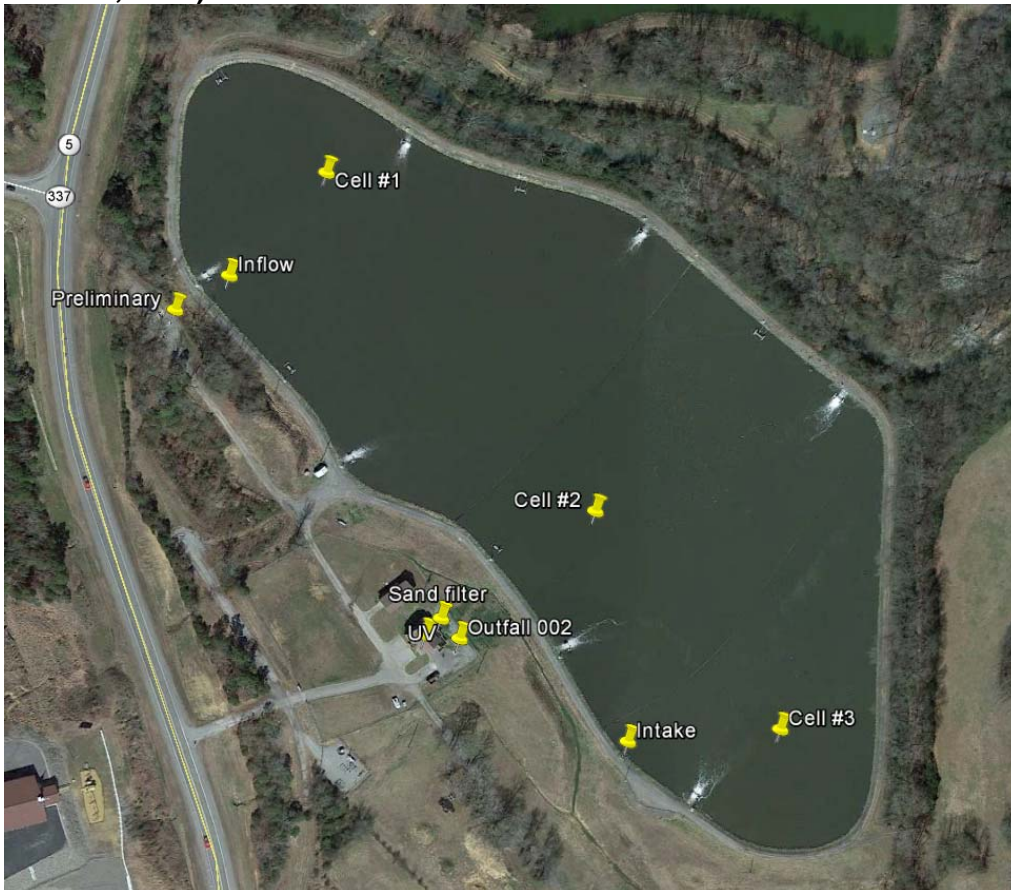
Figure 2. General overview of the site with major components labeled (Google Earth: imagery date March 4, 2016).
