RE: City of Hope - Bois D'Arc (West) WWTP Inspections (Hempstead Co)
AFIN: 29-00034
NPDES Permit No.: AR0038466

Inspection Report: City of Hope - Bois D'Arc (West) WWTP, AFIN: 29-00034, Permit #: AR0038466 DMR Calculation Check

Water Division Photographic Evidence Sheet								
Location: City of Hope - Bois D'Arc (West) WWTP								
Photographer: Kerri McCabe		Date: July 25, 2018	Time:	1111				
Witness: N/A			Photo #:	1

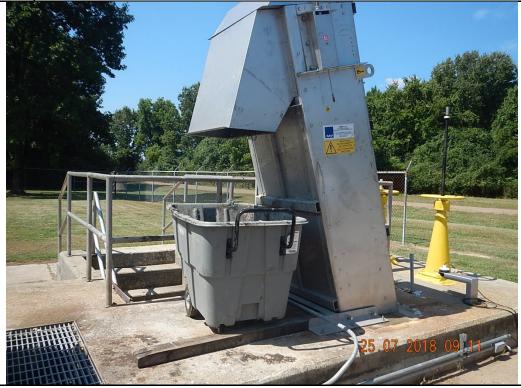
Description: Automatic bar screen at headworks.

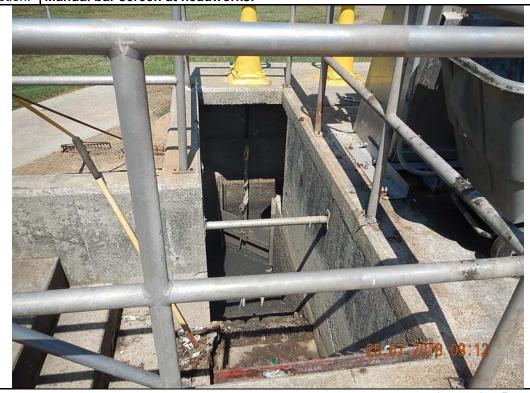
Photographer: Kerri McCabe Date: July 25, 2018 Time: 1112
Witness: N/A Photo #: 2

Description: Manual bar screen at headworks.

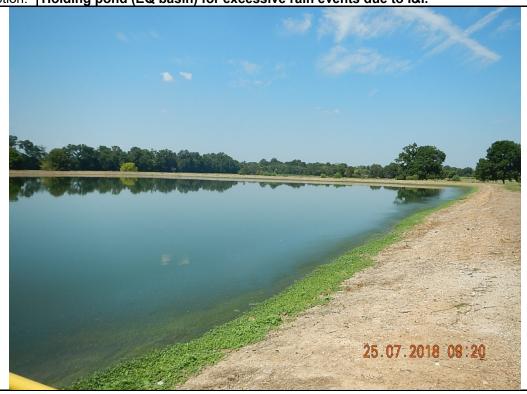
Water Division Photographic Evidence Sheet Location: City of Hope - Bois D'Arc (West) WWTP Photographer: Kerri McCabe Date: July 25, 2018 Time: 1120 Witness: N/A Photo #: 5 Description: Holding pond (EQ basin) for excessive rain events due to I&I.

Wastewater to the holding pond (EQ basin) is routed through the plant once I&I recedes. The holding pond (EQ basin) is equipped with a spillway for levee integrity.

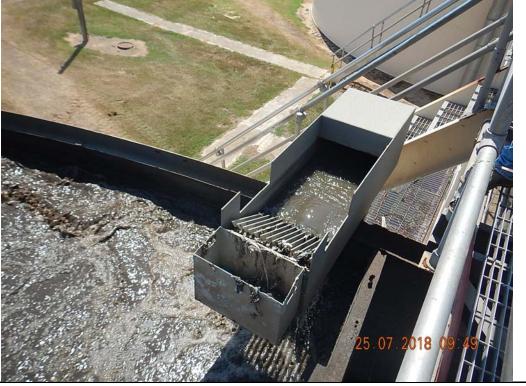
Water Division Photographic Evidence Sheet Location: City of Hope - Bois D'Arc (West) WWTP Photographer: Kerri McCabe Date: July 25, 2018 Time: 1149 Witness: N/A Photo #: 9

Description: Bar screen at North Plant.

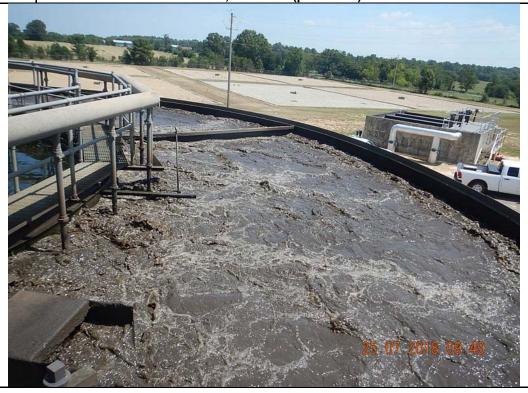
Photographer:Kerri McCabeDate:July 25, 2018Time:1149Witness:N/APhoto #:10

Description: Aeration basin of North Plant; RAS box (photo left).

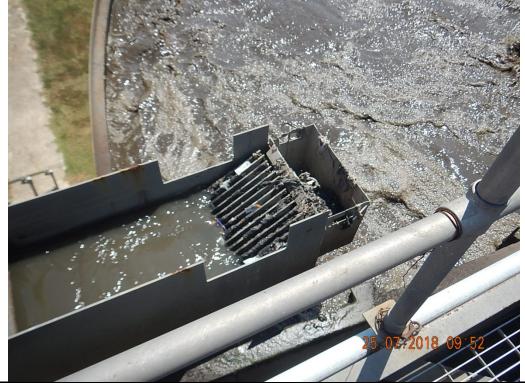
Water Division Photographic Evidence Sheet									
Location:	City	of Ho	pe - Bois D'Arc (West) WWTP					
Photograp	her:	Kerri I	McCabe		Date:	July 25, 2018	Time:	1153	
Witness:	N/A						Photo #:	17

Description: Aeration basin for South Plant; RAS box (photo right).

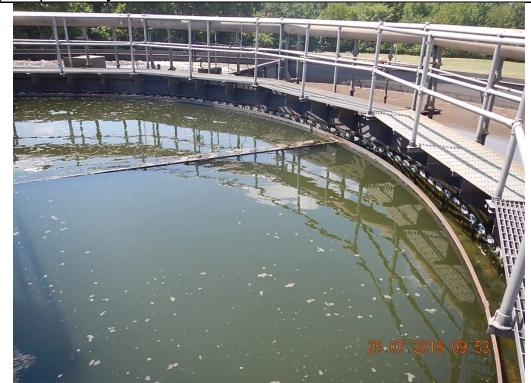
Photographer: Kerri McCabe Date: July 25, 2018 Time: 1153
Witness: N/A Photo #: 18

Description: Secondary clarifier and baffle/weir of South Plant.

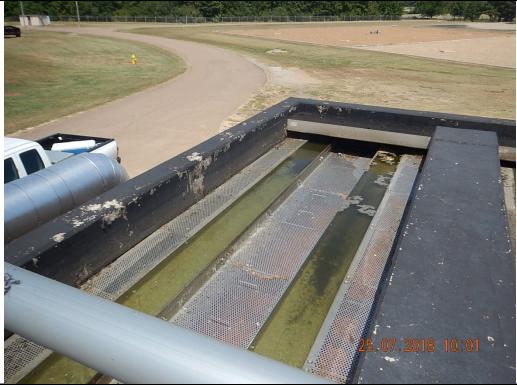
Water Division Photographic Evidence Sheet Location: City of Hope - Bois D'Arc (West) WWTP Photographer: Kerri McCabe Date: July 25, 2018 Time: 1201 Witness: N/A Photo #: 21

The rapid sand filter was installed to replace the intermittent sand filters; however, the facility is reporting that the rapid sand filters do not work properly (contractor is scheduled to reevaluate the system and make adjustments). Of the eight intermittent sand filters onsite, four have been disconnected from the treatment system and four are still functional for emergency use only.

Description: Rapid sand filter (left cell)

We did want to update with information on our rapid sand filters. The contractor has gotten them fully operational at this time and we are keeping a close eye on them for the future.

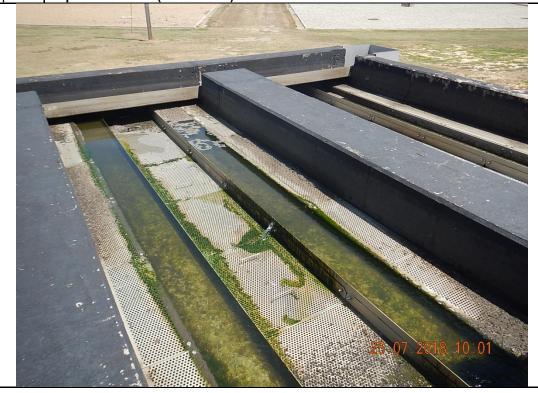
Photographer: Kerri McCabe	Date: July 25, 2018	Time:	1201
Witness: N/A		Photo #:	22

Description: Rapid sand filter (middle cell)

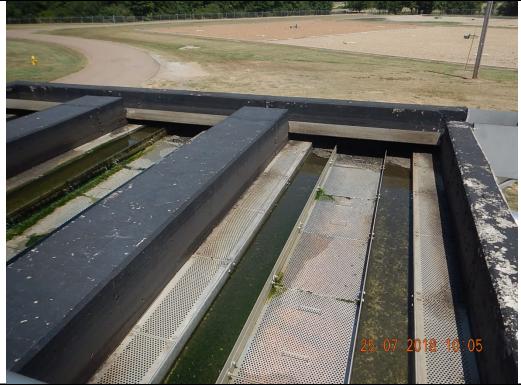
Water Division Photographic Evidence Sheet Location: City of Hope - Bois D'Arc (West) WWTP Photographer: Kerri McCabe Date: July 25, 2018 Time: 1205 Witness: N/A Photo #: 23

Description: Rapid sand filter (right cell)

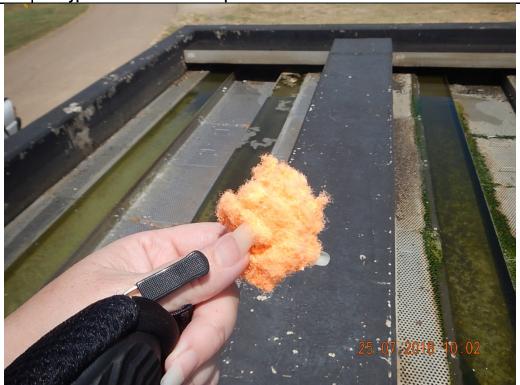
Photographer:	Kerri McCabe	Date:	July 25, 2018	Time:	1202
Witness: N/A				Photo #	24

Description: The type of medium for the rapid sand filter.

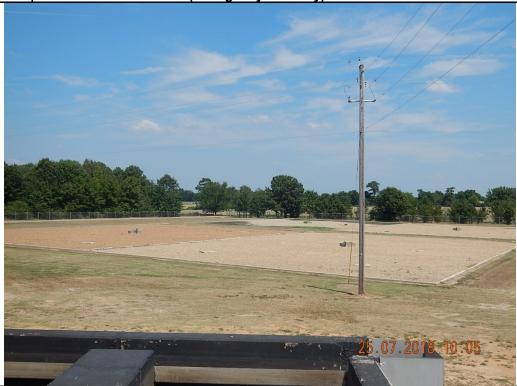
Water Division Photographic Evidence Sheet							
Location:	City	of Hope - Bois D'Arc (West) WWTP				
Photograp	her:	Kerri McCabe	Date:	July 25, 2018	Time:	1205	
Witness:	N/A				Photo #:	25

Description: Intermittent sand filters (emergency use only)

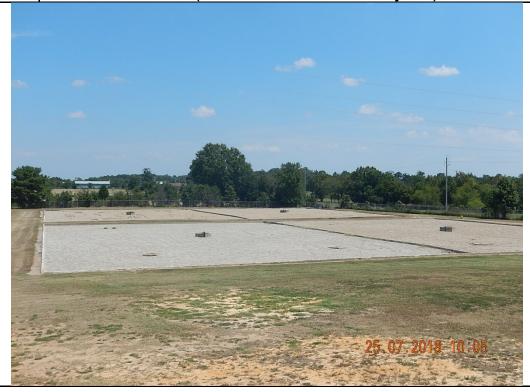
Photographer:Kerri McCabeDate:July 25, 2018Time:1205Witness:N/APhoto #:26

Description: Intermittent sand filters (disconnected from treatment system)

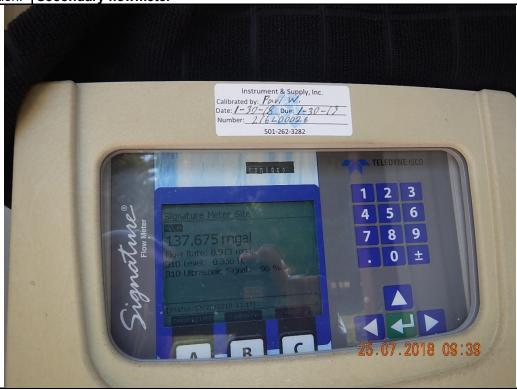
Water Division Photographic Evidence Sheet							
Location: C	ity of Ho	pe - Bois D'Ar	c (West) WWTP				
Photographe	: Kerri I	McCabe	Date:	July 25, 2018	Time:	1139	
Witness: N/	4				Photo #:	27

Description: Secondary flowmeter

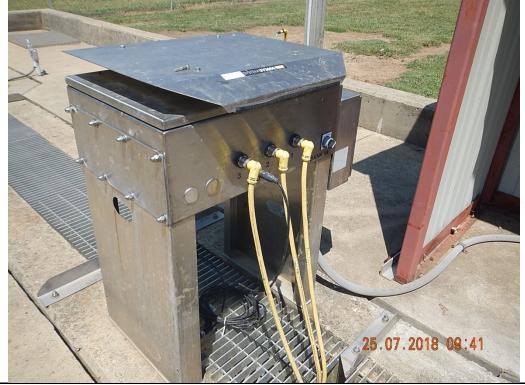
Photographer:Kerri McCabeDate:July 25, 2018Time:1141Witness:N/APhoto #:28

Description: **UV bulb unit for disinfection.**

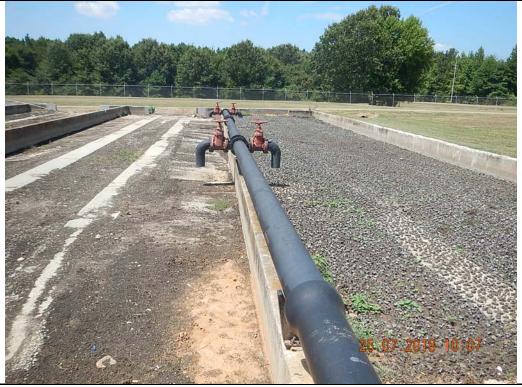
Water Division Photographic Evidence Sheet							
Location:	Location: City of Hope - Bois D'Arc (West) WWTP						
Photograp	her:	Kerri McCabe	Date:	July 25, 2018	Time:	1207	
Witness:	N/A				Photo #:	31

Description: Sludge drying beds (right)

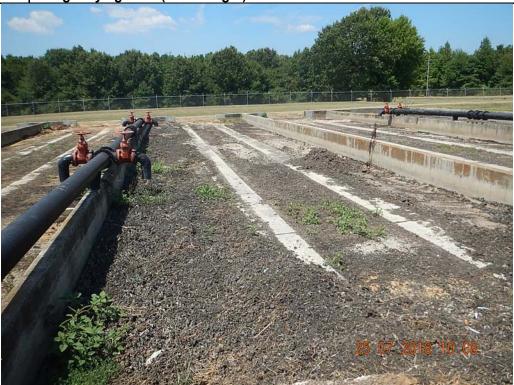
Photographer:	Kerri McCabe	Date:	July 25, 2018	Time:	1208
Witness: N/A				Photo #:	32

Description: Sludge drying beds (middle-right)

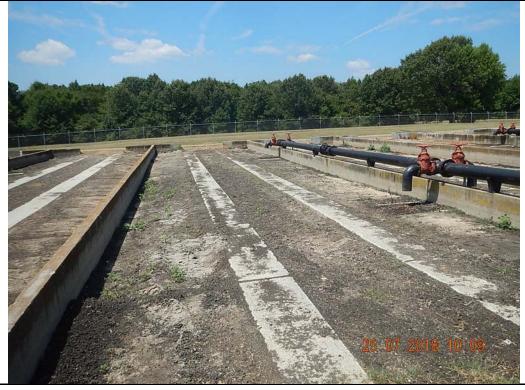
Water Division Photographic Evidence Sheet							
Location:	City	of Hope - Bois D'Arc (West)	WWTP				
Photograp	her:	Kerri McCabe	Date:	July 25, 2018	Time:	1209	
Witness:	N/A				Photo #:	33

Description: Sludge drying beds (middle-left)

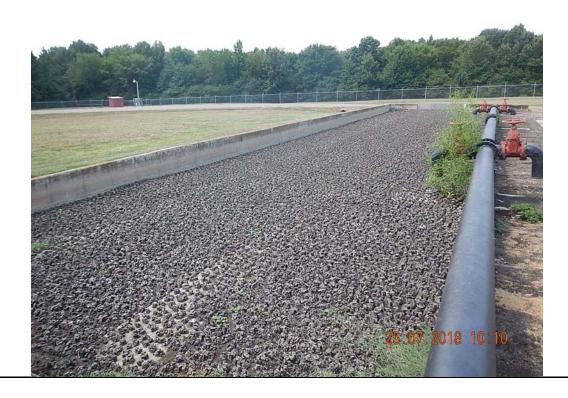
Photographer: Kerri McCabe	Date: July 25, 2018	Time:	1210
Witness: N/A		Photo #:	34

Description: Sludge drying beds (left)

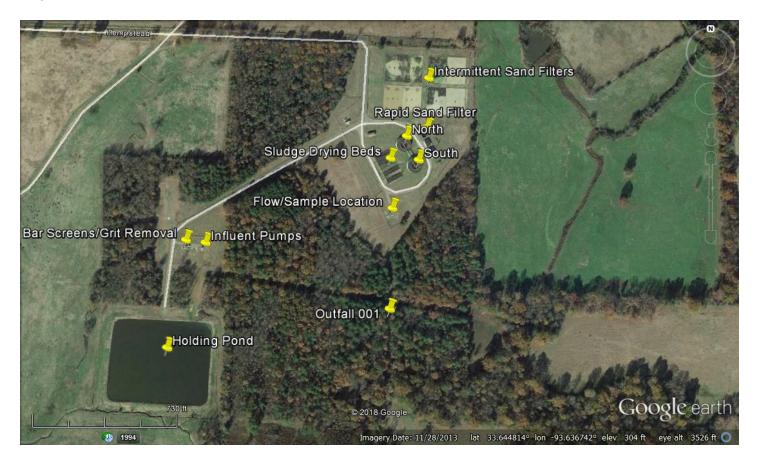
Inspection Report: City of Hope - Bois D'Arc (West) WWTP, AFIN: 29-00034, Permit #: AR0038466 Figure 1. Google Earth image dated Nov 28, 2013 of the City of Hope - Bois D'Arc (West) Plant with major components identified.
