A R K A N S A S Department of Environmental Quality		WATER DIVISION INSPECTION REPORT						
		AFIN: 73-00055		PERMIT #: AR0021601		DATE: 2/5/2019		
		COUNTY: 73 White			PDS #: 106608		MEDIA: WN	
		GPS LAT: 35.243674 LONG: -91.738233 LOCATION: Entrance						
FACILITY INFORMATION				INSPECTION INFORMATION				
NAME: Searcy WWTP LOCATION: Cintas Laundry CITY: Searcy				FACILITY TYPE: 1 - Municipal		INSPECTOR ID#: 83321 S - State		
				FACILITY EVALUATION RATING: ***		INSPECTION TYPE: Industrial User		
				DATE(S): 2/5/2019	ENTRY TIME: 10:20	EXIT TIME: 10:51	PERMIT EFFECTIVE DATE: 10/1/2013 PERMIT EXPIRATION DATE: 9/30/2018	
				RESPONSIBLE OFFICIAL				INSPECTION PARTICIPANTS
NAME / TITLE: Daniel Dawson / General Manager COMPANY: Searcy Board of Public Utilities MAILING ADDRESS: P.O. Box 1319 CITY, STATE, ZIP: Searcy AR 72145 PHONE & EXT. / FAX: 501-268-2481 / EMAIL: d.dawson@cablelynx.com				NAME/TITLE/PHONE/FAX/EMAIL/ETC.: Jimmy Smith, WWTP Manager, City of Searcy Spencer Oyemaja, Pretreatment Coordinator, City of Searcy Jason Gibson, Maintenance Supervisor, Cintas Keith Waters, Inspector, ADEQ

POTW Pretreatment Program

Industrial Site Visit

Name of Industry: **Cintas Laundry**

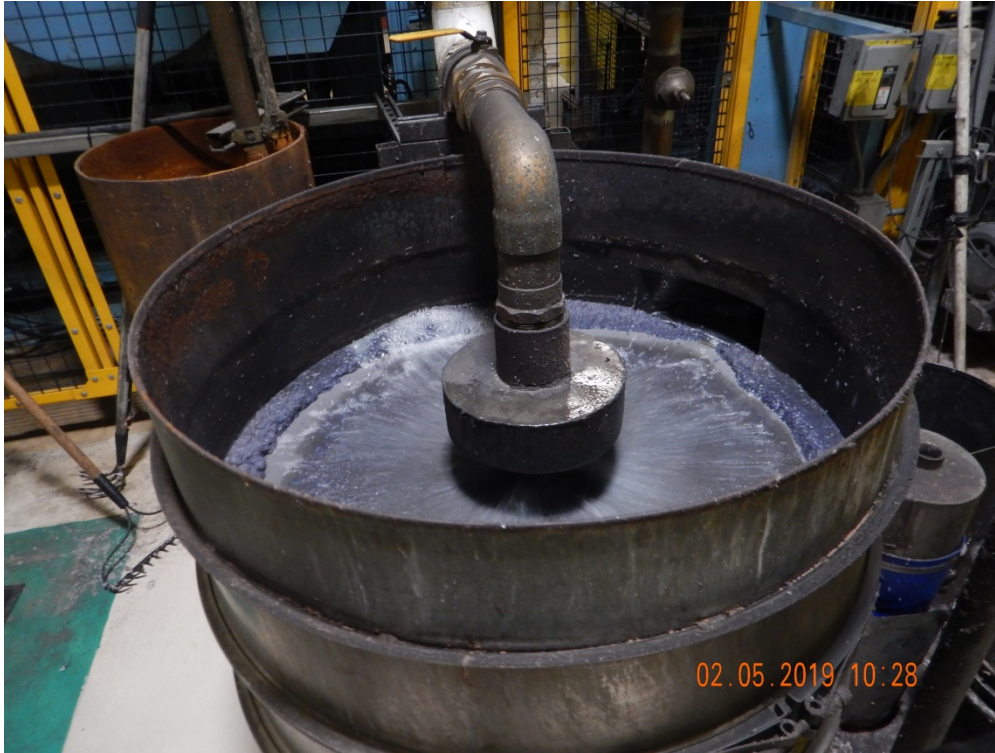
Location:	Searcy WWTP		
Photographer:	Jason Bolenbaugh	Date:	2/5/2019
Witness:		Time:	10:28
		Photo #:	1
Description:	Solid separation of lint.

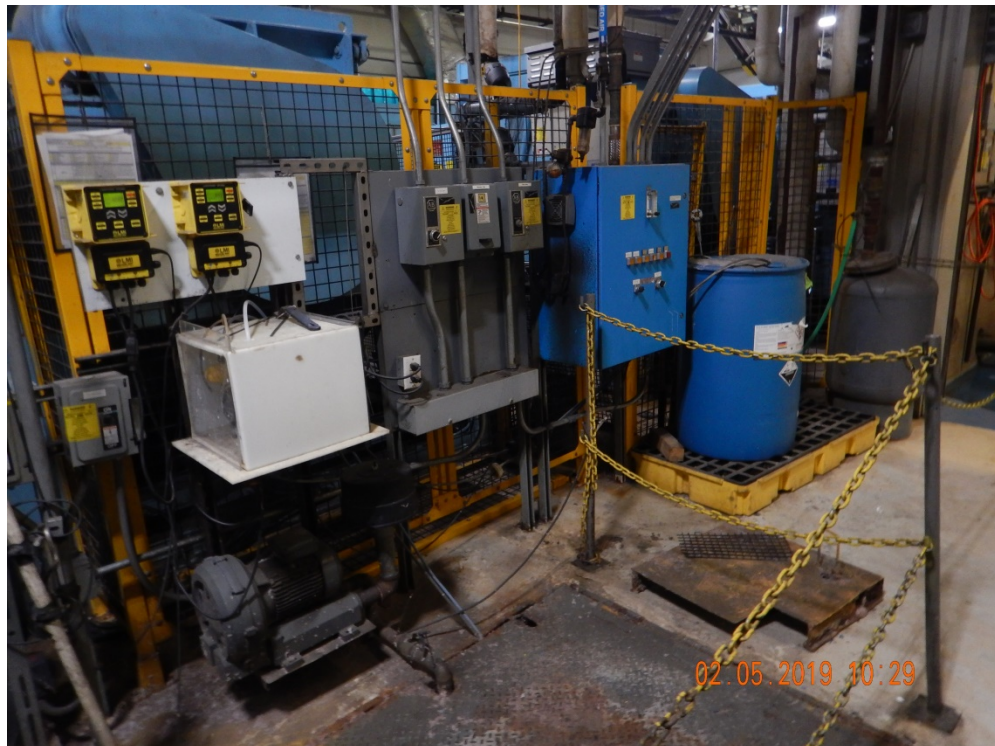
Photographer:	Jason Bolenbaugh	Date:	2/5/2019
Witness:		Time:	10:29
		Photo #:	2
Description:	Pretreatment system with sulfuric acid addition for pH adjustment.

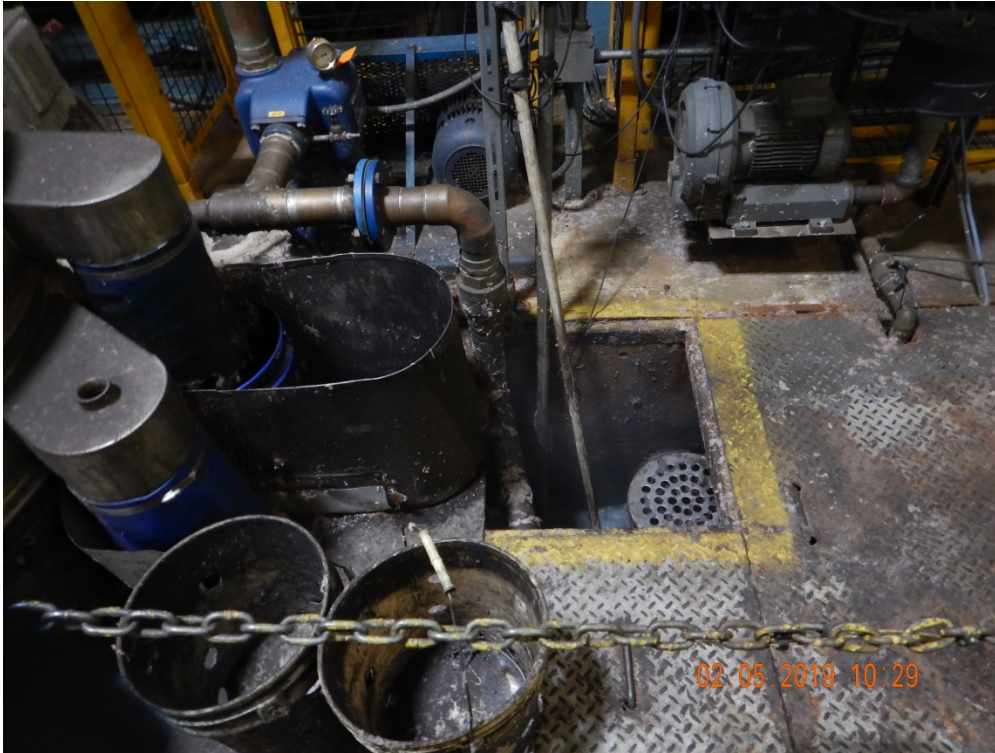
Location:	Searcy WWTP		
Photographer:	Jason Bolenbaugh	Date:	2/5/2019
Witness:		Time:	10:29
		Photo #:	3
Description:	PH adjustment basin and discharge pipe to the city's collection system.

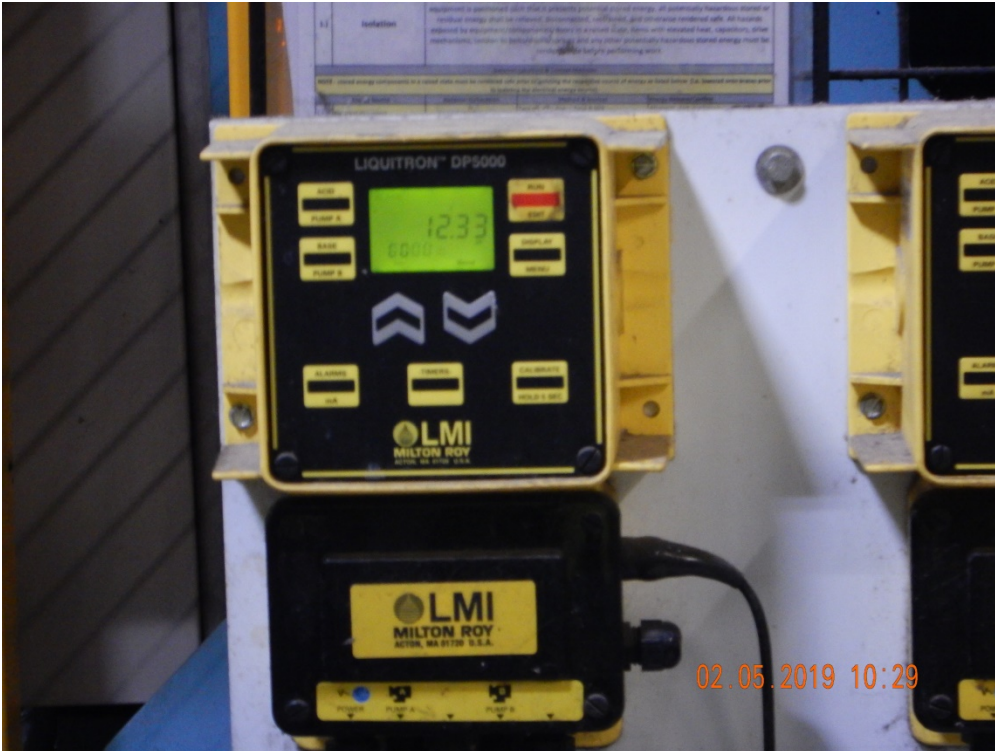
Photographer:	Jason Bolenbaugh	Date:	2/5/2019
Witness:		Time:	10:29
		Photo #:	4
Description:	PH of wastewater prior to adjustment.

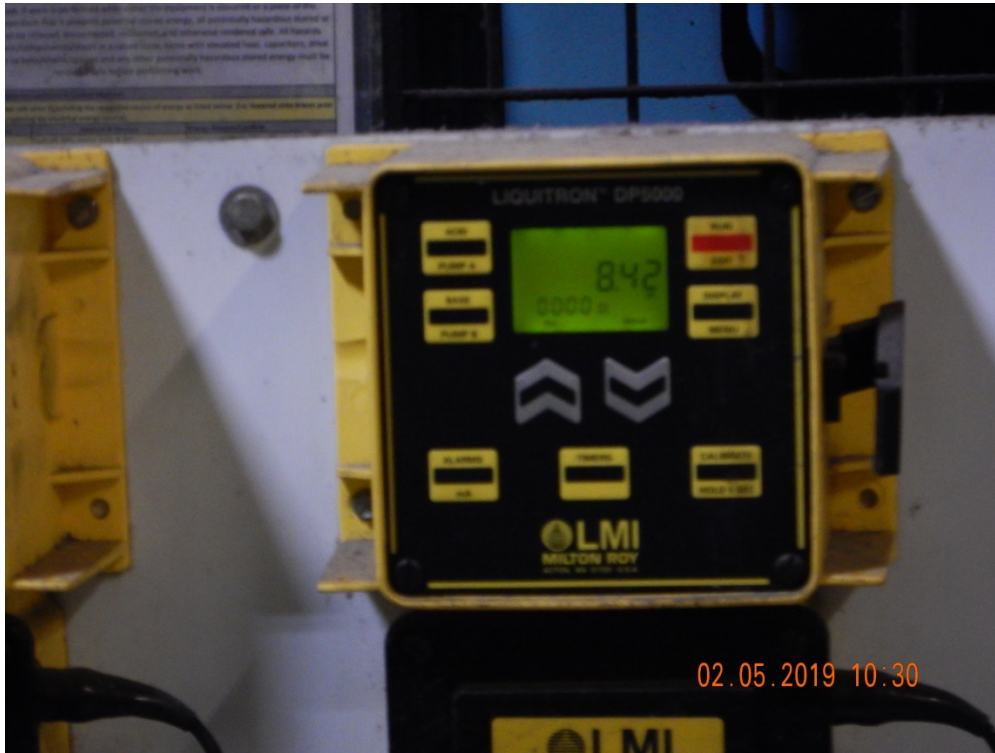
Location:	Searcy WWTP		
Photographer:	Jason Bolenbaugh	Date:	2/5/2019
Witness:		Time:	10:30
		Photo #:	5
Description:	PH of wastewater discharged to city's collection system following pH adjustment.
