A R K A N S A S Department of Environmental Quality		WATER DIVISION INSPECTION REPORT						
		AFIN: 73-00055		PERMIT #: AR0021601		DATE: 2/5/2019		
		COUNTY: 73 White			PDS #: 106609		MEDIA: WN	
		GPS LAT: 35.240034 LONG: -91.732767 LOCATION: Entrance						
FACILITY INFORMATION				INSPECTION INFORMATION				
NAME: Searcy WWTP LOCATION: Eaton Hydraulics, LLC. CITY: Searcy				FACILITY TYPE: 1 - Municipal		INSPECTOR ID#: 83321 S - State		
				FACILITY EVALUATION RATING: ***		INSPECTION TYPE: Industrial User		
				DATE(S): 2/5/2019	ENTRY TIME: 09:31	EXIT TIME: 10:10	PERMIT EFFECTIVE DATE: 10/1/2013	
						PERMIT EXPIRATION DATE: 9/30/2018		
RESPONSIBLE OFFICIAL				INSPECTION PARTICIPANTS				
NAME / TITLE: Daniel Dawson / General Manager COMPANY: Searcy Board of Public Utilities MAILING ADDRESS: P.O. Box 1319 CITY, STATE, ZIP: Searcy AR 72145 PHONE & EXT. / FAX: 501-268-2481 / EMAIL: d.dawson@cabkelynx.com

POTW Pretreatment Program

Industrial Site Visit

Name of Industry: Eaton Hydraulics, LLC.

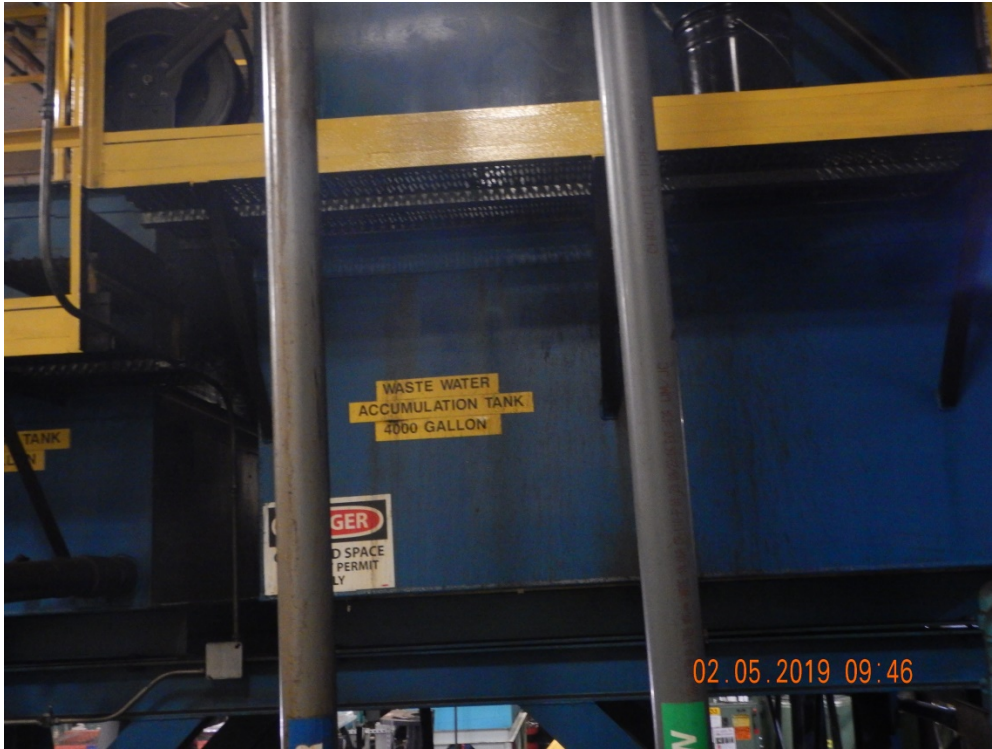
Location:	Searcy WWTP		
Photographer:	Jason Bolenbaugh	Date:	2/5/2019
Witness:		Time:	09:46
		Photo #:	1
Description:	4,000 gallon accumulation tank with oil skimmer.

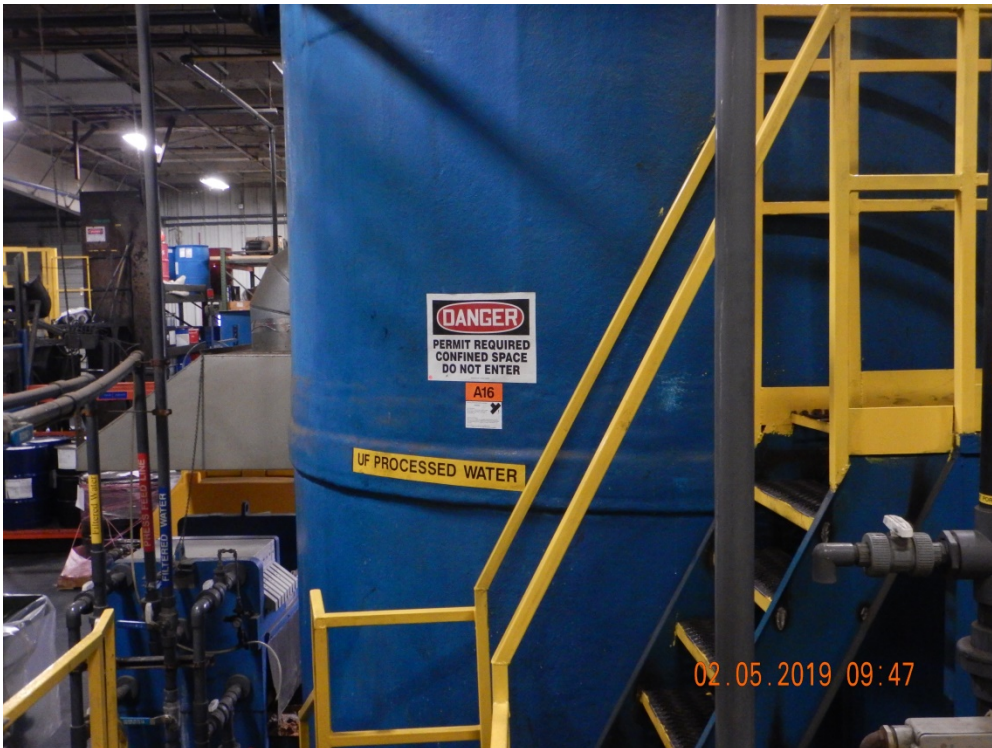
Photographer:	Jason Bolenbaugh	Date:	2/5/2019
Witness:		Time:	09:47
		Photo #:	2
Description:	6,000 gallon tank that receives all plating process wastewater.

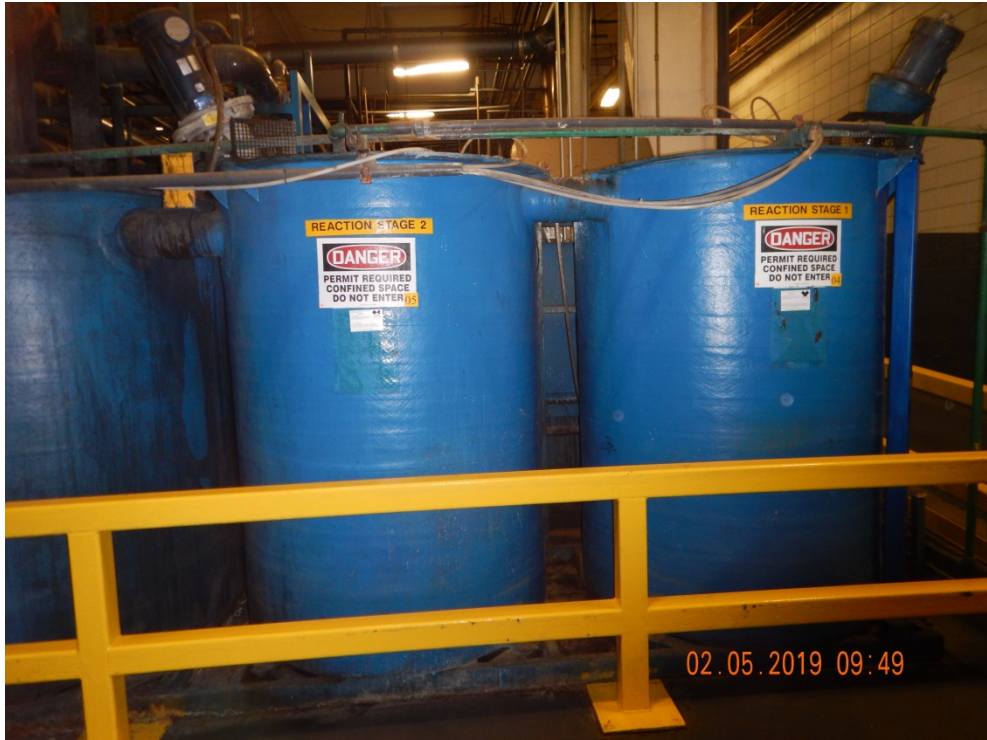
Location:	Searcy WWTP		
Photographer:	Jason Bolenbaugh	Date:	2/5/2019
Witness:		Time:	09:49
		Photo #:	3
Description:	Reaction stage tanks that adjust pH levels.

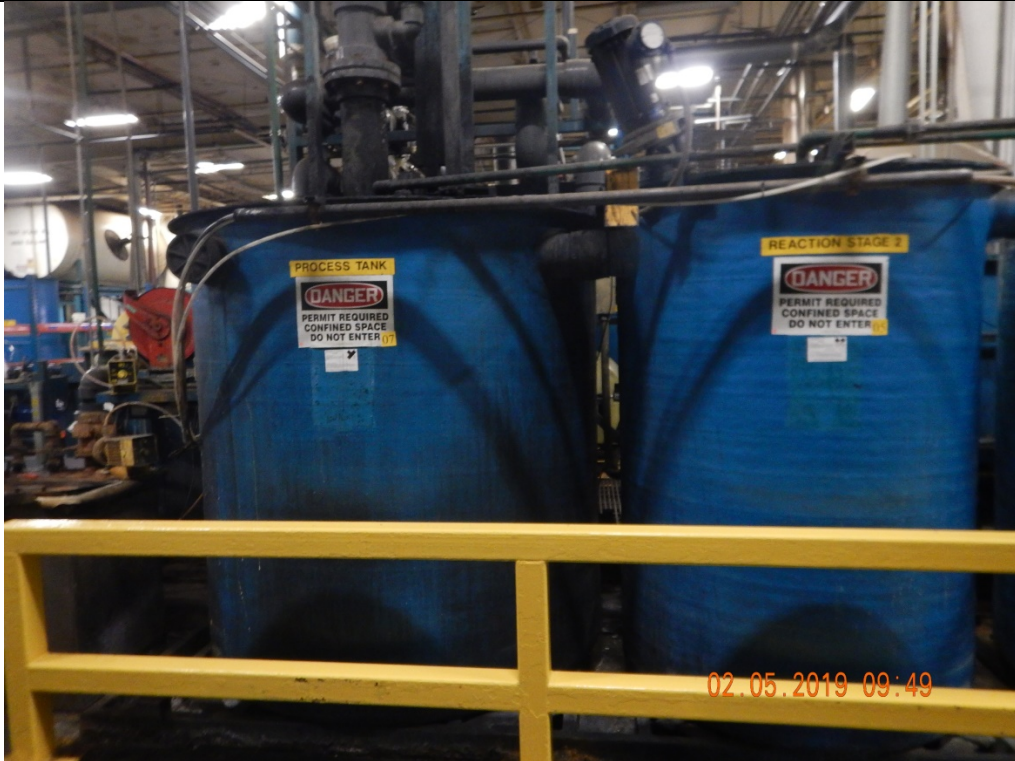
Photographer:	Jason Bolenbaugh	Date:	2/5/2019
Witness:		Time:	09:49
		Photo #:	4
Description:	Process tank where carbon is added to help remove organics.

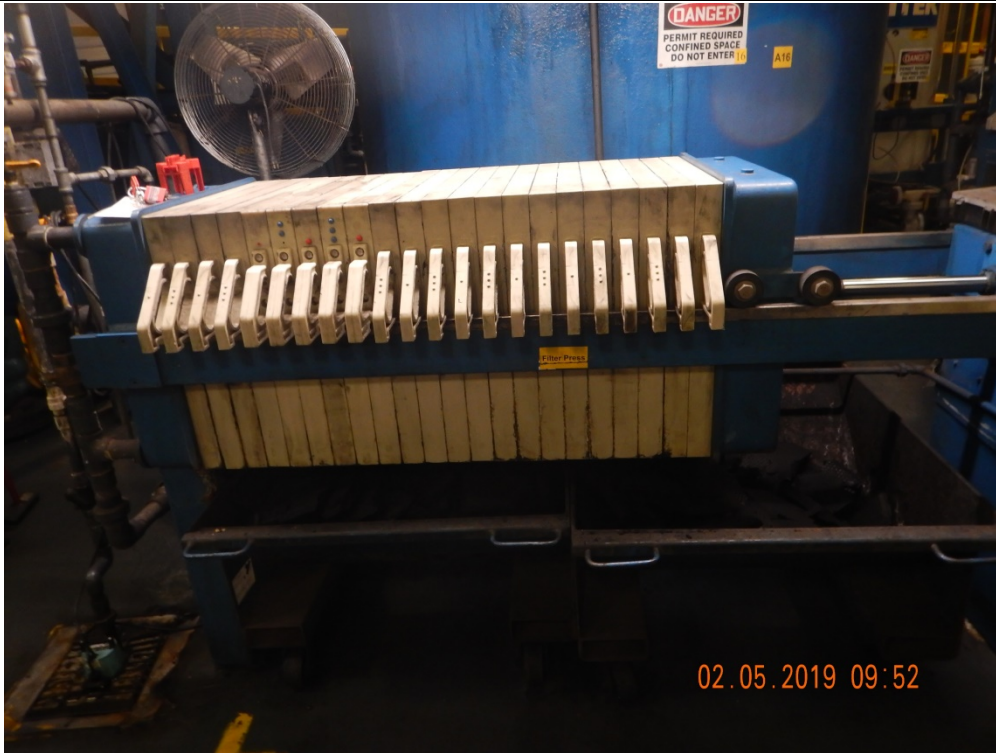
Location:	Searcy WWTP				
Photographer:	Jason Bolenbaugh	Date:	2/5/2019	Time:	09:52
Witness:				Photo #:	5
Description:	Sludge press.

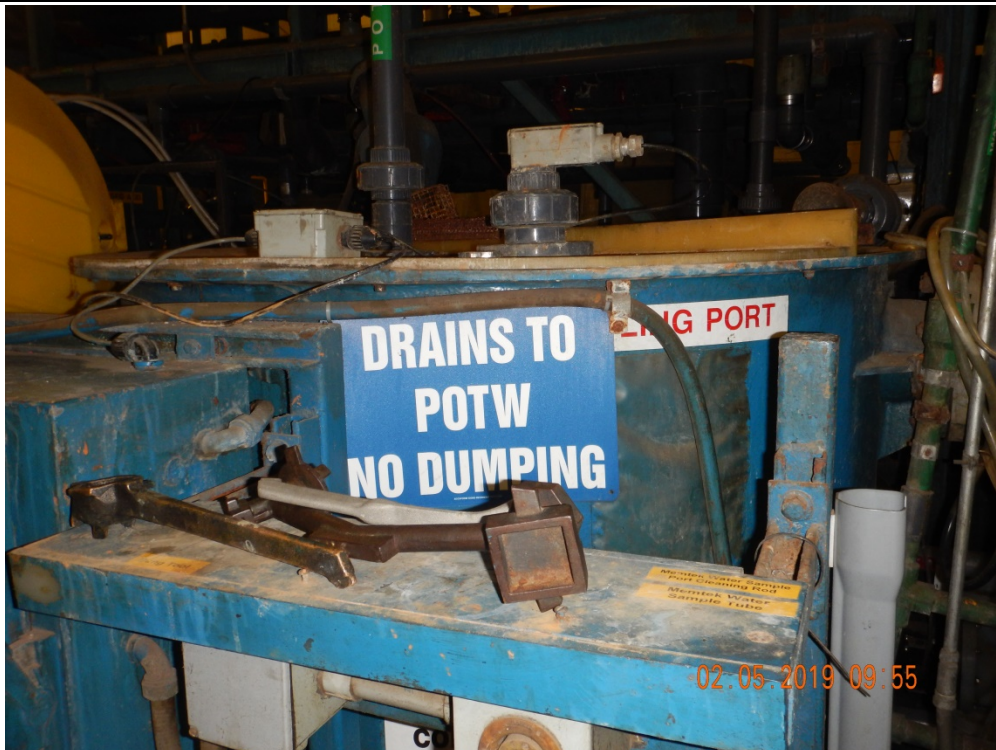
Photographer:	Jason Bolenbaugh	Date:	2/5/2019	Time:	09:55
Witness:				Photo #:	6
Description:	Final sampling port tank where water is discharged to the POTW.

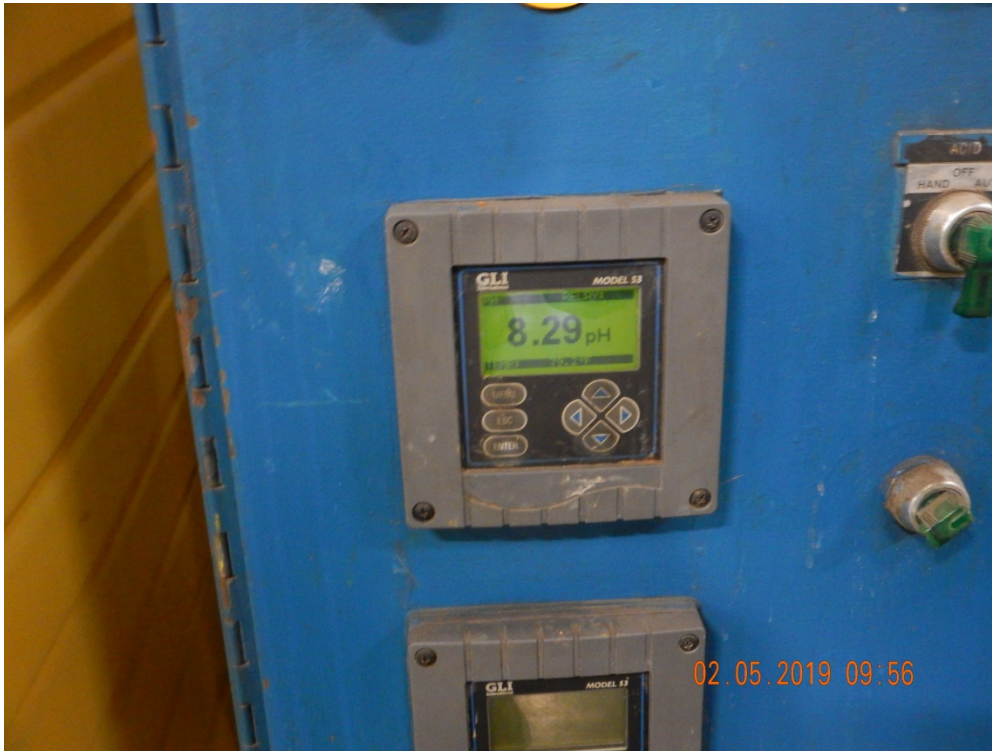
Location:	Searcy WWTP				
Photographer:	Jason Bolenbaugh	Date:	2/5/2019	Time:	09:56
Witness:				Photo #:	7
Description:	PH reading of process water being discharged to the POTW.

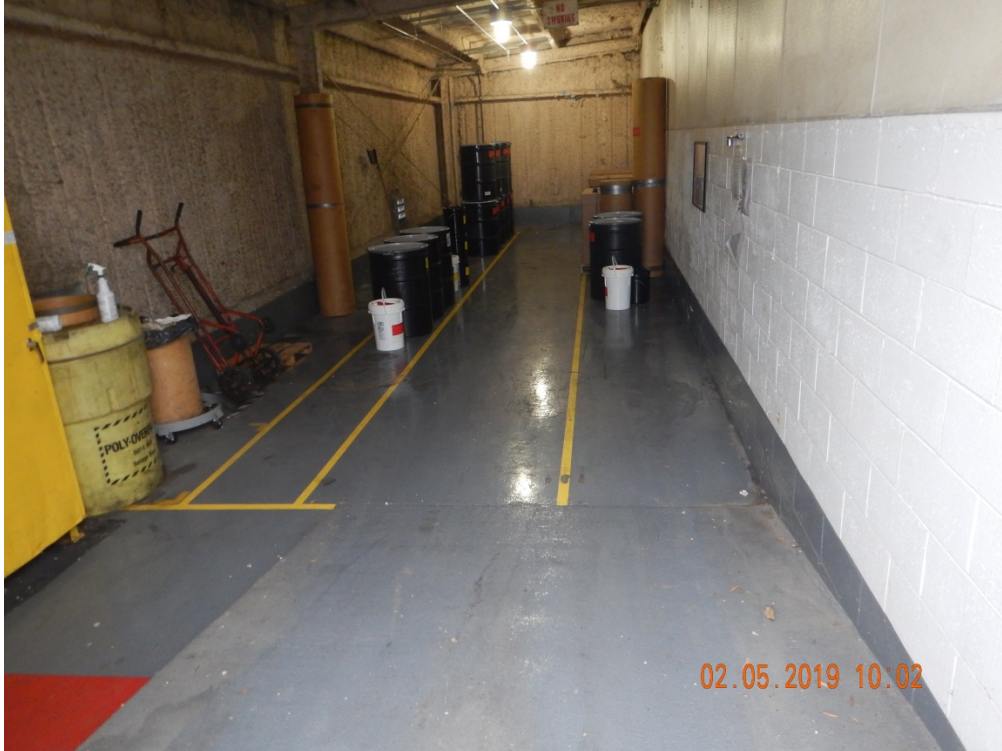
Photographer:	Jason Bolenbaugh	Date:	2/5/2019	Time:	10:02
Witness:				Photo #:	8
Description:	Hazardous waste storage area.
