A R K A N S A S Department of Environmental Quality		WATER DIVISION INSPECTION REPORT					
		AFIN: 04-00106		PERMIT #: AR0020273		DATE: 8/20/2019	
		COUNTY: 04 Benton			PDS #: 109286		MEDIA: WN
		GPS LAT: 36.198716 LONG: -94.519986 LOCATION: Outfall					
FACILITY INFORMATION			INSPECTION INFORMATION				
NAME: City of Siloam Springs PCI LOCATION: 975 Anderson Road CITY: Siloam Springs			FACILITY TYPE: 2 - Industrial	INSPECTOR ID#: 83321 S - State			
			FACILITY EVALUATION RATING: ***		INSPECTION TYPE: Industrial User		
			DATE(S): 8/20/2019	ENTRY TIME: 13:00	EXIT TIME: 13:45	PERMIT EFFECTIVE DATE: 10/1/2007 PERMIT EXPIRATION DATE: 9/30/2012	
RESPONSIBLE OFFICIAL							
NAME / TITLE: Mr. Charles Clay / HSE Manager COMPANY: Gates Corporation MAILING ADDRESS: 1801 North Lincoln CITY, STATE, ZIP: Siloam Springs AR 72761 PHONE & EXT: / FAX: 479-524-1299 / EMAIL: CHARLES.CLAY@GATES.COM			FAYETTEVILLE SHALE RELATED: N FAYETTEVILLE SHALE VIOLATIONS: N

POTW Pretreatment Program

Industrial Site Visit

Name of Industry: GATES CORPORATION

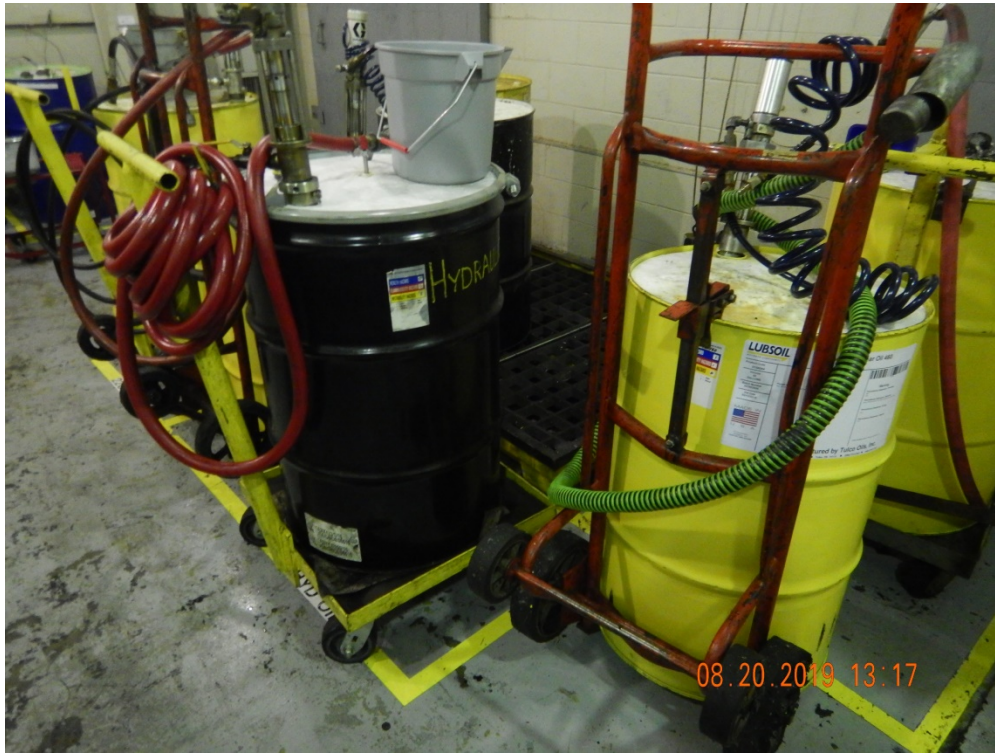
Location:	City of Siloam Springs PCI		
Photographer:	Jason Bolenbaugh	Date:	8/20/2019
Witness:		Time:	13:17
		Photo #:	1
Description:	Oil drums with spill containment.

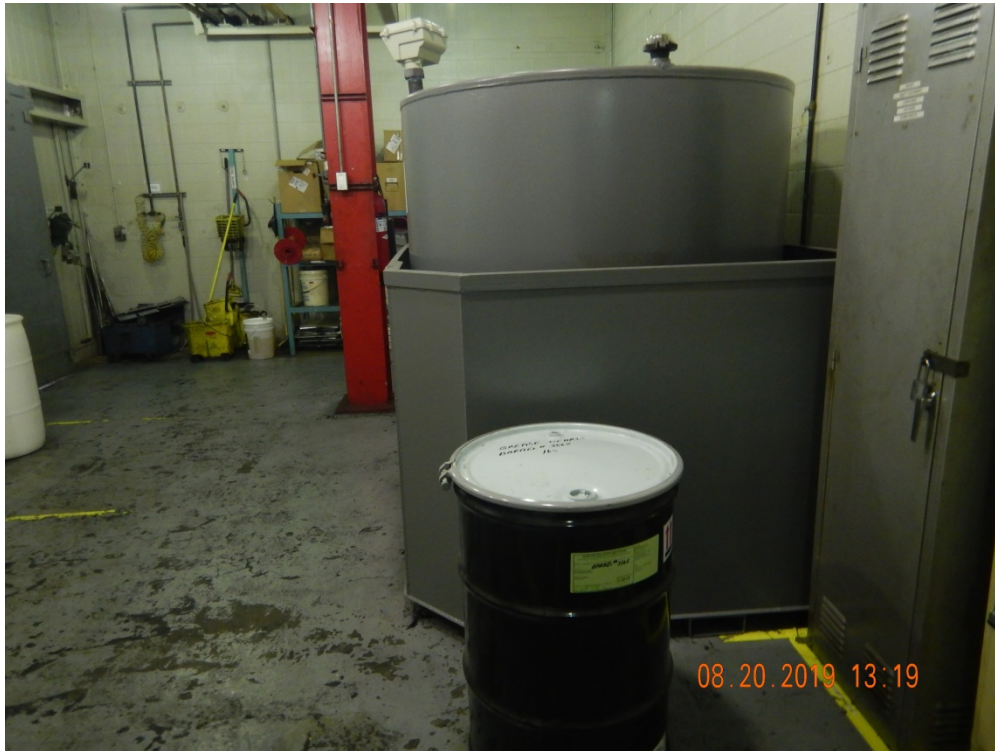
Photographer:	Jason Bolenbaugh	Date:	8/20/2019
Witness:		Time:	13:19
		Photo #:	2
Description:	New oil storage container with a 1,000 gallon secondary containment structure.

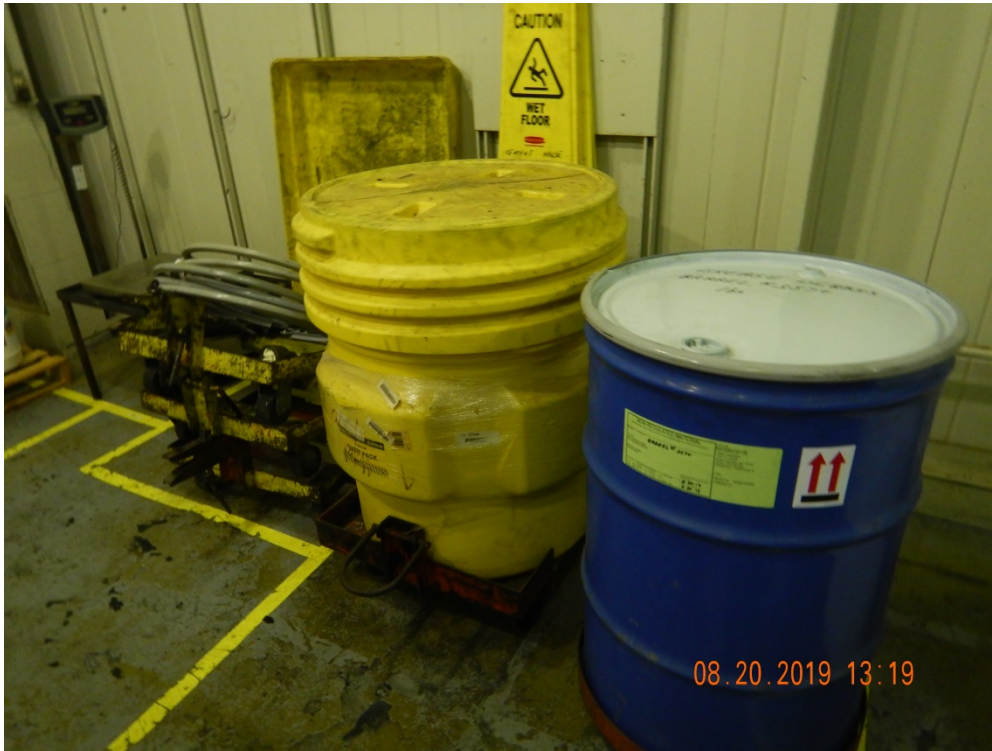
Location:	City of Siloam Springs PCI		
Photographer:	Jason Bolenbaugh	Date:	8/20/2019
Witness:		Time:	13:19
		Photo #:	3
Description:	Chemical building spill kit.

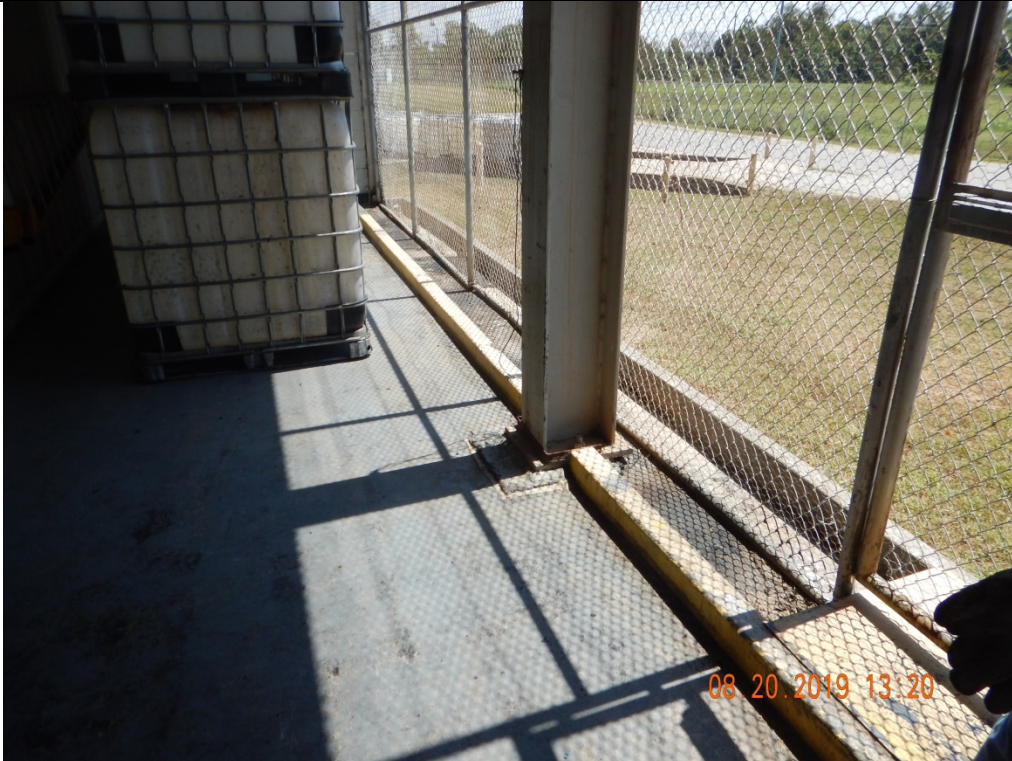
Photographer:	Jason Bolenbaugh	Date:	8/20/2019
Witness:		Time:	13:20
		Photo #:	4
Description:	Outside area of the chemical building that has secondary containment.

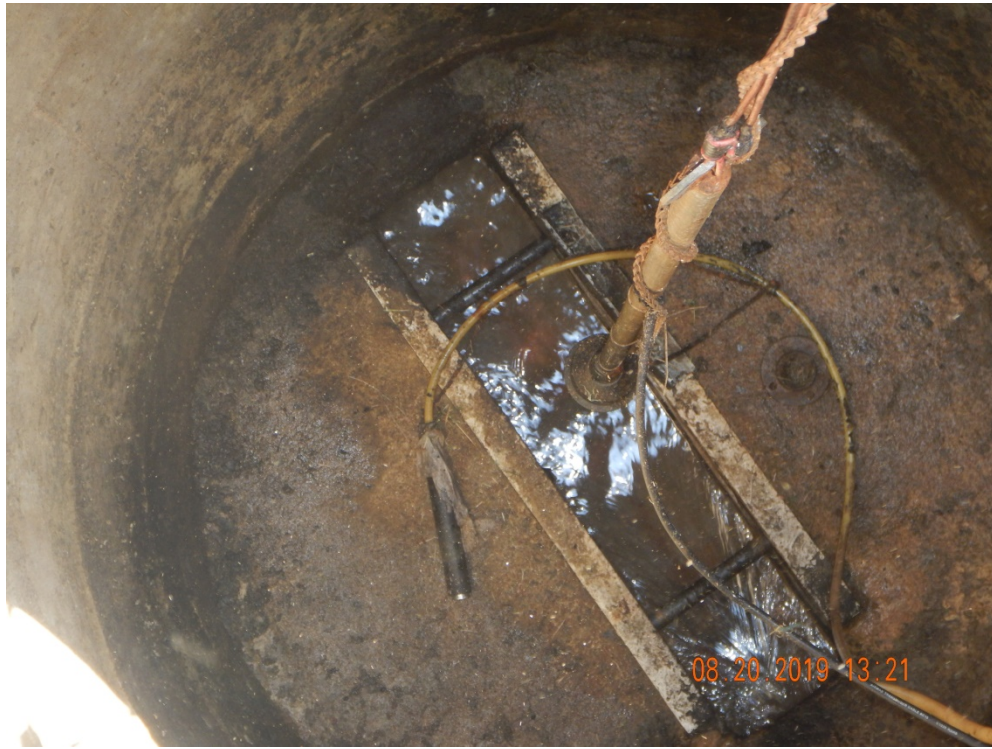
Location:	City of Siloam Springs PCI		
Photographer:	Jason Bolenbaugh	Date:	8/20/2019
Witness:		Time:	13:21
		Photo #:	5
Description:	Weir discharging pretreated wastewater to the city collection system.

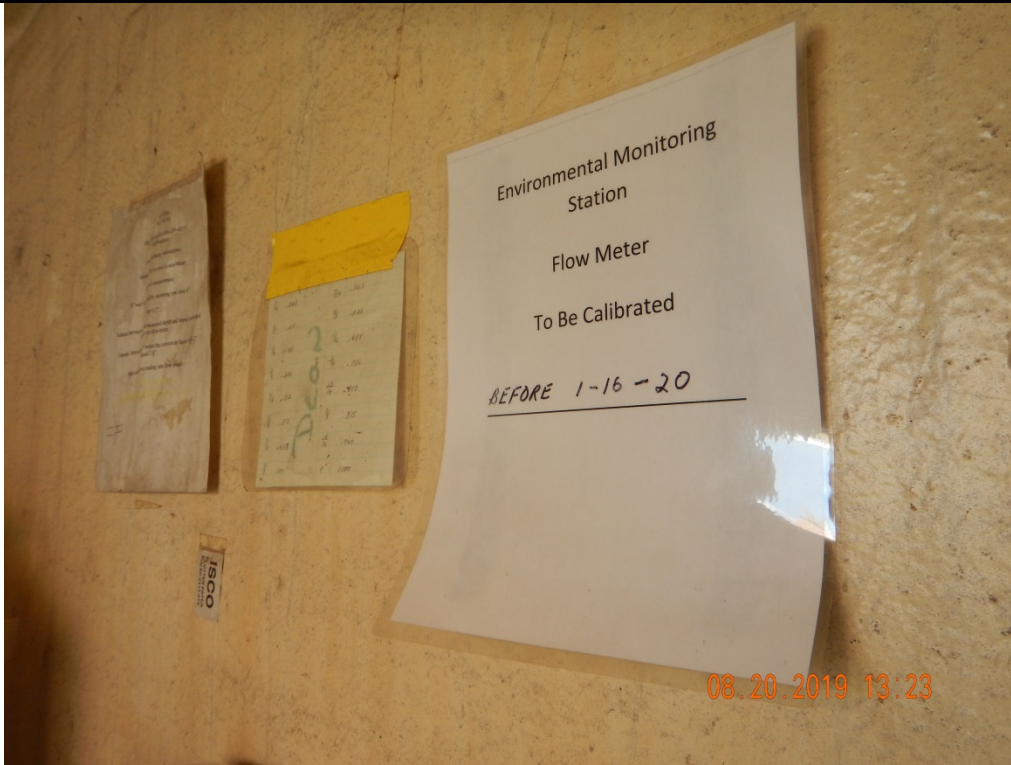
Location:	City of Siloam Springs PCI		
Photographer:	Jason Bolenbaugh	Date:	8/20/2019
Witness:		Time:	13:23
		Photo #:	7
Description:	Reminder to calibrate flow meter per annual city requirements.

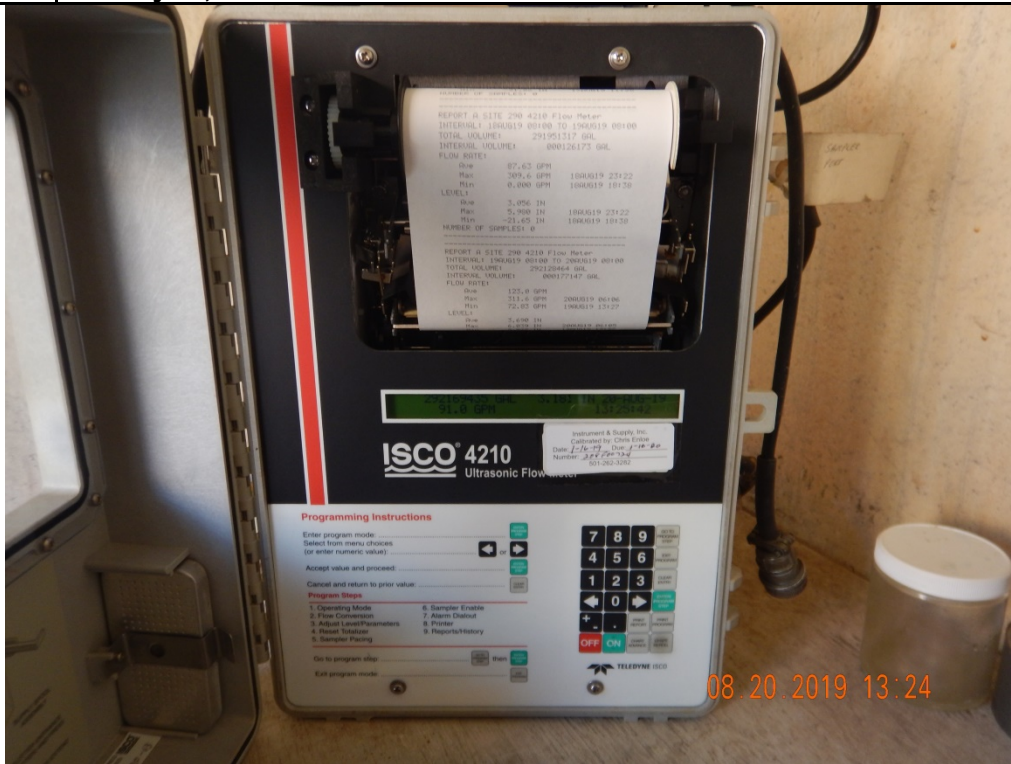
Photographer:	Jason Bolenbaugh	Date:	8/20/2019
Witness:		Time:	13:24
		Photo #:	8
Description:	ISCO 4210 Ultrasonic Flow Meter last calibrated by Instrument & Supply, Inc. on January 16, 2019.

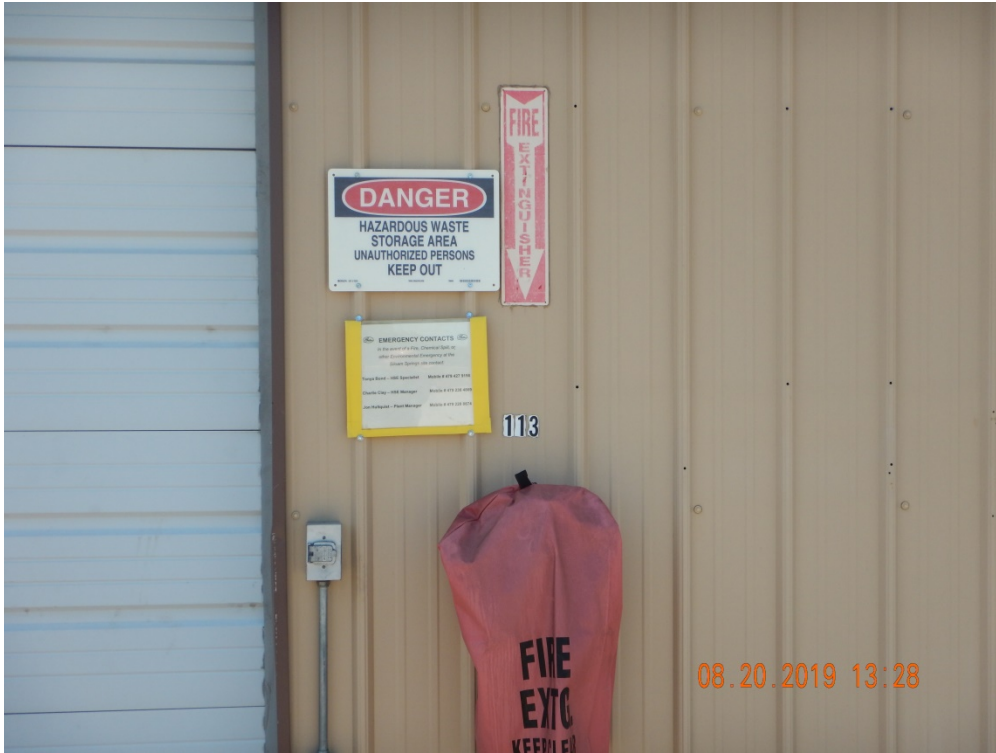
Location:	City of Siloam Springs PCI		
Photographer:	Jason Bolenbaugh	Date:	8/20/2019
Witness:		Time:	13:28
		Photo #:	9
Description:	Hazardous waste storage area with proper facility contact information in case of an emergency.

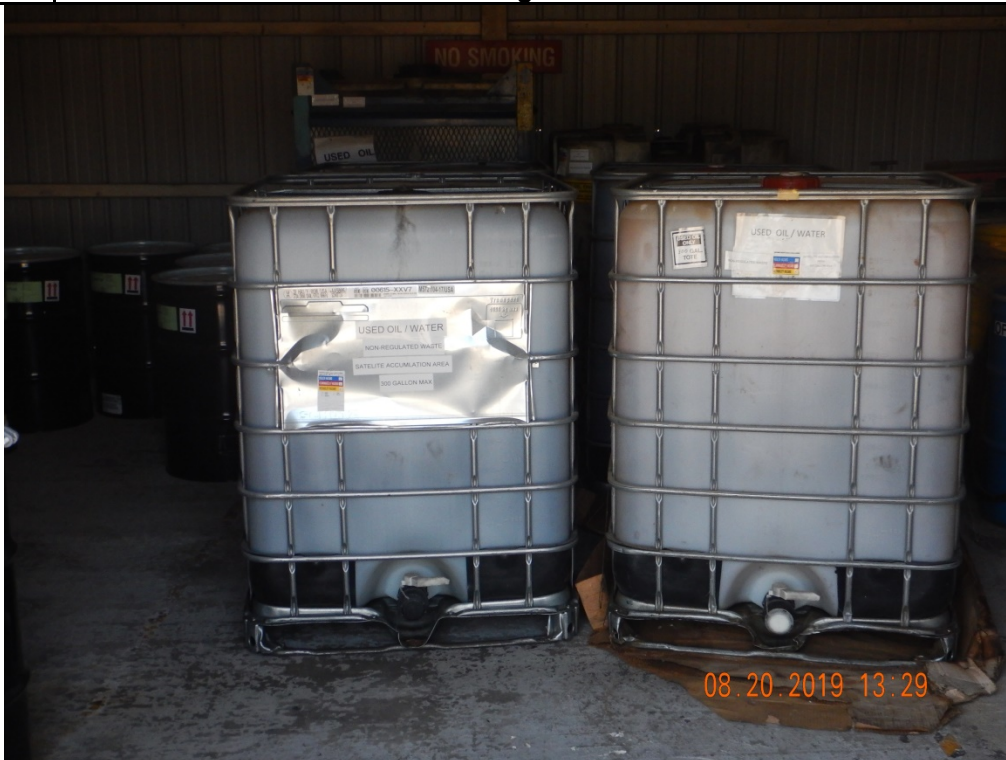
Photographer:	Jason Bolenbaugh	Date:	8/20/2019
Witness:		Time:	13:29
		Photo #:	10
Description:	Used oil and hazardous waste storage area.

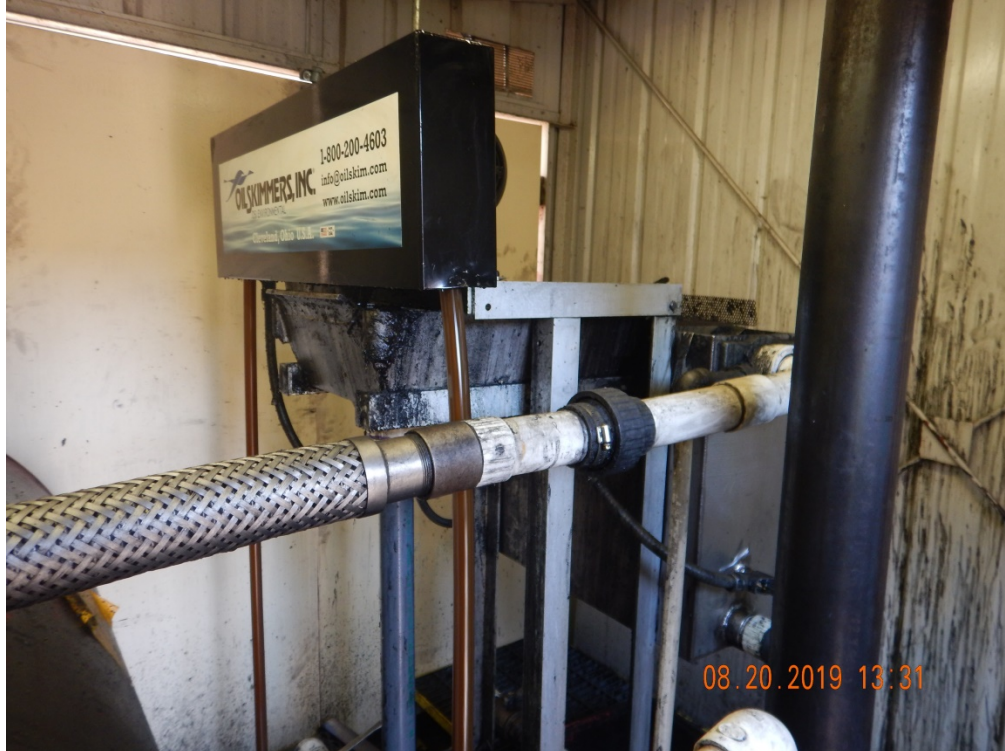
Photographer:	Jason Bolenbaugh	Date:	8/20/2019
Witness:		Time:	13:31
		Photo #:	12
Description:	Mechanism delivering oil into the drain pan that leads to the used oil tank.
