RE: City of El Dorado - Southt Inspections (Union Co)

AFIN: 70-00341 NPDES Permit No.: AR0033723 70-01349 AR0033936

WATER DIVISION INSPECTION REPORT								PORT
ADLQ	AF	IN: 70-00341 P	ERMIT #: AR0033723			I	DATE: 8/19/2019	
ARKANSAS	CC	DUNTY: 70 Union)	PDS	#: 109	9382		MEDIA: WN
Department of Environmental Quality	GF	S LAT: 33.17691	6 LONG: -92.574	1492	LOCA	TION: E	ntrance	9
FACILITY INFORMAT	ION		IN	ISPE	CTION	INFORI	MATIO	N
NAME: City of El Dorado - South LOCATION:			facility type: 1 - Municipal	101	CTOR ID#:	- State		
325 Quail Crossing			5 - Satisfactory	,				Evaluation
El Dorado, AR 71730			(-)	NTRY TIME 19:30		T TIME: 5:05		FFECTIVE DATE:
RESPONSIBLE OFFIC	CIAL		0/10/2010	.5.55			1/1/20 PERMIT EX	J15 (PIRATION DATE:
NAME: / TITLE							12/31	/2019
Veronica Smith-Creer / Mayor			FAYETTEVILLE	SHA	I F RF	I ATFD:	N	
City of El Dorado			FAYETTEVILLE SHALE VIOLATIONS: N					
MAILING ADDRESS: P.O. Box 2170			INSPECTION PARTICIPANTS					
CITY, STATE, ZIP:			NAME/TITLE/PHONE/FAX/EMAIL/ETC.:					
El Dorado AR 71730			John Peppers/Superintendent/870-862-6451 (ext. 117)

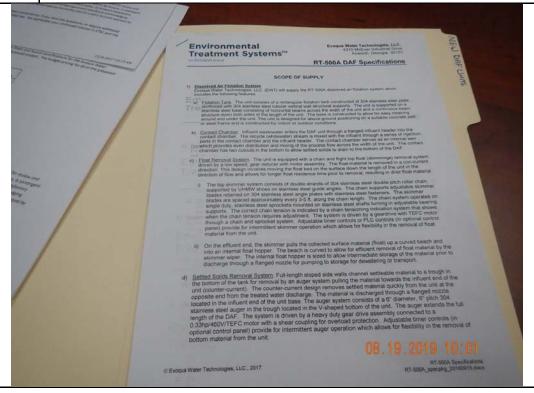
Photographer:	Michael Young	Date:	08/19/2019	Time:	10:01
Witness:				Photo #:	2

Description: Quotes for the new DAF units for South Plant.

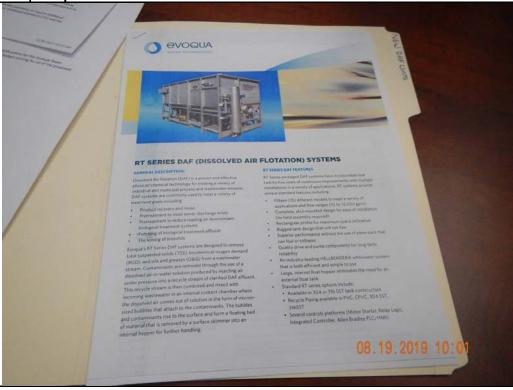
Description: **Evoqua DAF unit to be ordered for South Plant.**

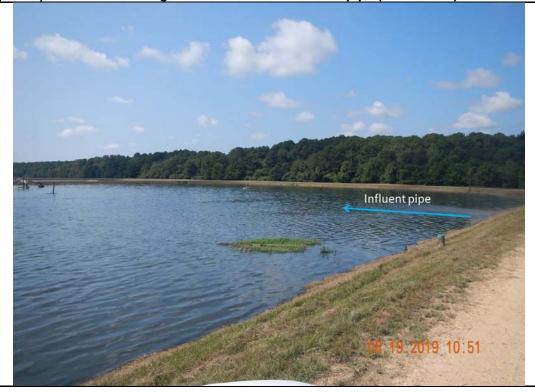
Photographer: Michael Young Date: 08/19/2019 Time: 10:51
Witness: Photo #: 4

Description: Influent aerated lagoon and location of influent pipe (underwater).

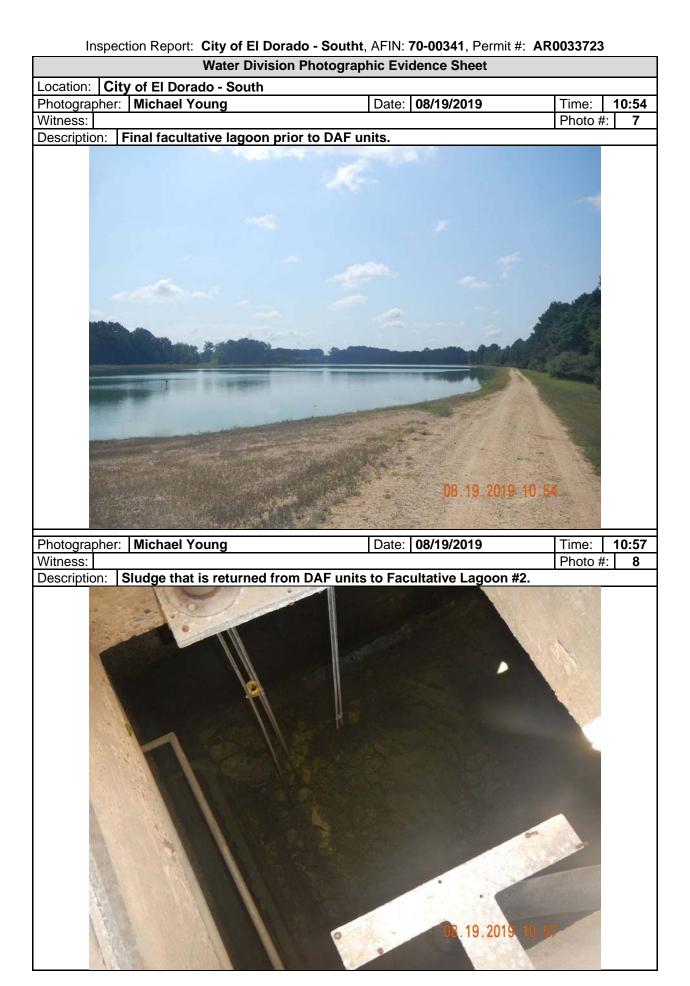
Water Division Photographic Evidence Sheet Location: City of El Dorado - South Photographer: Michael Young Date: 08/19/2019 Time: 10:58 Witness: Photo #: 9

Description: Exterior of DAF unit at South Plant.

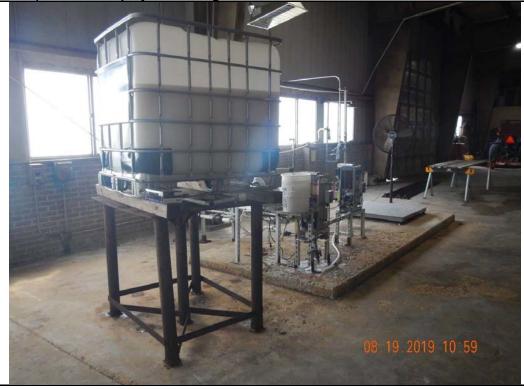
Water Division Photographic Evidence Sheet						
Location: City of El Dorado - South						
Photographer: Michael Young	Date:	08/19/2019	Time:	10:59		
Witness:			Photo #:	11

Description: Caustic and polymer dosing.

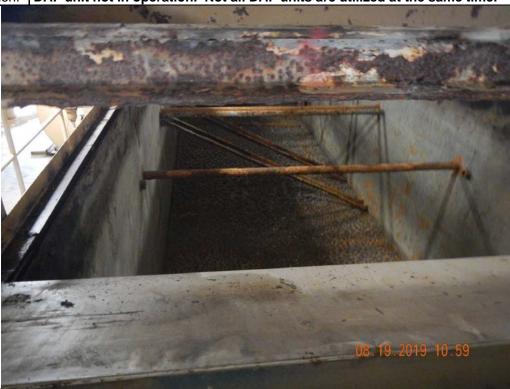
Photographer:	Michael Young	Date:	08/19/2019	Time:	10:59
Witness:				Photo #:	12

Description: DAF unit not in operation. Not all DAF units are utilized at the same time.

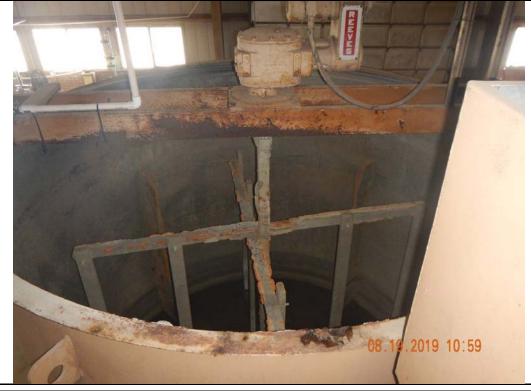
Water Division Photographic Evidence Sheet Location: City of El Dorado - South Photographer: Michael Young Date: 08/19/2019 Time: 10:59 Witness: Photo #: 13

Description: Chemical mixing unit empty when DAF unit is not used.

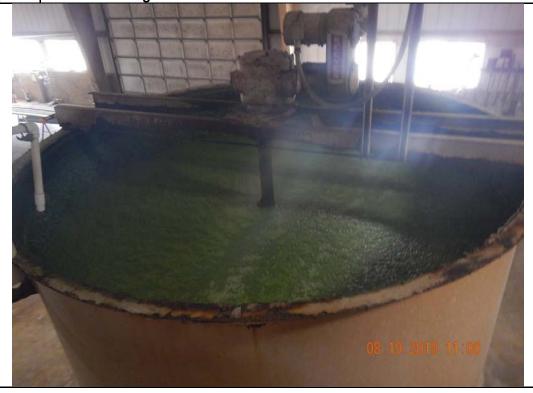
Photographer:	Michael Young	Date:	08/19/2019	Time:	11:00
Witness:				Photo #:	14

Description: Chemical mixing unit in use.

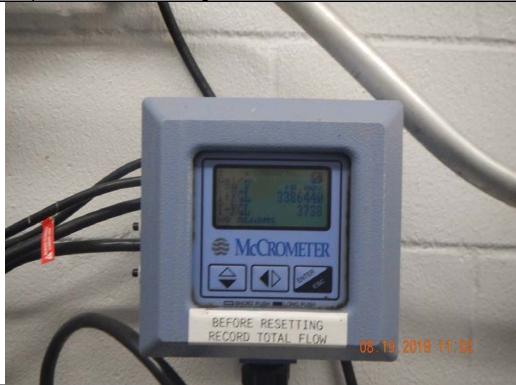
Water Division Photographic Evidence Sheet							
Location: City of El Dorado - South							
Photograph	ner:	Michael Young	Date:	08/19/2019	Time:	11:02	
Witness:				Photo #	: 17

Description: Flowmeter readout for mag-flow device at Outfall 010R.

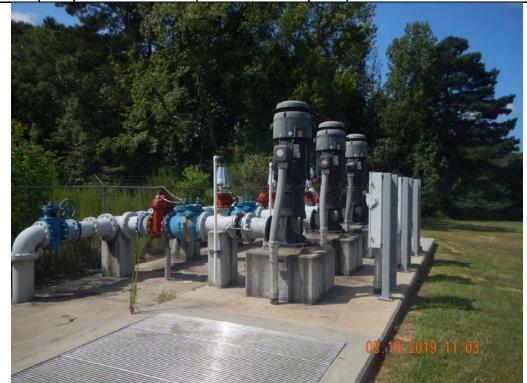
Photographer: Michael Young Date: 08/19/2019 Time: 11:03
Witness: Photo #: 18

Description: Pumps for Outfall 010S (Ouachita Joint Pipeline).

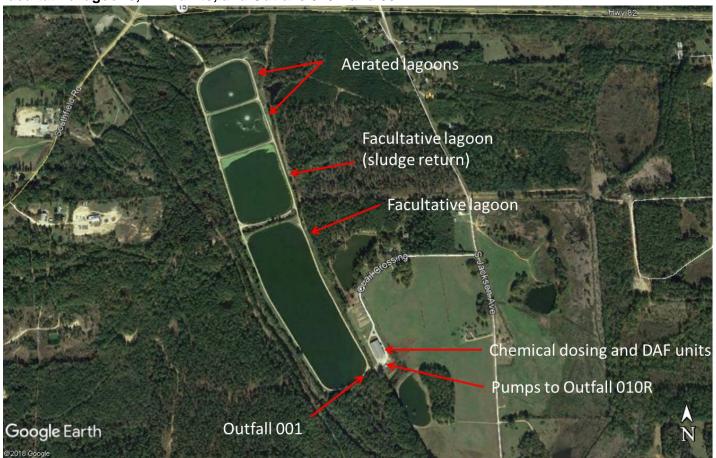
Figure 1. Overview of City of El Dorado – South Plant with the locations of the aerated lagoons, facultative lagoons, DAF units, and Outfalls 010R and 001.
