**RE: Camden Water Utilities Inspections (Ouachita Co)**  
**AFIN: 52-00073**                      **NPDES Permit No.: AR0022365**  
**ARR000962**

<p><b>A R K A N S A S</b> Department of Environmental Quality</p>	<b>WATER DIVISION INSPECTION REPORT</b>				
	AFIN: <b>52-00073</b>	PERMIT #: <b>AR0022365</b>	DATE: <b>10/30/2019</b>		
	COUNTY: <b>52 Ouachita</b>	PDS #: <b>110284</b>	MEDIA: <b>WN</b>		
	GPS LAT: <b>33.563409</b> LONG: <b>-92.816980</b> LOCATION: <b>Entrance</b>				
<b>FACILITY INFORMATION</b>		<b>INSPECTION INFORMATION</b>			
NAME: <b>Camden Water Utilities</b> LOCATION: <b>101 Ouachita 197</b> CITY: <b>Camden, AR 71701</b>		FACILITY TYPE: <b>1 - Municipal</b> INSPECTOR ID#: <b>101531 S - State</b> FACILITY EVALUATION RATING: <b>2 - Marginal</b> INSPECTION TYPE: <b>Compliance Evaluation</b>			
<b>RESPONSIBLE OFFICIAL</b>		DATE(S): <b>10/30/2019</b> ENTRY TIME: <b>09:40</b> EXIT TIME: <b>12:52</b> PERMIT EFFECTIVE DATE: <b>9/1/2018</b> PERMIT EXPIRATION DATE: <b>8/31/2023</b>			
NAME / TITLE: <b>David Richardson / Manager</b> COMPANY: <b>Camden Water Utilities</b> MAILING ADDRESS: <b>P.O. Drawer J</b> CITY, STATE, ZIP: <b>Camden AR 71711</b> PHONE & EXT: / FAX: <b>870-8

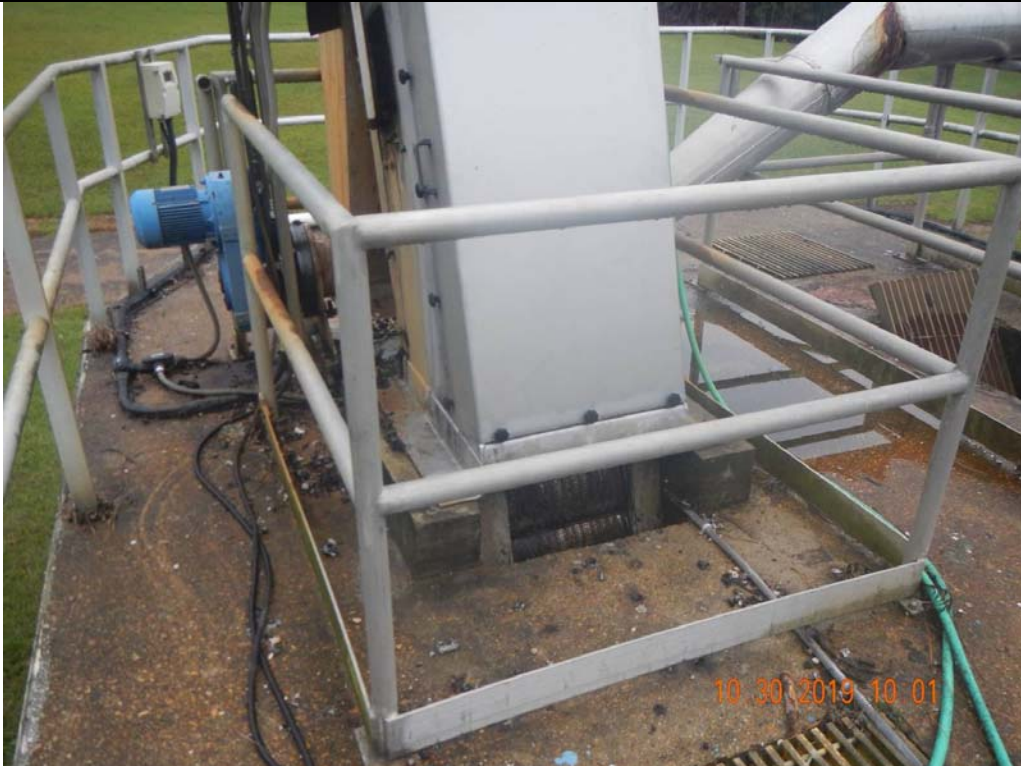
Location:	<b>Camden Water Utilities</b>		
Photographer:	<b>Michael Young</b>	Date:	<b>10/30/2019</b>
Witness:		Time:	<b>10:01</b>
		Photo #:	<b>1</b>

Description: **Rotating bar screen that is automatically cleaned.**

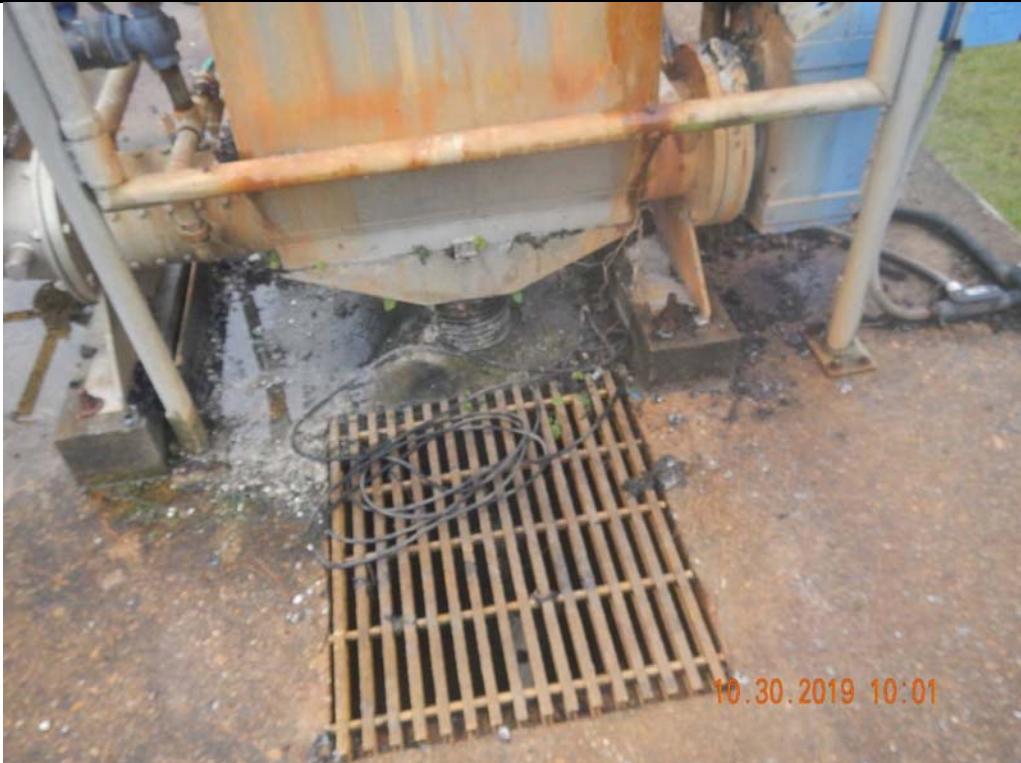
Photographer:	<b>Michael Young</b>	Date:	<b>10/30/2019</b>
Witness:		Time:	<b>10:01</b>
		Photo #:	<b>2</b>

Description: **Influent discharge to bar screen.**

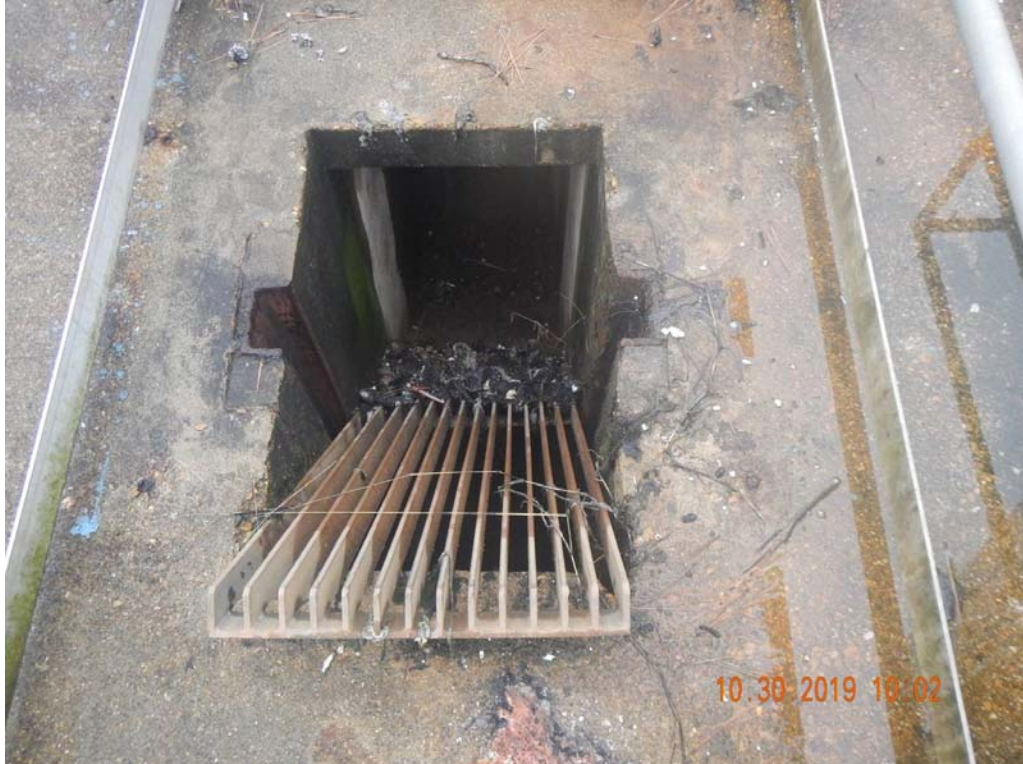
Location:	<b>Camden Water Utilities</b>		
Photographer:	<b>Michael Young</b>	Date:	<b>10/30/2019</b>
Time:	<b>10:02</b>	Witness:	
Photo #:	<b>3</b>

Description: **Manual bar screen used only in redundancy.**

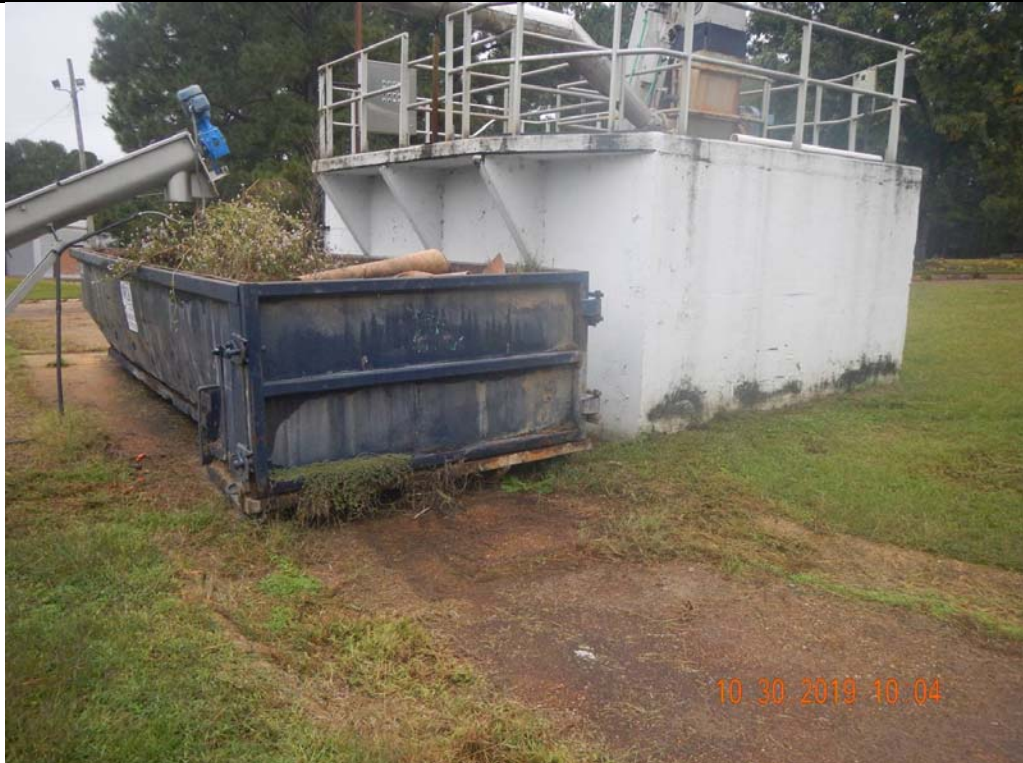
Photographer:	<b>Michael Young</b>	Date:	<b>10/30/2019</b>
Time:	<b>10:04</b>	Witness:	
Photo #:	<b>4</b>

Description: **Waste collection area for bar screen and grit screener.**

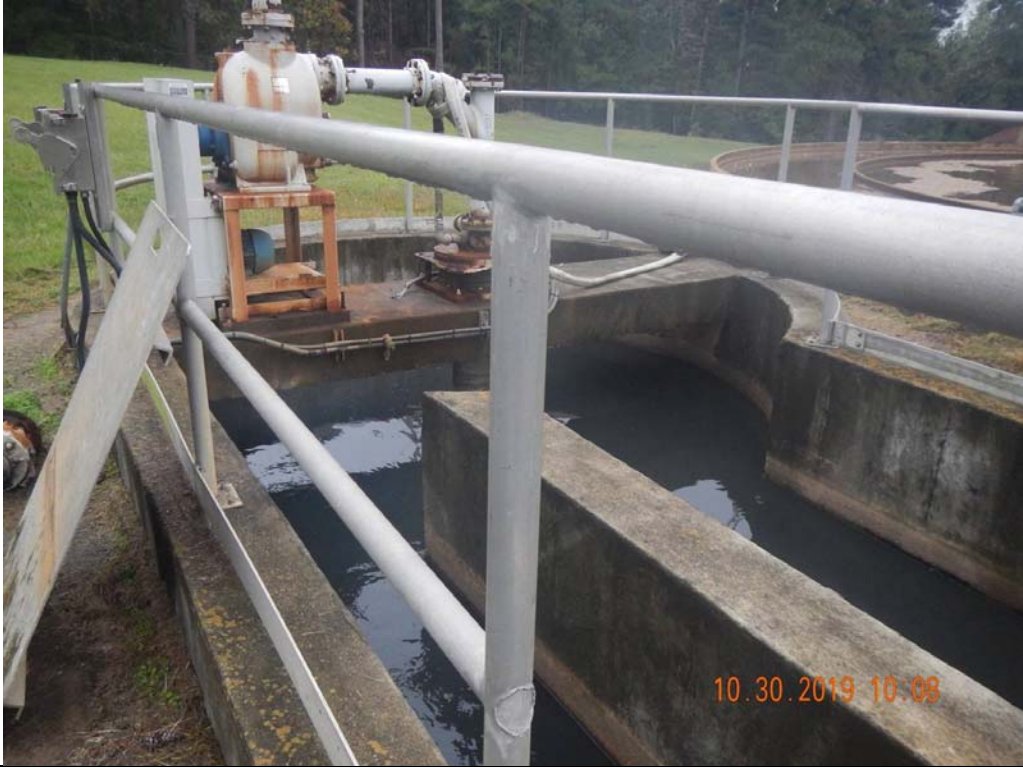
Location:	<b>Camden Water Utilities</b>		
Photographer:	<b>Michael Young</b>	Date:	<b>10/30/2019</b>
Time:	<b>10:08</b>	Witness:	
Photo #:	<b>5</b>	Description:	
<b>Grit collection area in centrifugal screener.</b>

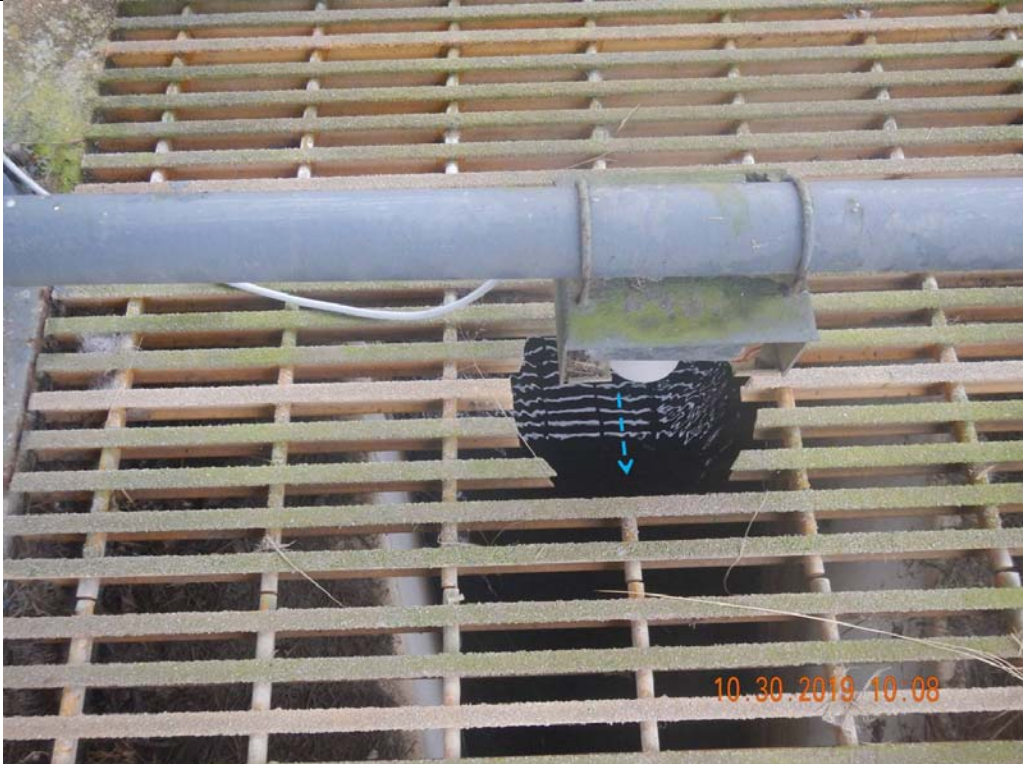
Photographer:	<b>Michael Young</b>	Date:	<b>10/30/2019</b>
Time:	<b>10:08</b>	Witness:	
Photo #:	<b>6</b>	Description:	
<b>Influent Parshall flume and ultrasonic flowmeter sonde.</b>

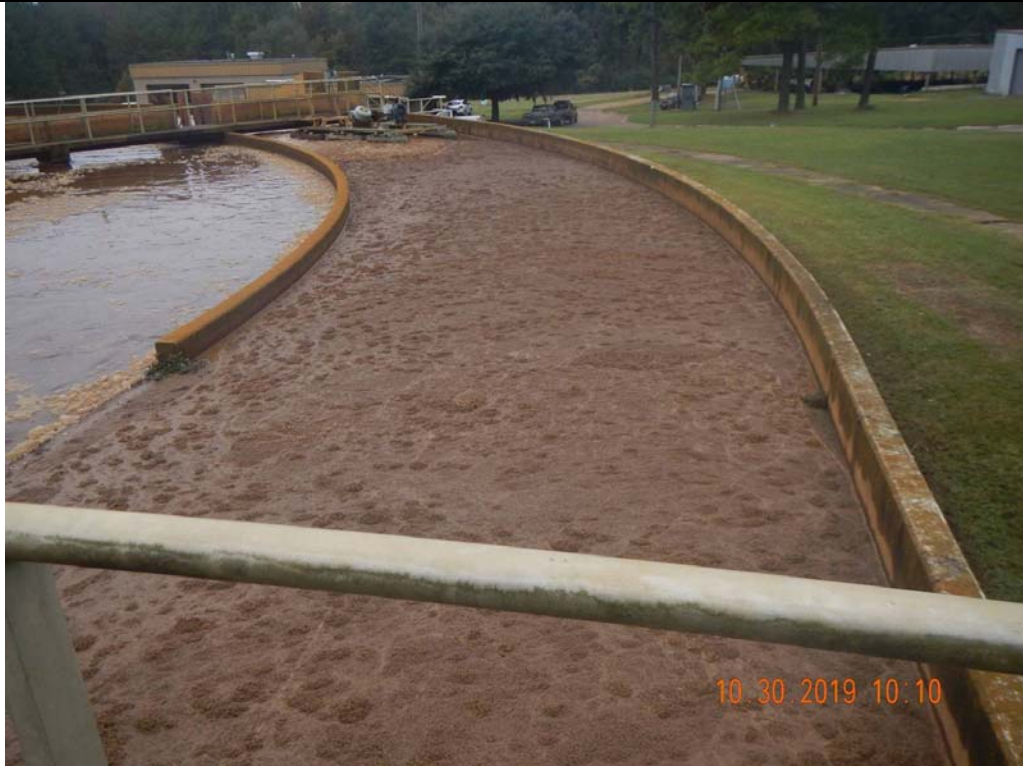
Location:	<b>Camden Water Utilities</b>		
Photographer:	<b>Michael Young</b>	Date:	<b>10/30/2019</b>
Time:	<b>10:10</b>	Witness:	
Photo #:	<b>7</b>

Description: **Denitrification zone of oxidation ditch.**

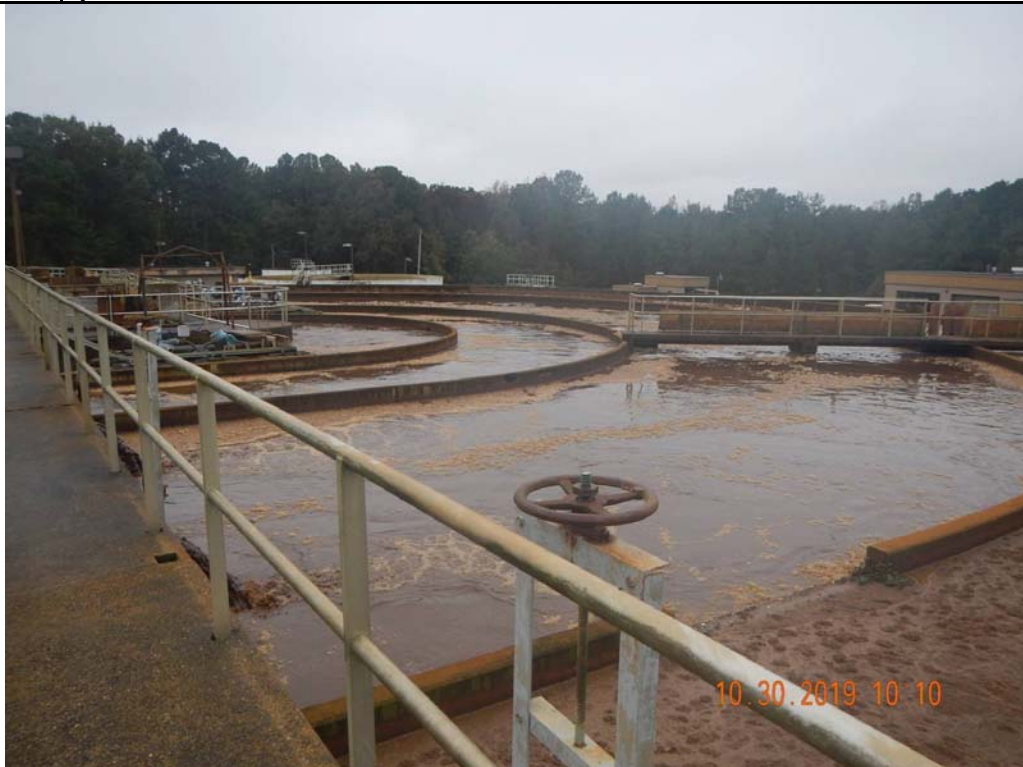
Photographer:	<b>Michael Young</b>	Date:	<b>10/30/2019</b>
Time:	<b>10:10</b>	Witness:	
Photo #:	<b>8</b>

Description: **Oxidation ditch in the aeration basin for the activated sludge process. Note low quantities of foam.**

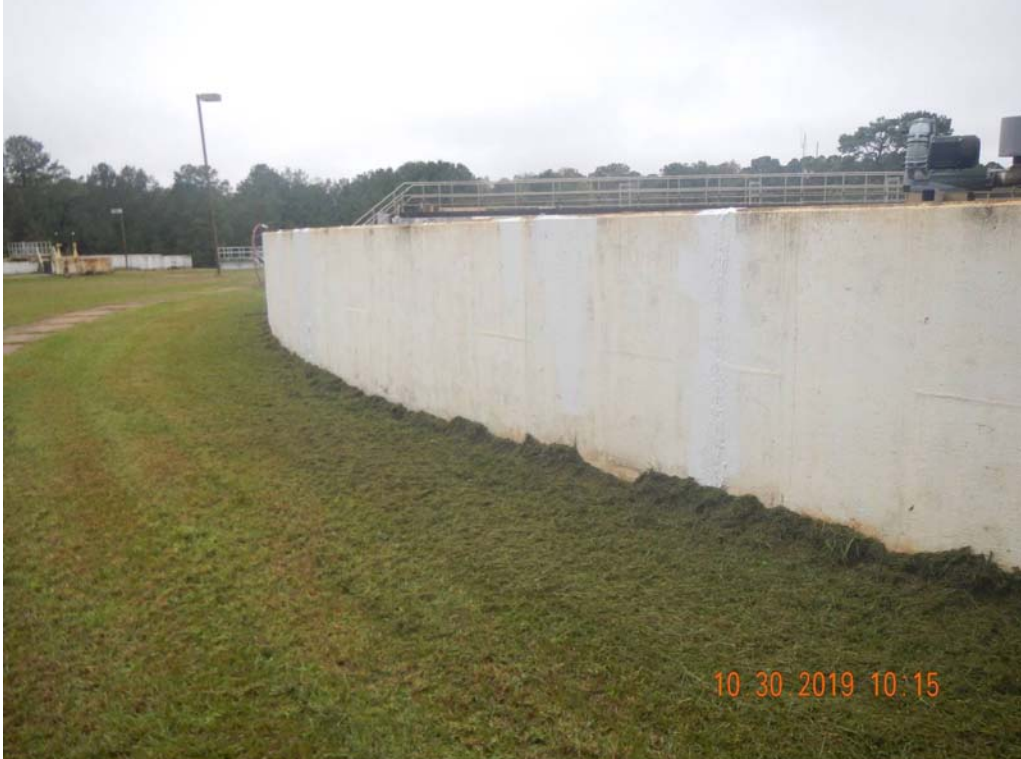
Location:	<b>Camden Water Utilities</b>		
Photographer:	<b>Michael Young</b>	Date:	<b>10/30/2019</b>
Time:	<b>10:15</b>	Witness:	
Photo #:	<b>9</b>	Description: <b>Aeration basin wall had cracks repaired following previous inspection.</b>

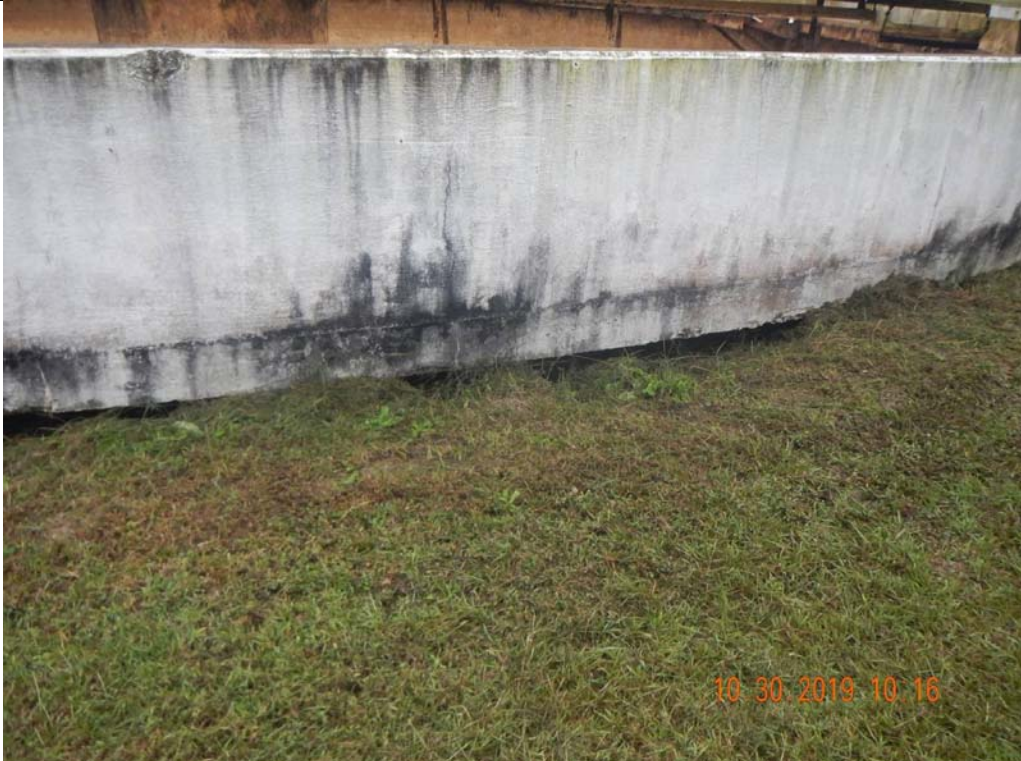
Photographer:	<b>Michael Young</b>	Date:	<b>10/30/2019</b>
Time:	<b>10:16</b>	Witness:	
Photo #:	<b>10</b>	Description: <b>Some erosion around base of clarifier.</b>

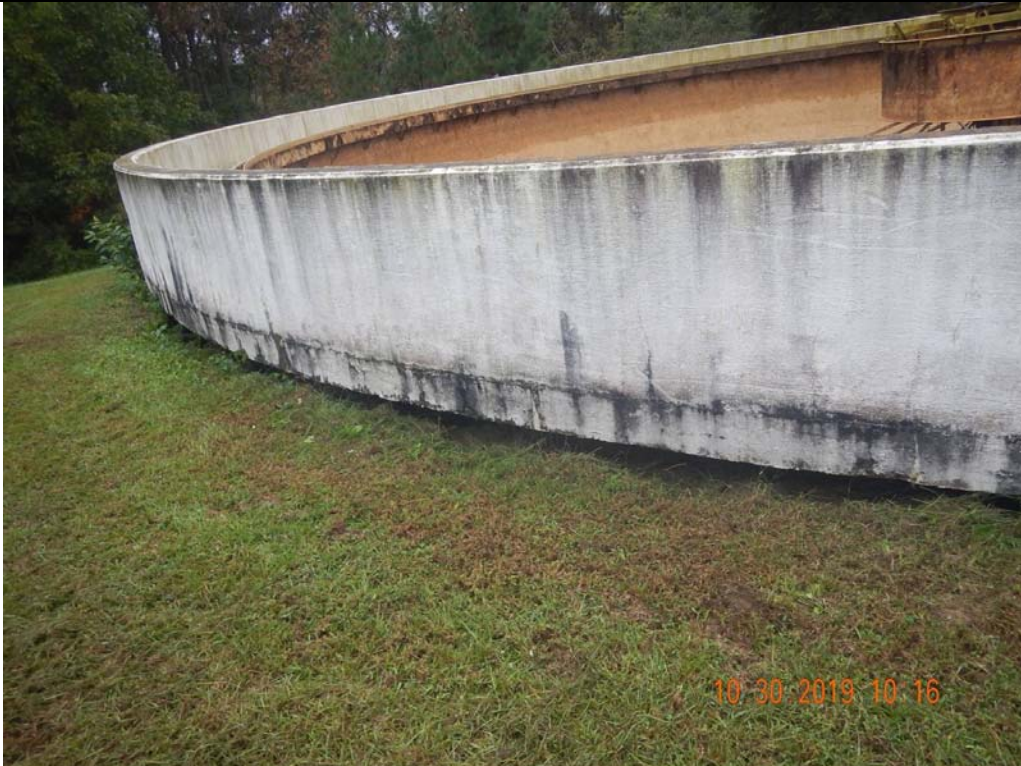
Location:	<b>Camden Water Utilities</b>		
Photographer:	<b>Michael Young</b>	Date:	<b>10/30/2019</b>
Time:	<b>10:16</b>	Witness:	
Photo #:	<b>11</b>	Description:	
<b>Some erosion around base of clarifier.</b>

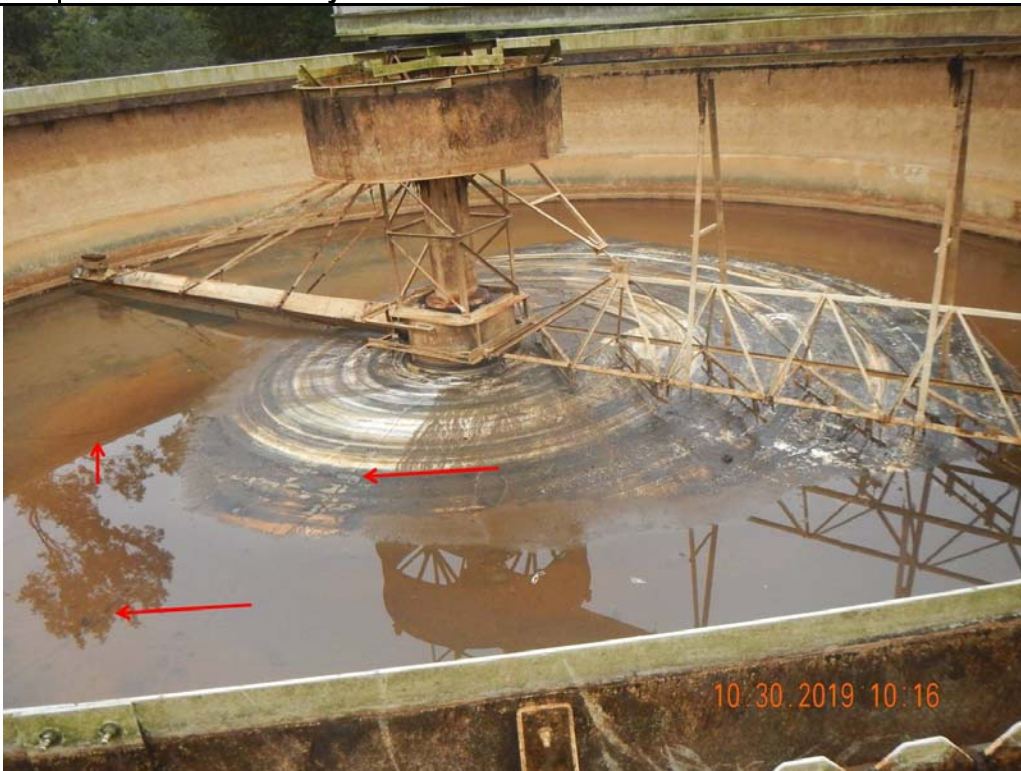
Photographer:	<b>Michael Young</b>	Date:	<b>10/30/2019</b>
Time:	<b>10:16</b>	Witness:	
Photo #:	<b>12</b>	Description:	
<b>Secondary clarifier that was not in operation at time of inspection. Cracks in concrete indicated by red arrows.</b>

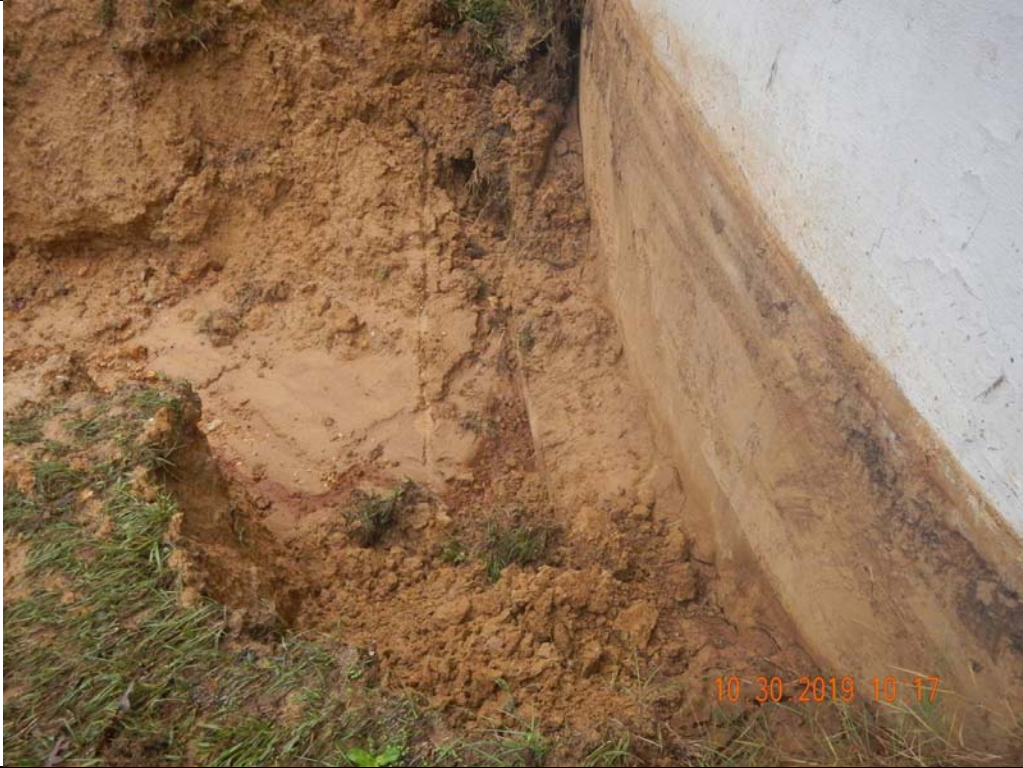
Location:	<b>Camden Water Utilities</b>		
Photographer:	<b>Michael Young</b>	Date:	<b>10/30/2019</b>
Witness:		Time:	<b>10:17</b>
		Photo #:	<b>13</b>
Description:	<b>Hole and trench dug to relieve groundwater from under clarifier. Note iron stain of groundwater discharge.</b>

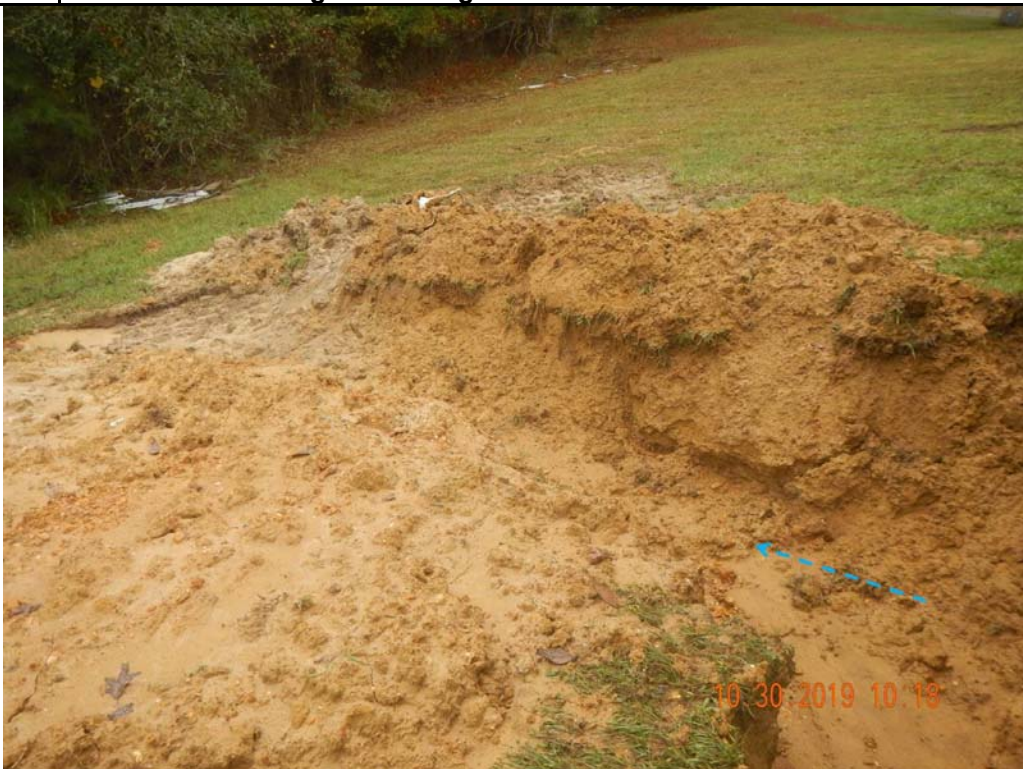
Photographer:	<b>Michael Young</b>	Date:	<b>10/30/2019</b>
Witness:		Time:	<b>10:18</b>
		Photo #:	<b>14</b>
Description:	<b>Hole and trench dug to relieve groundwater from under clarifier.</b>

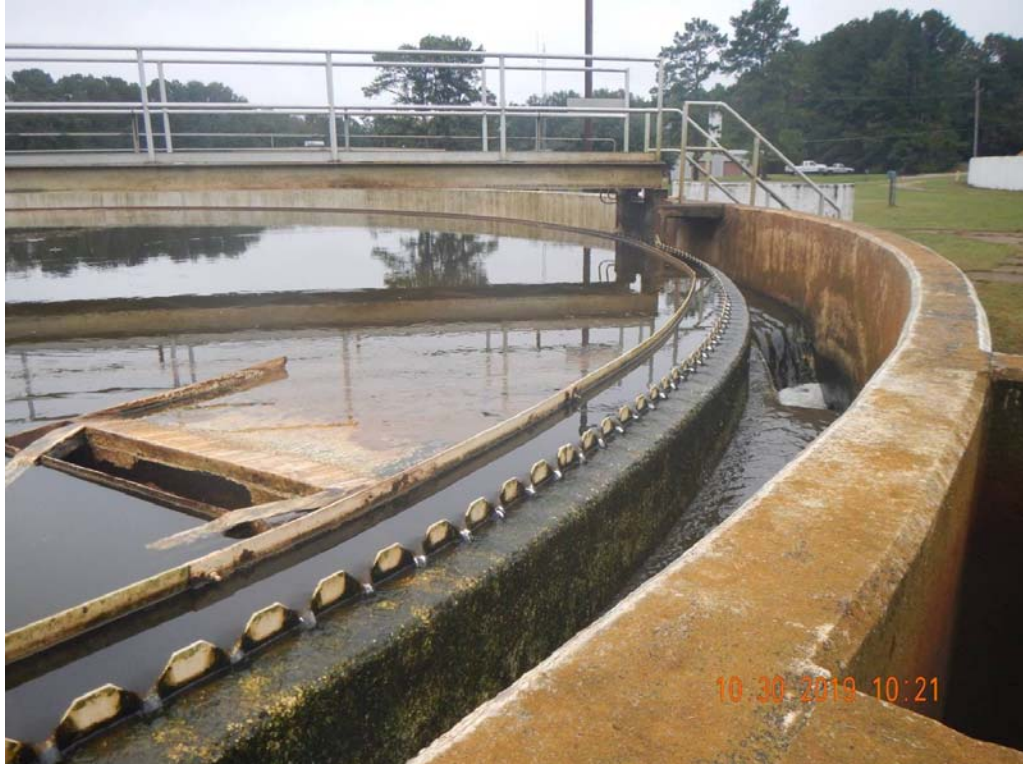
Location:	<b>Camden Water Utilities</b>		
Photographer:	<b>Michael Young</b>	Date:	<b>10/30/2019</b>
Time:	<b>10:21</b>	Witness:	
Photo #:	<b>15</b>	Description:	
<b>Discharge from clarifier weir was clear and contained no solids.</b>

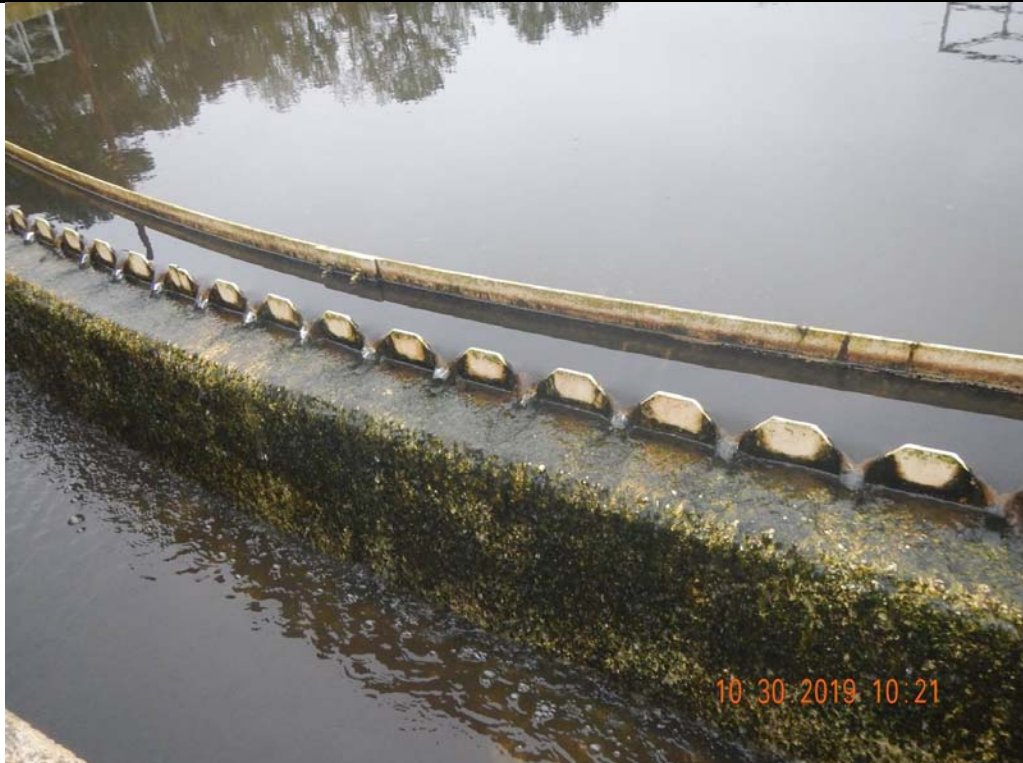
Photographer:	<b>Michael Young</b>	Date:	<b>10/30/2019</b>
Time:	<b>10:21</b>	Witness:	
Photo #:	<b>16</b>	Description:	
<b>Discharge from clarifier weir was clear and contained no solids.</b>

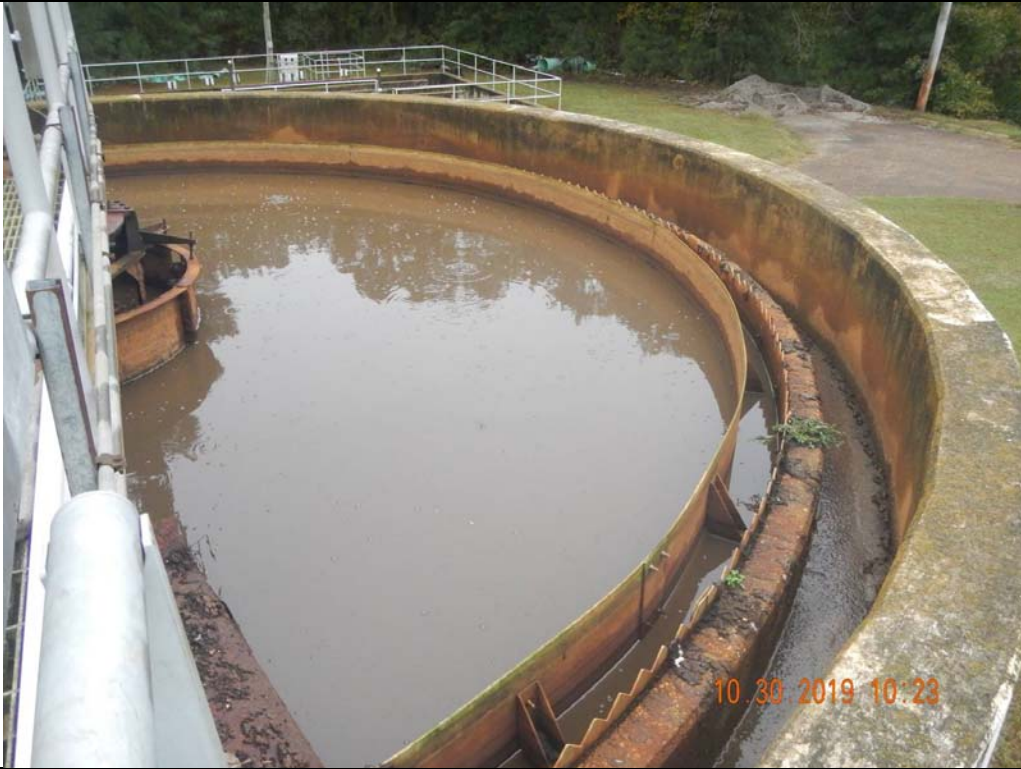
Location:	<b>Camden Water Utilities</b>		
Photographer:	<b>Michael Young</b>	Date:	<b>10/30/2019</b>
Time:	<b>10:23</b>	Witness:	
Photo #:	<b>17</b>

Description: **Aerobic sludge digester.**

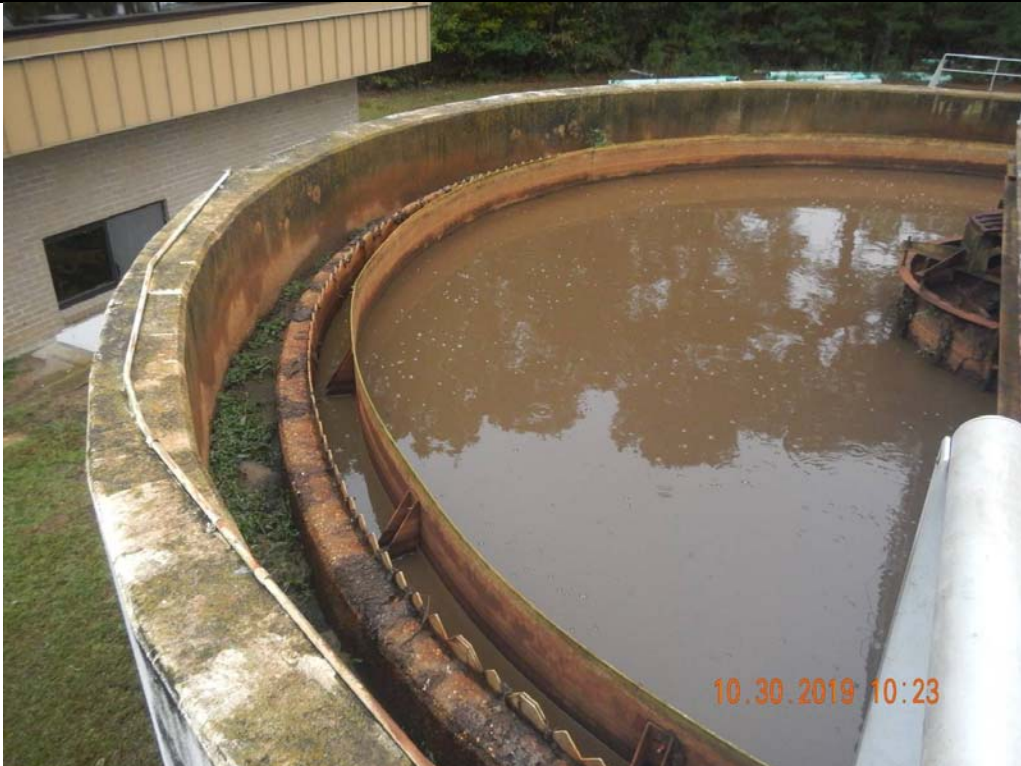
Photographer:	<b>Michael Young</b>	Date:	<b>10/30/2019</b>
Time:	<b>10:23</b>	Witness:	
Photo #:	<b>18</b>

Description: **Aerobic sludge digester.**

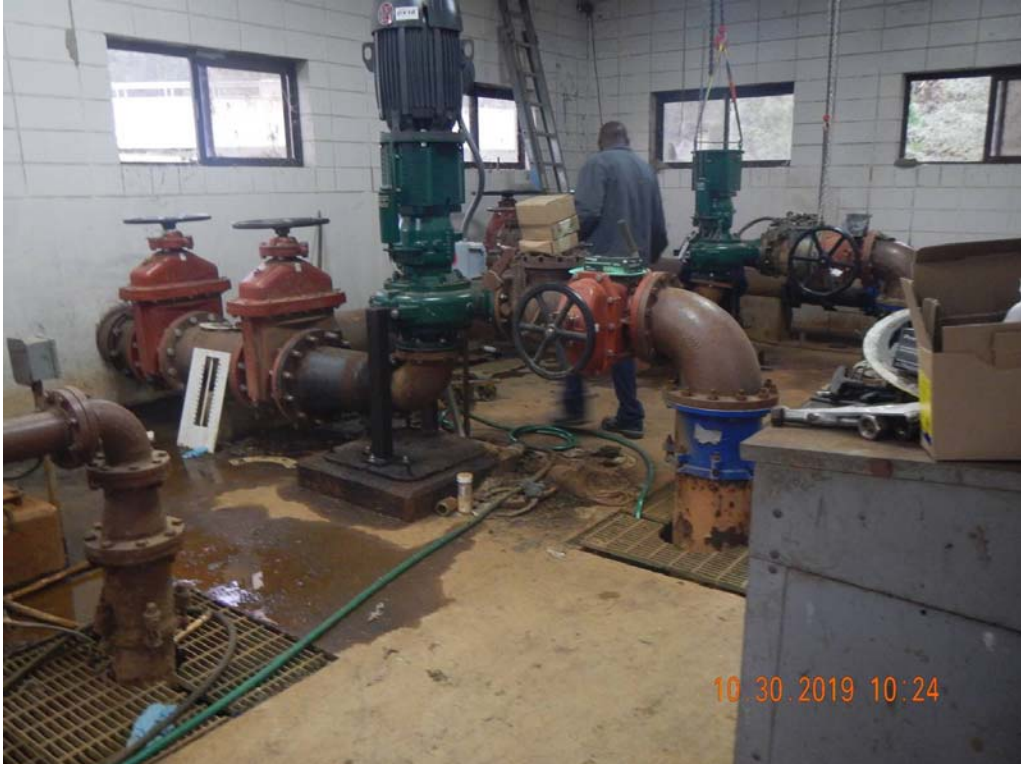
Location:	<b>Camden Water Utilities</b>		
Photographer:	<b>Michael Young</b>	Date:	<b>10/30/2019</b>
Witness:		Time:	<b>10:24</b>
		Photo #:	<b>19</b>
Description:	<b>Pumps for activated sludge system. Maintenance being performed on pump.</b>

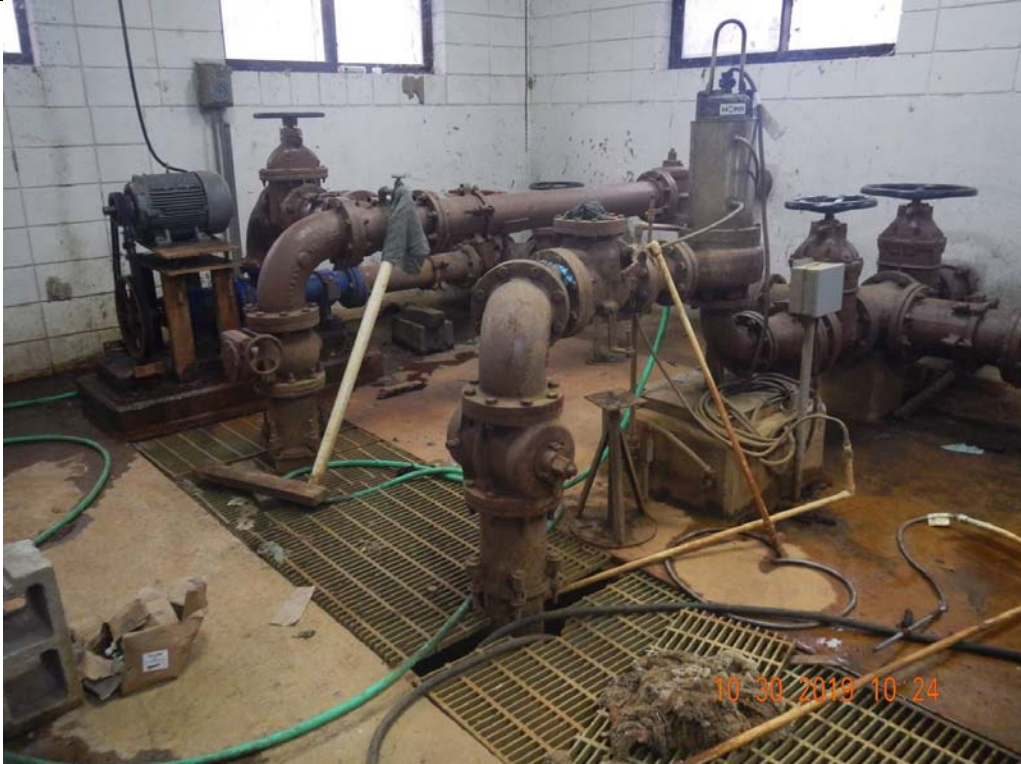
Photographer:	<b>Michael Young</b>	Date:	<b>10/30/2019</b>
Witness:		Time:	<b>10:24</b>
		Photo #:	<b>20</b>
Description:	<b>Pumps for activated sludge system.</b>

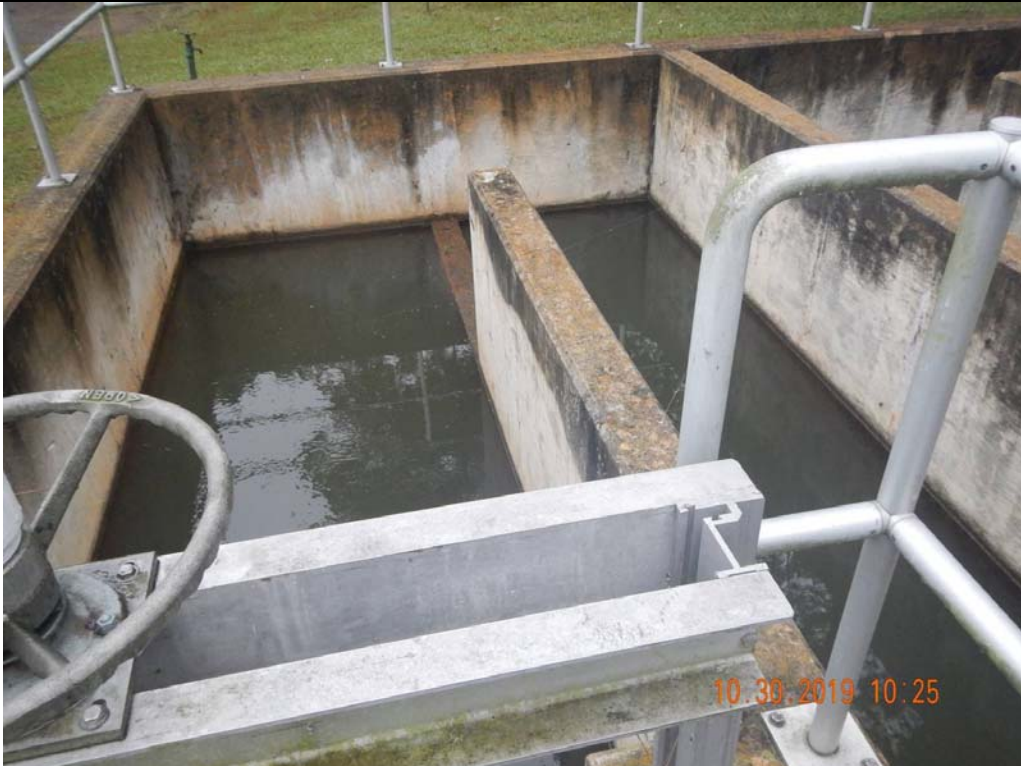
Location:	<b>Camden Water Utilities</b>		
Photographer:	<b>Michael Young</b>	Date:	<b>10/30/2019</b>
Time:	<b>10:25</b>	Witness:	
Photo #:	<b>21</b>

Description: **Chlorine dosing location for chlorine contact.**

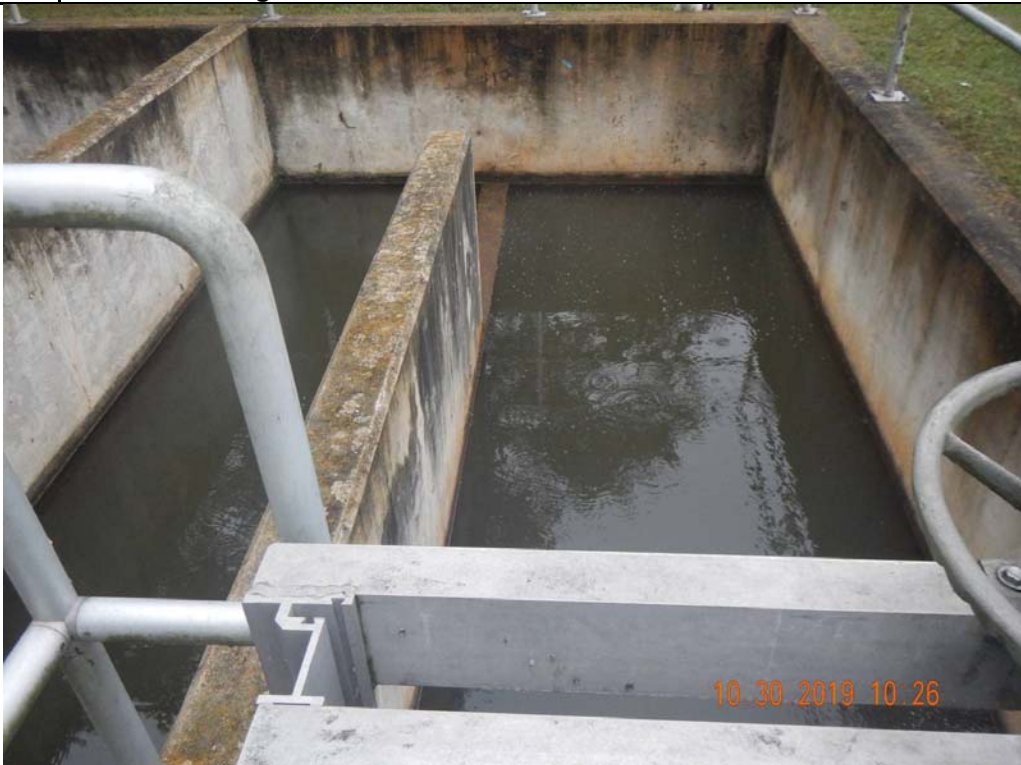
Photographer:	<b>Michael Young</b>	Date:	<b>10/30/2019</b>
Time:	<b>10:26</b>	Witness:	
Photo #:	<b>22</b>

Description: **Chlorine dosing location for chlorine contact.**

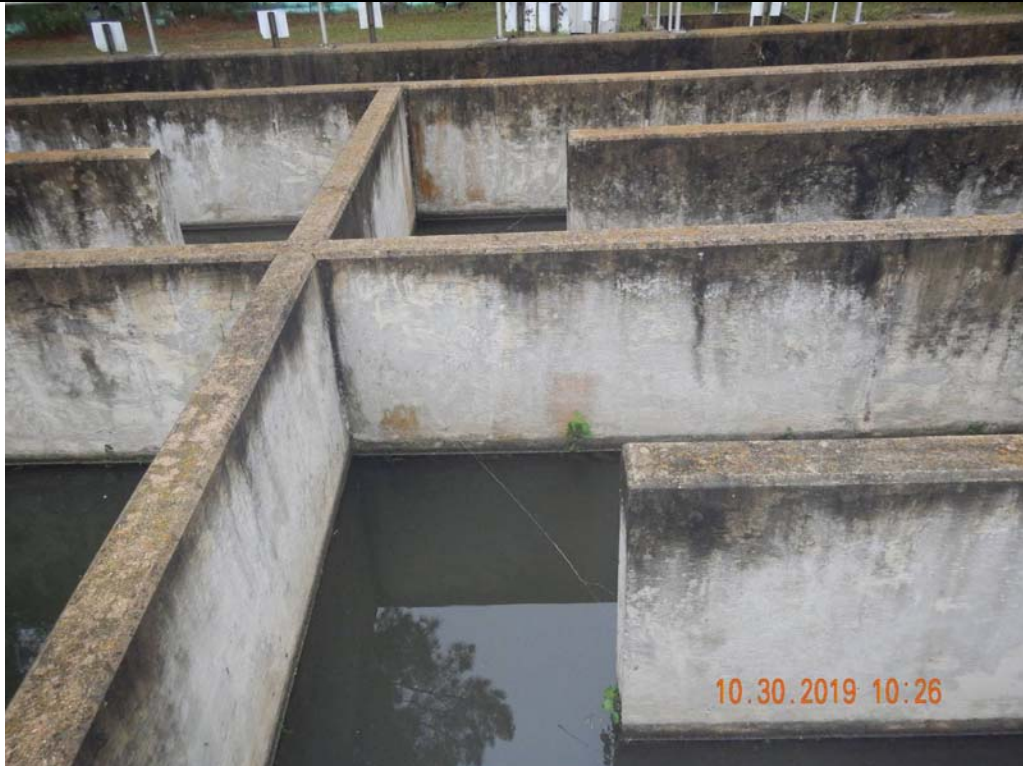
Location:	<b>Camden Water Utilities</b>		
Photographer:	<b>Michael Young</b>	Date:	<b>10/30/2019</b>
Witness:		Time:	<b>10:26</b>
		Photo #:	<b>23</b>
Description:	<b>Chlorine contact chamber.</b>

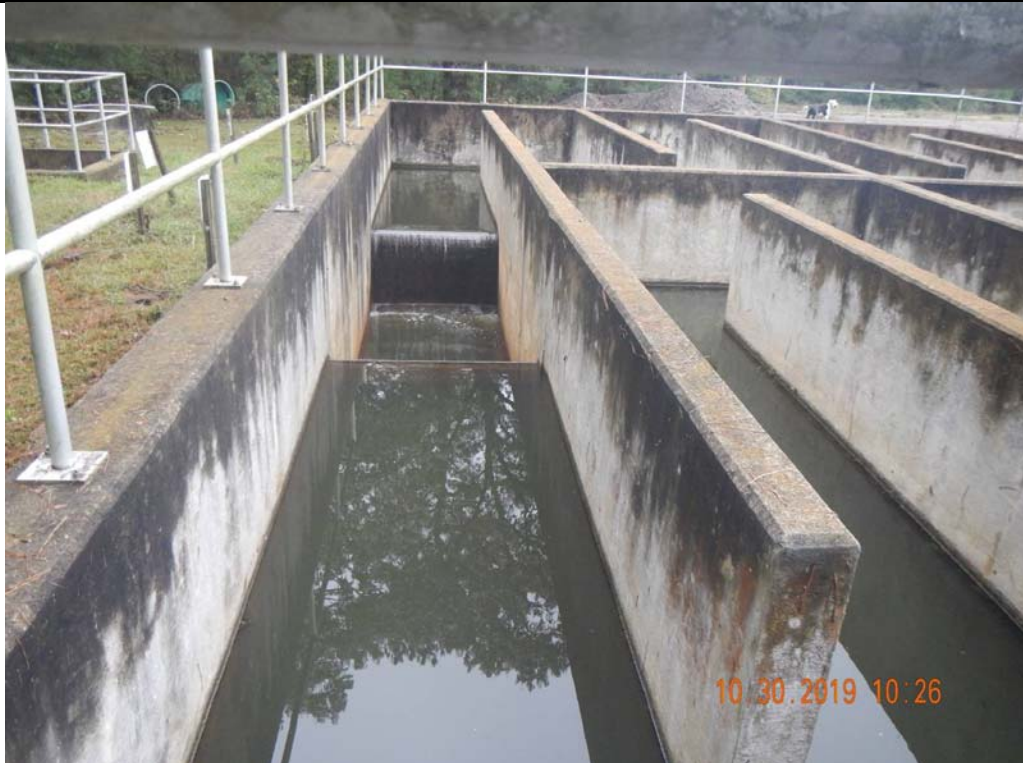
Photographer:	<b>Michael Young</b>	Date:	<b>10/30/2019</b>
Witness:		Time:	<b>10:26</b>
		Photo #:	<b>24</b>
Description:	<b>Discharge from chlorine contact chamber to dechlorination zone.</b>

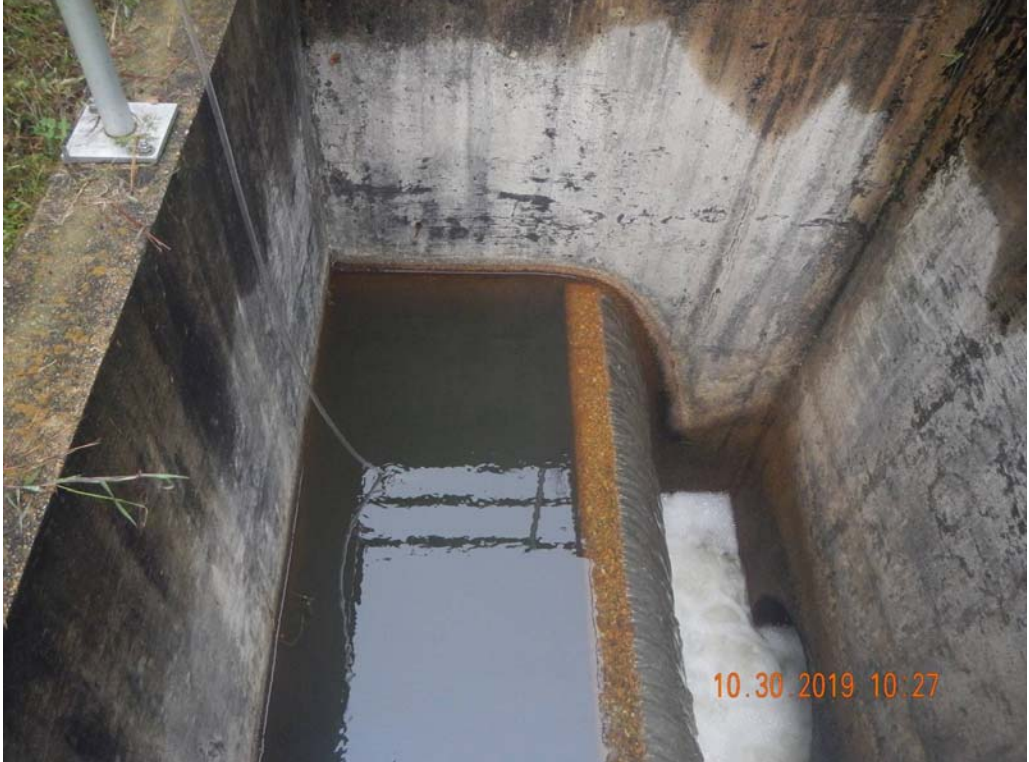
Location:	<b>Camden Water Utilities</b>		
Photographer:	<b>Michael Young</b>	Date:	<b>10/30/2019</b>
Witness:		Time:	<b>10:27</b>
		Photo #:	<b>25</b>

Description: **Sample location for composite sampler is prior to post-aeration. Discharge is piped to Outfall 001 at the Ouachita River.**

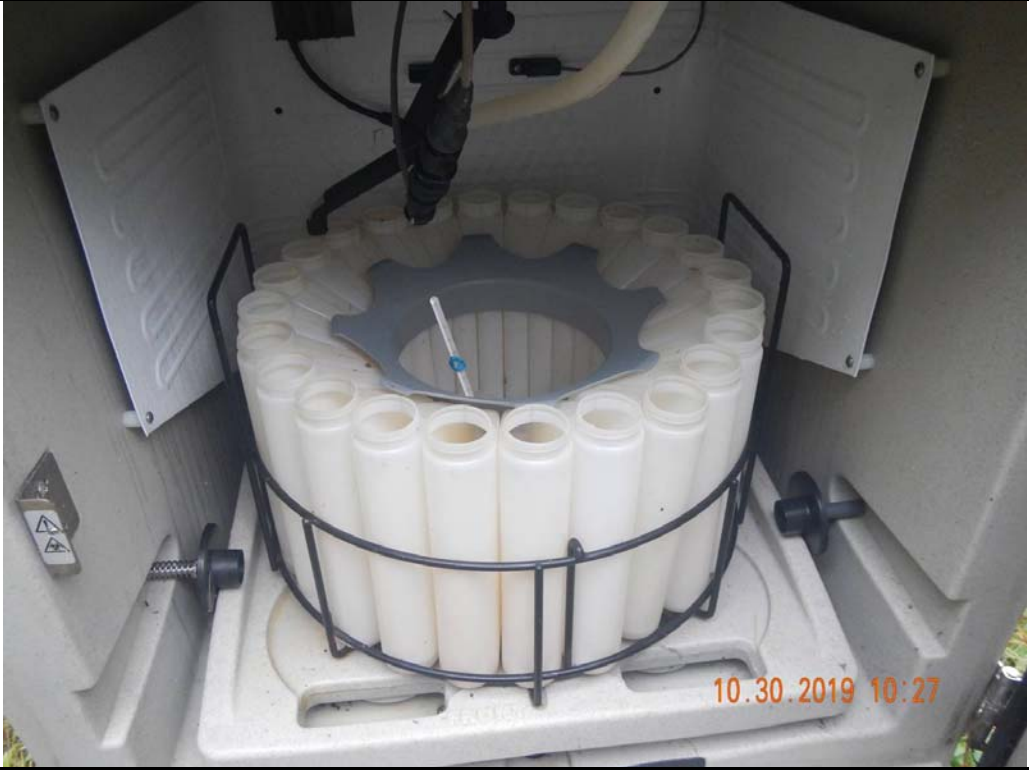
Photographer:	<b>Michael Young</b>	Date:	<b>10/30/2019</b>
Witness:		Time:	<b>10:27</b>
		Photo #:	<b>26</b>

Description: **Refrigerated composite sampler with 24 aliquots in the carousel.**

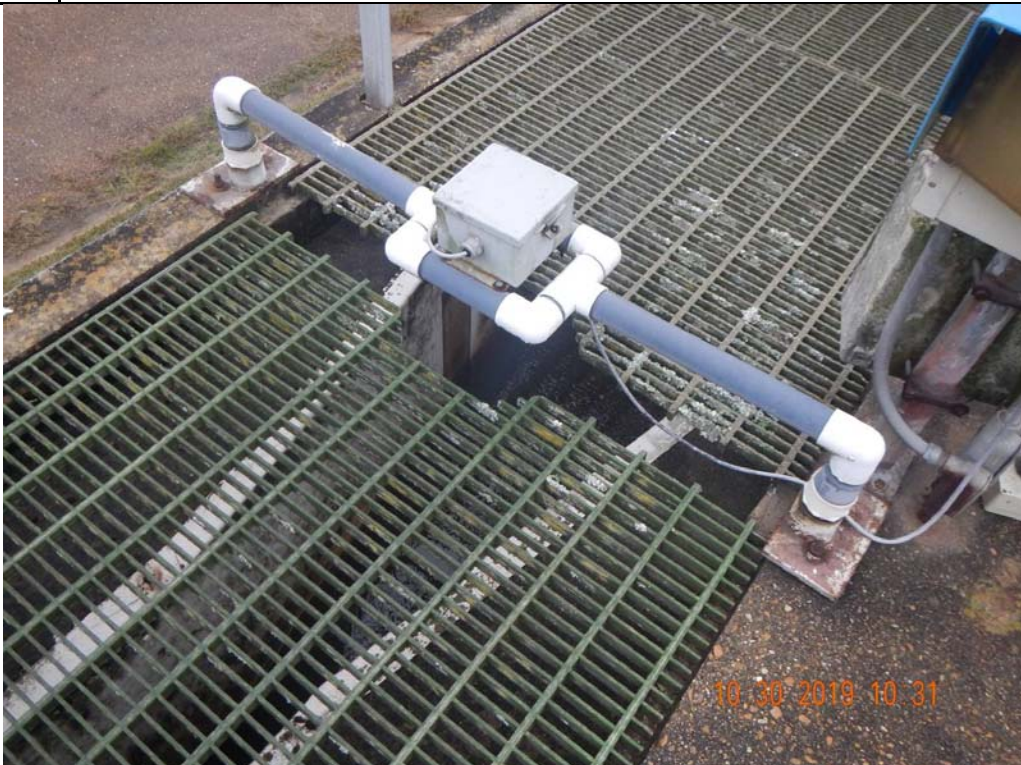
Photographer:	<b>Michael Young</b>	Date:	<b>10/30/2019</b>
Witness:		Time:	<b>10:31</b>
		Photo #:	<b>28</b>

Description: **Ultrasonic flowmeter sonde.**
